EUROPEAN COMMISSION
JOINT RESEARCH CENTRE

Mw 7.5 Earthquake in Indonesia, 28 Sep 2018

01 Oct 2018 - Emergency Report - UPDATE #1

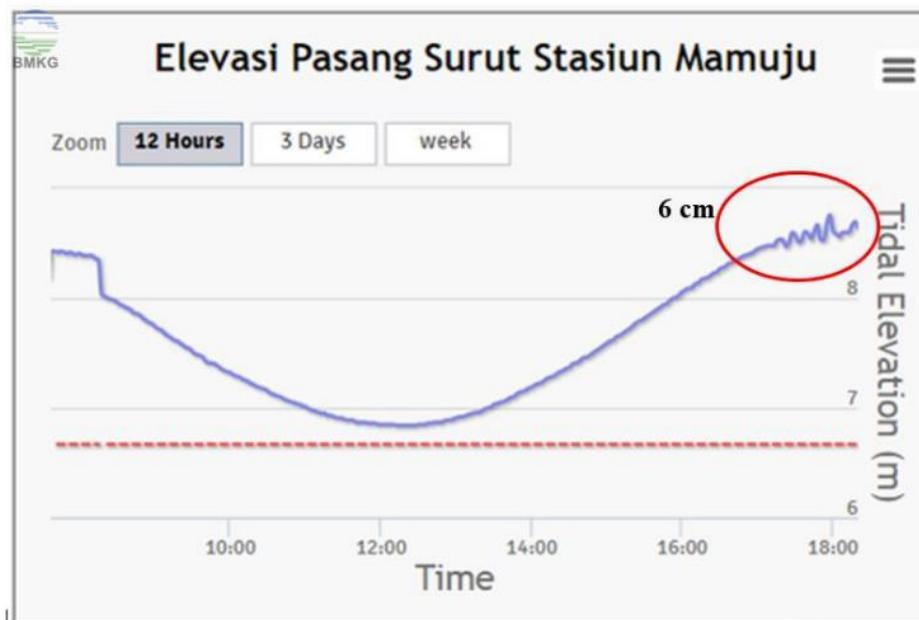
Figure 4 - Mamuju tide gauge signal, on the basis of which the alert was cancelled

From the BMGK report³, automatically translated: '*Based on the results of visual monitoring and equipment at sea for about 30 minutes no changes in sea level and tsunami were observed, BMKG stated that the tsunami early warning ended on 9/28/2018 at 17.39 WIB. Thus the tsunami does not occur. Conditions are safe and people can return to their place*'. This type of action is not normal and in other Monitoring centers there is a time to wait of at least 2 h before lifting the alert. In this case the alert removal after 37 min seems however too optimistic.

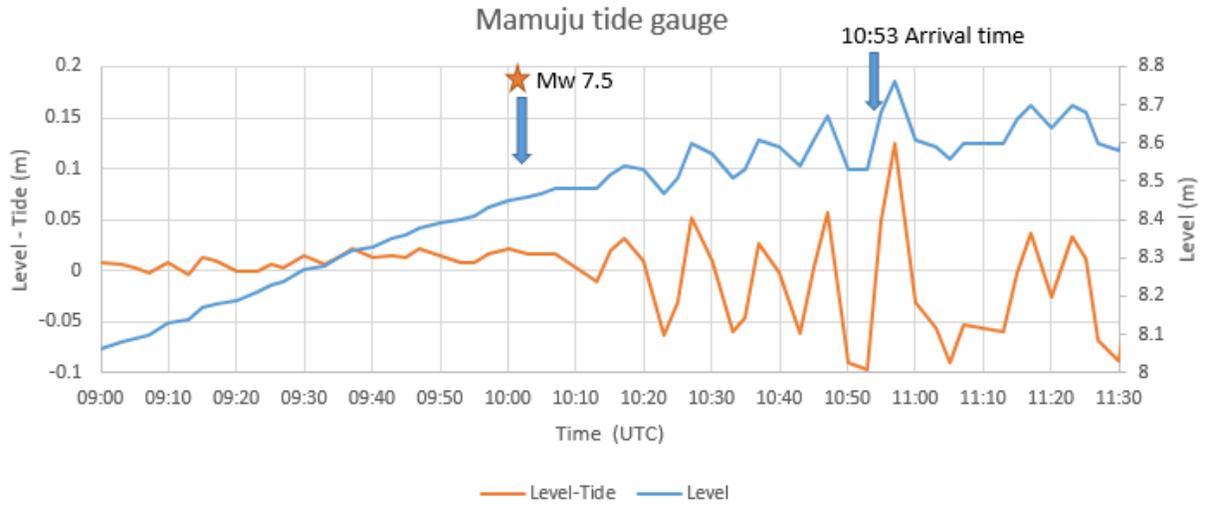
Figure 5 - Processing of Mamuju tide gauge signal

In order to understand the timeline and the following actions, we have processed the signal of Figure. 3 by digitizing the signal and subtracting the continuous component (see Figure. 4). From the residual curve (orange curve) it is possible to note that the oscillation visible at 10:00 cannot be attributed to the Tsunami because the time needed to reach Mamuju, located about 180 km from the epicentre, is in the order of 50-55 minutes (see Figure 5).

Indeed at **10:53** an increase of the oscillations is visible together with a change in the oscillation frequency. Those information could suggest that at **10:27** UCT the 6 cm signal indication that suggested BMG to cancel the alert could be related to a local oscillation eg. shaking induced by the earthquake). At that time the Tsunami had not yet reached Mamuju location (reached instead at 10:53 UTC).

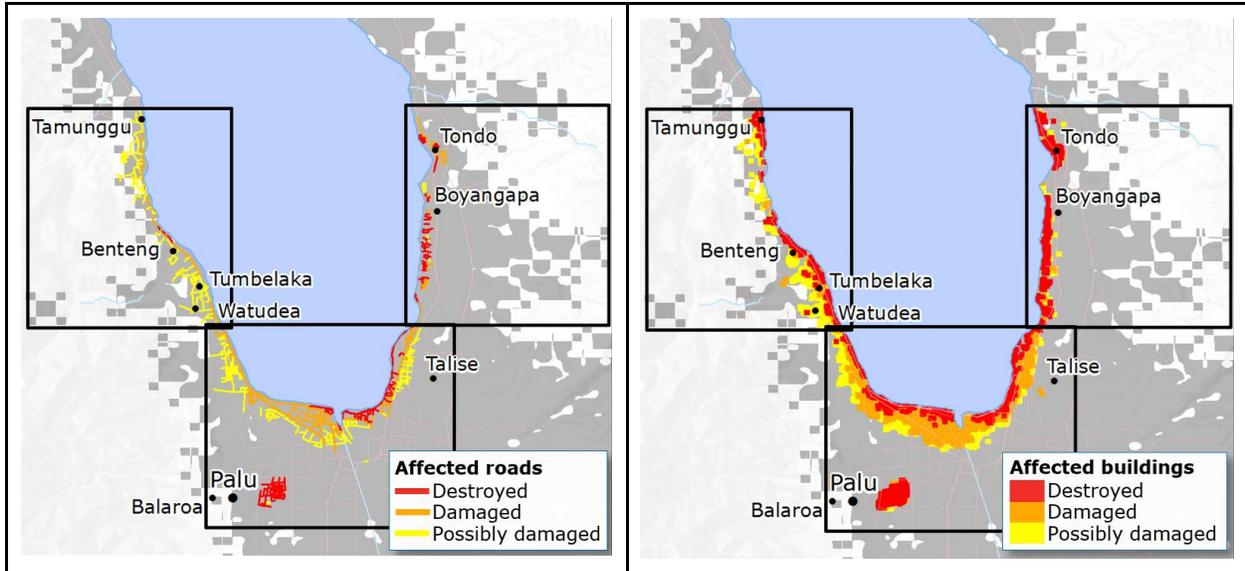
Figure 7 - Affected roads and buildings over the whole town of Palu extracted from Copernicus EMS © 2018 EU, [EMSR317] . From the preliminary assessment of the damage data, the combined effects of the tsunami (along the coast) and of the earthquake are detected. On the South-West of the city, an area affected by liquefaction.

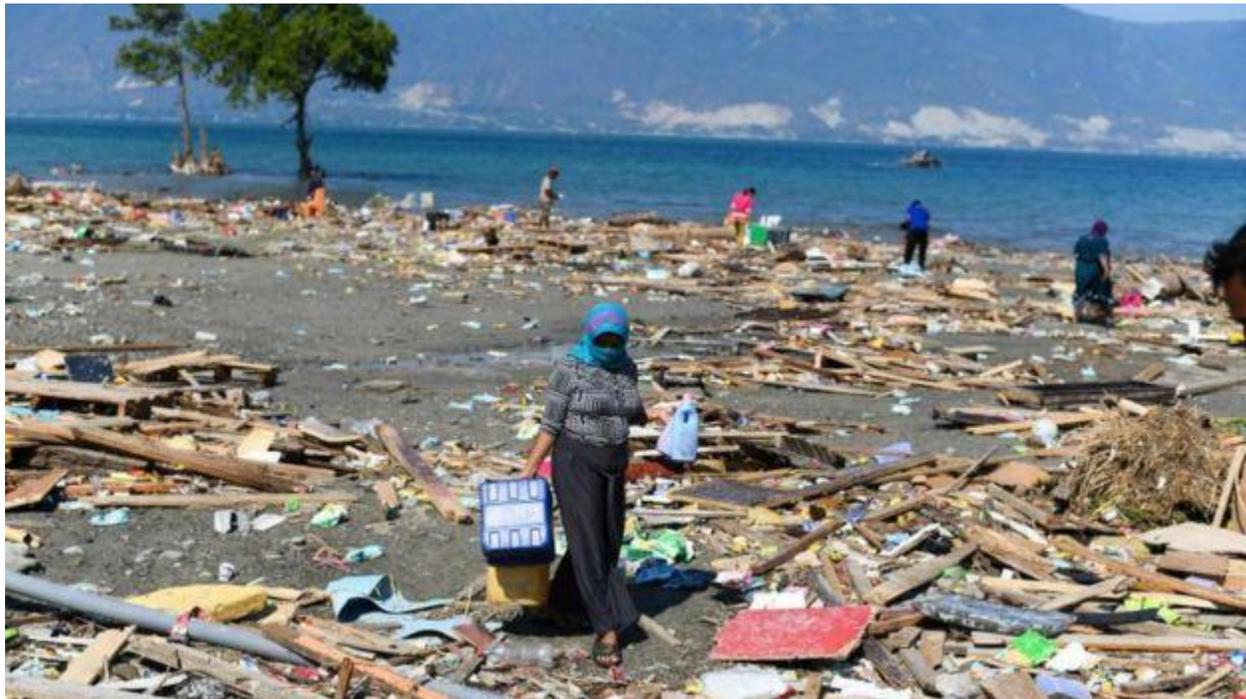
Figure 8 - Tsunami impact (source: <https://www.bbc.com/news/world-asia-45663054>)

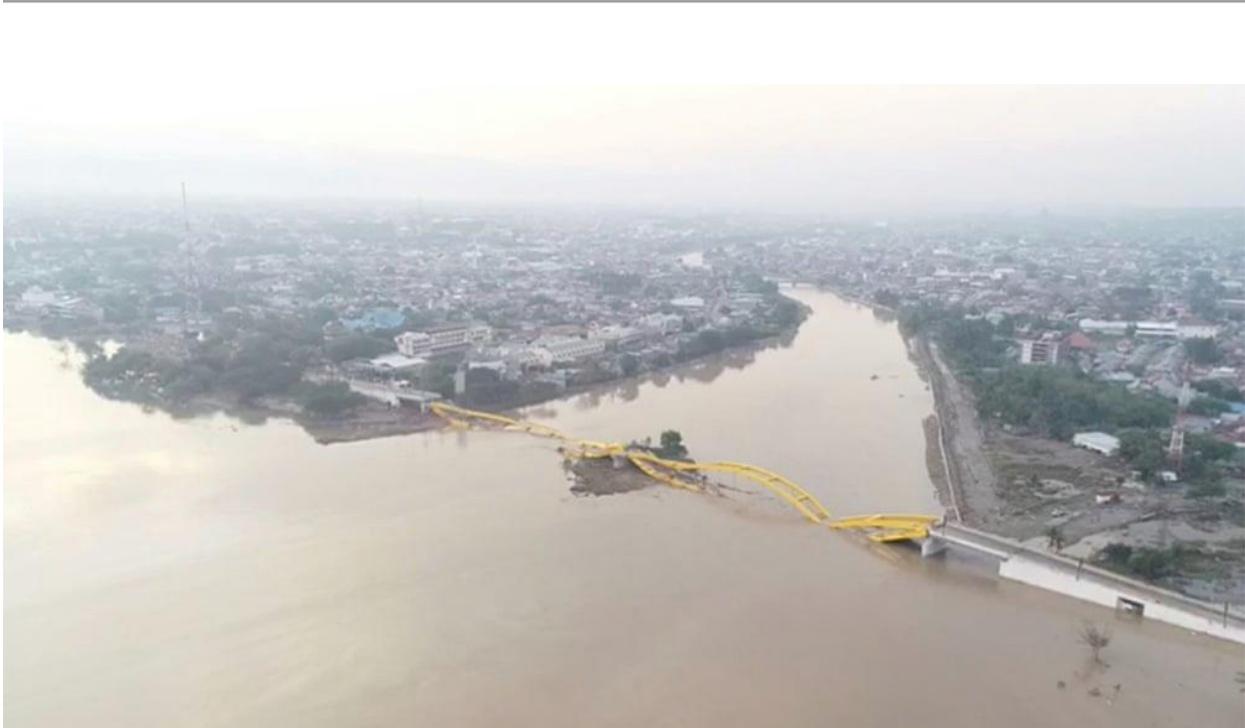
Figure 9 - Earthquake impact in Palu (source: <https://www.theguardian.com/world/gallery/2018/sep/30/Aerial-footage-shows-tsunami-destruction-in-sulawesi-in-pictures> - Photograph: Social media/Reuters)

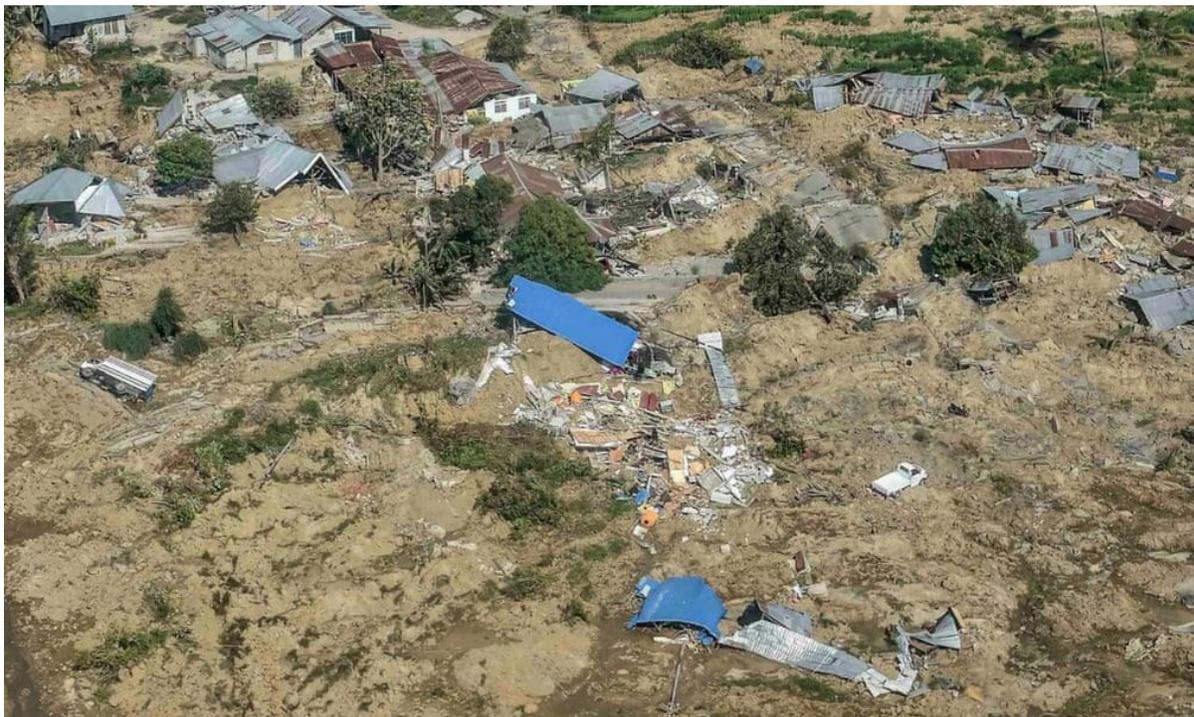
Figure 10 - Earthquake impact: liquefaction in Balaroa Housing areas
(Source: AHA report - Courtesy: BNPB).

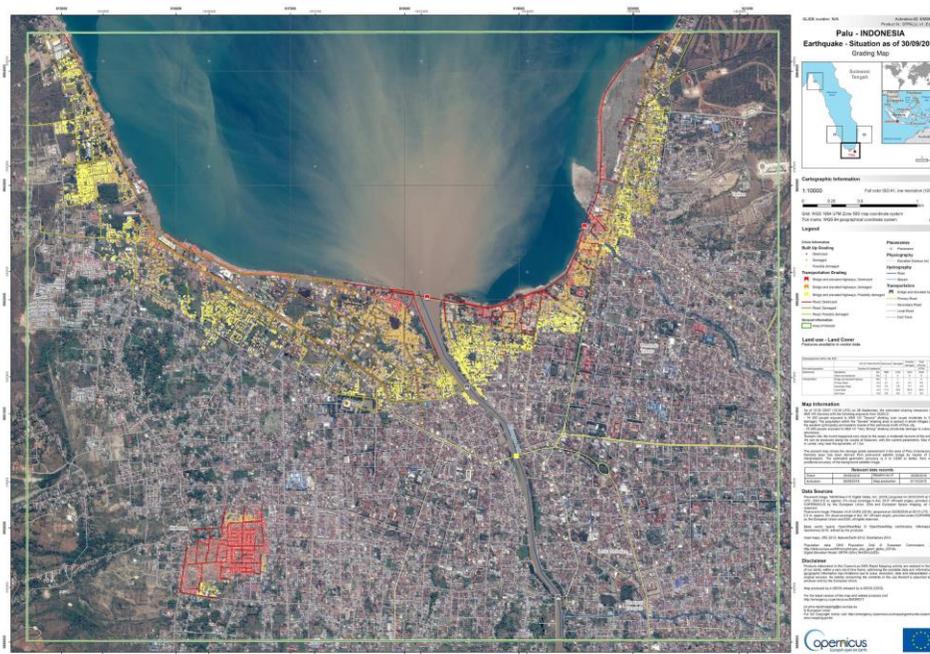
From the preliminary assessment of the grading map of Palu (see figure below), the combined effects of the tsunami (along the coast) and of the earthquake are detected. On the South-West of the city, an area affected by liquefaction.

Figure 25 - Grading map for the town of Palu. The combined effects of the tsunami (along the coast) and of the earthquake are detected (Copernicus EMS © 2018 EU, [EMSR317] Palu: Grading map).

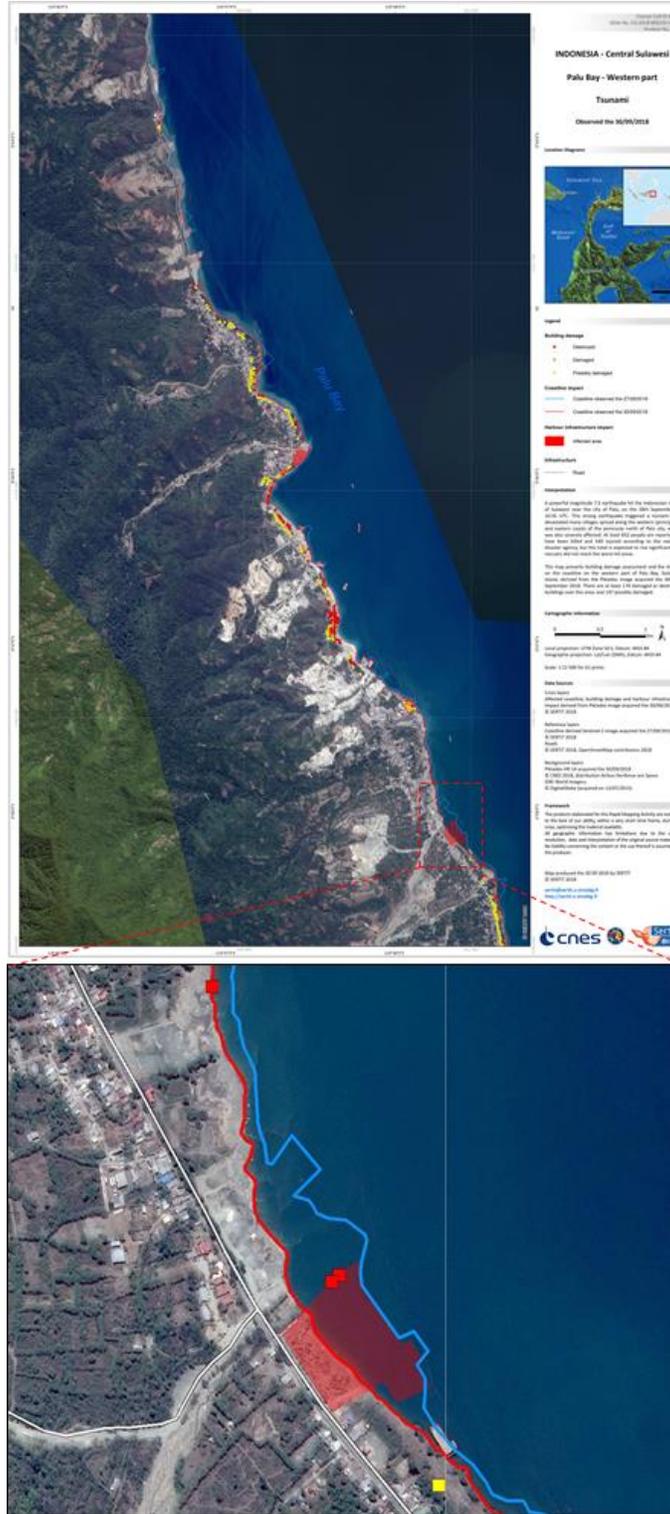
A first map has been produced and related to the west side of the Palu channel and showing extended damage on the coastal area as well indication of subsidence of this area, shown by the definite coseismic change of the shoreline that appears inland of few hundreds mt, if compared with pre-event images.

Figure 26 - Damage map from the International Charter for the Palu bay. The changes on the coastline are identified (blu-red line), together with the coast collapsed due to the subsidence caused by the earthquake.
