EMSR884 - AOI02  
Earthquake in Venezuela  
CARACAS

Situation as of 26/06/2026 15:19 UTC  
Grading MONIT01 - Overview map 01

**Situation as of 26/06/2026 15:19 UTC**  
Grading MONIT01 - Detail map 02

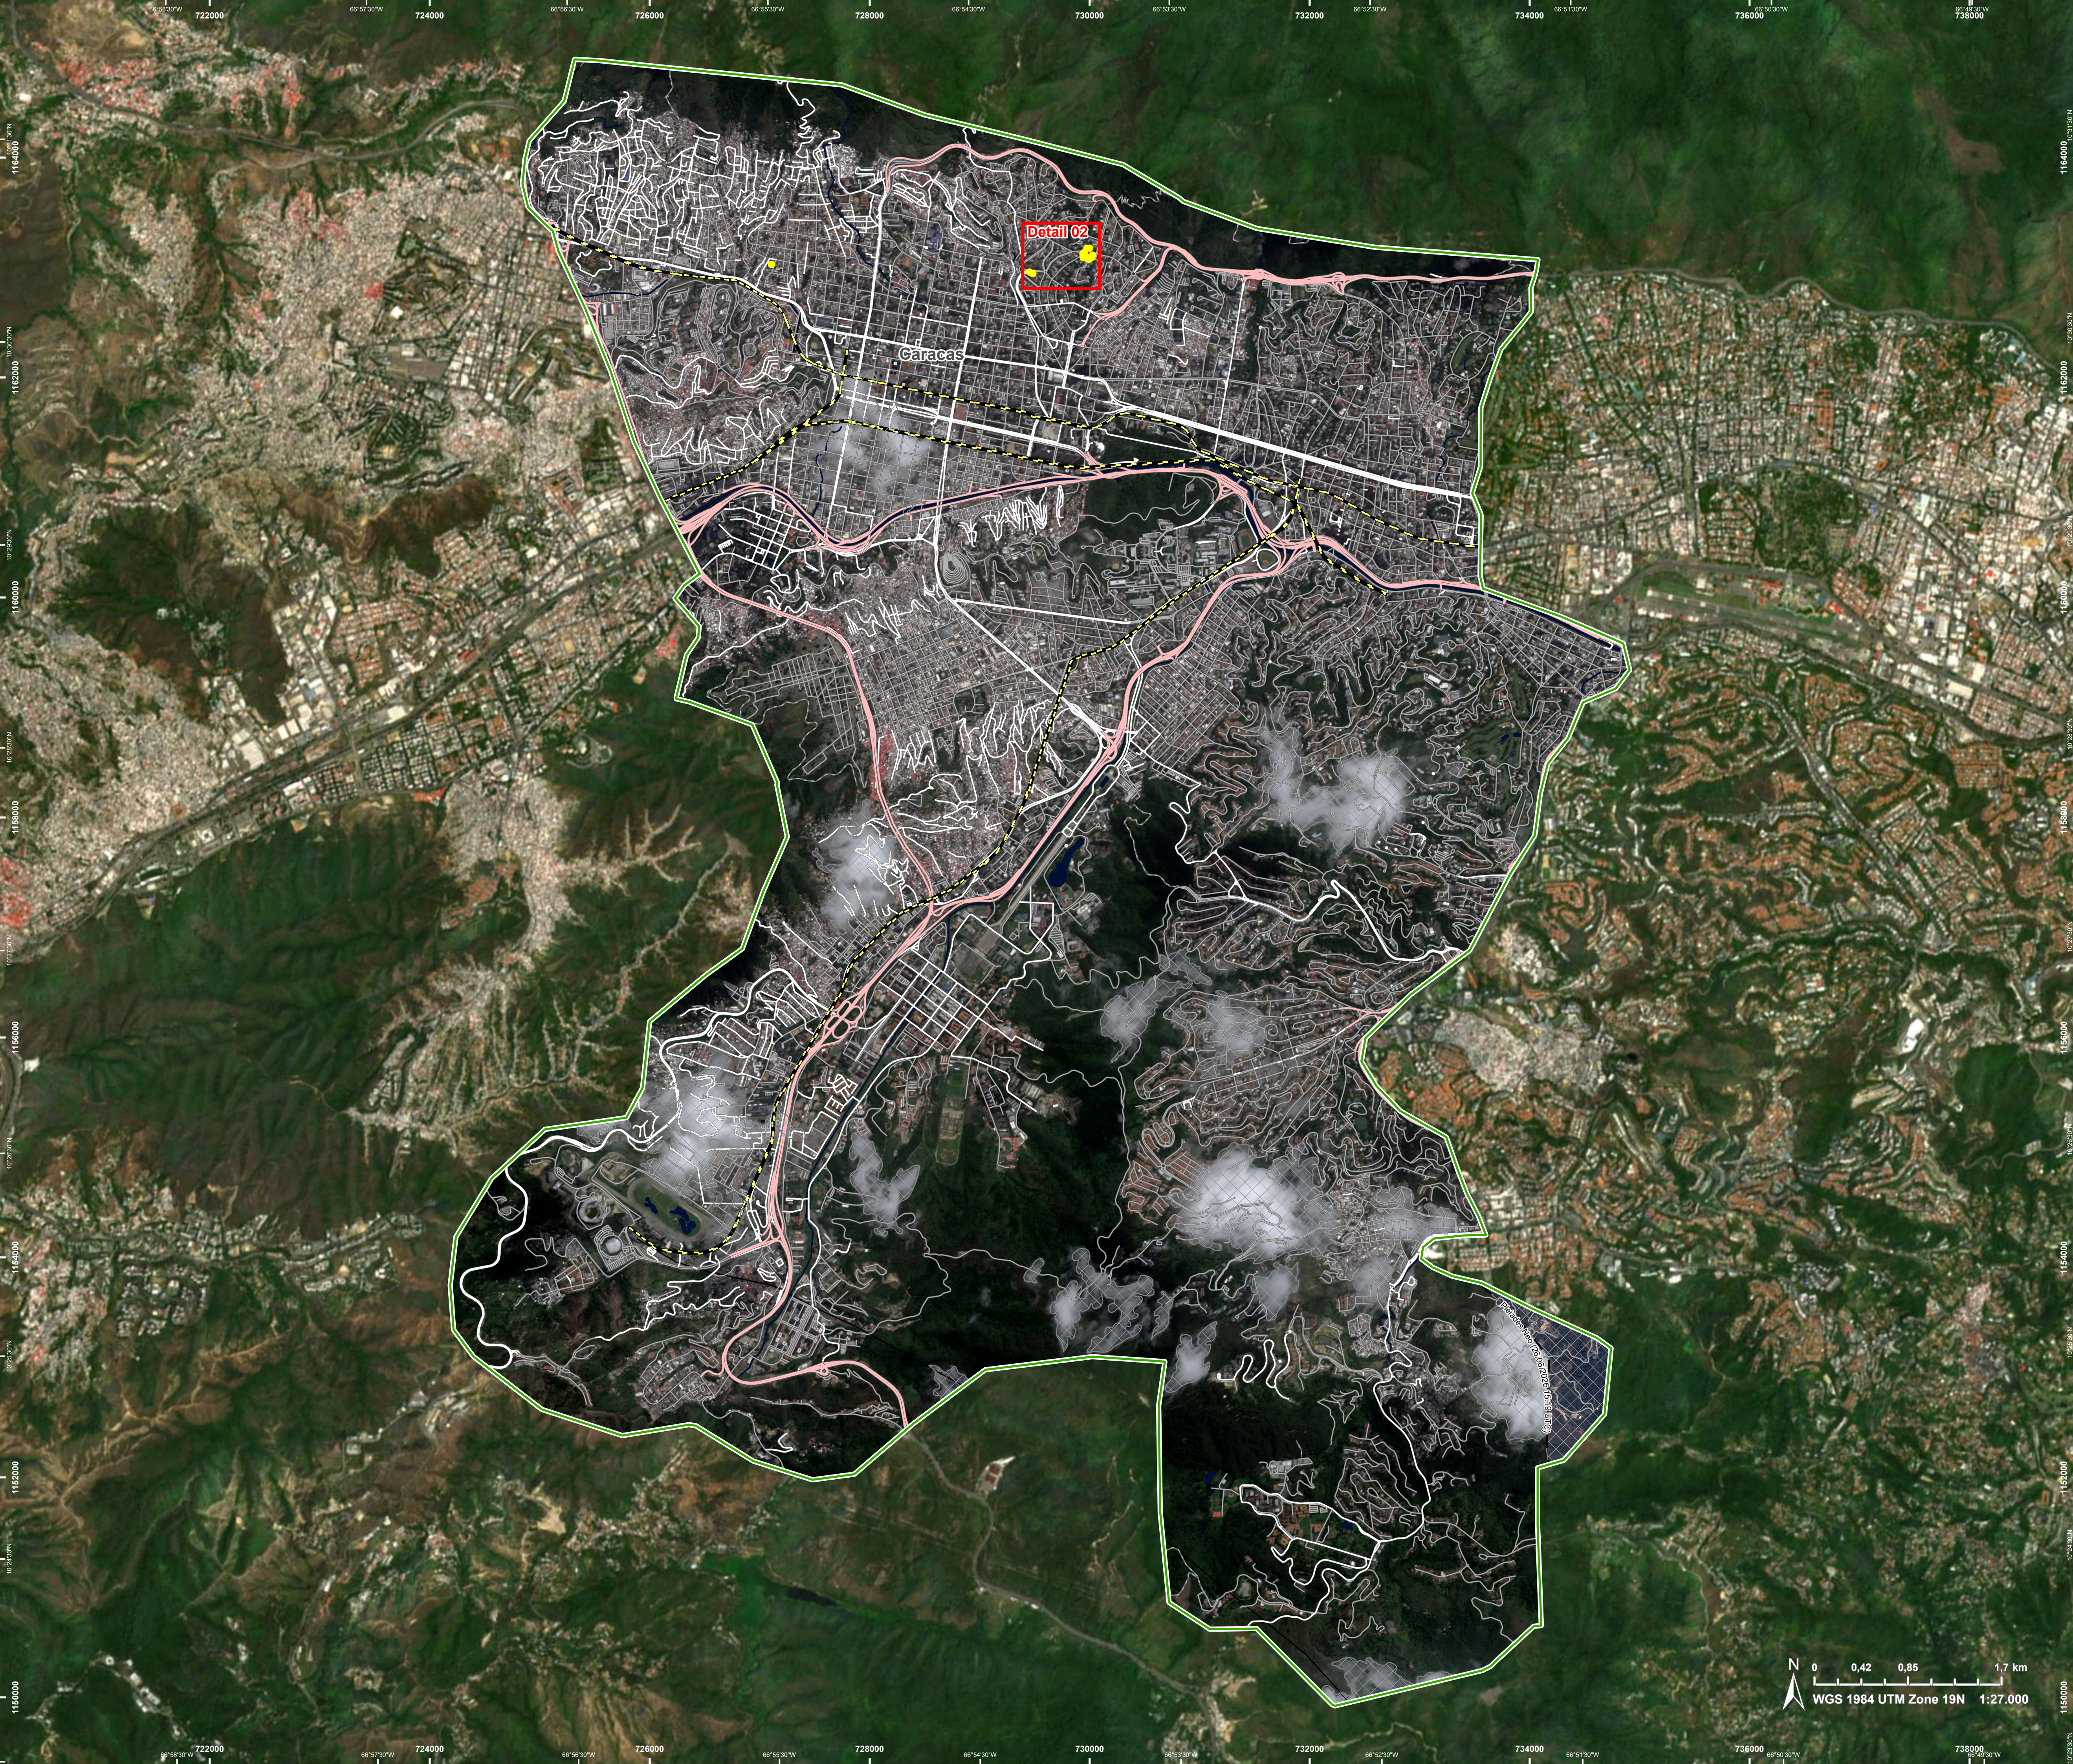
Blocked road / interruption  
2 No.

Road  
0.1 km

Built-Up  
20 No.

**Event:** On 24 Jun 2026 22:05 UTC a 7.5M earthquake, preceded by a strong foreshock, occurred in Venezuela. The impact on population is deemed high at this stage, with low visibility on the extent of the damage. Copernicus EMS Rapid Mapping is requested to provide damage assessment emergency mapping.

The thematic layer has been derived from post-event satellite image using a semi-automatic approach.

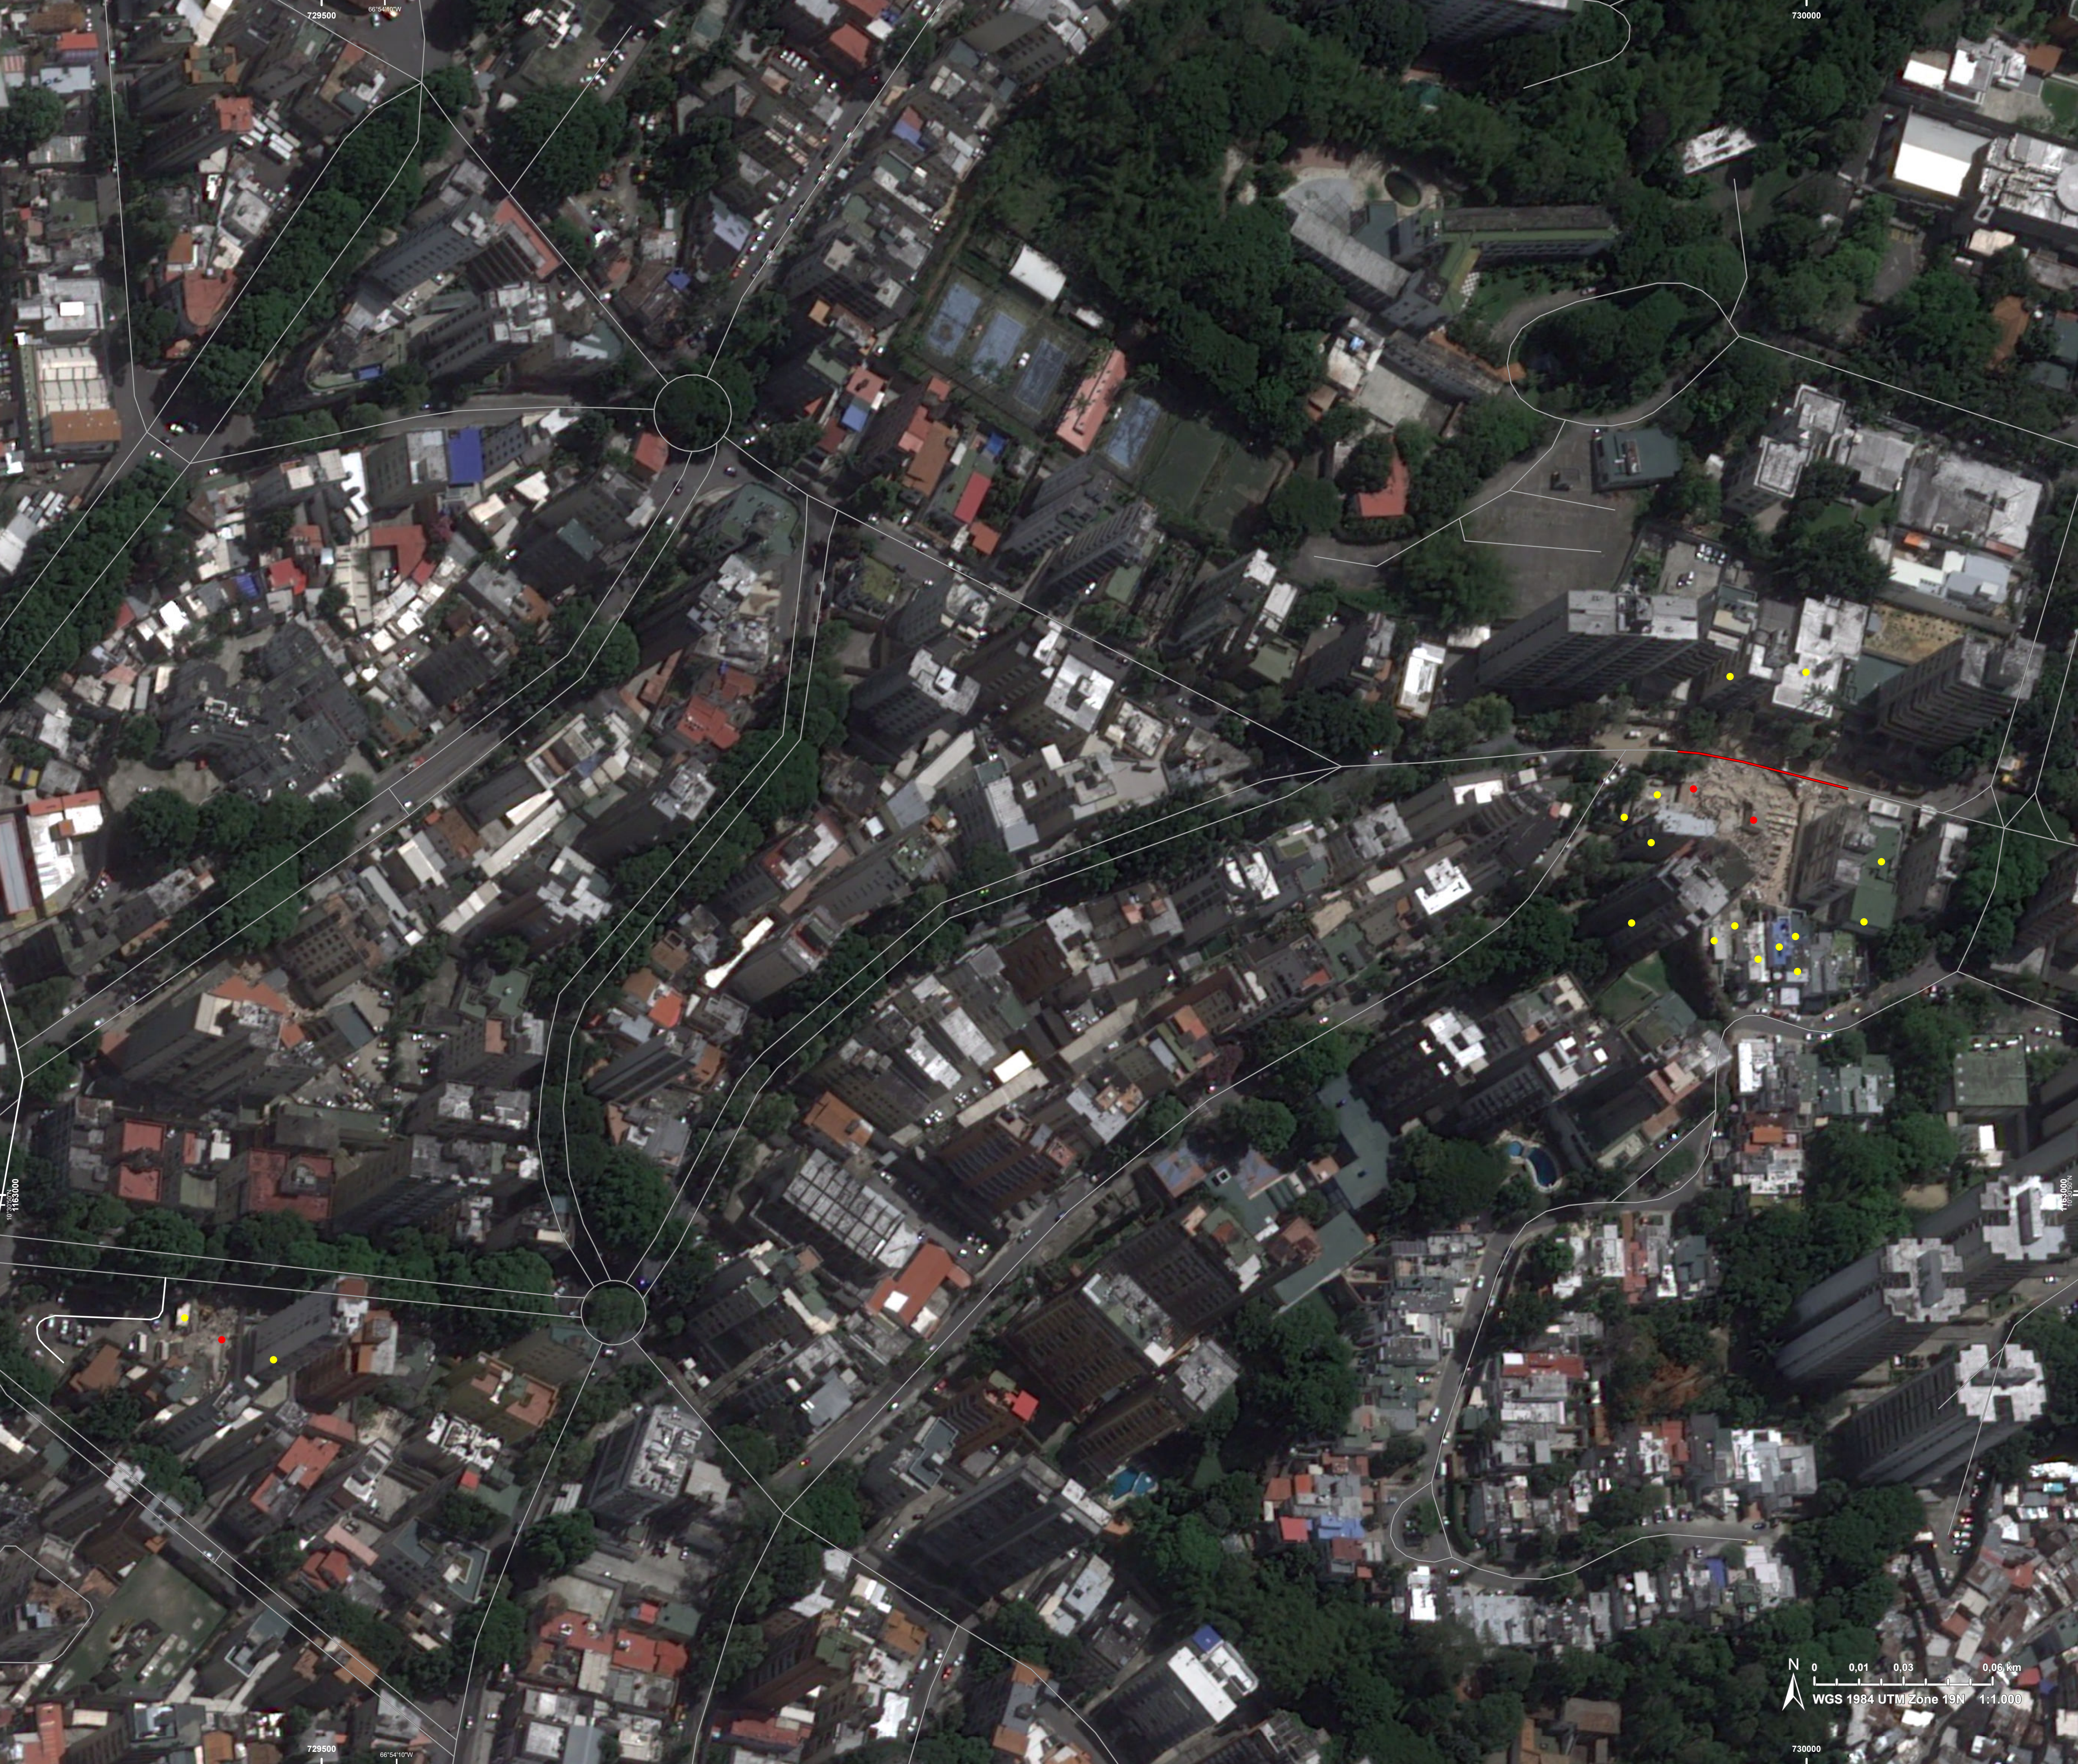
- Built Up Grading**
- Destroyed
  - Possibly damaged
- Transportation Grading**
- Road, Destroyed
- Main road, No visible damage  
Local road, No visible damage

**Event:** On 24 Jun 2026 22:05 UTC a 7.5M earthquake, preceded by a strong foreshock, occurred in Venezuela. The impact on population is deemed high at this stage, with low visibility on the extent of the damage. Copernicus EMS Rapid Mapping is requested to provide damage assessment emergency mapping.

The thematic layer has been derived from post-event satellite image using a semi-automatic approach.
