EMSR884 - AOI02  
Earthquake in Venezuela  
CARACAS

Situation as of 26/06/2026 15:19 UTC  
Grading MONIT01 - Overview map 01

**Situation as of 26/06/2026 15:19 UTC**  
Grading MONIT01 - Detail map 02

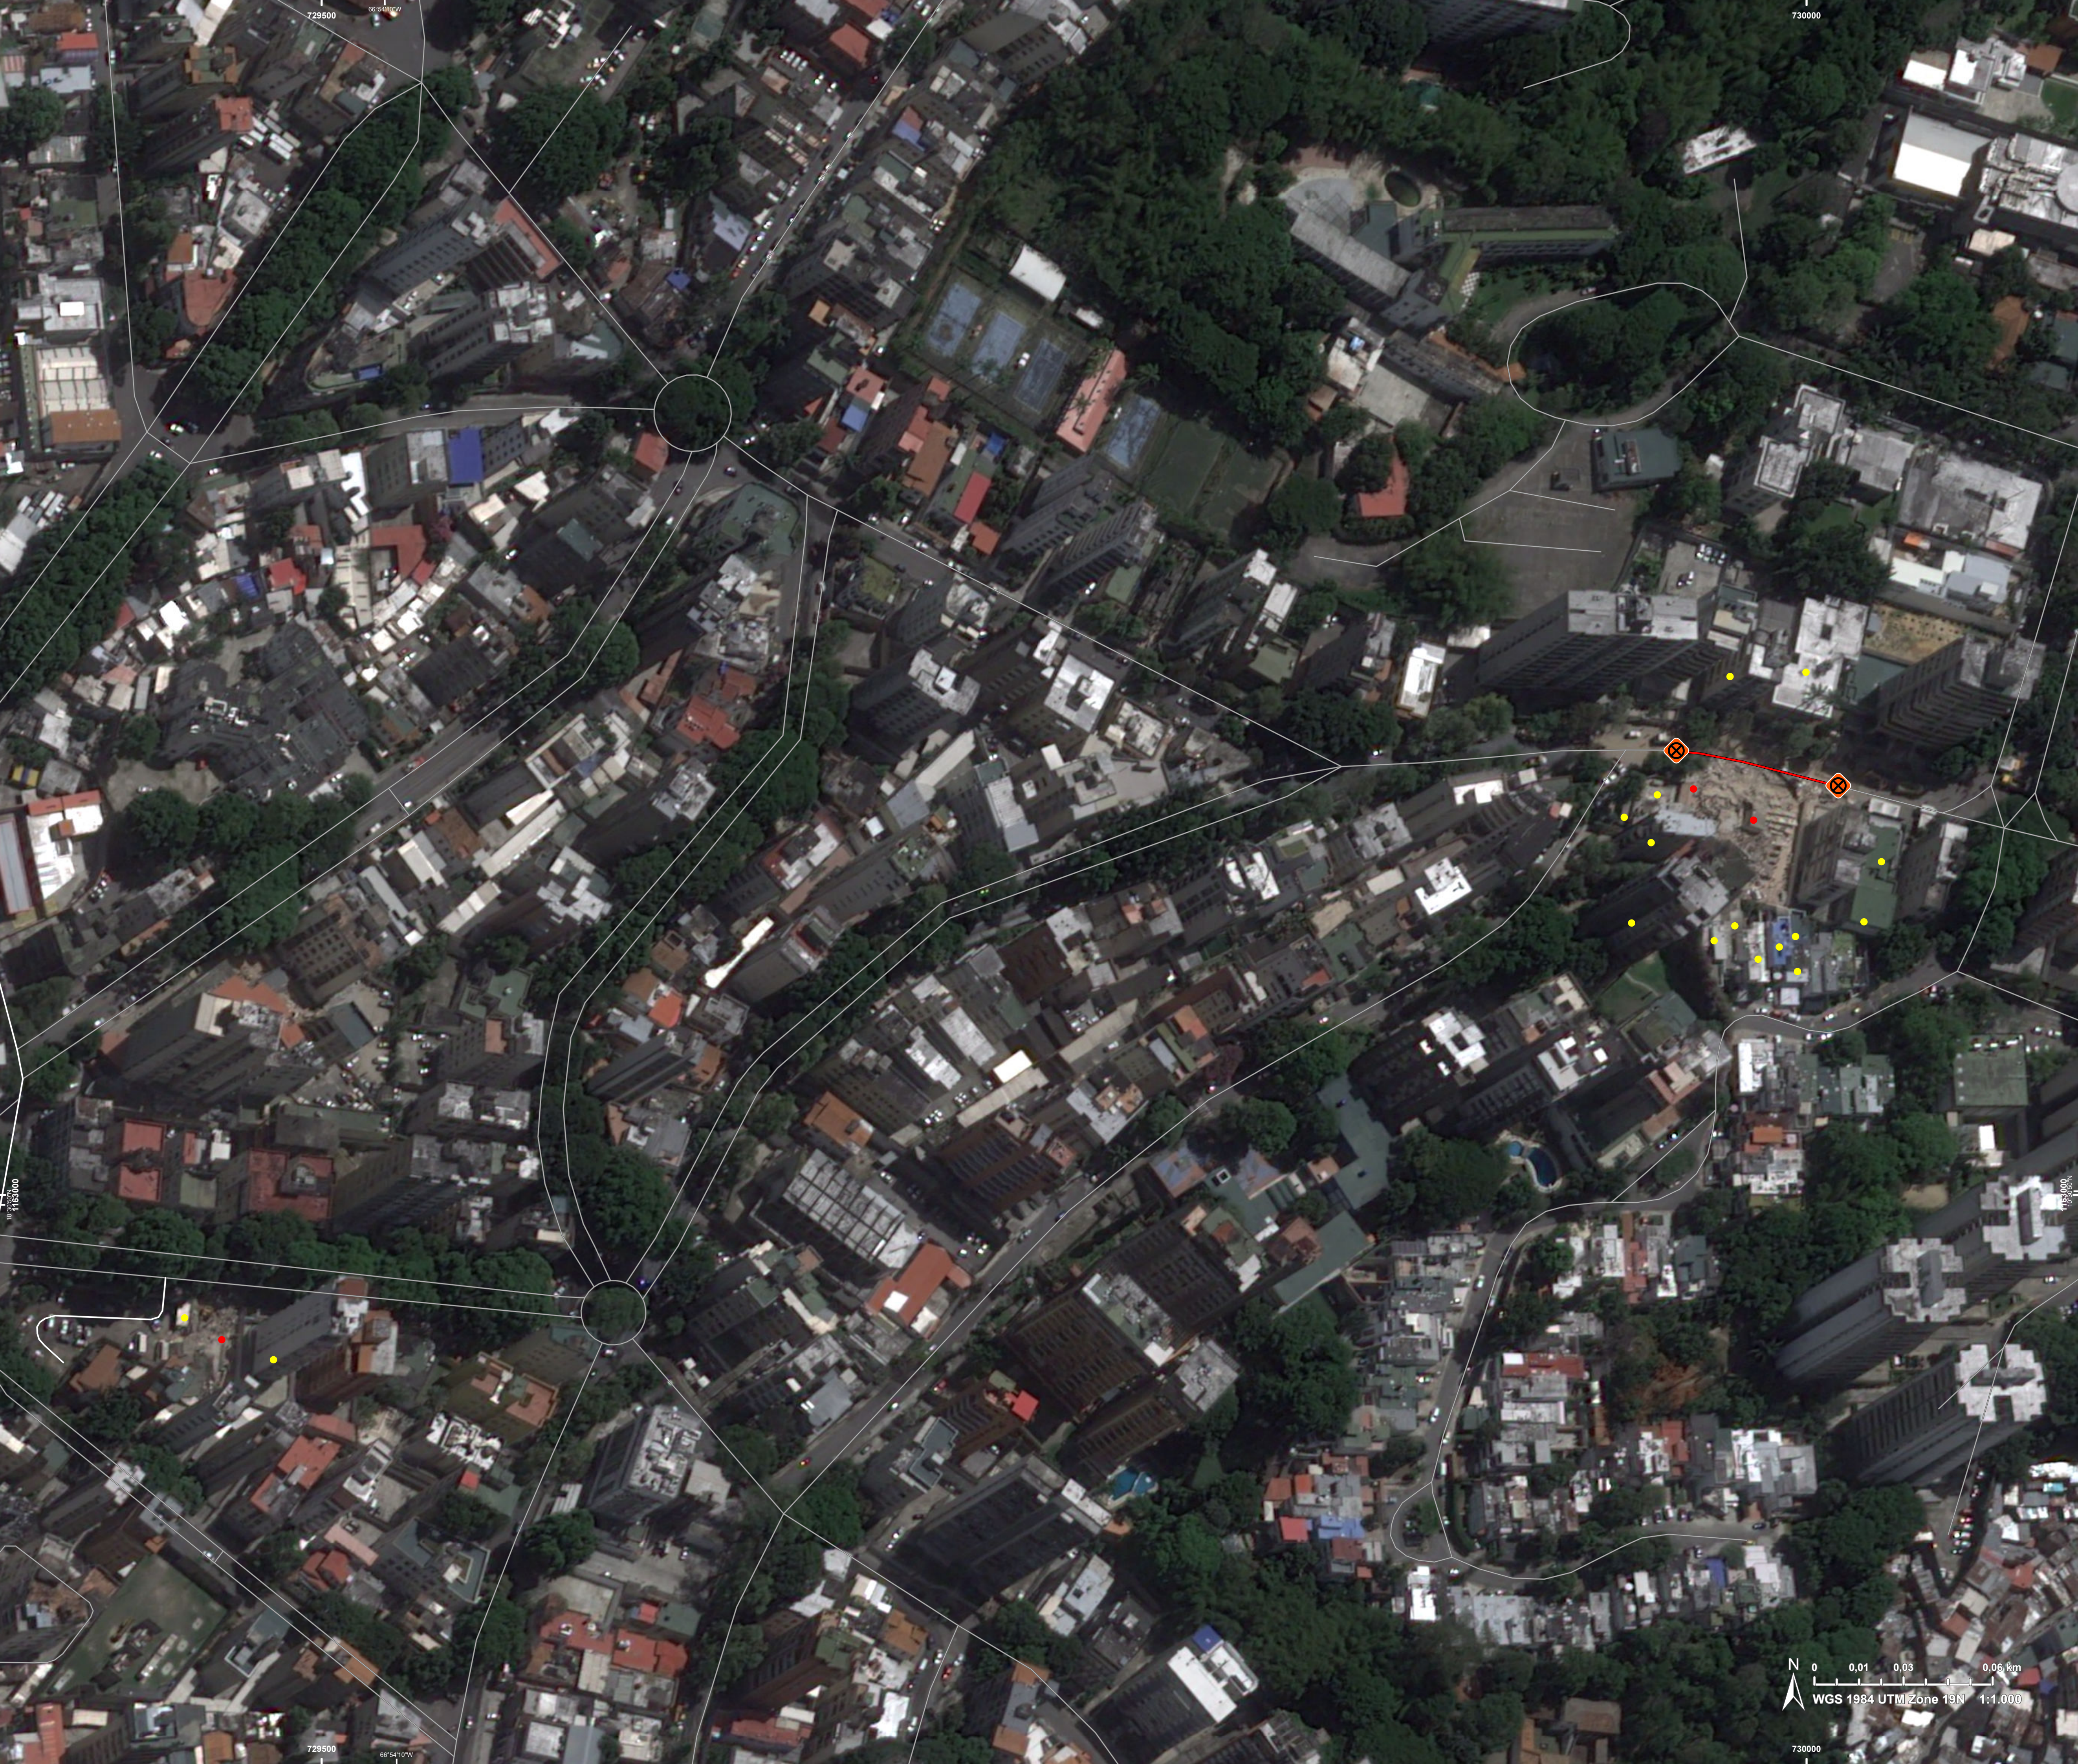
**Event:** On 24 Jun 2026 22:05 UTC a 7.5M earthquake, preceded by a strong foreshock, occurred in Venezuela. The impact on population is deemed high at this stage, with low visibility on the extent of the damage. Copernicus EMS Rapid Mapping is requested to provide damage assessment emergency mapping.

The thematic layer has been derived from post-event satellite image using a semi-automatic approach.

| | | | | LATEST IMPACT | | | | |
|---|---|---|---|---|---|---|---|---|
| Crisis information | Blocked road / interruption | | No. | | | | 2 | |
| | | Unclassified | No. | 3 | 0 | 17 | 20 | 119.380 |
| | | Local Road | km | 0,1 | 0 | 0 | 0,1 | 902,9 |
