Situation as of 26/06/2026 15:10 UTC  
Grading - Overview map 01

**EMSR884 - AOI05**  
**Earthquake in Venezuela**  
**SANTA CRUZ**

**Situation as of 26/06/2026 15:10 UTC**  
Grading - Detail map 02

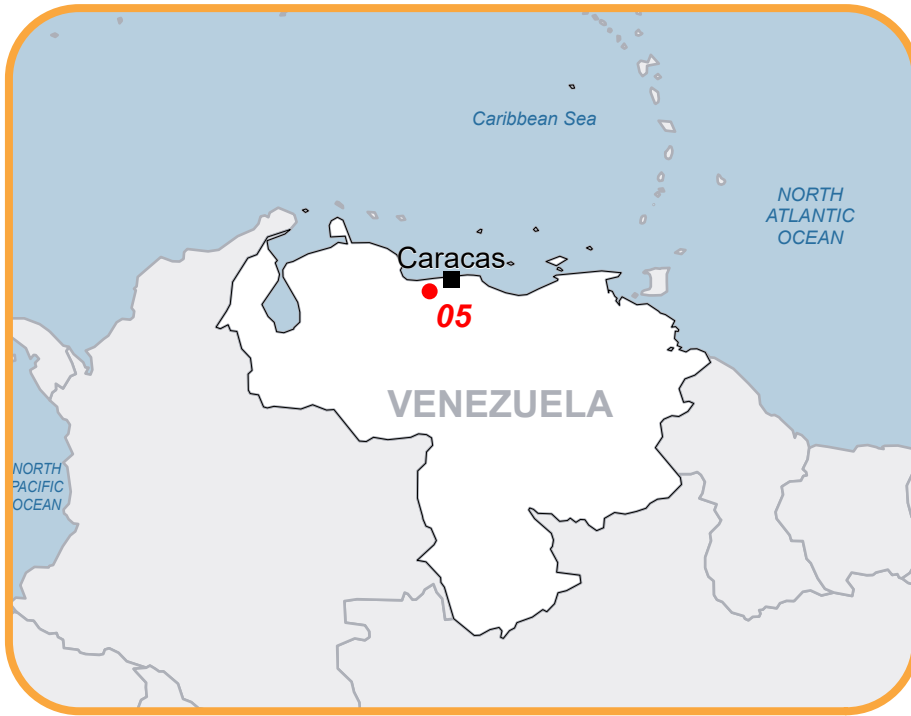
Built-Up  
3 No.

- Built Up Grading**
- Destroyed
- Transportation Grading**
- Highway, No visible damage
  - Main road, No visible damage
  - Local road, No visible damage
  - Track, No visible damage
- General Information**
- Airfield runway, No visible damage
  - Airfield and Heliport, No visible damage
  - Area of Interest
  - Detail map
  - Image Footprint
  - Not Analysed
- Hydrography**
- Lake, River

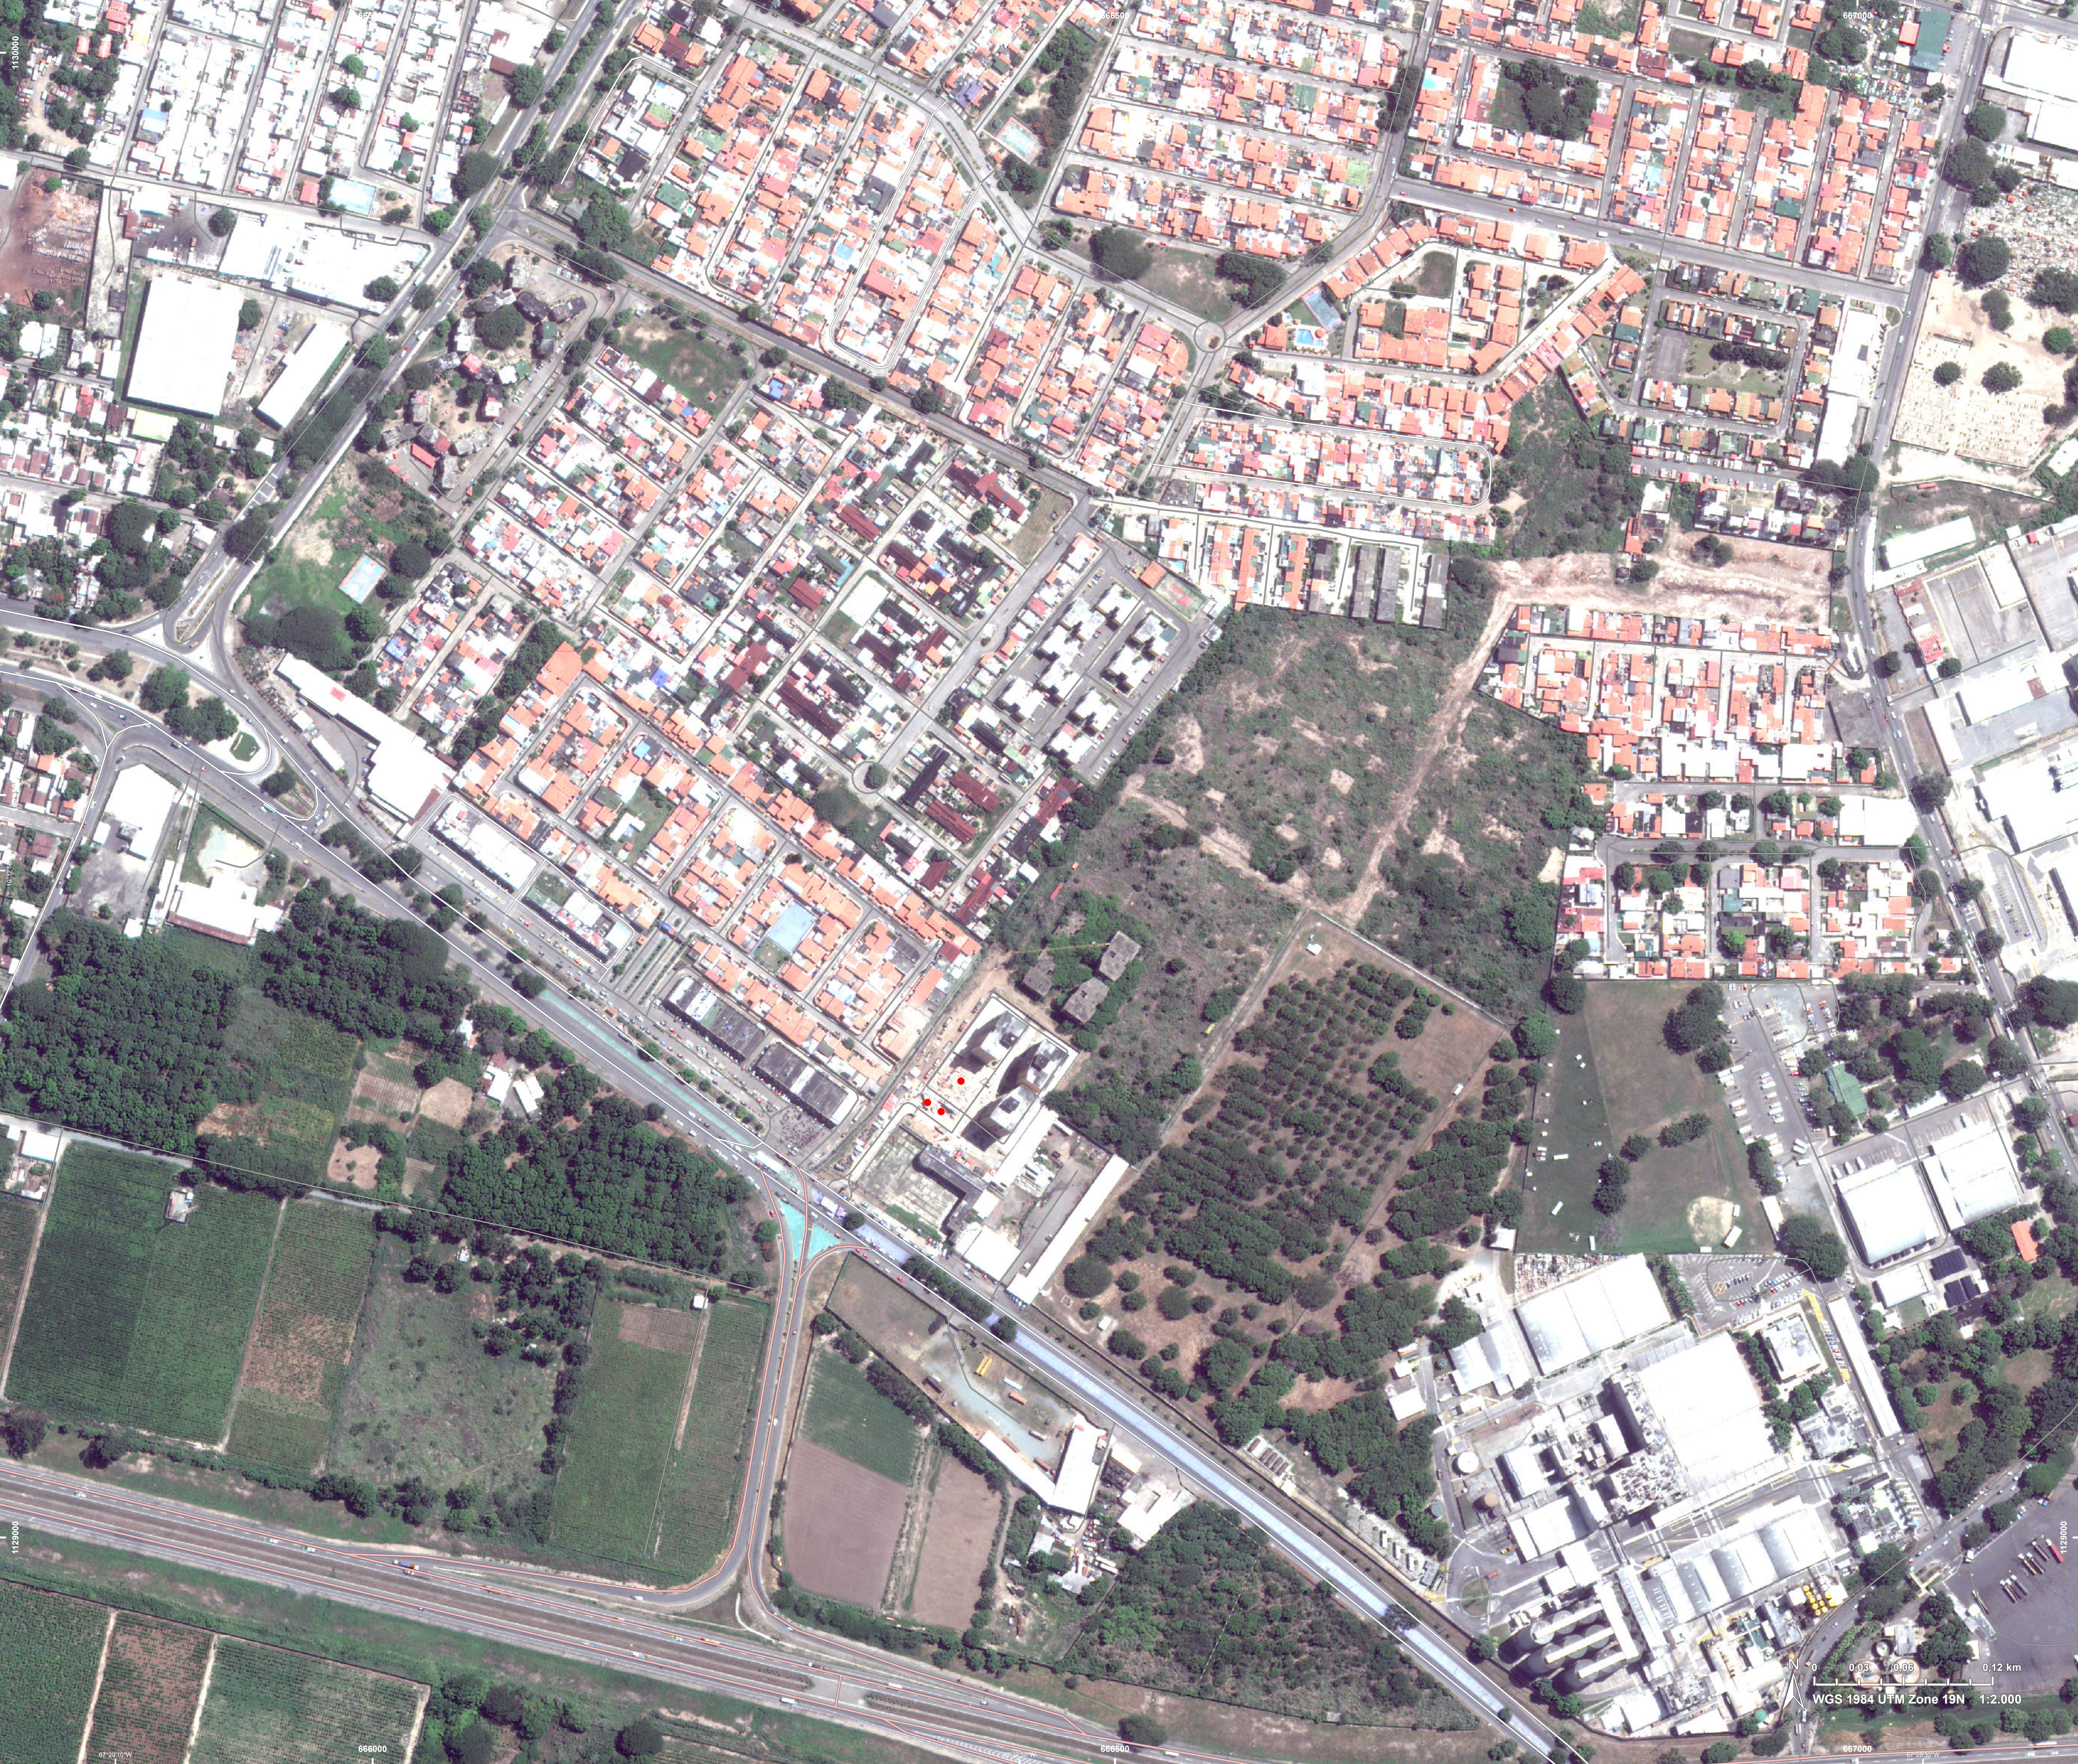
- Built Up Grading**
- Destroyed
- Transportation Grading**
- Highway, No visible damage
  - Main road, No visible damage
  - Local road, No visible damage
  - Track, No visible damage

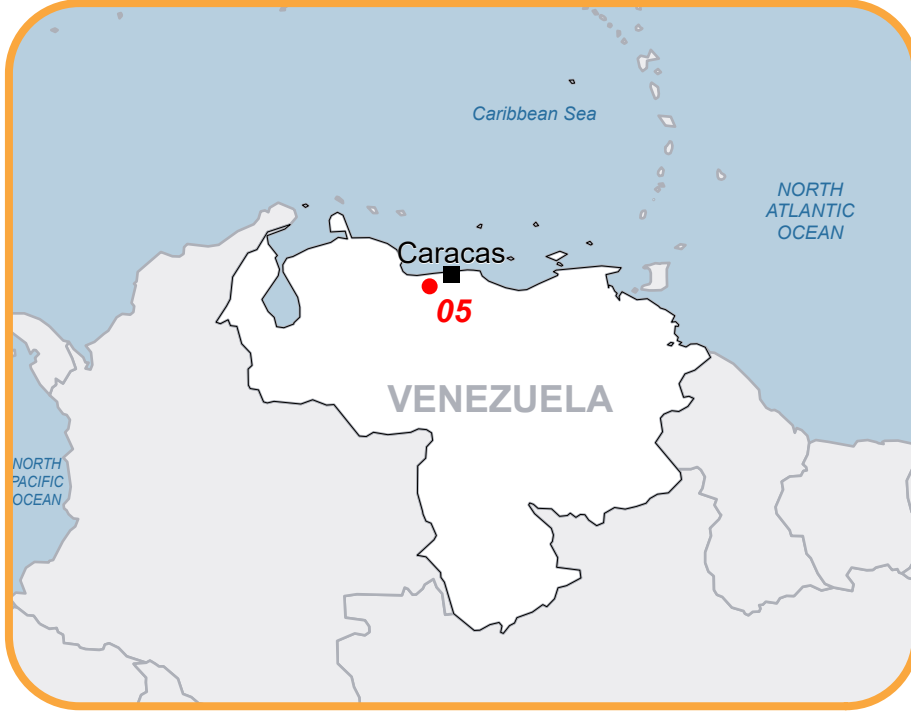
| Estimated population | | Inhabitants | No. | Destroyed | Damaged | Possibly damaged* | Total affected** | Total in AOI |
|---|---|---|---|---|---|---|---|---|
| Assets | | Residential Buildings | No. | 3 | 0 | 0 | 3 | 144.654 |
