EMSR884 - AOI08  
Earthquake in Venezuela  
SAN FELIPE

Situation as of 26/06/2026 20:20 UTC  
Grading MONIT01 - Overview map 01

**Event:** On 24 Jun 2026 22:05 UTC a 7.5M earthquake, preceded by a strong foreshock, occurred in Venezuela. The impact on population is deemed high at this stage, with low visibility on the extent of the damage. Copernicus EMS Rapid Mapping is requested to provide damage assessment emergency mapping.

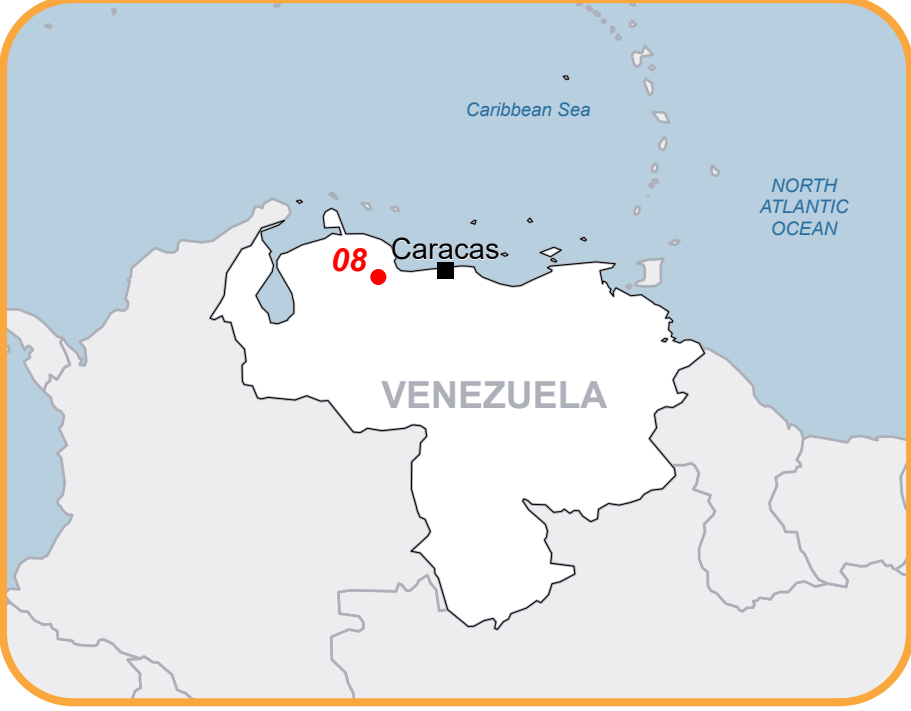
Built-up  
Built-Up  
183 No.

- Built Up Grading**
- Damaged
  - Possibly damaged
- Transportation Grading**
- Main road, No visible damage
  - Airfield and Heliport, No visible damage
- General Information**
- Area of Interest
  - Detail map
  - Image Footprint
  - Not Analysed
- Hydrography**
- Lake, River

The thematic layer has been derived from post-event satellite image by means of visual interpretation.

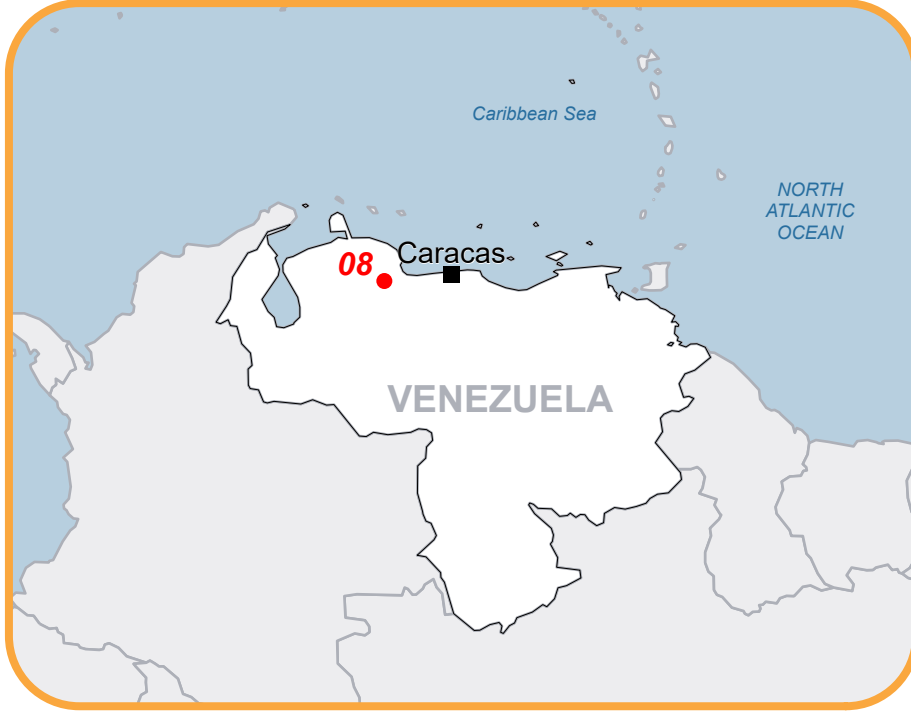
**Situation as of 26/06/2026 20:20 UTC**  
Grading MONIT01 - Detail map 02

- Built Up Grading**

- Possibly damaged

- Main road, No visible damage
- General Information**

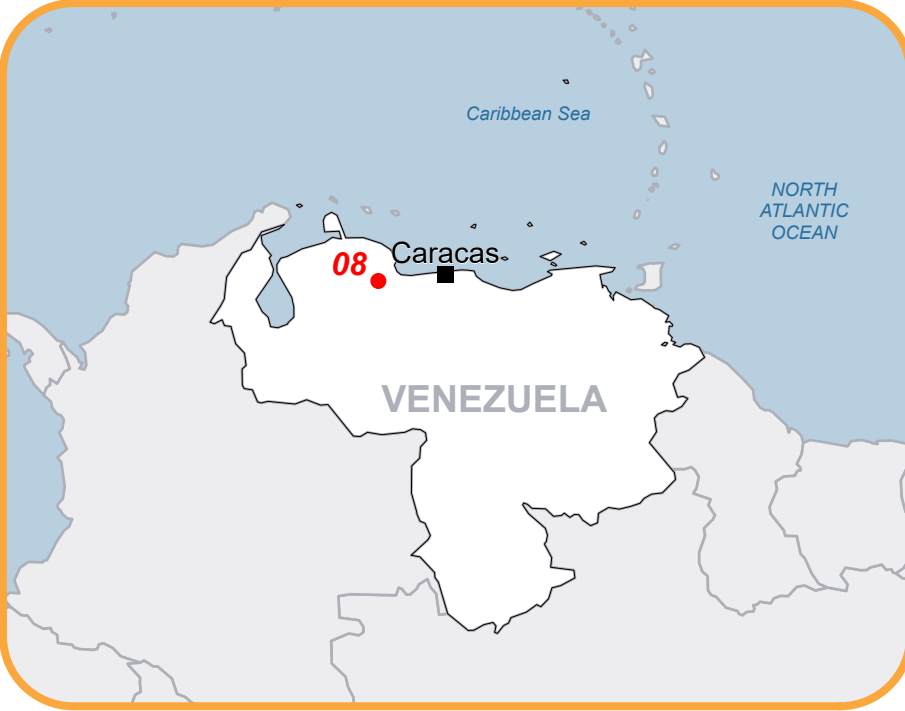
Situation as of 26/06/2026 20:20 UTC  
Grading MONIT01 - Detail map 03

Damaged

Possibly damaged
- Transportation Grading**

Main road, No visible damage
-

Airfield and Heliport, No visible damage
