Situation as of 26/06/2026 15:10 UTC  
Grading MONIT01 - Overview map 01

**Event:** On 24 Jun 2026 22:05 UTC a 7.5M earthquake, preceded by a strong foreshock, occurred in Venezuela. The impact on population is deemed high at this stage, with low visibility on the extent of the damage. Copernicus EMS Rapid Mapping is requested to provide damage assessment emergency mapping.

EMSR884 - AOI12  
Earthquake in Venezuela  
CARABALLEDA

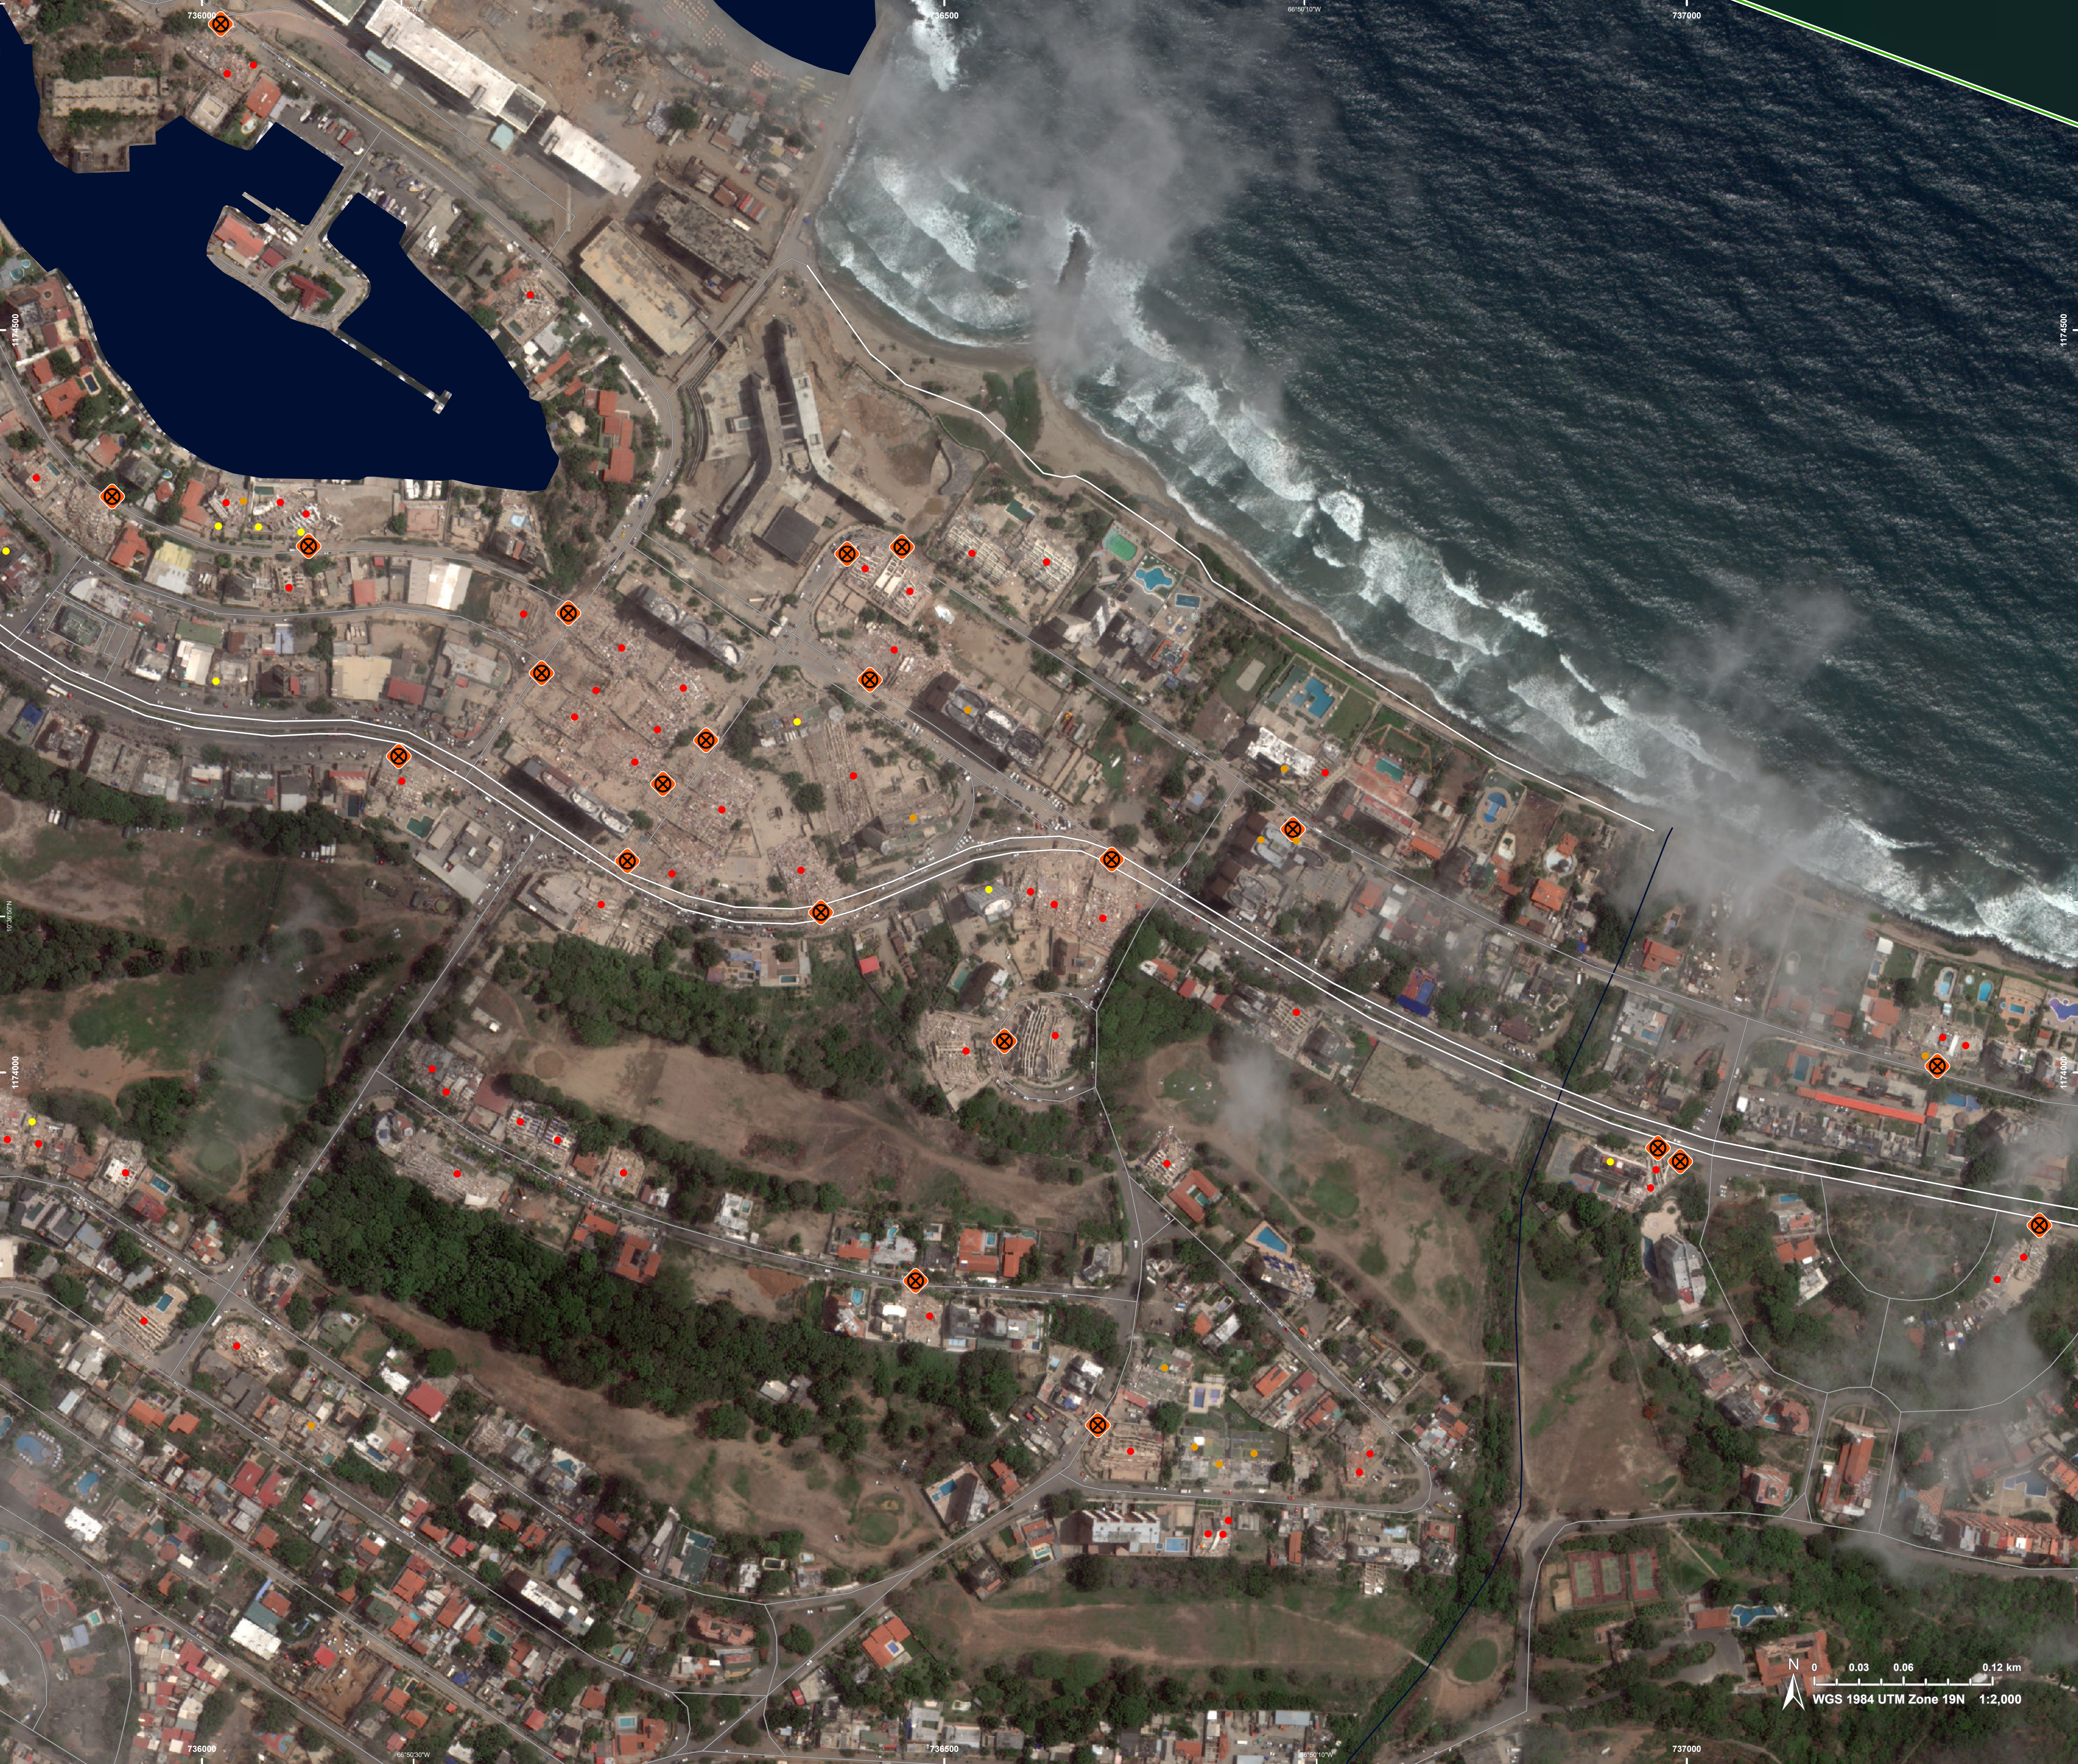
Potentially affected population  
~ Not available

Blocked road / interruption  
103 No.

Affected Built-up  
Built-Up  
1,004 No.
