**EMSR884 - AOI12**  
**Earthquake in Venezuela**  
**CARABALLEDA**

**Situation as of 26/06/2026 15:10 UTC**  
Grading MONIT01 - Overview map 01

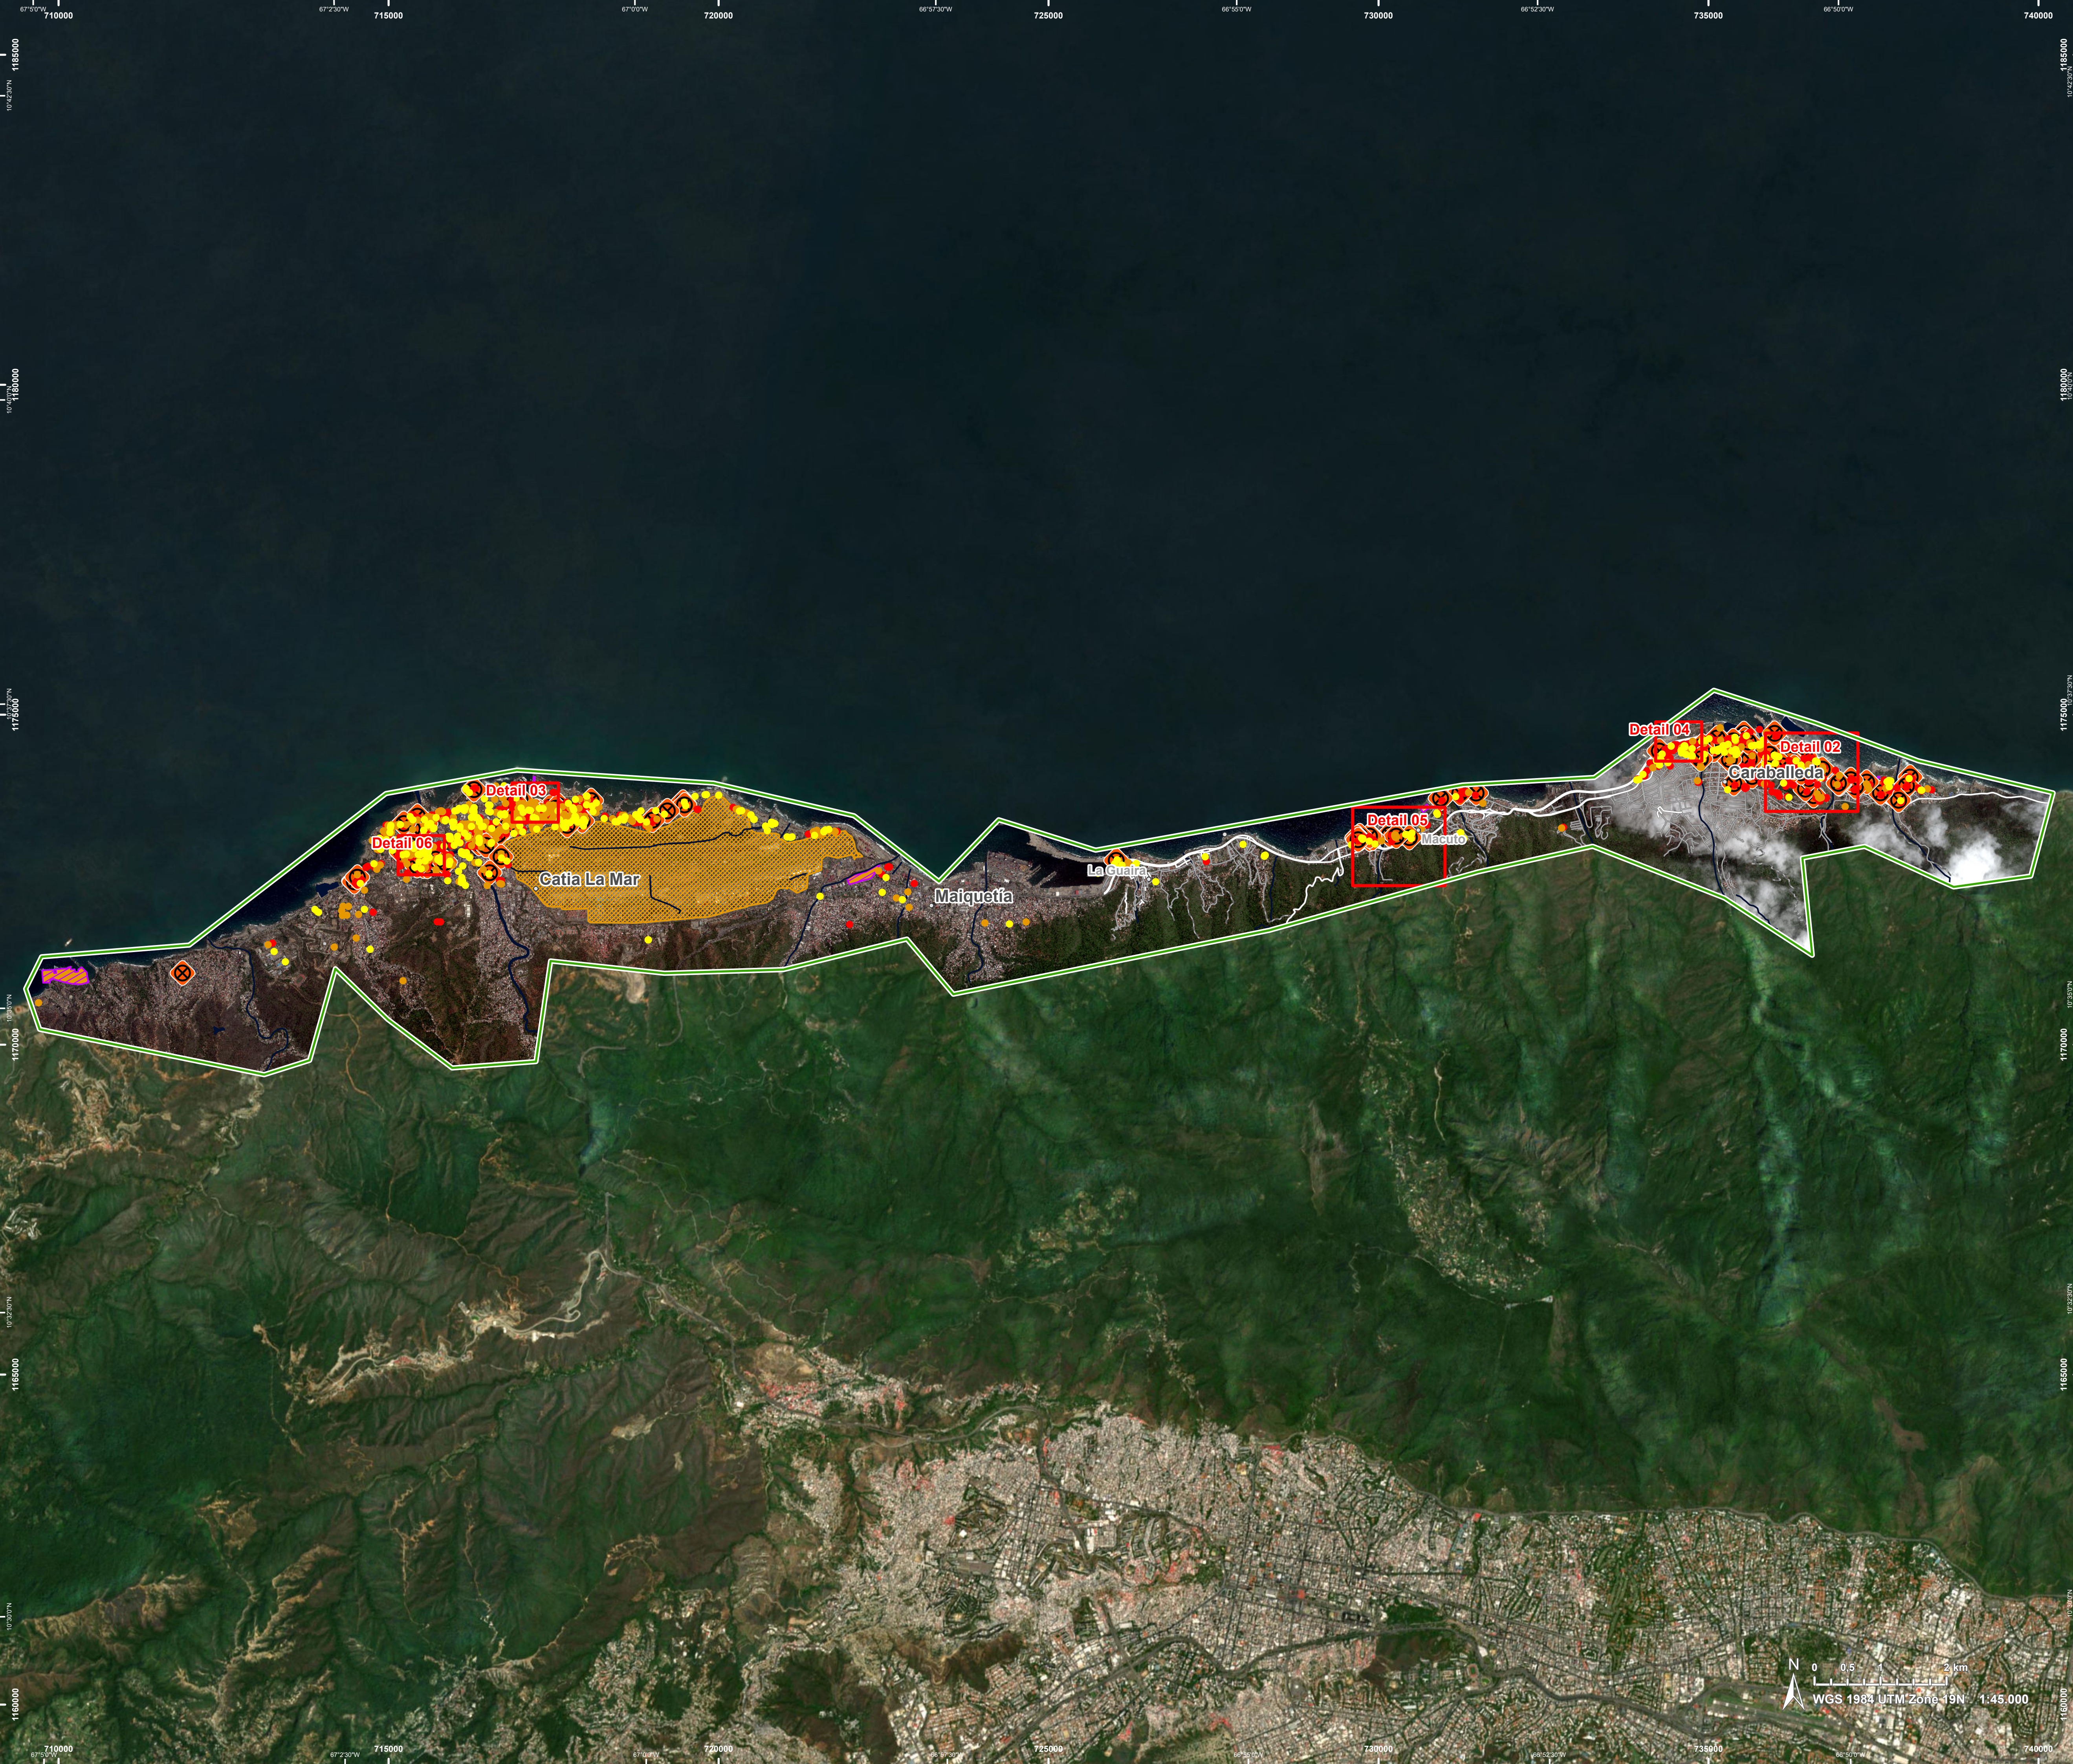
Potentially affected population  
~ Not available

Blocked road / interruption  
103 No.

Affected Built-up  
Built-Up  
1,353 No.
