**EMSR884 - AOI12**  
**Earthquake in Venezuela**  
**CARABALLEDA**

**Situation as of 26/06/2026 15:10 UTC**  
Grading MONIT01 - Overview map 01

**Event:** On 24 Jun 2026 22:05 UTC a 7.5M earthquake, preceded by a strong foreshock, occurred in Venezuela. The impact on population is deemed high at this stage, with low visibility on the extent of the damage. Copernicus EMS Rapid Mapping is requested to provide damage assessment emergency mapping.

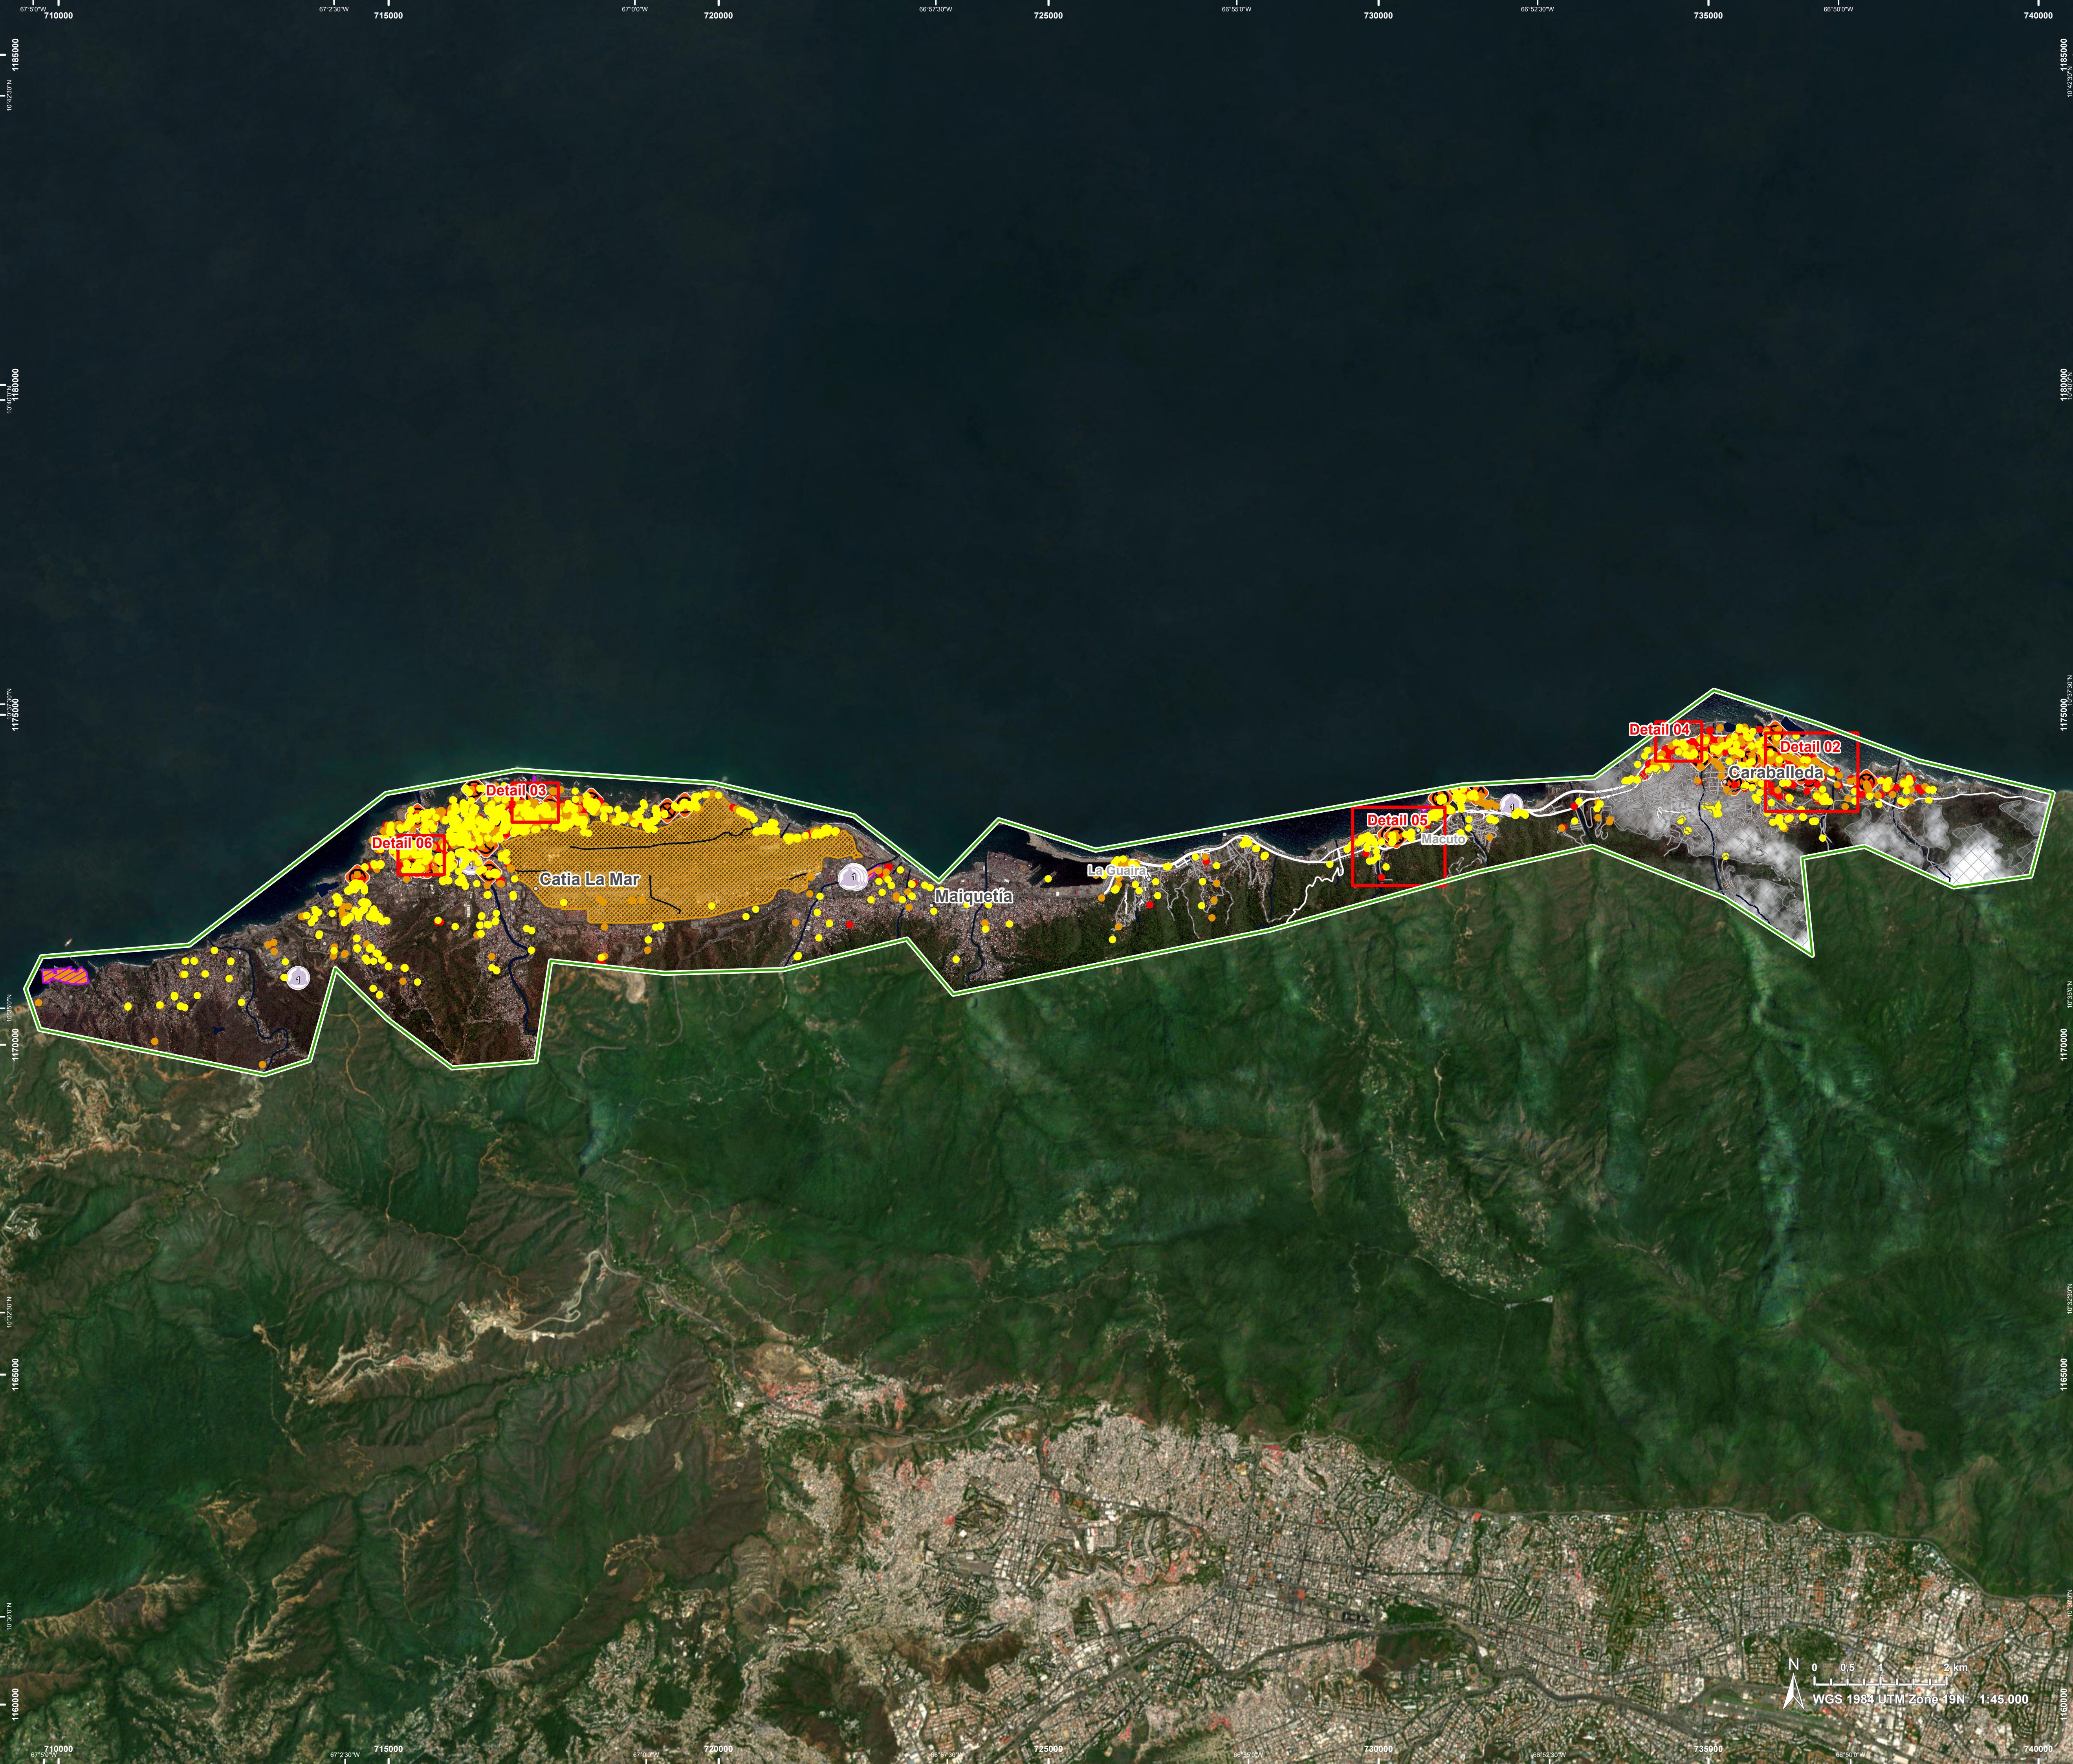
The thematic layer has been derived from post-event satellite image by means of visual interpretation.

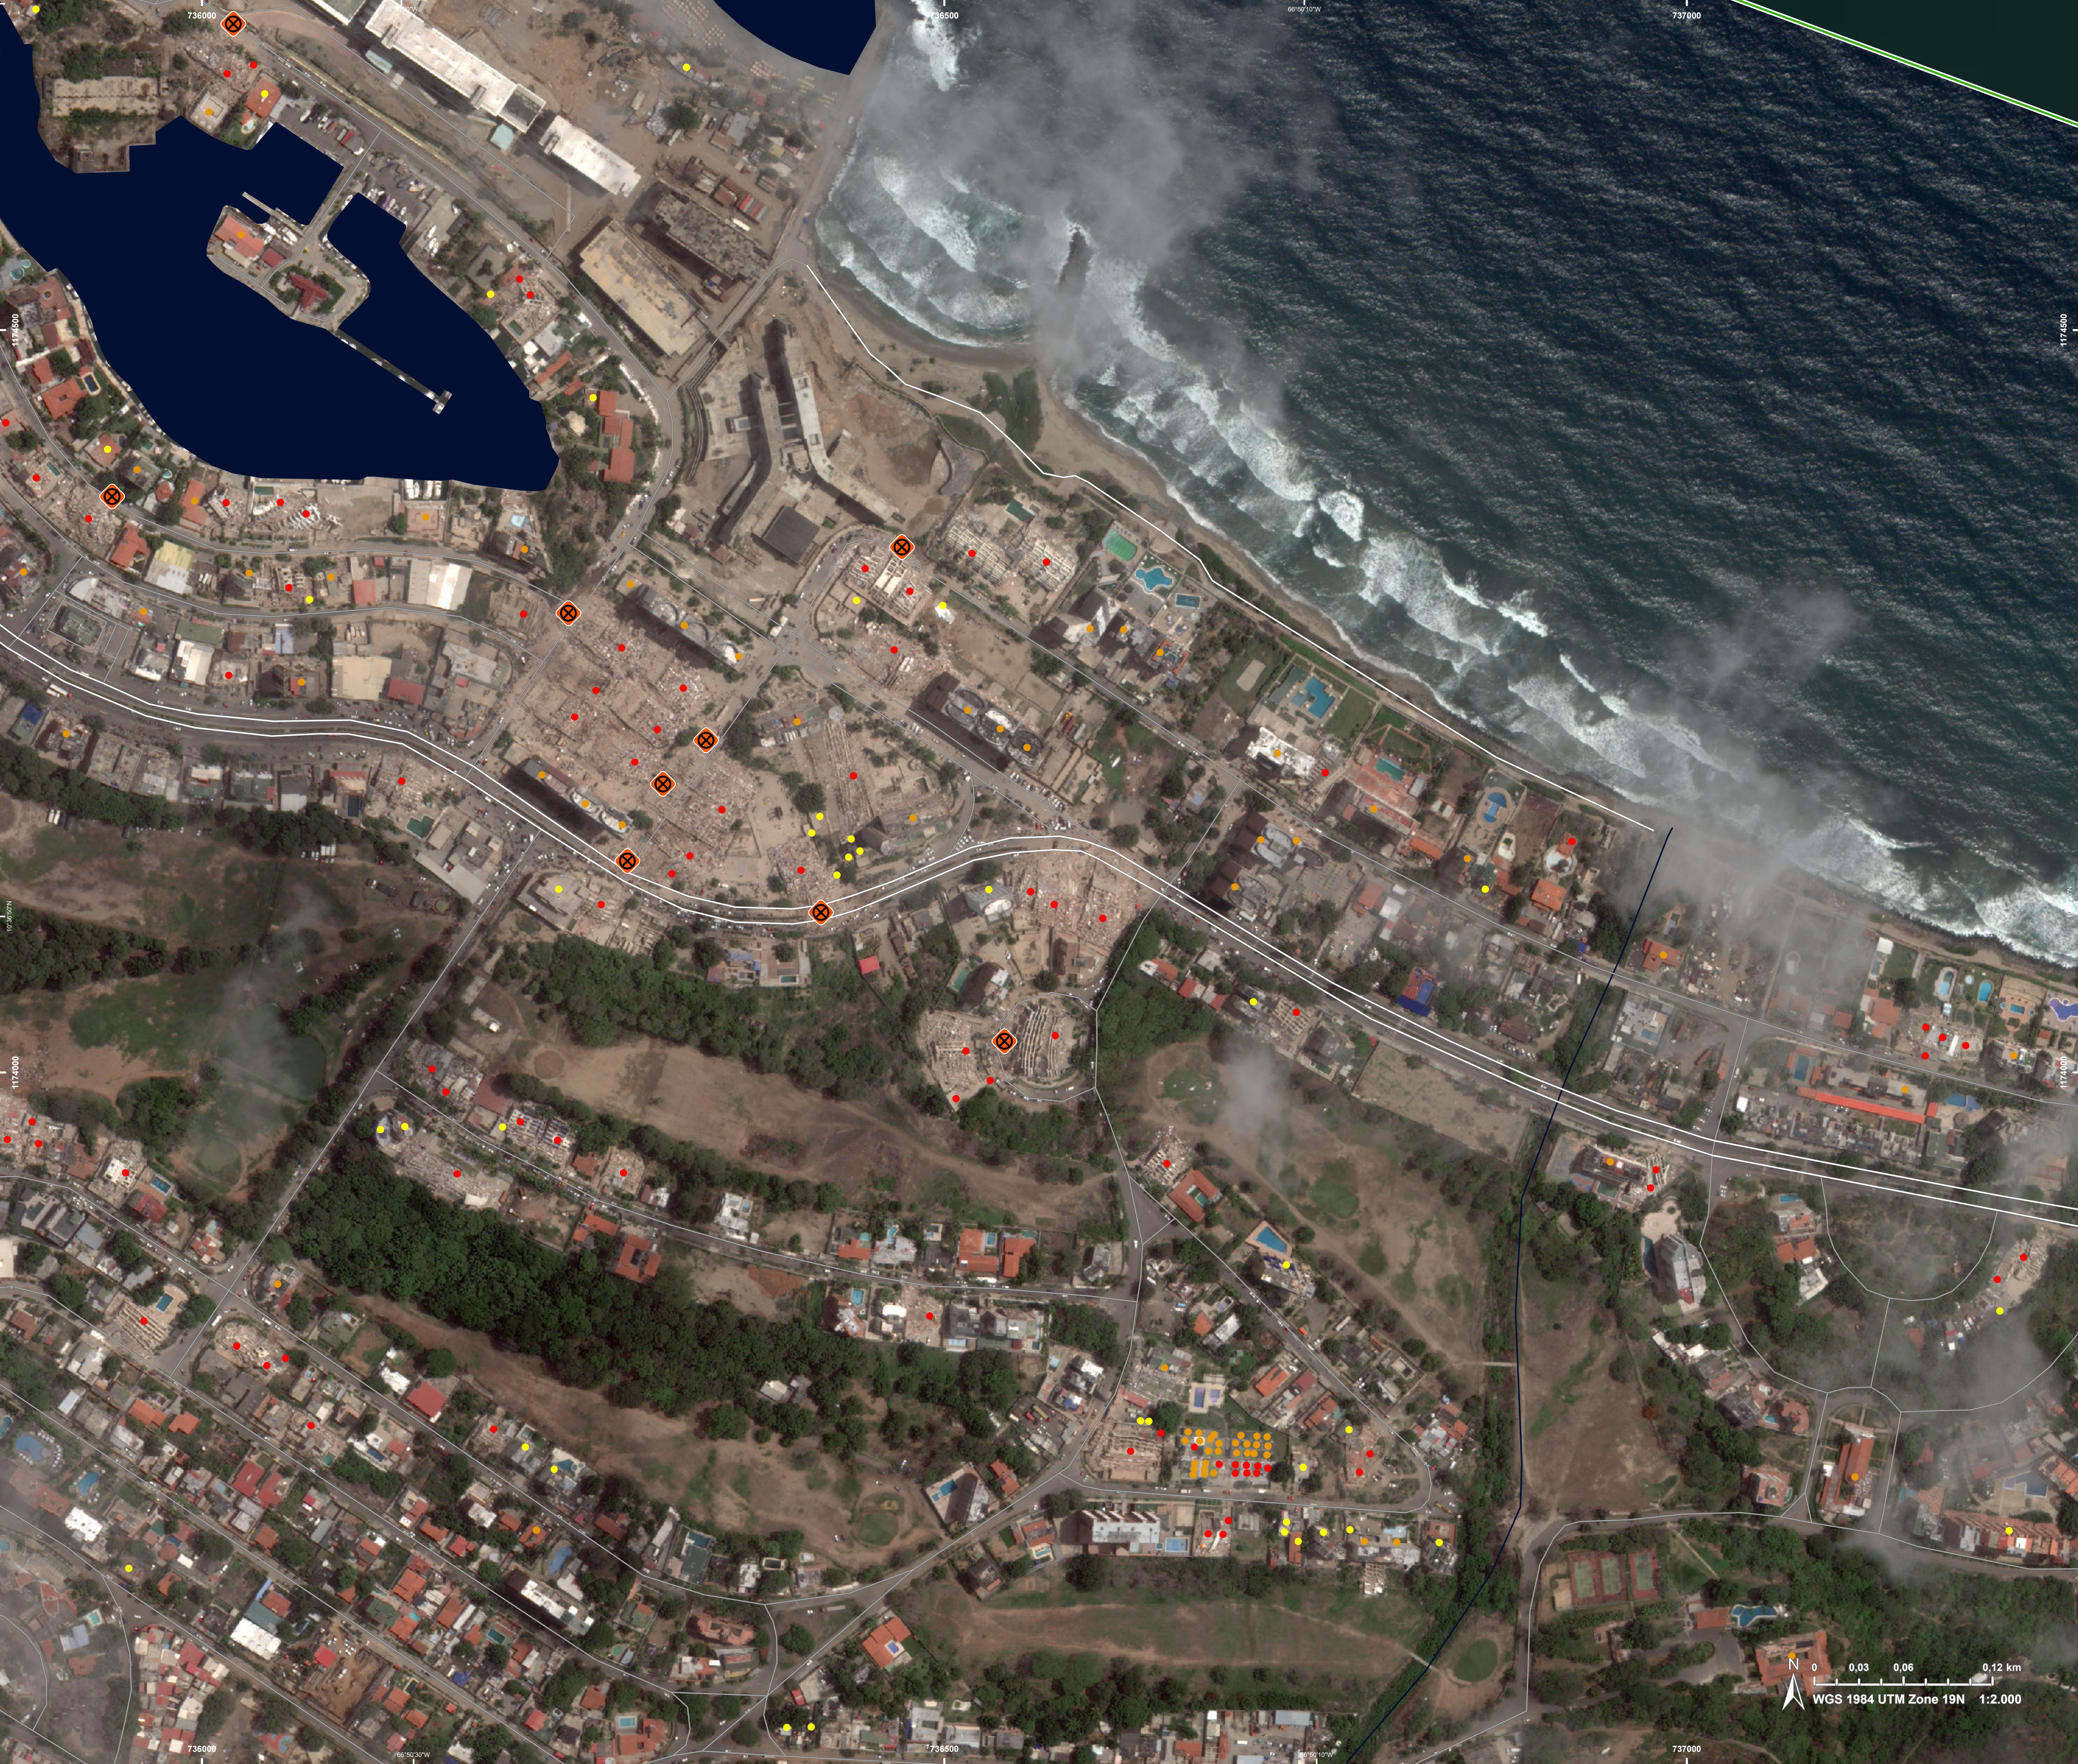
**Event:** On 24 Jun 2026 22:05 UTC a 7.5M earthquake, preceded by a strong foreshock, occurred in Venezuela. The impact on population is deemed high at this stage, with low visibility on the extent of the damage. Copernicus EMS Rapid Mapping is requested to provide damage assessment emergency mapping.

The thematic layer has been derived from post-event satellite image by means of visual interpretation.

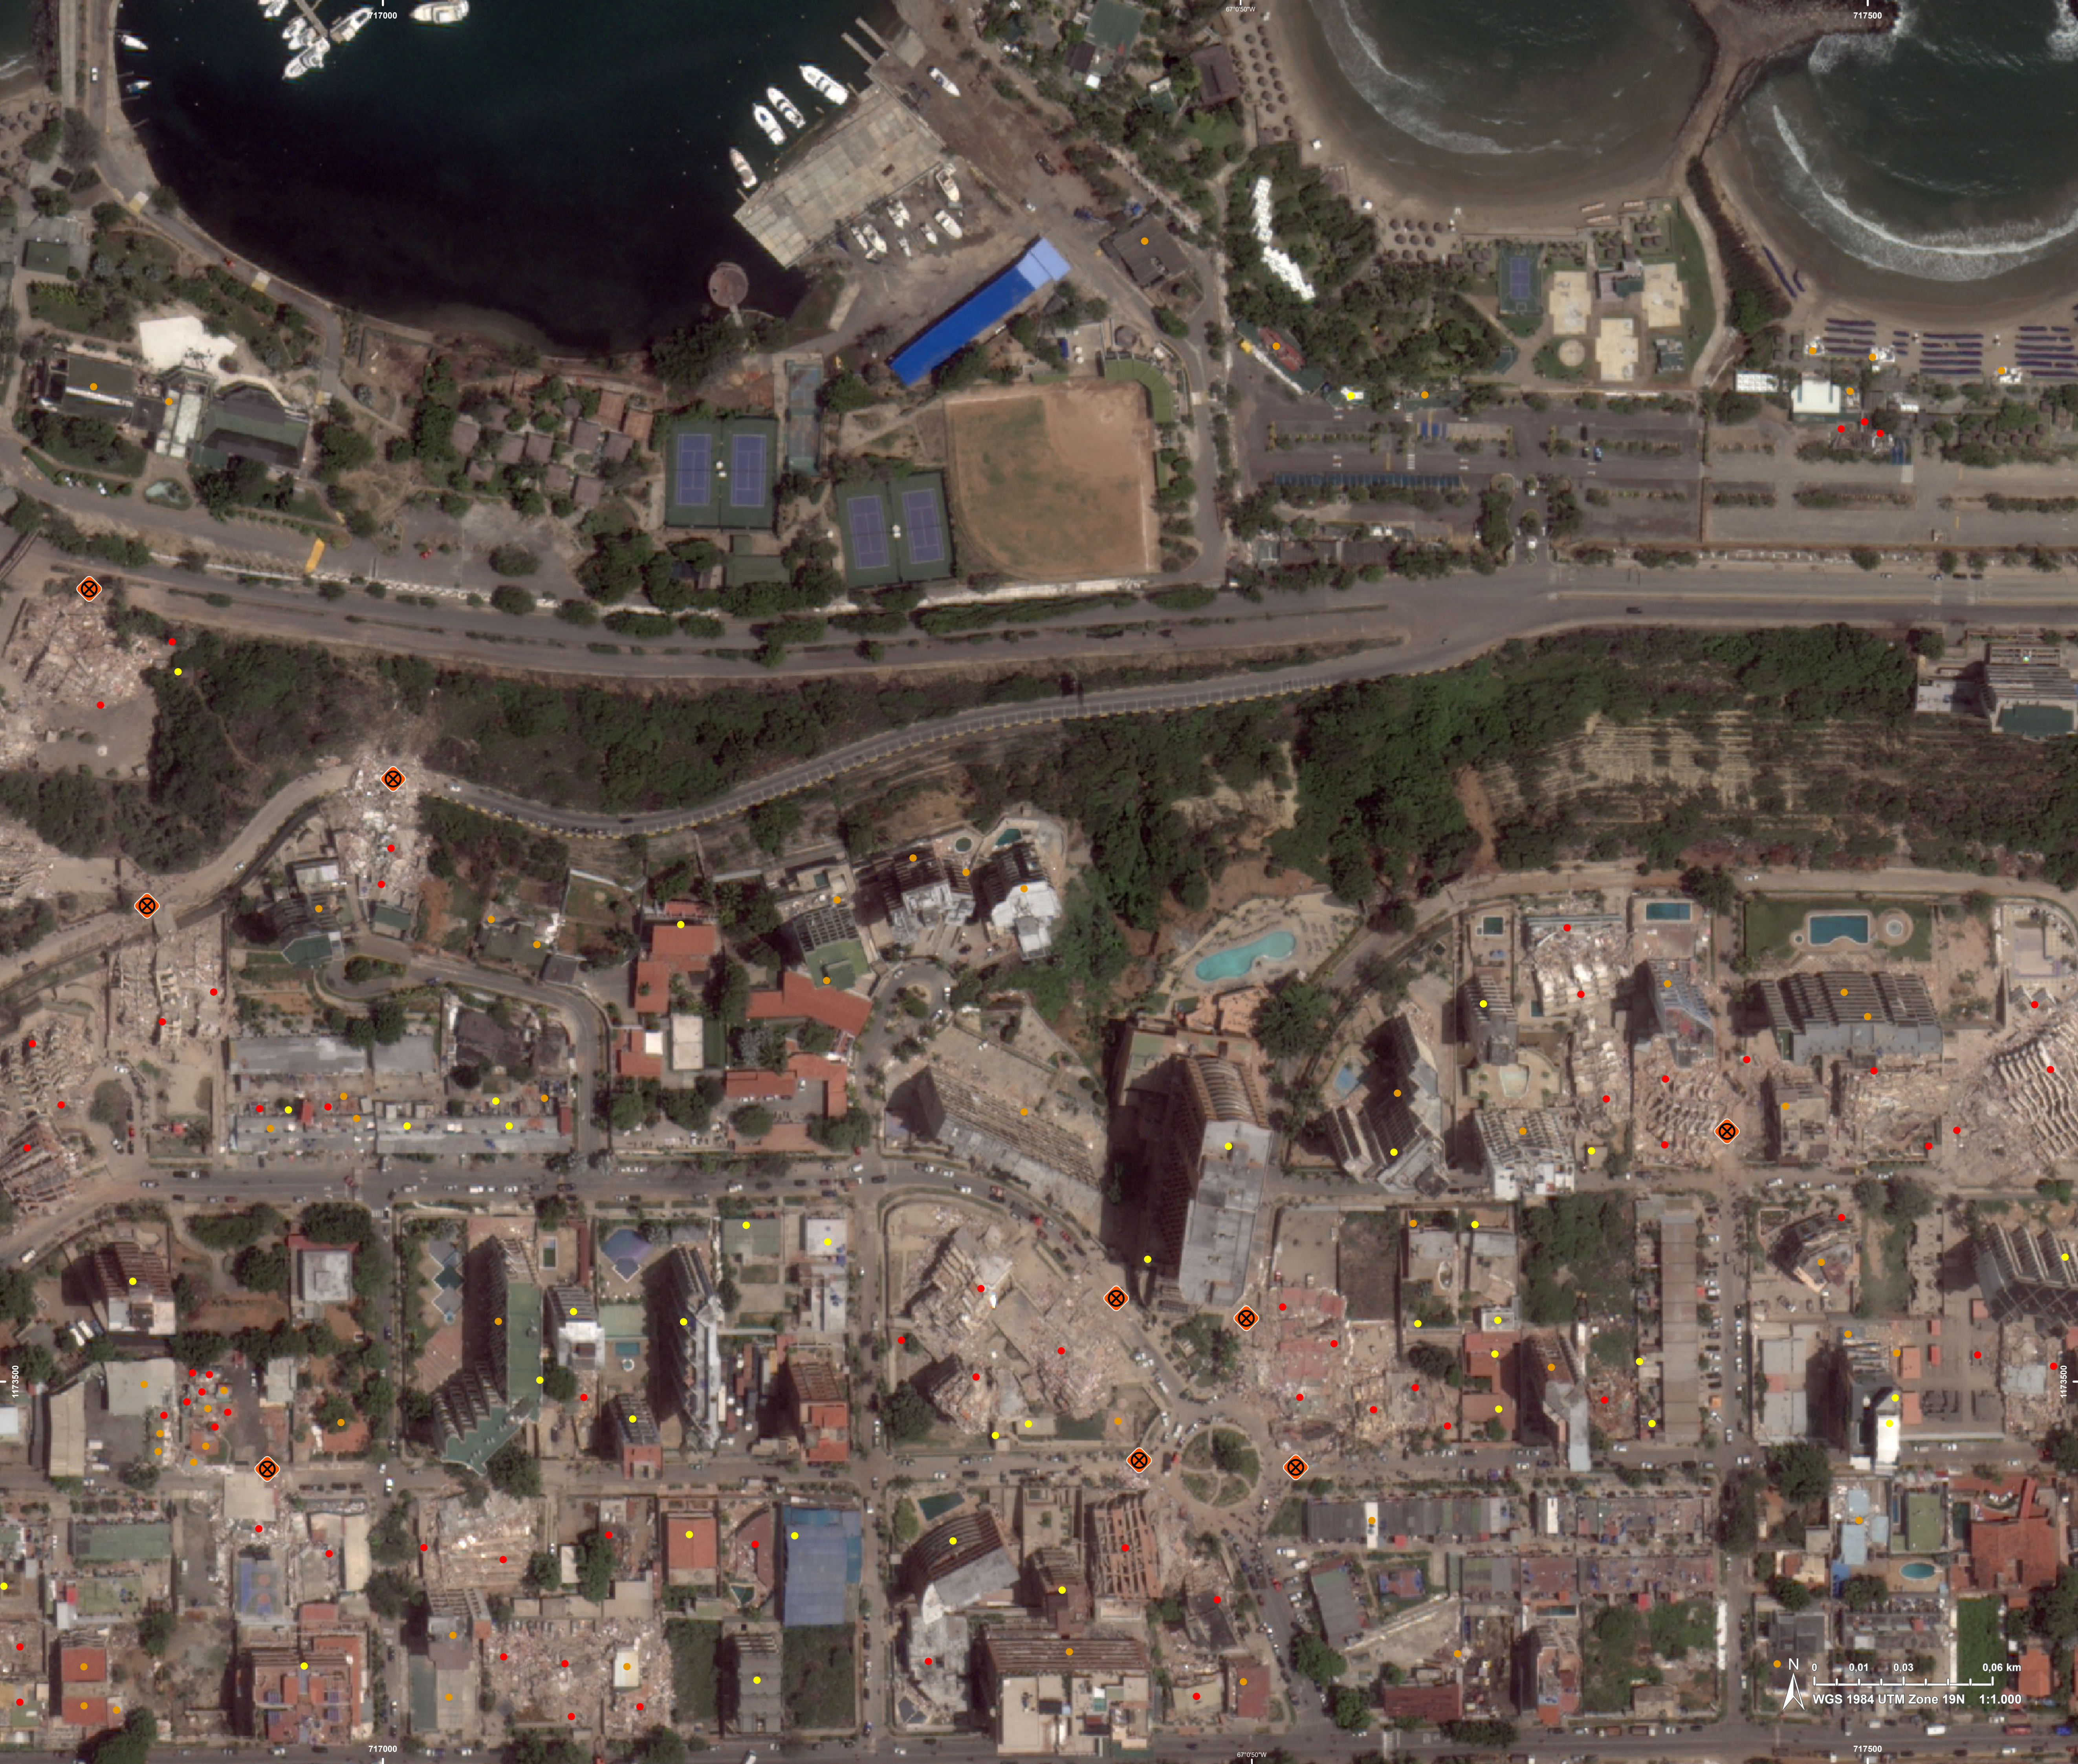
**Event:** On 24 Jun 2026 22:05 UTC a 7.5M earthquake, preceded by a strong foreshock, occurred in Venezuela. The impact on population is deemed high at this stage, with low visibility on the extent of the damage. Copernicus EMS Rapid Mapping is requested to provide damage assessment emergency mapping.

The thematic layer has been derived from post-event satellite image by means of visual interpretation.

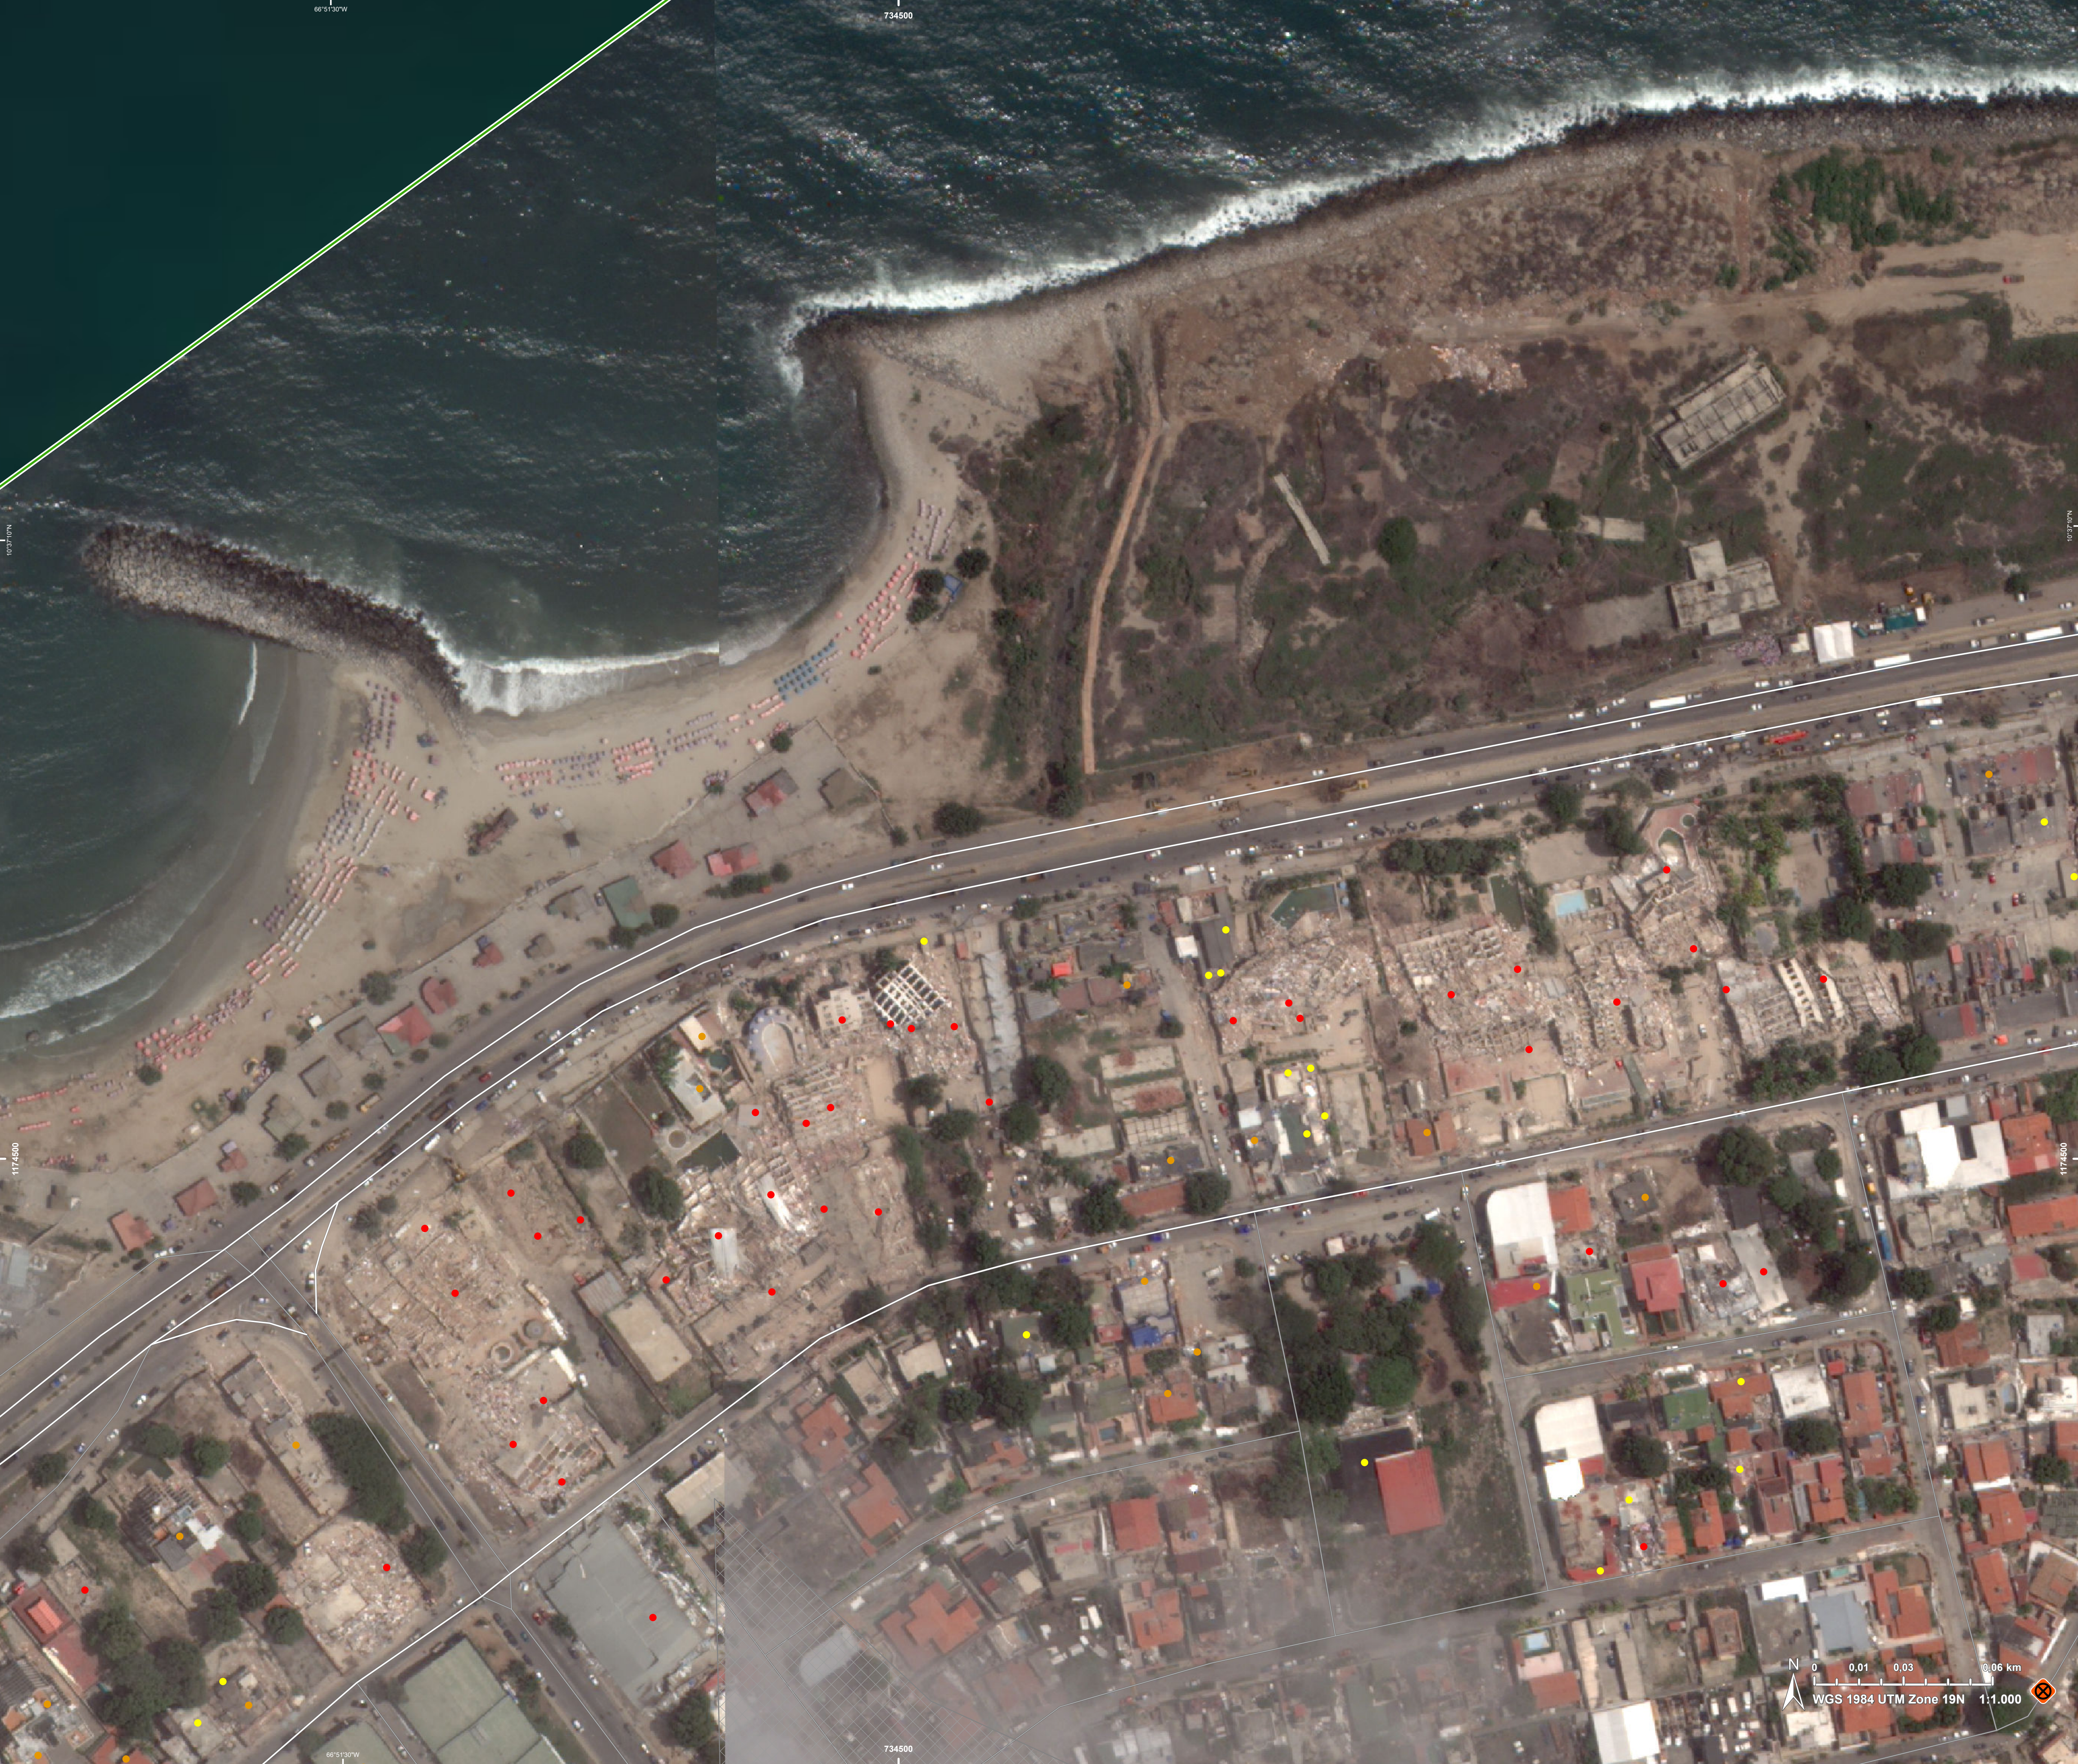
**Situation as of 26/06/2026 15:10 UTC**  
Grading MONIT01 - Detail map 04

**Event:** On 24 Jun 2026 22:05 UTC a 7.5M earthquake, preceded by a strong foreshock, occurred in Venezuela. The impact on population is deemed high at this stage, with low visibility on the extent of the damage. Copernicus EMS Rapid Mapping is requested to provide damage assessment emergency mapping.

The thematic layer has been derived from post-event satellite image by means of visual interpretation.

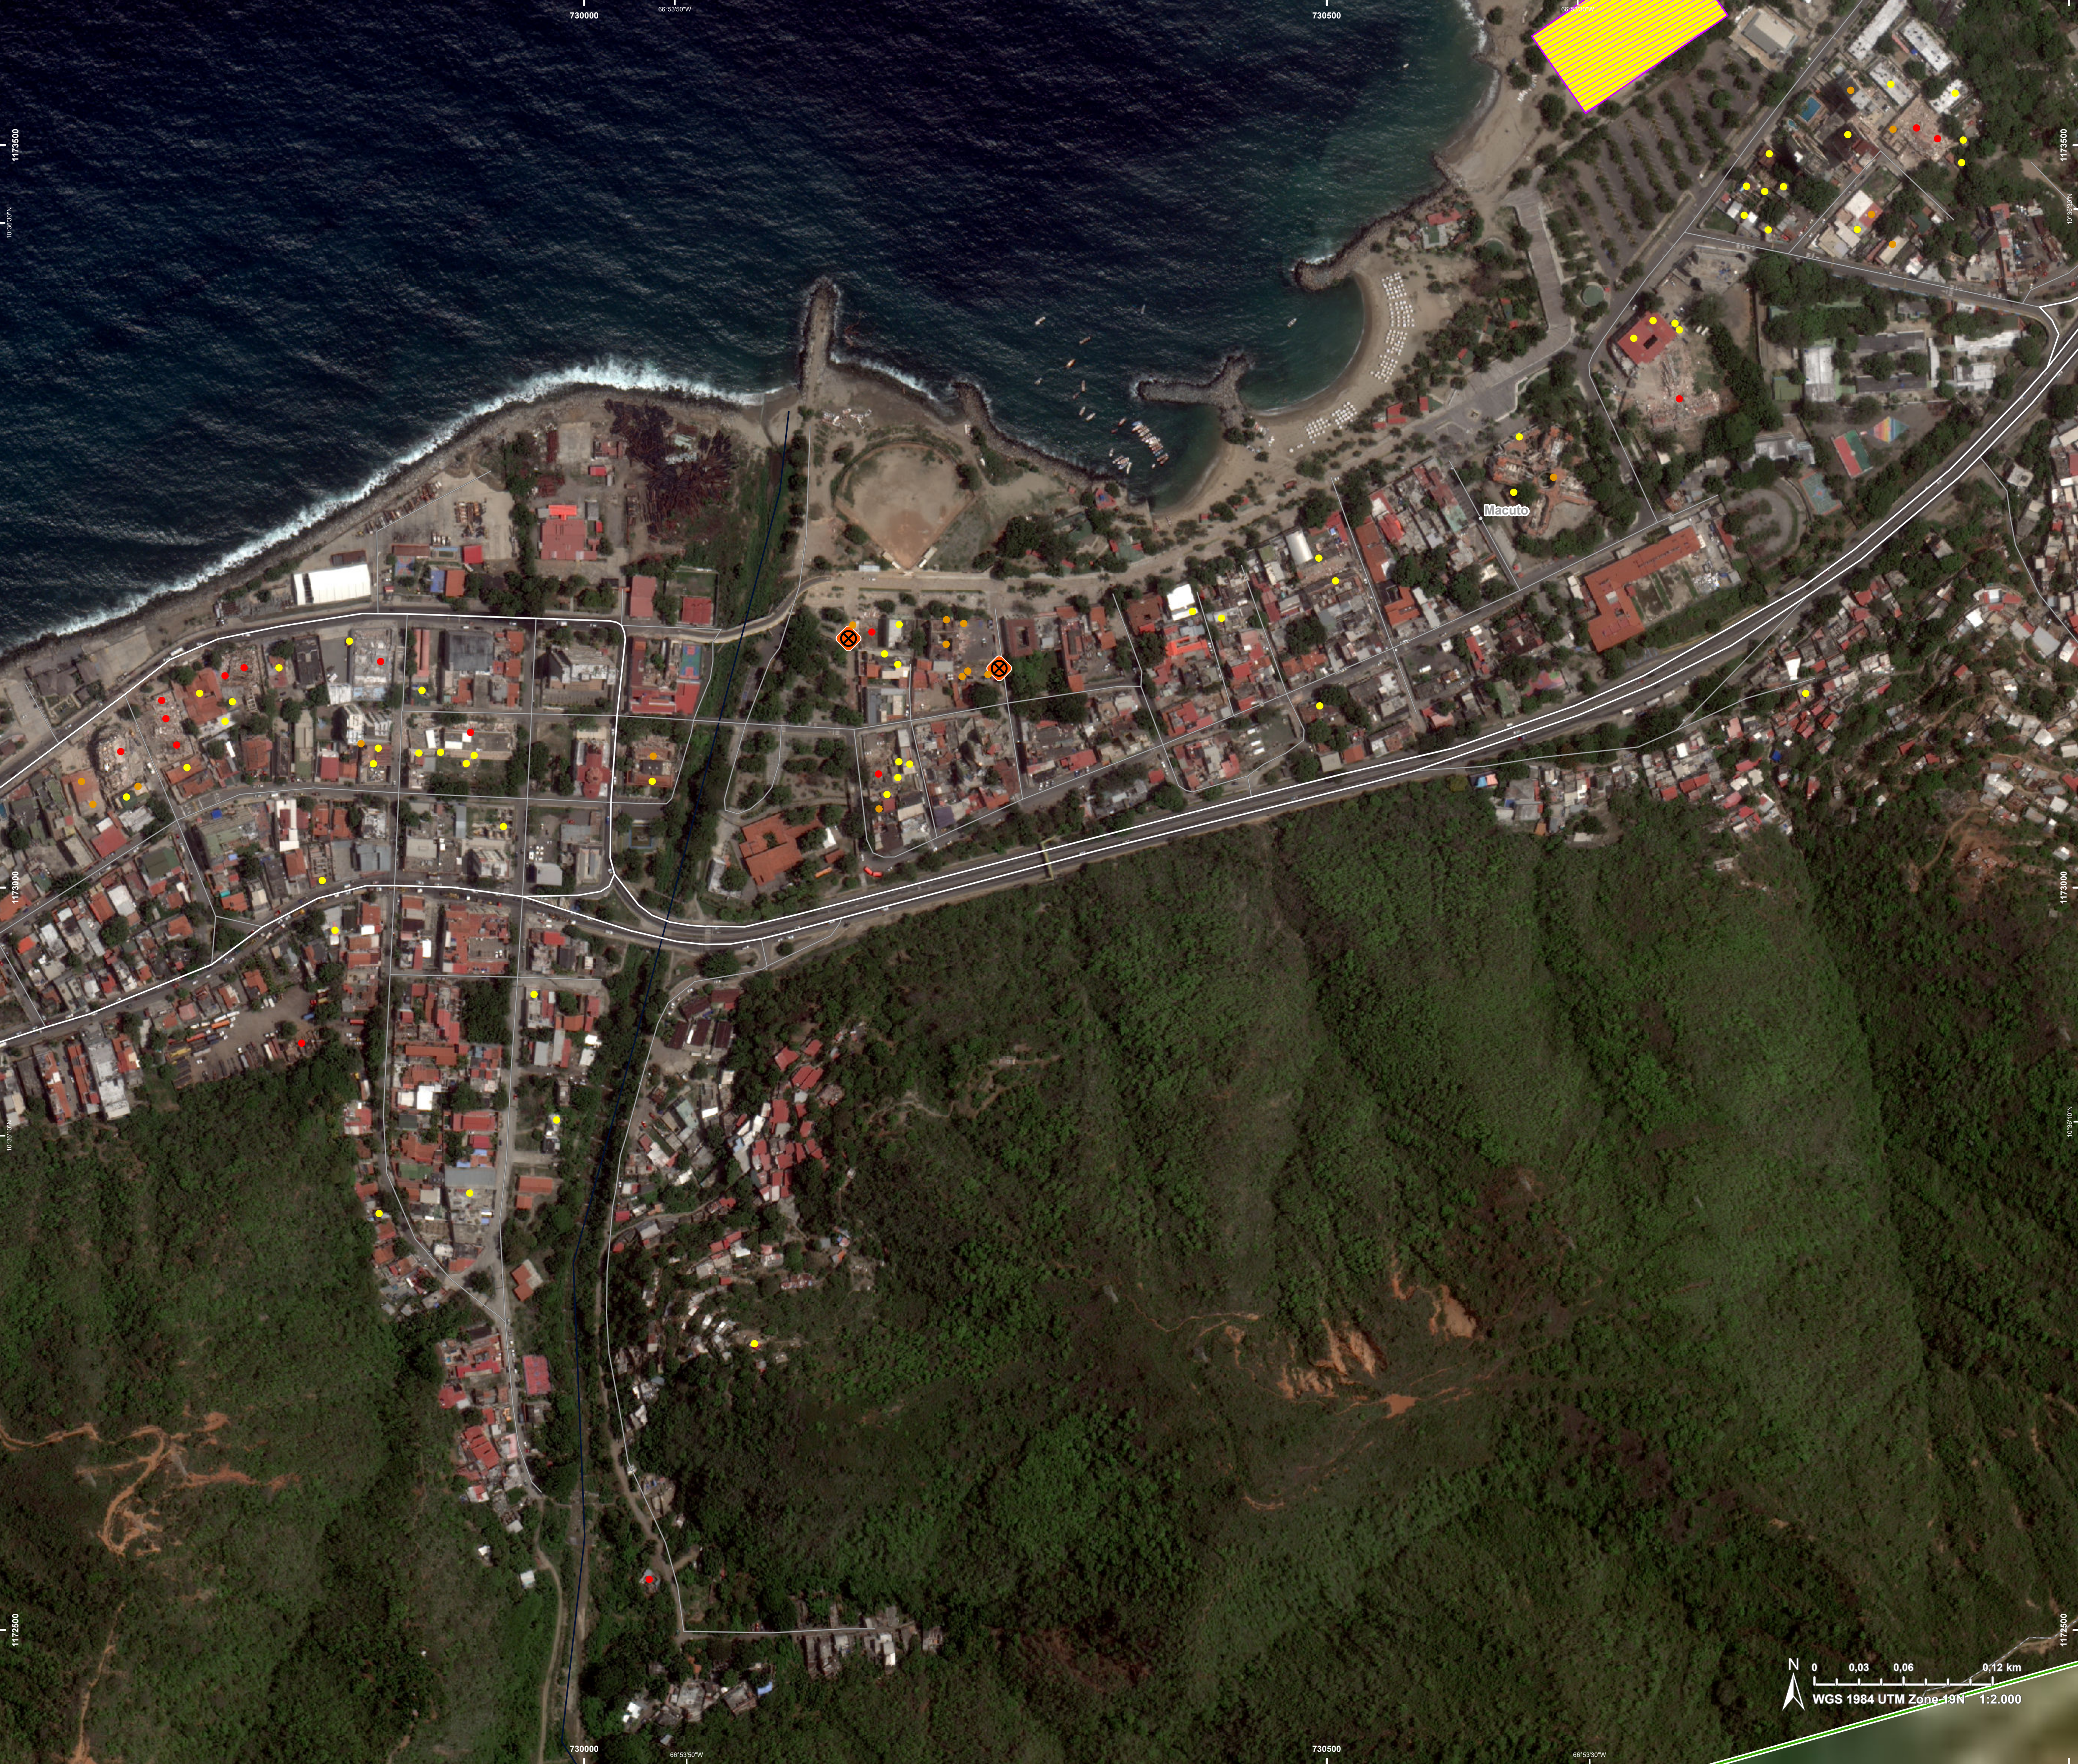
**Situation as of 26/06/2026 15:10 UTC**  
Grading MONIT01 - Detail map 05

**Event:** On 24 Jun 2026 22:05 UTC a 7.5M earthquake, preceded by a strong foreshock, occurred in Venezuela. The impact on population is deemed high at this stage, with low visibility on the extent of the damage. Copernicus EMS Rapid Mapping is requested to provide damage assessment emergency mapping.

The thematic layer has been derived from post-event satellite image by means of visual interpretation.

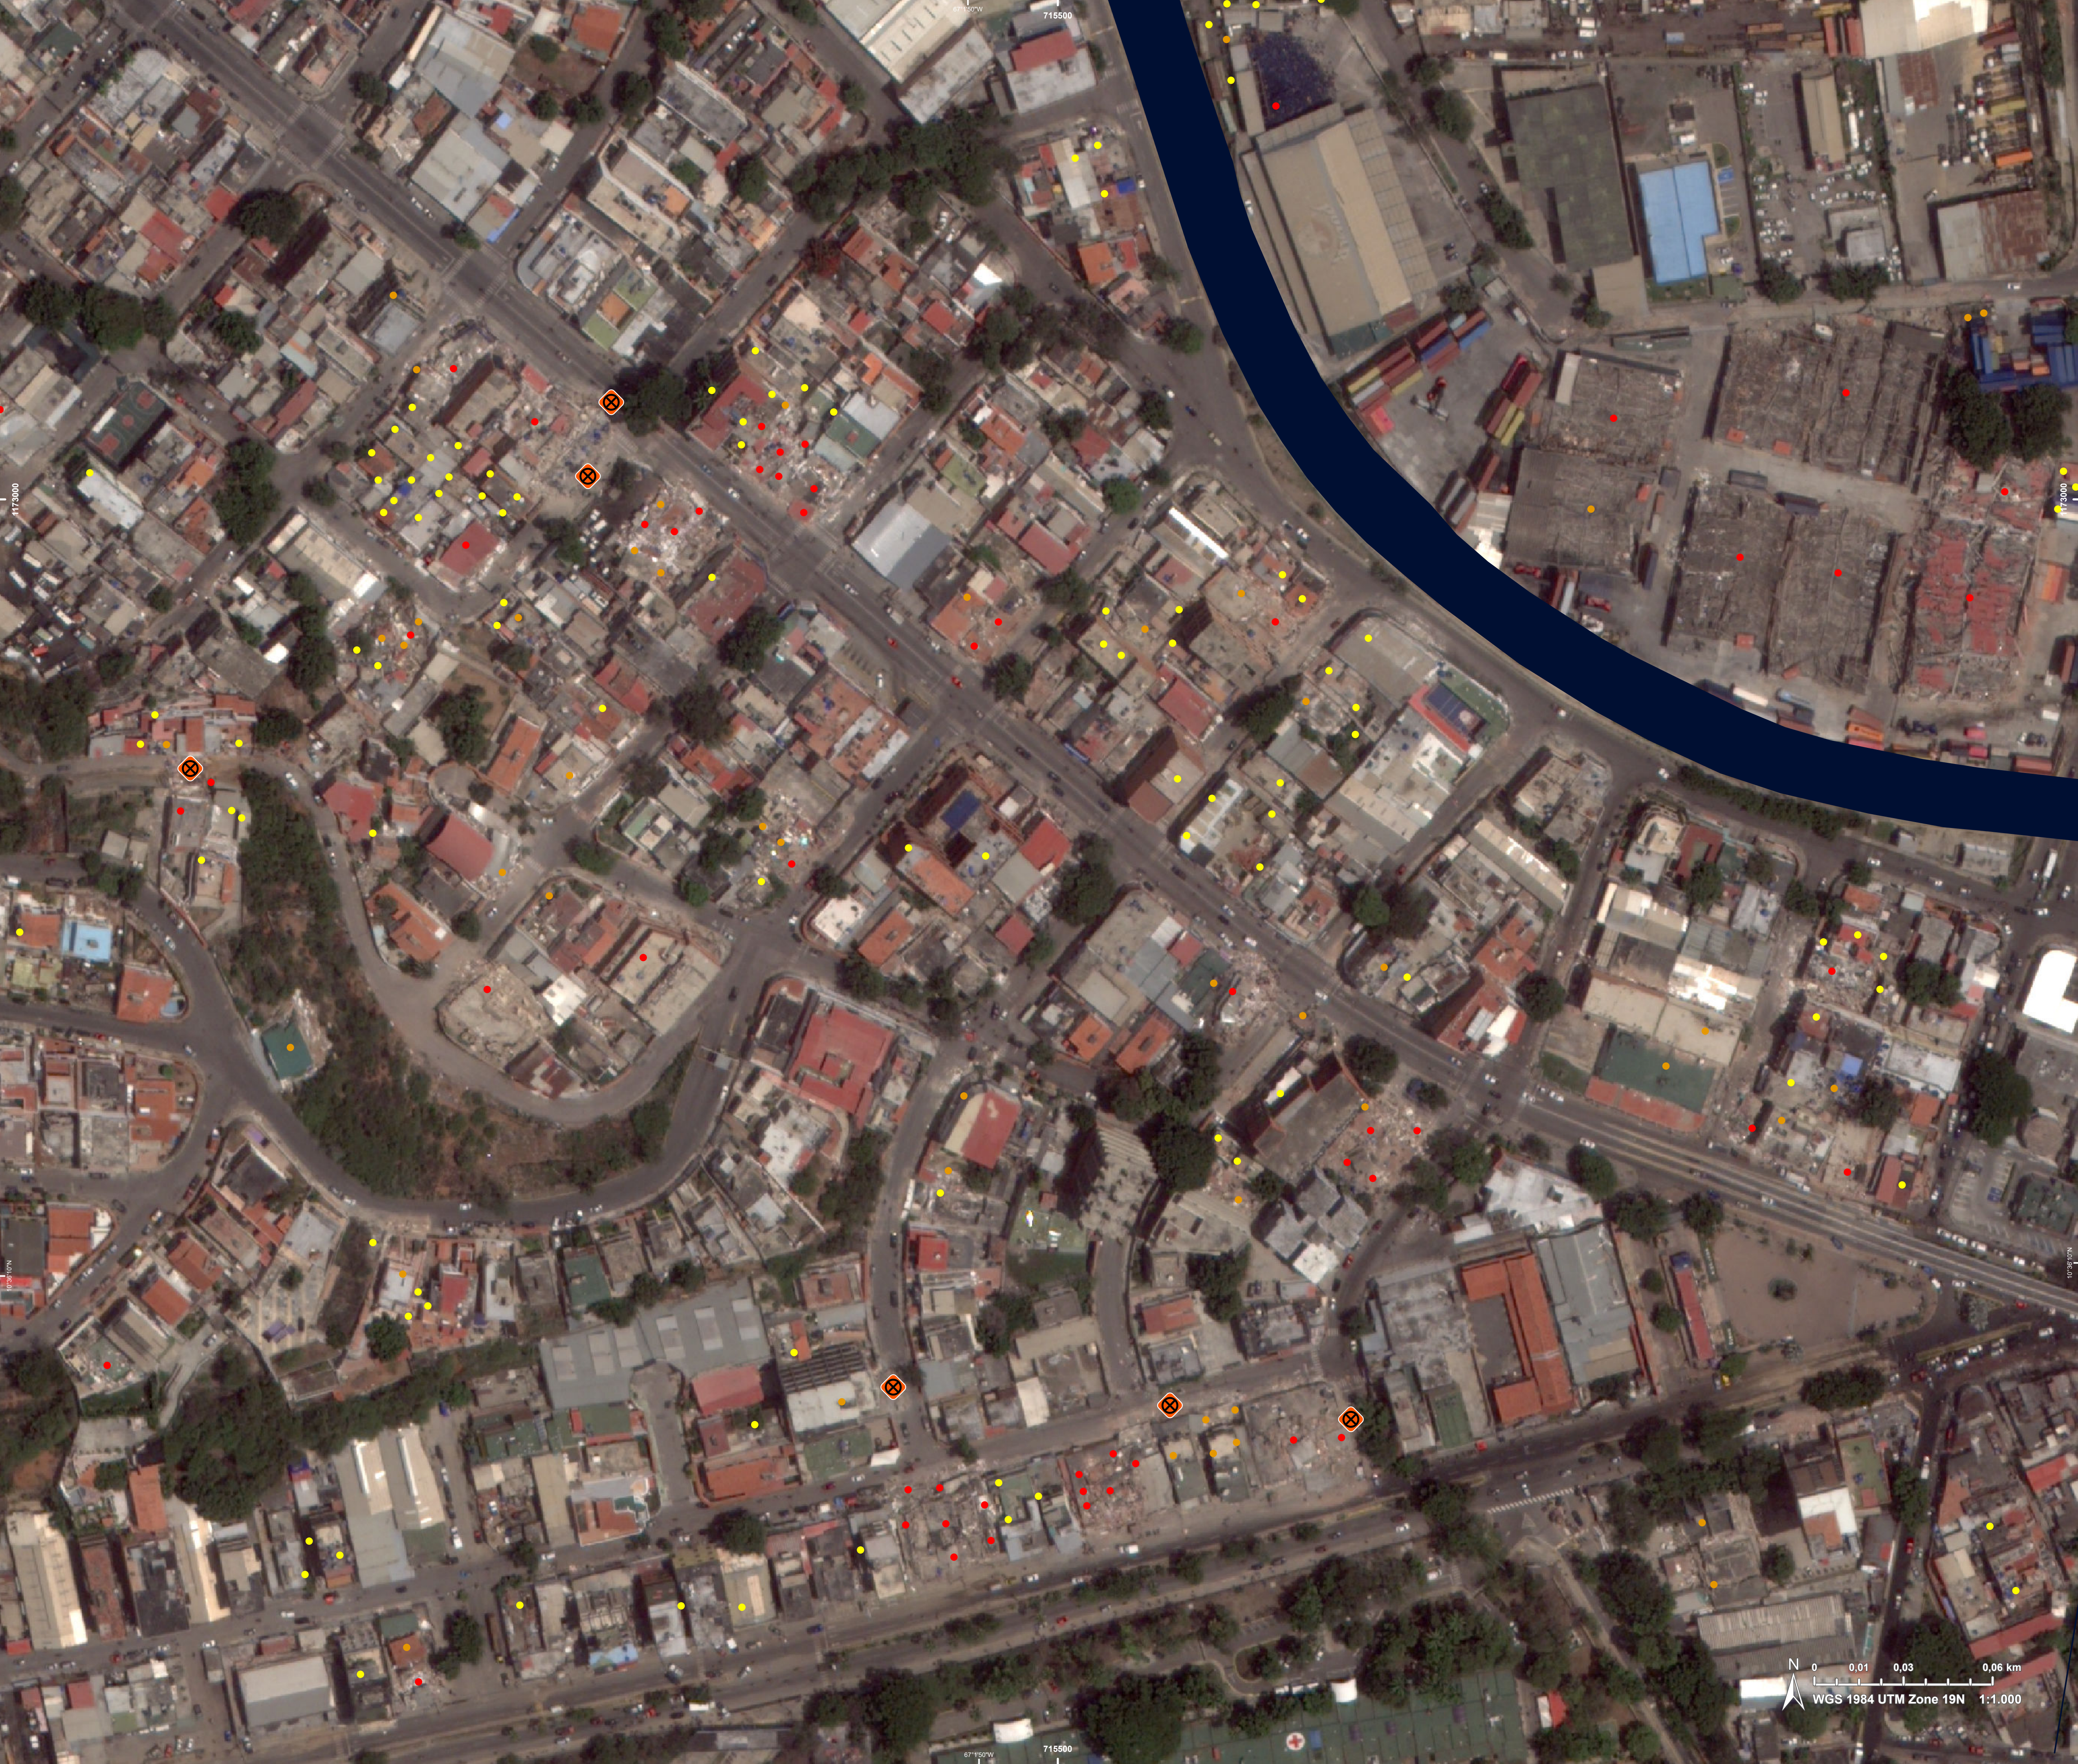
**Situation as of 26/06/2026 15:10 UTC**  
Grading MONIT01 - Detail map 06

**Event:** On 24 Jun 2026 22:05 UTC a 7.5M earthquake, preceded by a strong foreshock, occurred in Venezuela. The impact on population is deemed high at this stage, with low visibility on the extent of the damage. Copernicus EMS Rapid Mapping is requested to provide damage assessment emergency mapping.

The thematic layer has been derived from post-event satellite image by means of visual interpretation.
