EMSR884 - AOI12  
Earthquake in Venezuela  
CARABALLEDA

Situation as of 26/06/2026 15:10 UTC  
Grading - Overview map 01

**Event:** On 24 Jun 2026 22:05 UTC a 7.5M earthquake, preceded by a strong foreshock, occurred in Venezuela. The impact on population is deemed high at this stage, with low visibility on the extent of the damage. Copernicus EMS Rapid Mapping is requested to provide damage assessment emergency mapping.

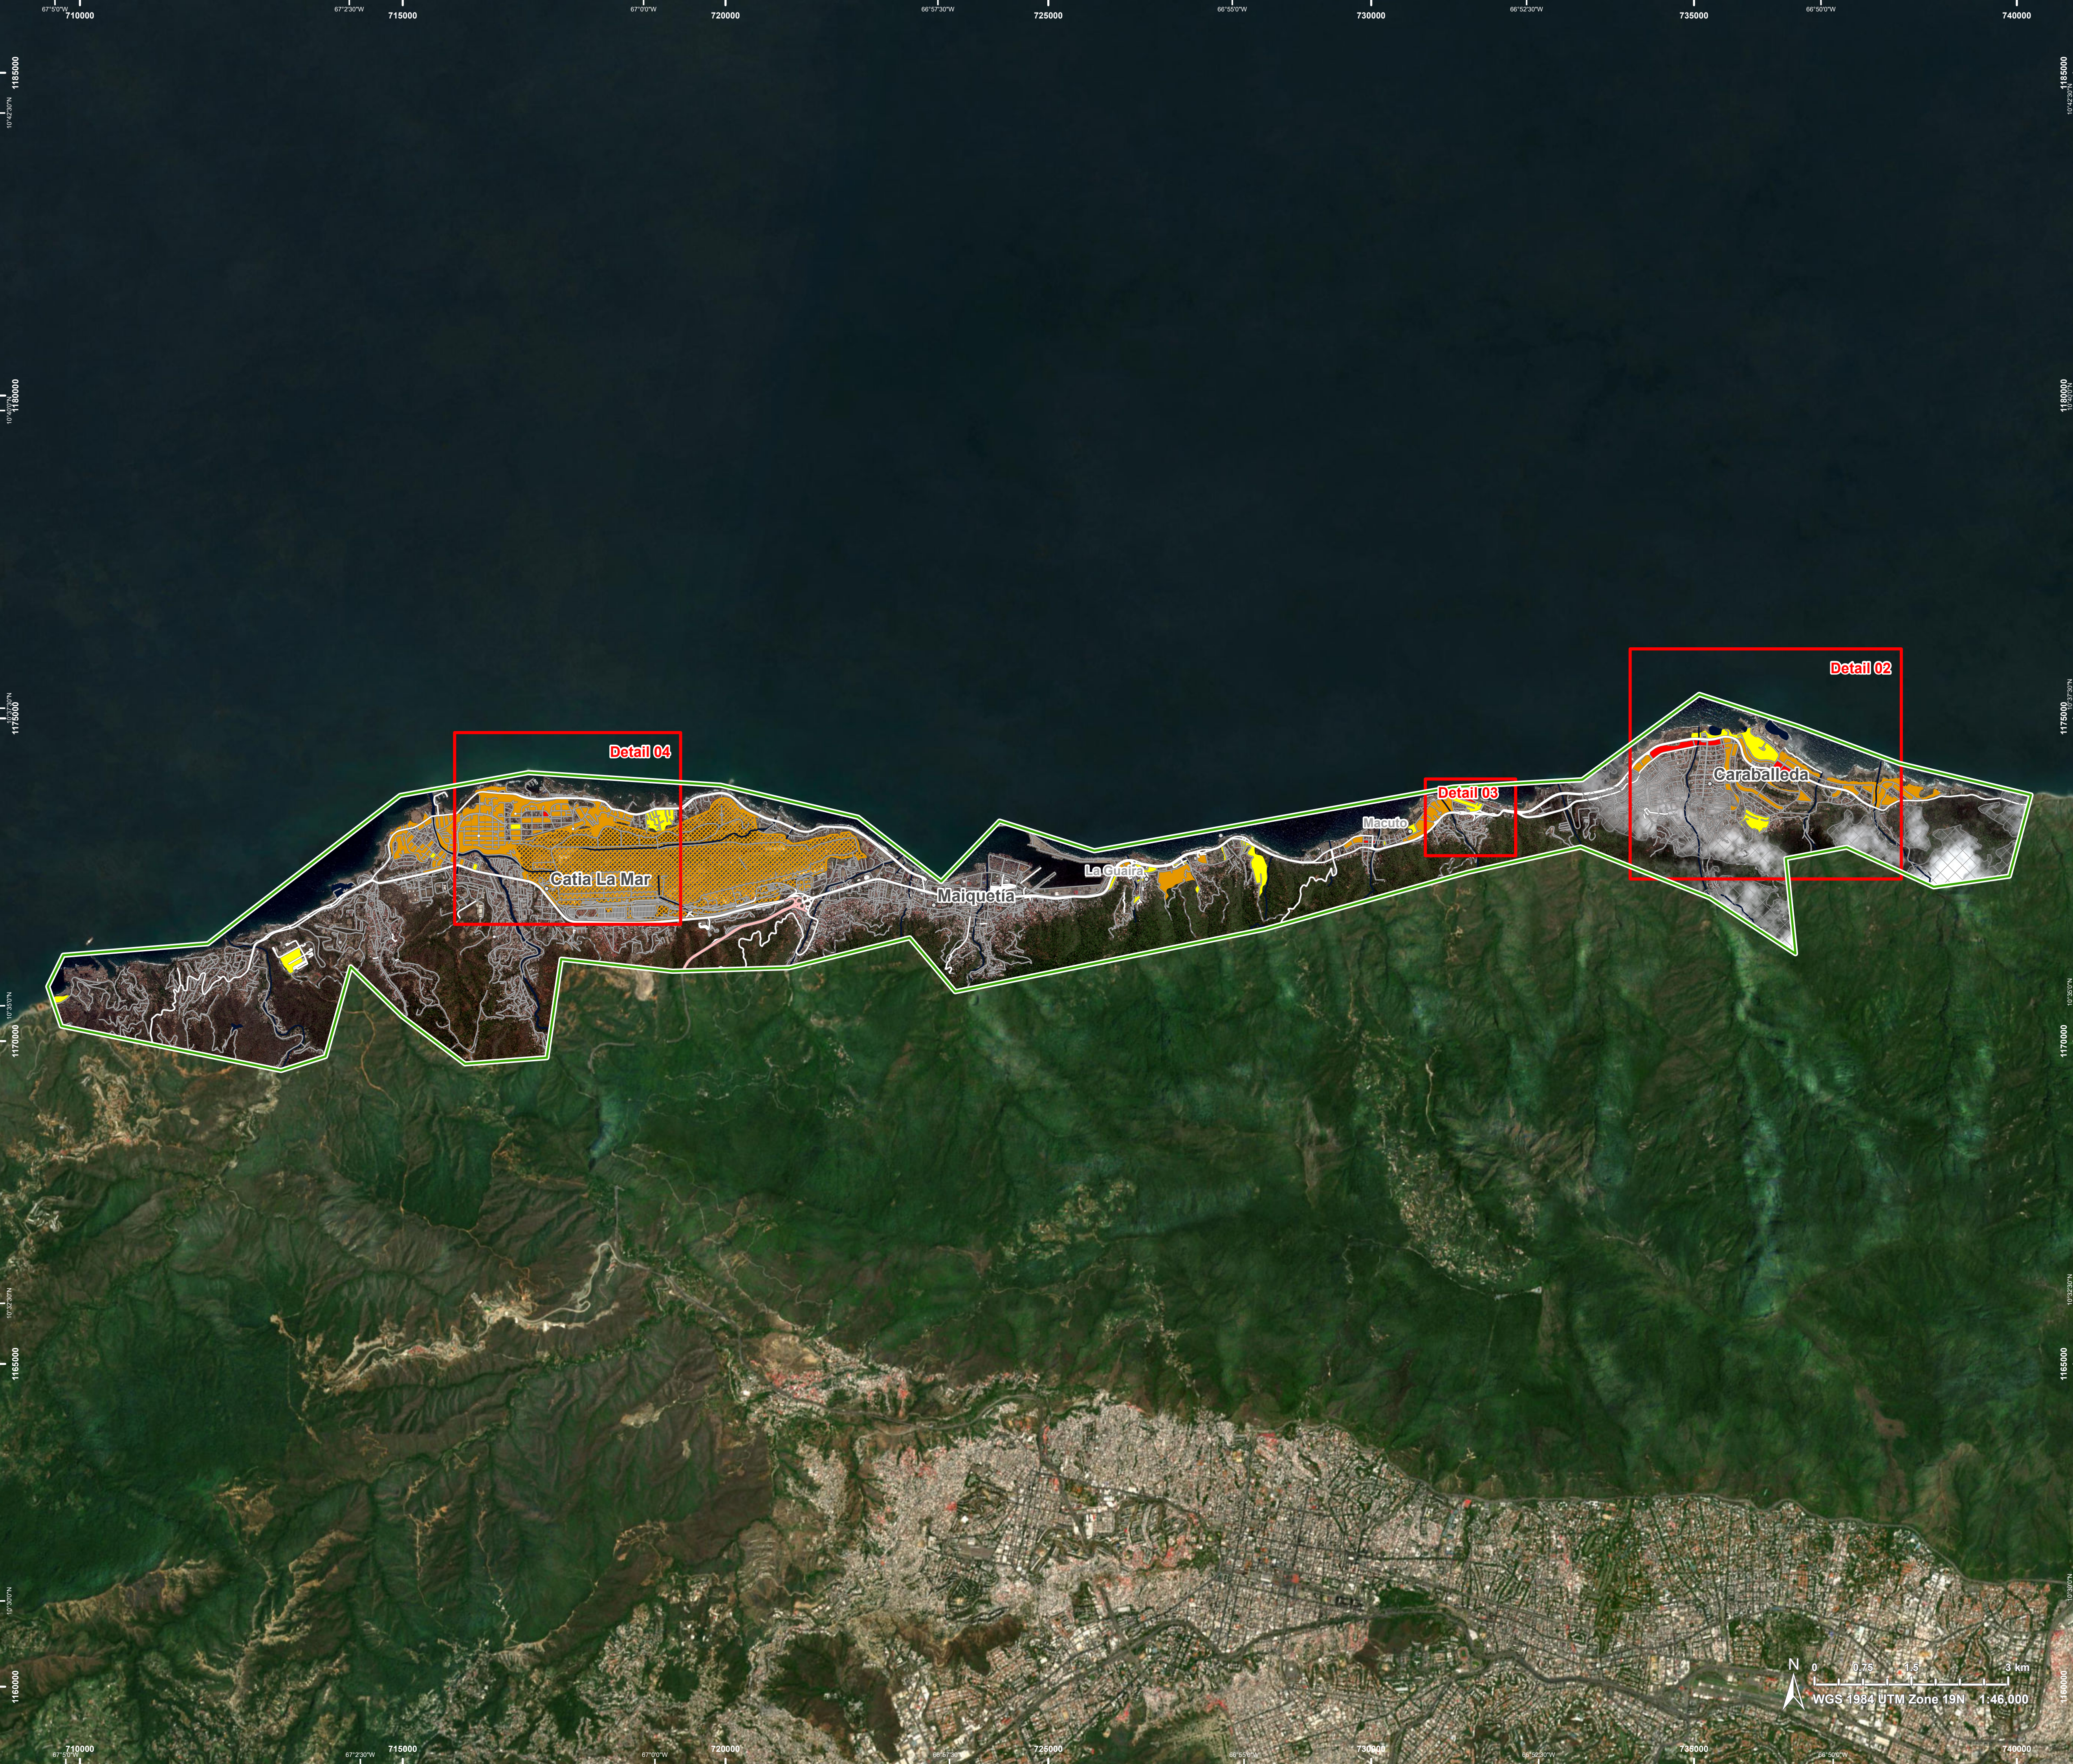
Built-Up  
379.4 ha

The thematic layer has been derived from post-event satellite image by means of visual interpretation.  
This analysis has been supplemented by the social media.

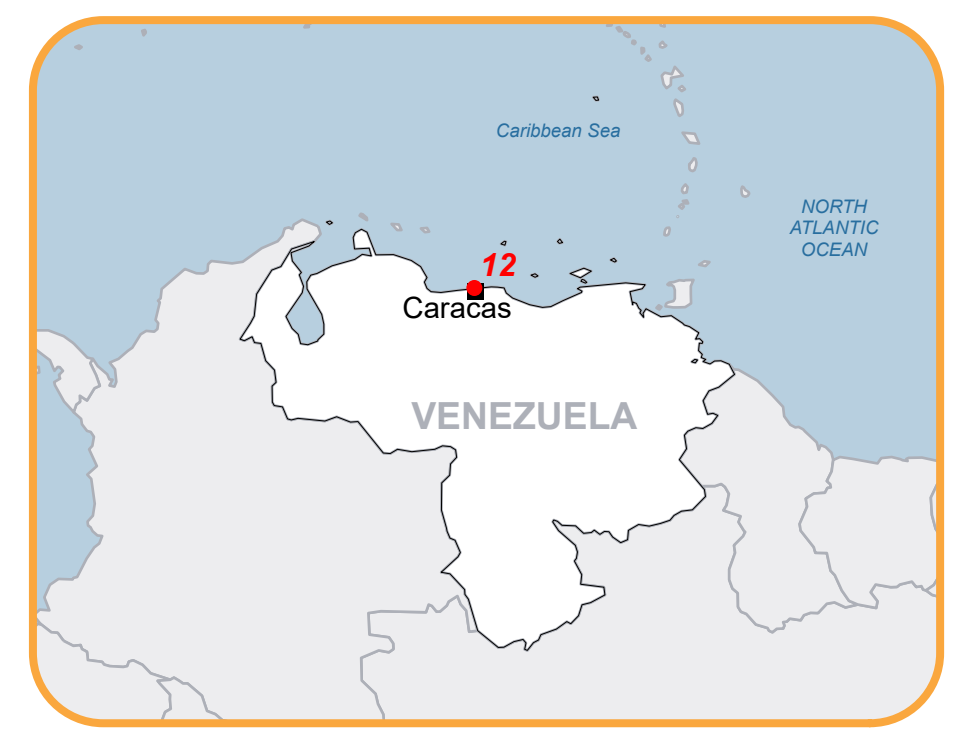
Airfield and Heliport, Damaged

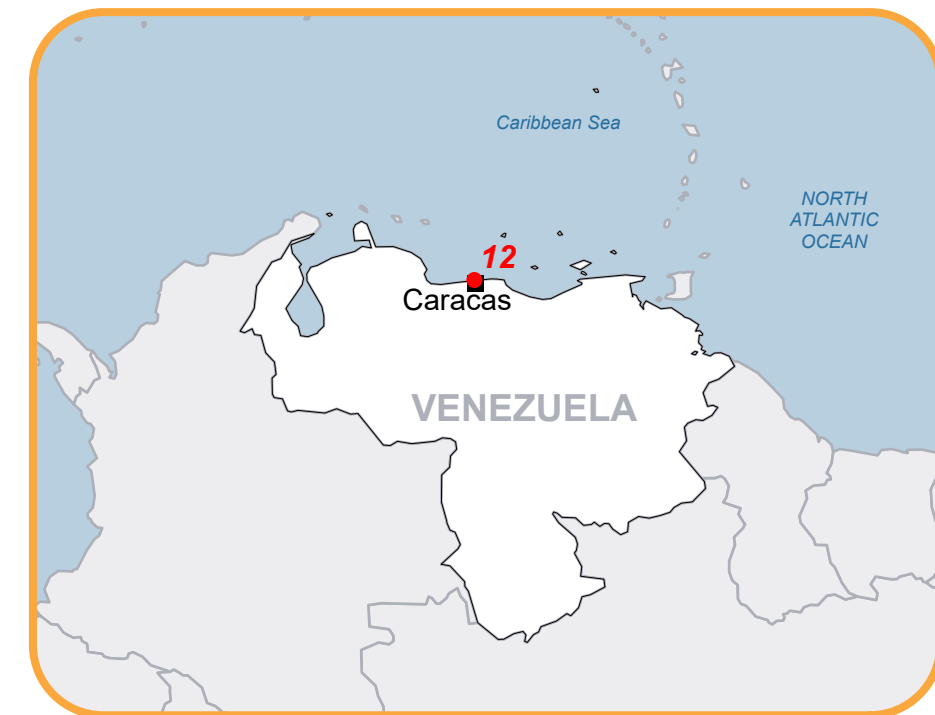
Situation as of 26/06/2026 15:10 UTC  
Grading - Detail map 03

The thematic layer has been derived from post-event satellite image by means of visual interpretation.

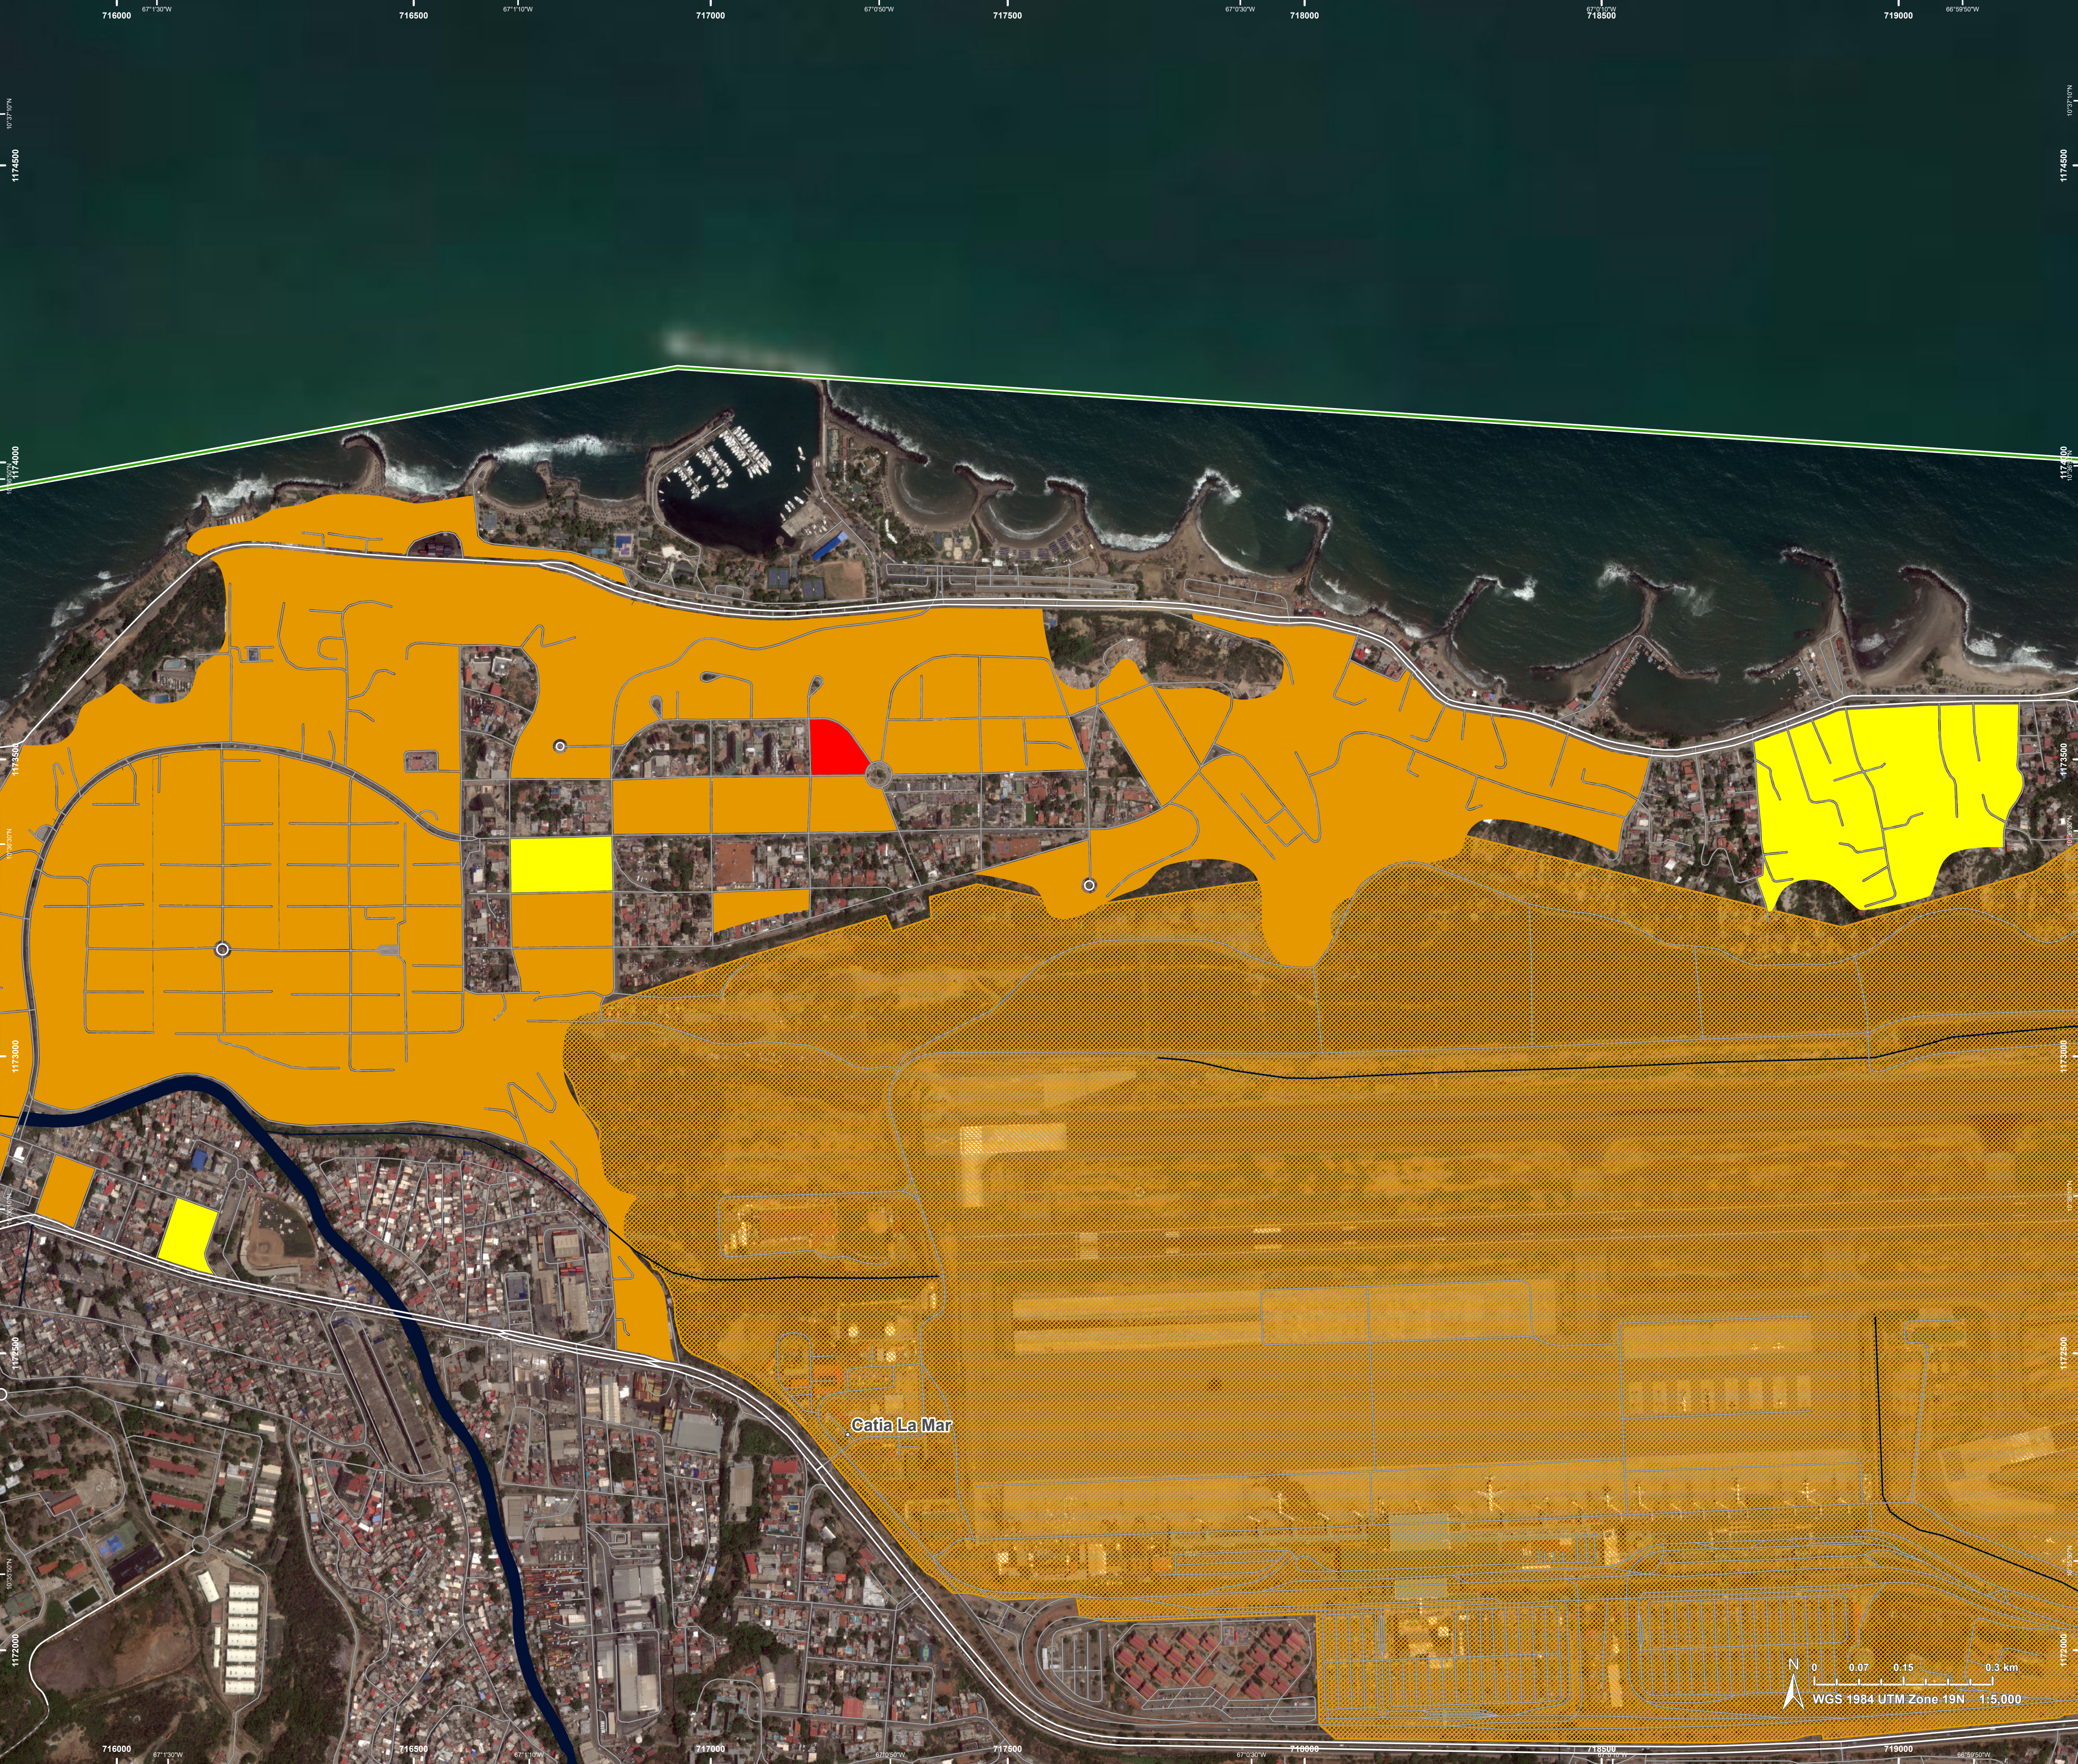
**Situation as of 26/06/2026 15:10 UTC**  
Grading - Detail map 04

The thematic layer has been derived from post-event satellite image by means of visual interpretation.

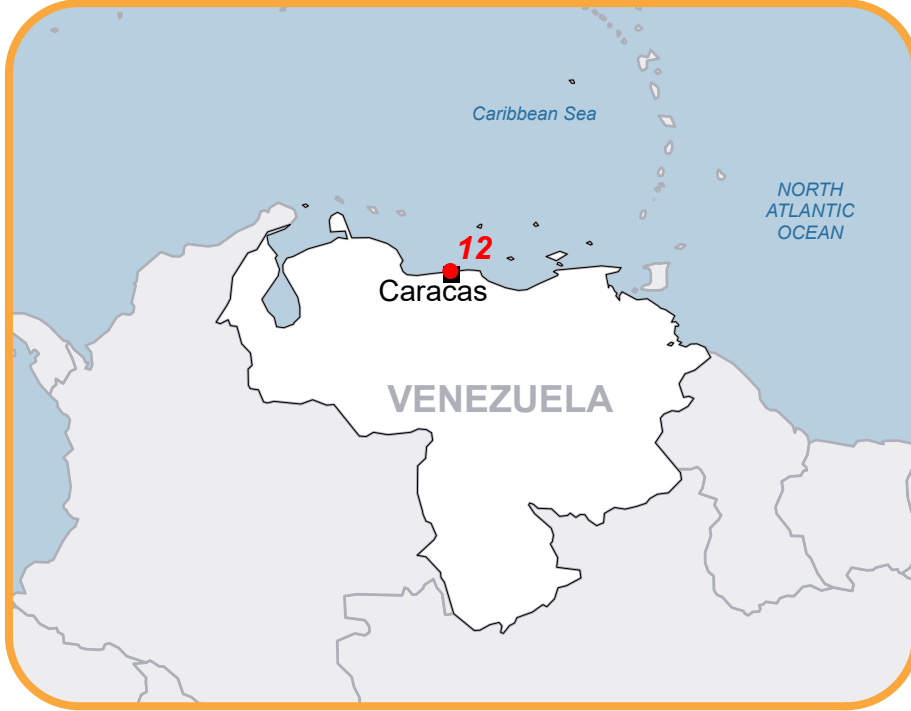
- Built Up Grading**
- Destroyed
  - Damaged
  - Possibly damaged
- Transportation Grading**
- Main road, No visible damage
  - Local road, No visible damage
- General Information**
- Airfield and Heliport, Damaged
  - Area of Interest
- Hydrography**
- Lake, River
- Track, No visible damage**
