EMSR884 - AOI12  
Earthquake in Venezuela  
CARABALLEDA

Situation as of 26/06/2026 15:10 UTC  
Grading - Overview map 01

Situation as of 26/06/2026 15:10 UTC  
Grading - Detail map 02

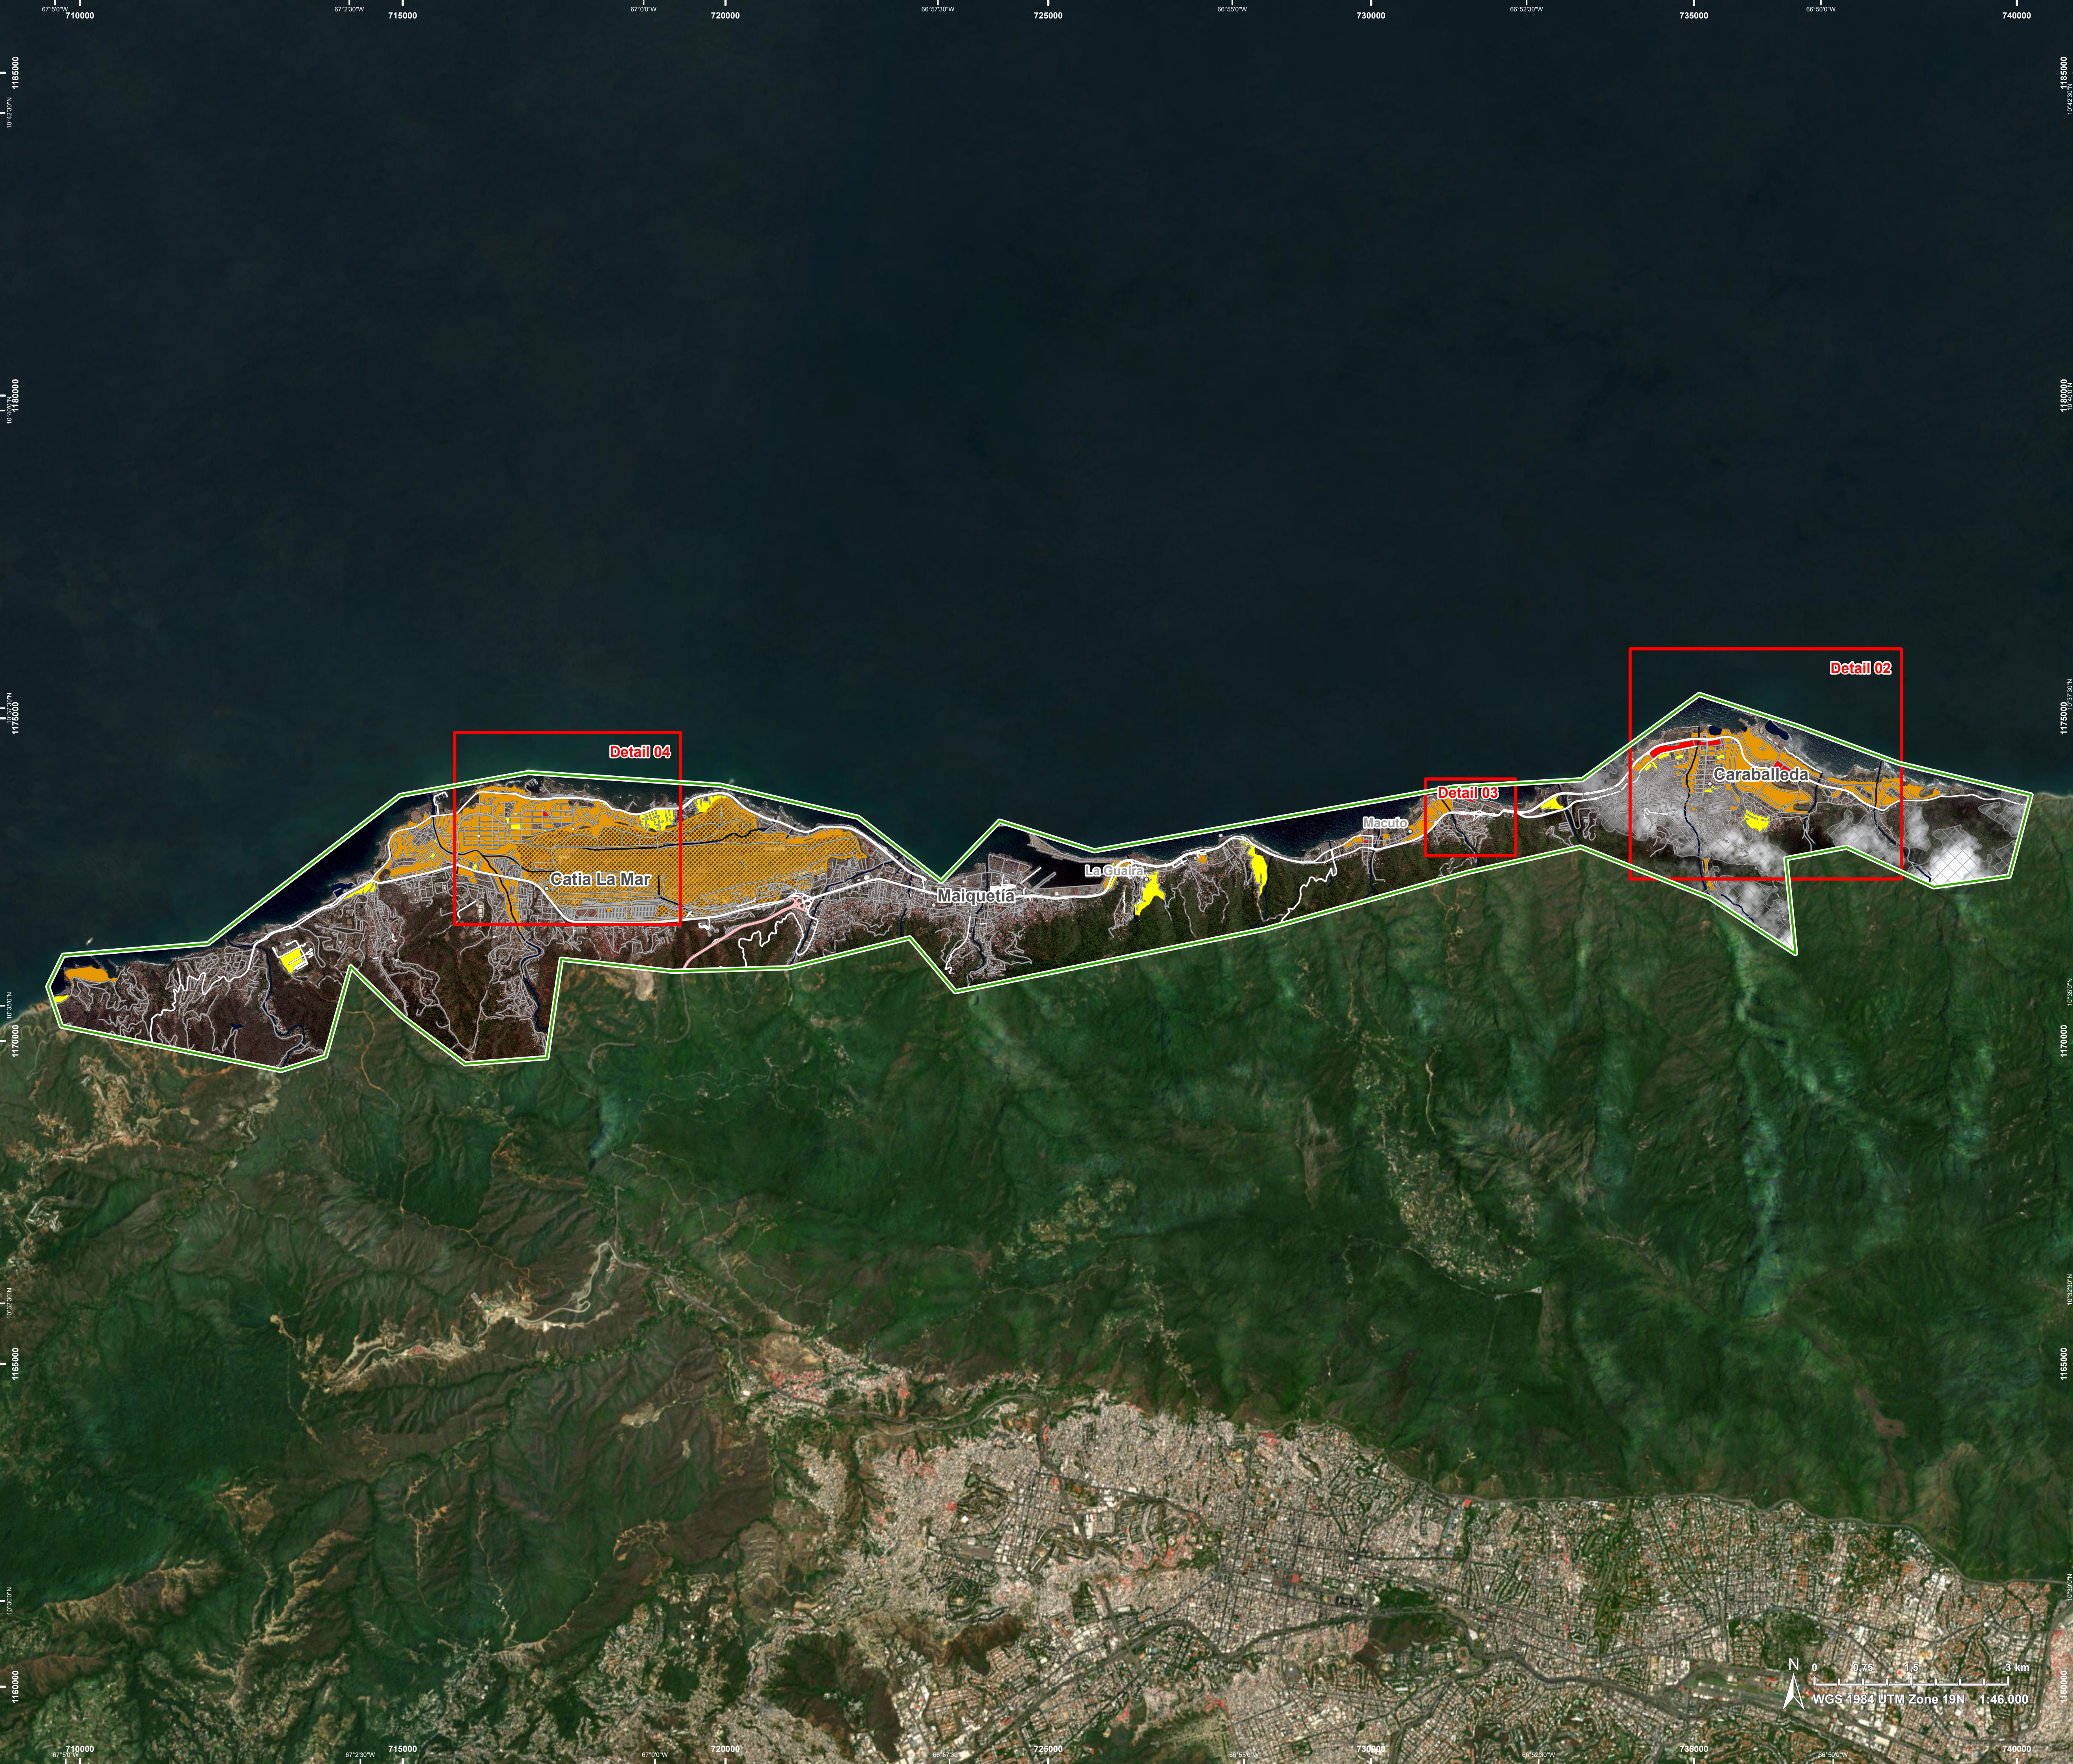
- Built Up Grading**
- Destroyed
  - Damaged
  - Possibly damaged
- Transportation Grading**
- Highway, No visible damage
  - Main road, No visible damage
  - Local road, No visible damage
- General Information**
- Track, No visible damage
  - Airfield and Heliport, Damaged
  - Airfield and Heliport, No visible damage
  - Area of Interest
  - Detail map
  - Not Analysed
- Hydrography**
- Lake, River

The thematic layer has been derived from post-event satellite image by means of visual interpretation.

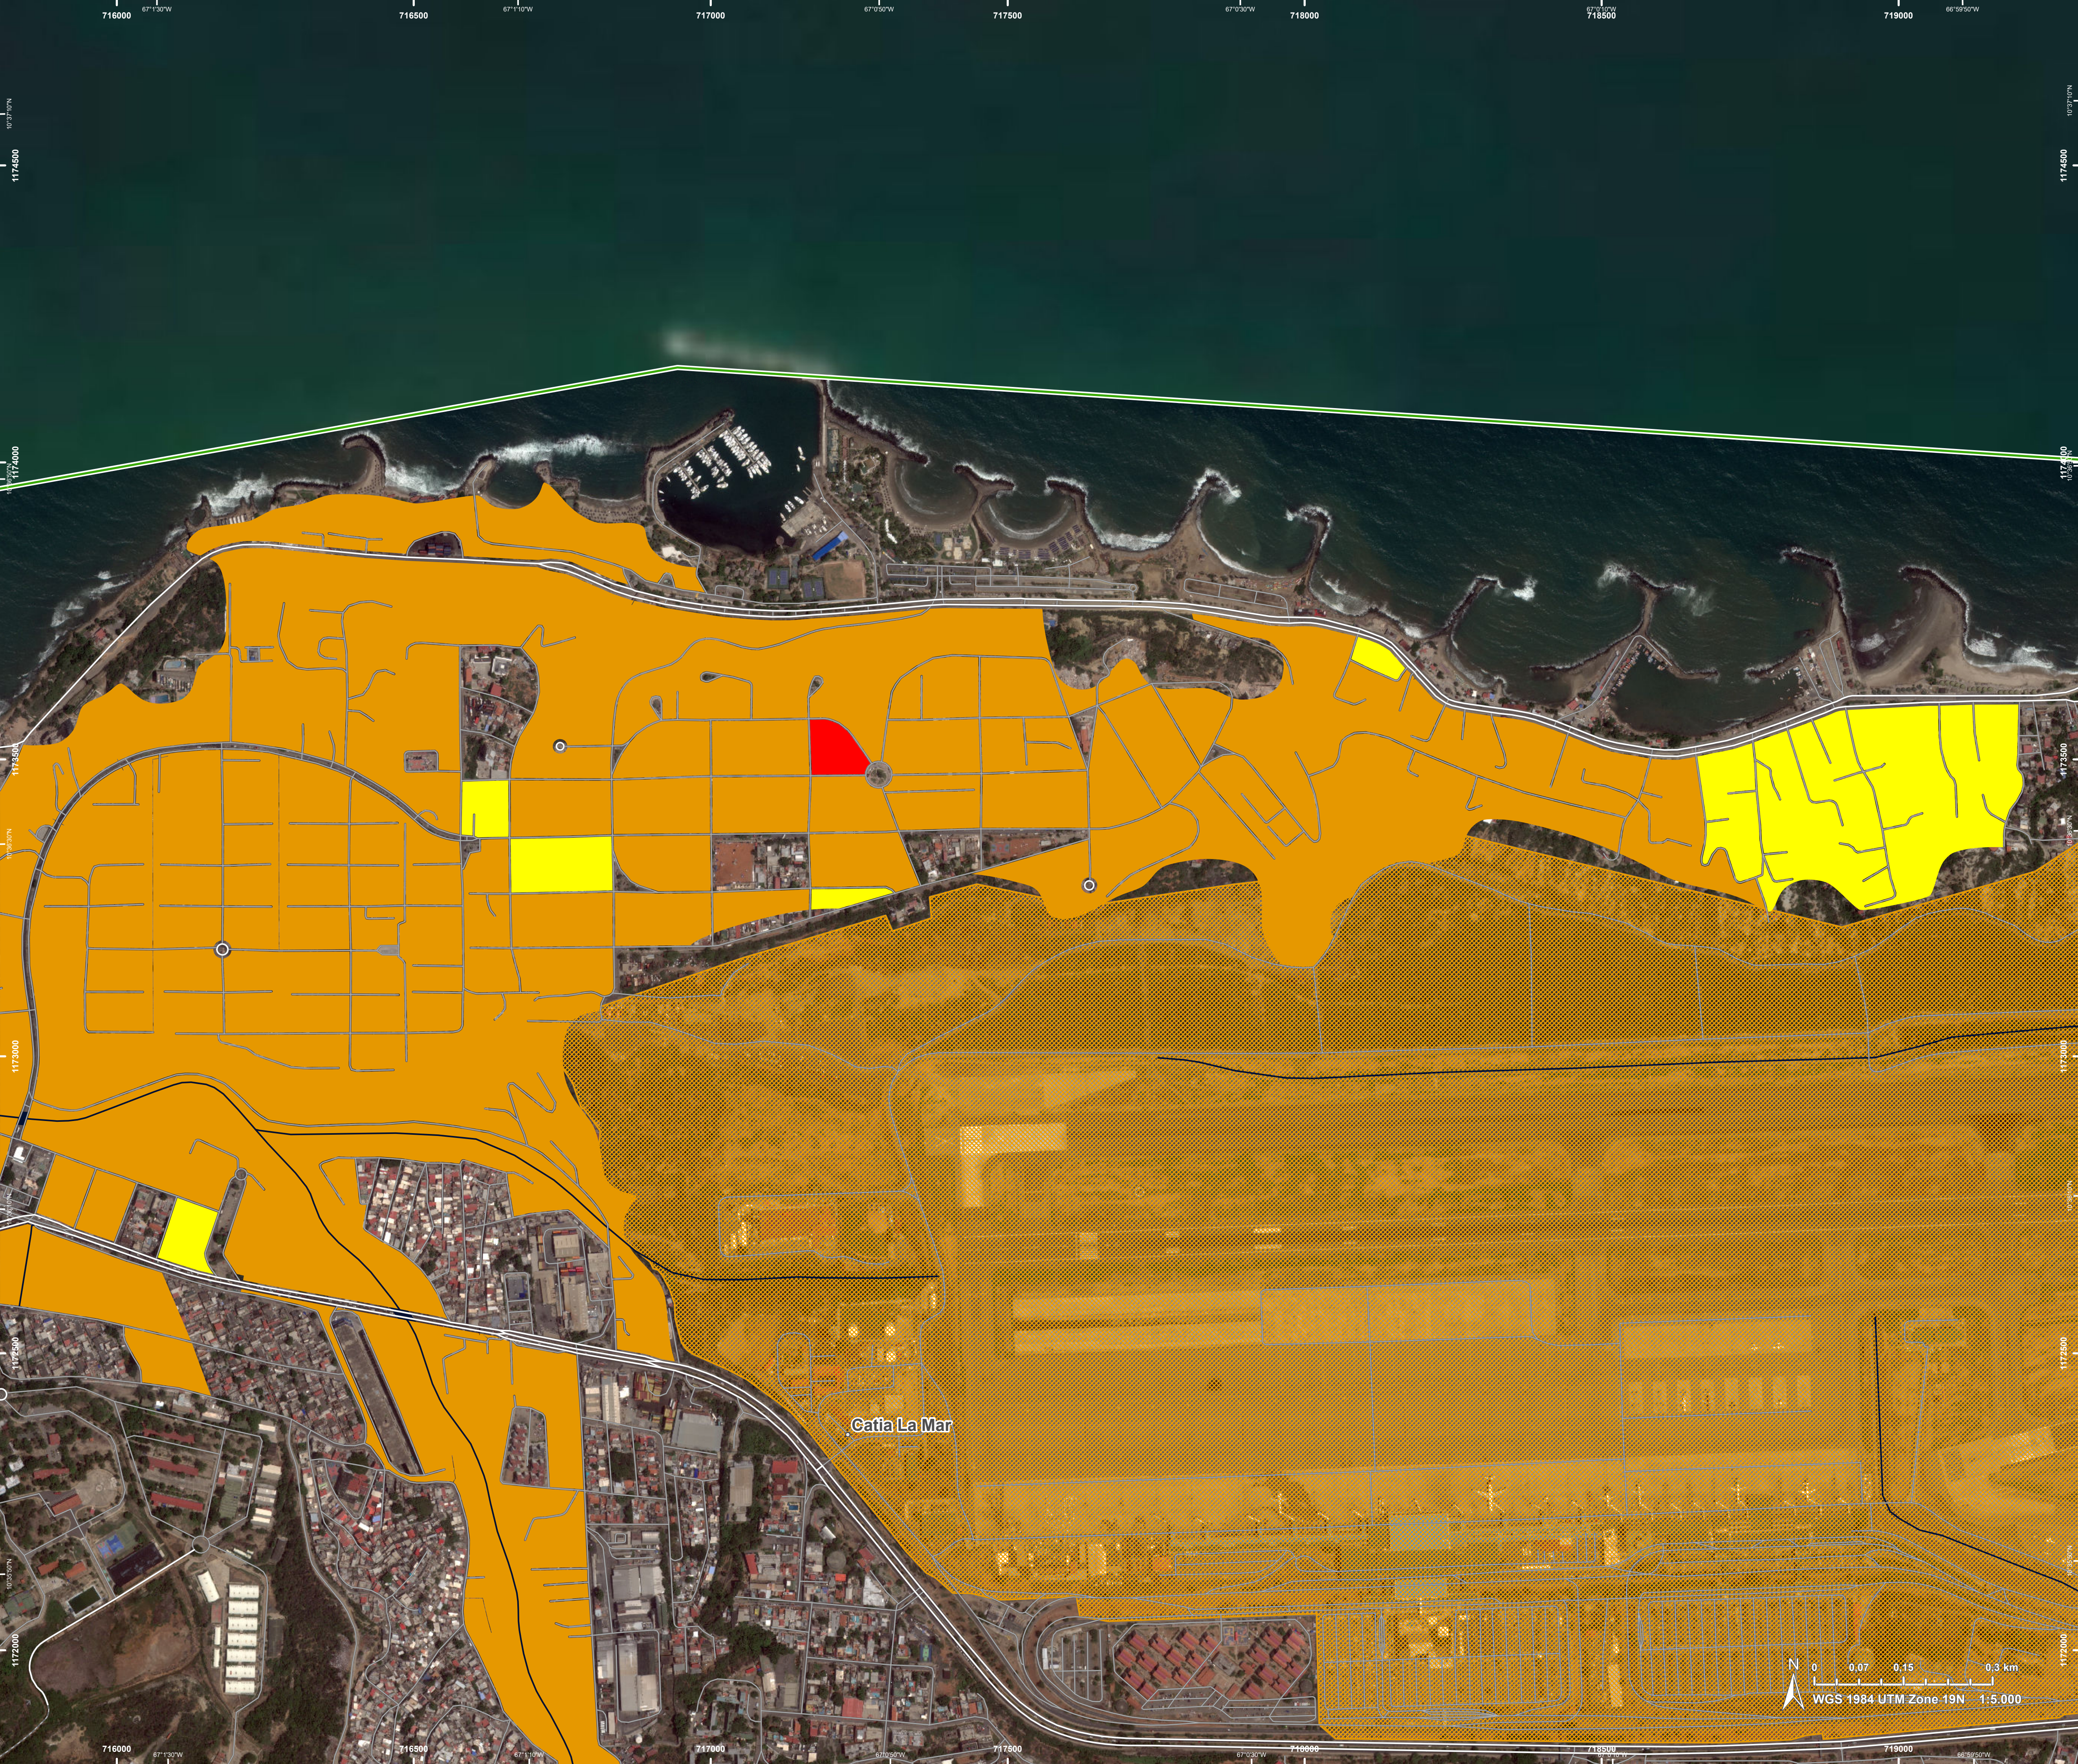
- Built Up Grading**
- Destroyed
  - Damaged
  - Possibly damaged
- Transportation Grading**
- Main road, No visible damage
  - Local road, No visible damage
- General Information**
- Airfield and Heliport, Damaged
  - Area of Interest
- Hydrography**
- Lake, River
- Track, No visible damage**

The thematic layer has been derived from post-event satellite image by means of visual interpretation.
