**EMSR916 - AOI06**  
**Earthquake in Colombia**  
**BUENAVENTURA**

**Situation as of 13/08/2026 15:42 UTC**  
Grading MONIT01 - Overview map 01

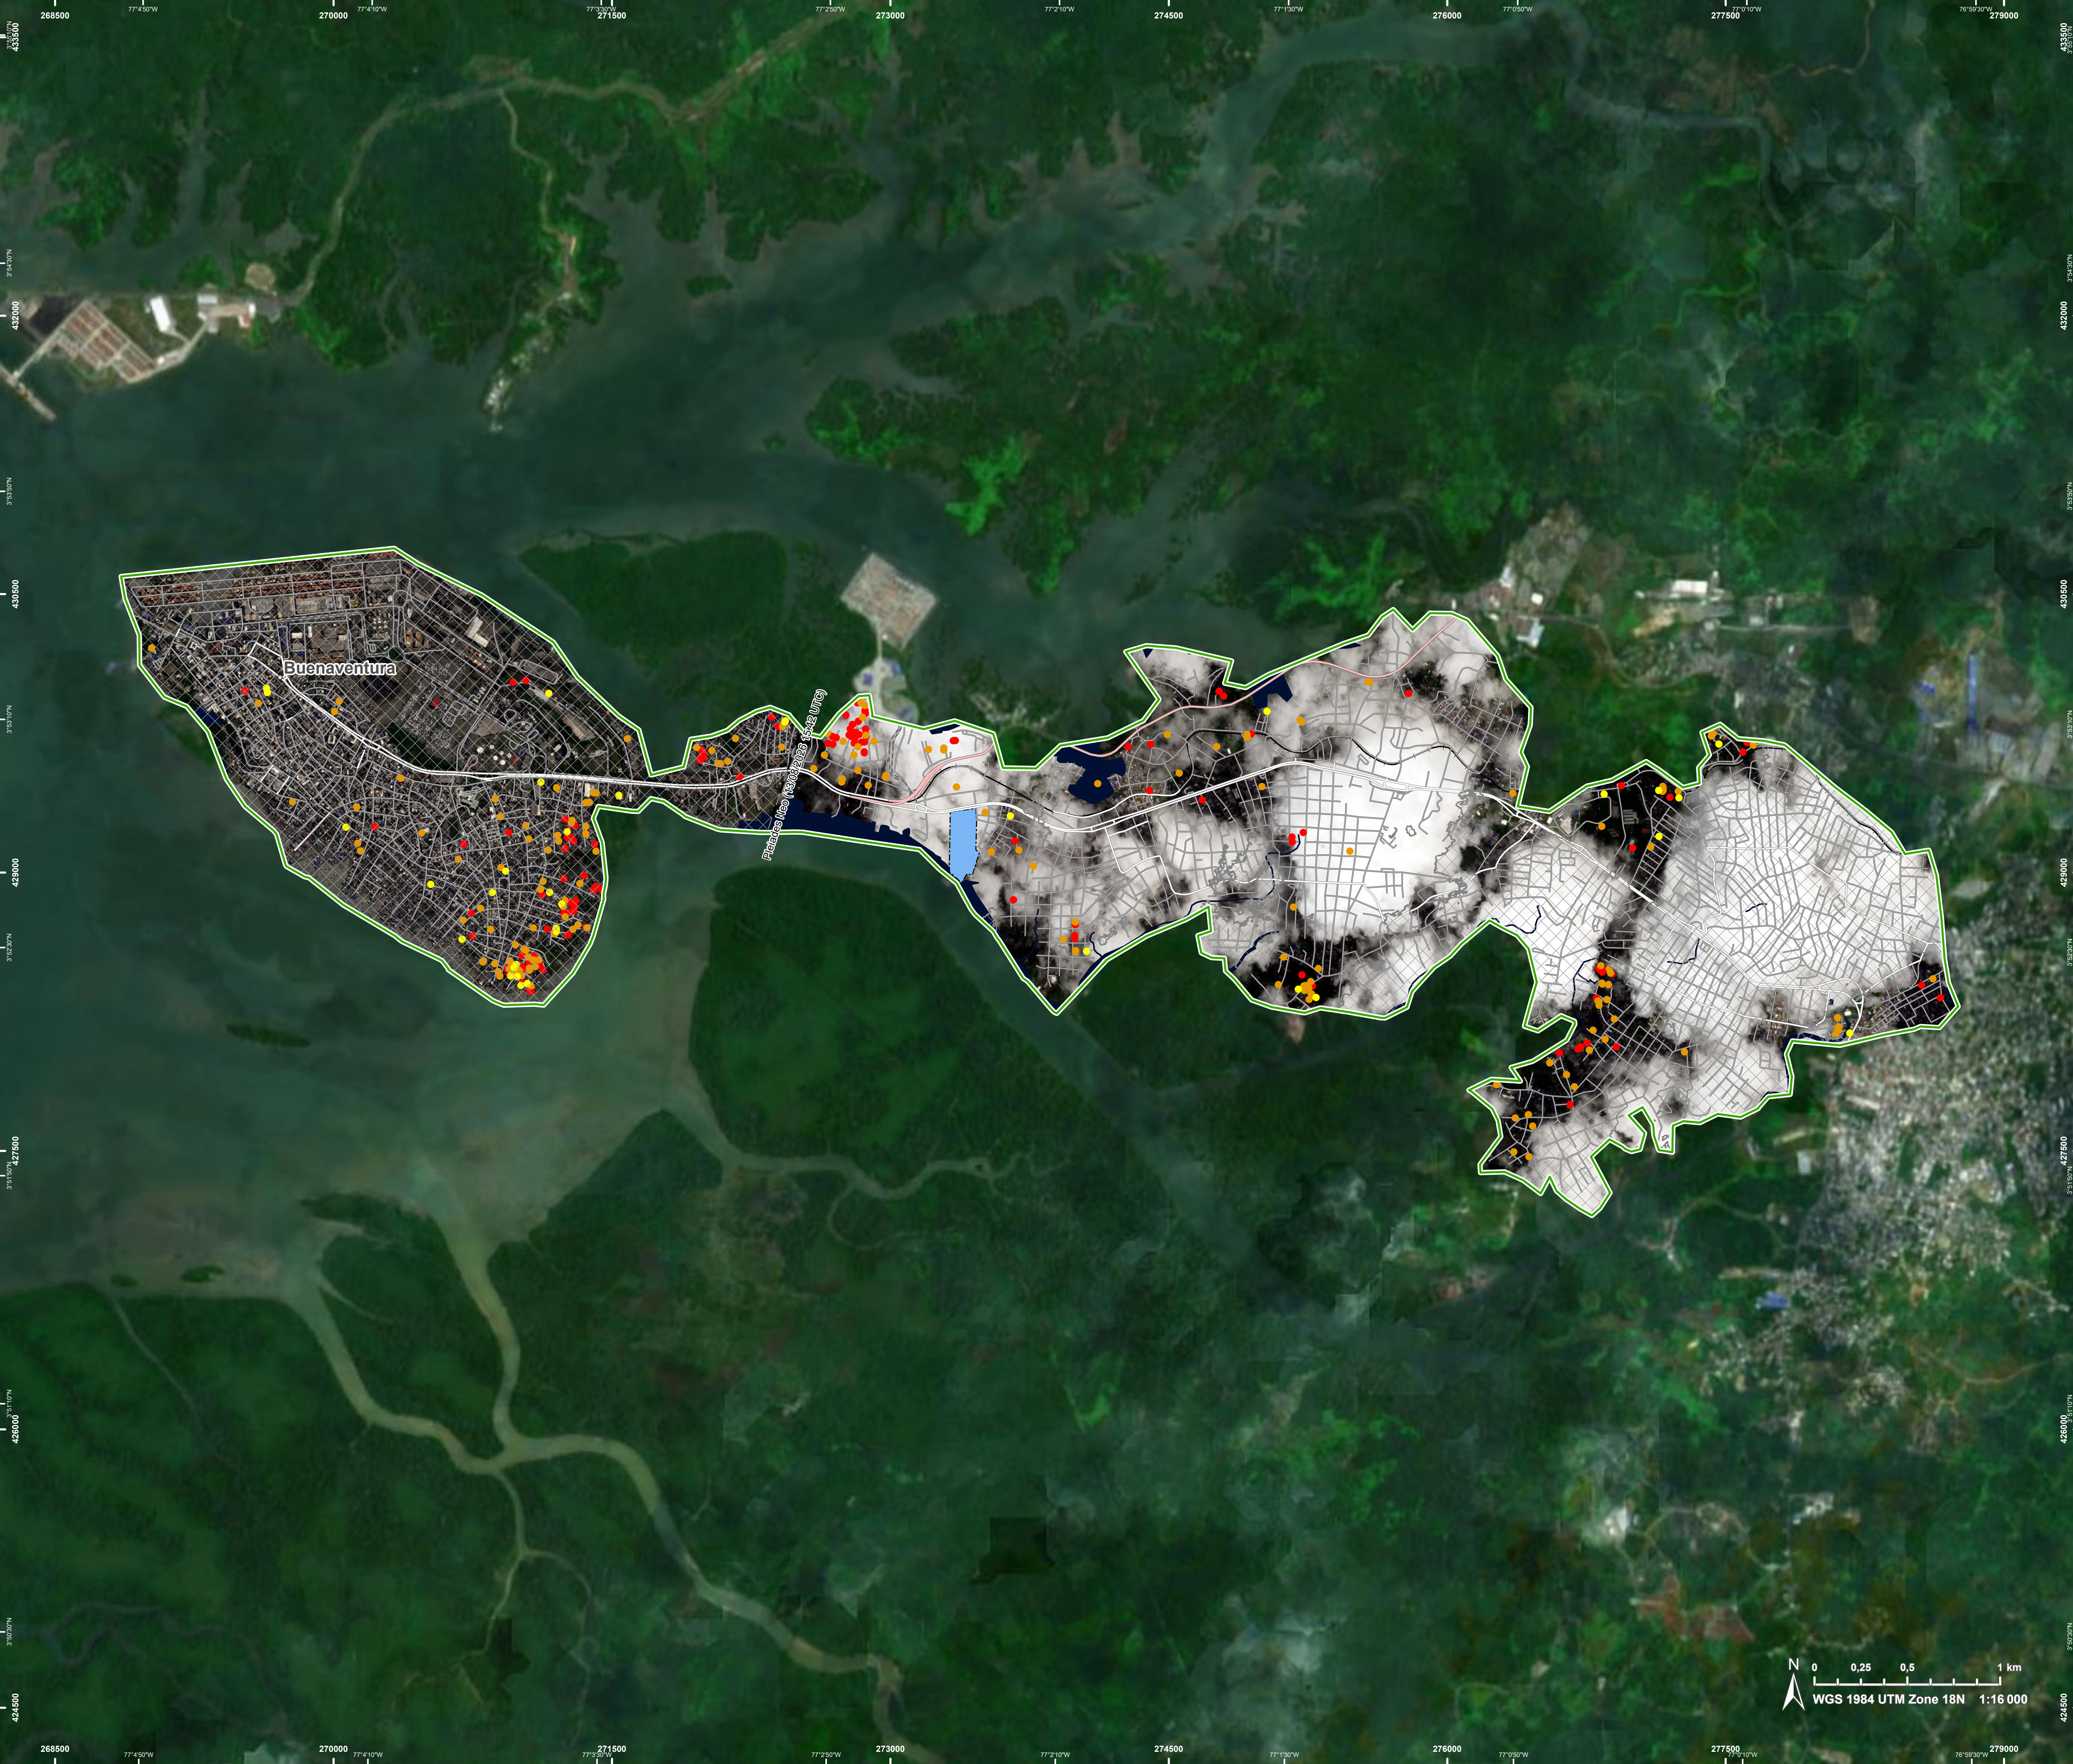
**Built-Up**  
335 No.

The thematic layer has been derived from post-event satellite image by means of visual interpretation.

| Estimated population | | Inhabitants | No. | Destroyed | Damaged | Possibly damaged* | Total affected** | Total in AOI |
|---|---|---|---|---|---|---|---|---|
| Assets | Built-up | Residential Buildings | No. | 134 | 167 | 34 | NA | ~ 320 000 |
