**EMSR916 - AOI06**  
**Earthquake in Colombia**  
**BUENAVENTURA**

**Situation as of 13/08/2026 15:42 UTC**  
Grading MONIT01 - Overview map 01

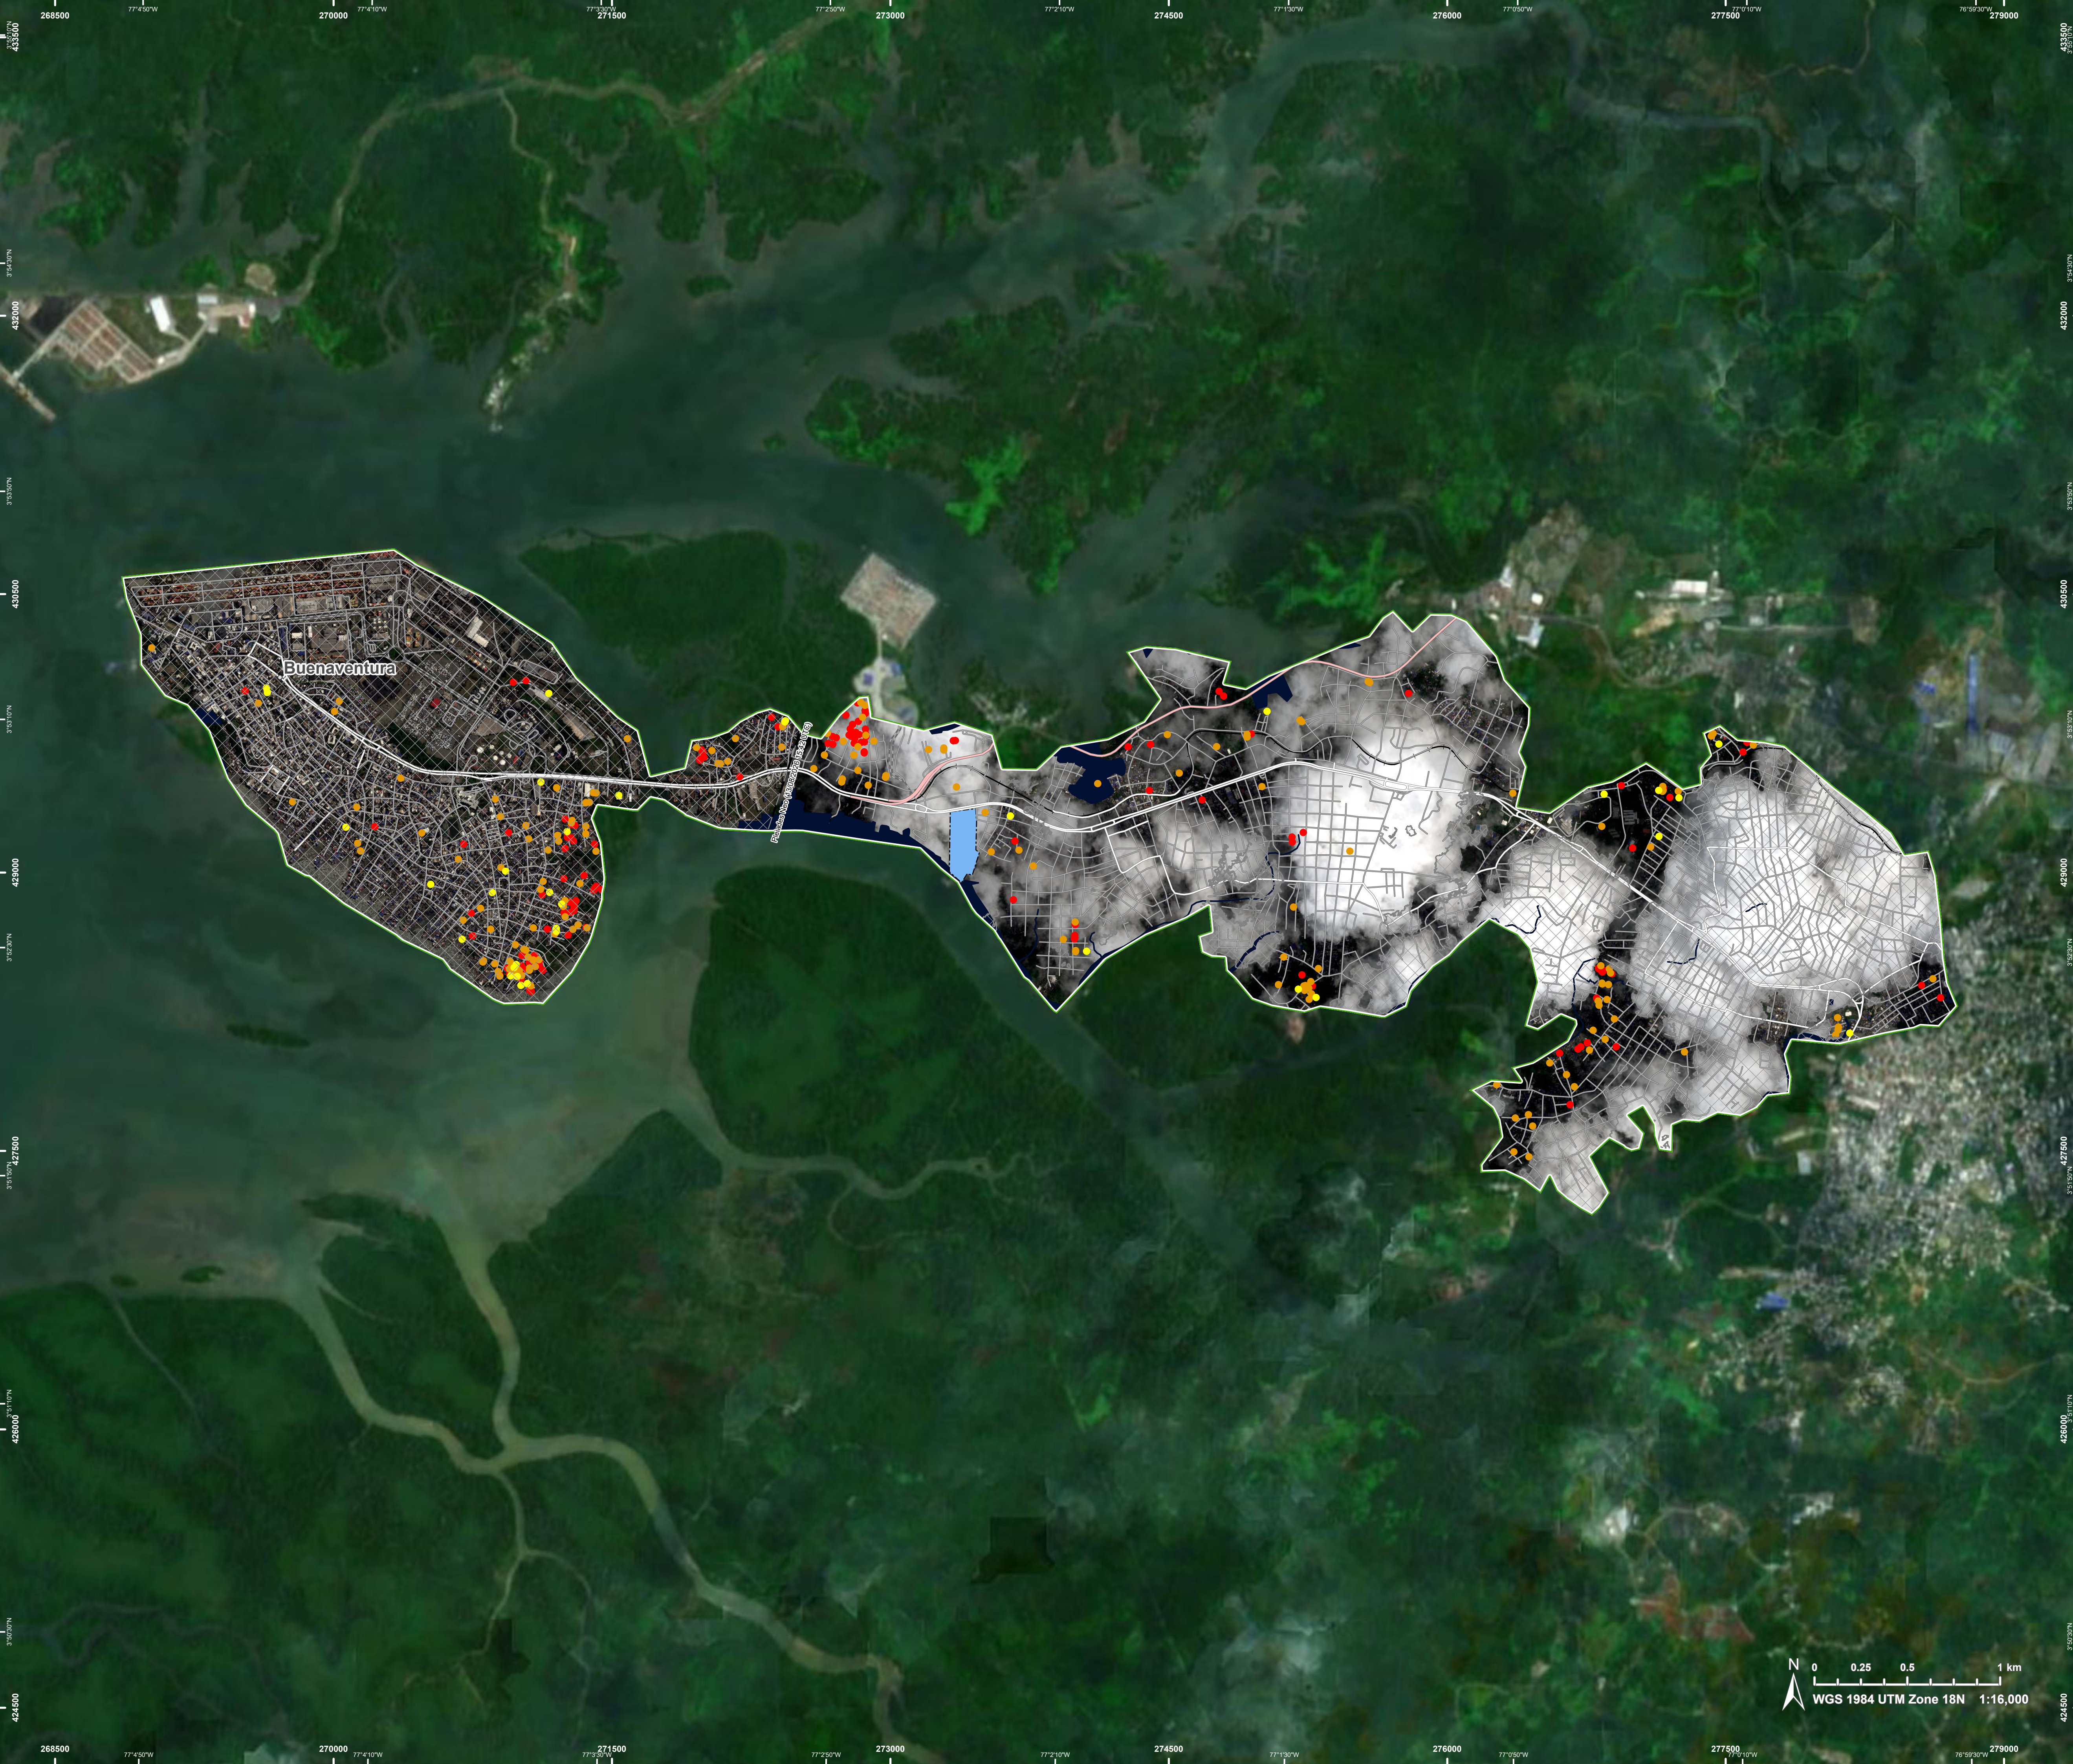
**Event:** On the 10 August 2026 at 12:30 UTC, a major earthquake with a magnitude of 7.4 is reported to have affected western and central Colombia, with the epicentre near San José del Palmar. The event has caused significant damage in several cities, including Quibdó, Pereira, Manizales and Cali, with collapsed buildings reported. Copernicus EMS Rapid Mapping is requested to provide earthquake damage assessment emergency mapping.

The thematic layer has been derived from post-event satellite image by means of visual interpretation.

| | | | | Destroyed | Damaged | Possibly damaged* | Total affected** | Total in AOI |
|---|---|---|---|---|---|---|---|---|
| Assets | Built-up | Residential Buildings | No. | 131 | 159 | 32 | 322 | NA |
| | | School, university and research buildings | No. | 0 | 2 | 0 | 2 | NA |
| | | Other non-residential buildings | No. | 3 | 6 | 2 | 11 | NA |

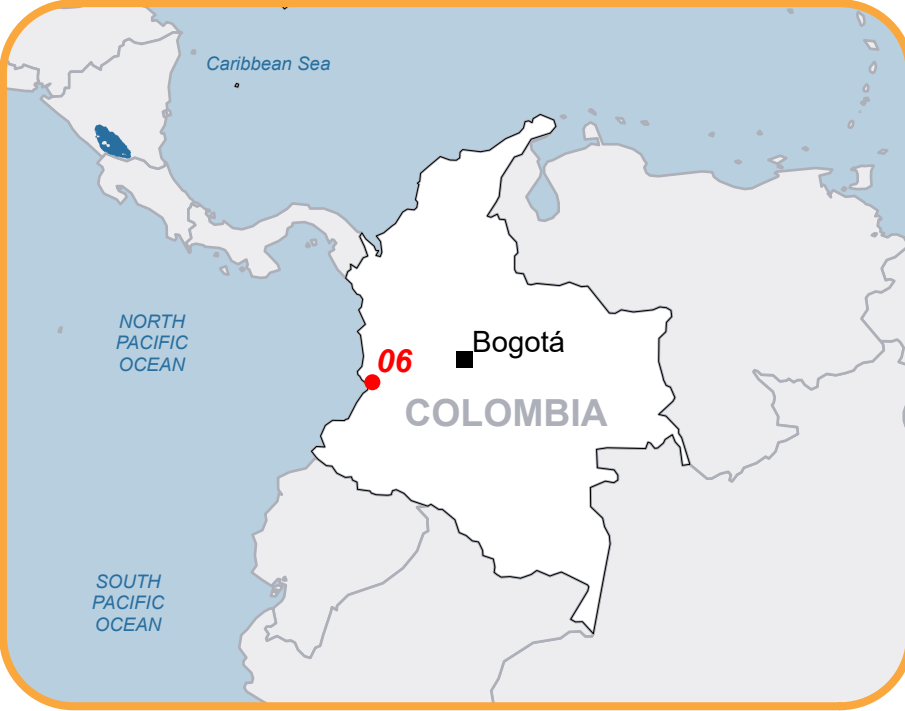
**Built-Up**  
335 No.
