EMSR934 - AOI03  
Earthquake in Los Santos, Panama  
SANTIAGO DE VERAGUAS

Situation as of 11/10/2026 15:52 UTC  
Grading - Overview map 01

**Event:** On 09 October at 17:56 UTC (12:56 Local Time) Panama was struck by a 7.7M earthquake. The epicentre was 12 km west-southwest of Pitaloza Arriba, Panama (inland). Copernicus EMS Rapid Mapping is requested to provide earthquake damage assessment emergency mapping.

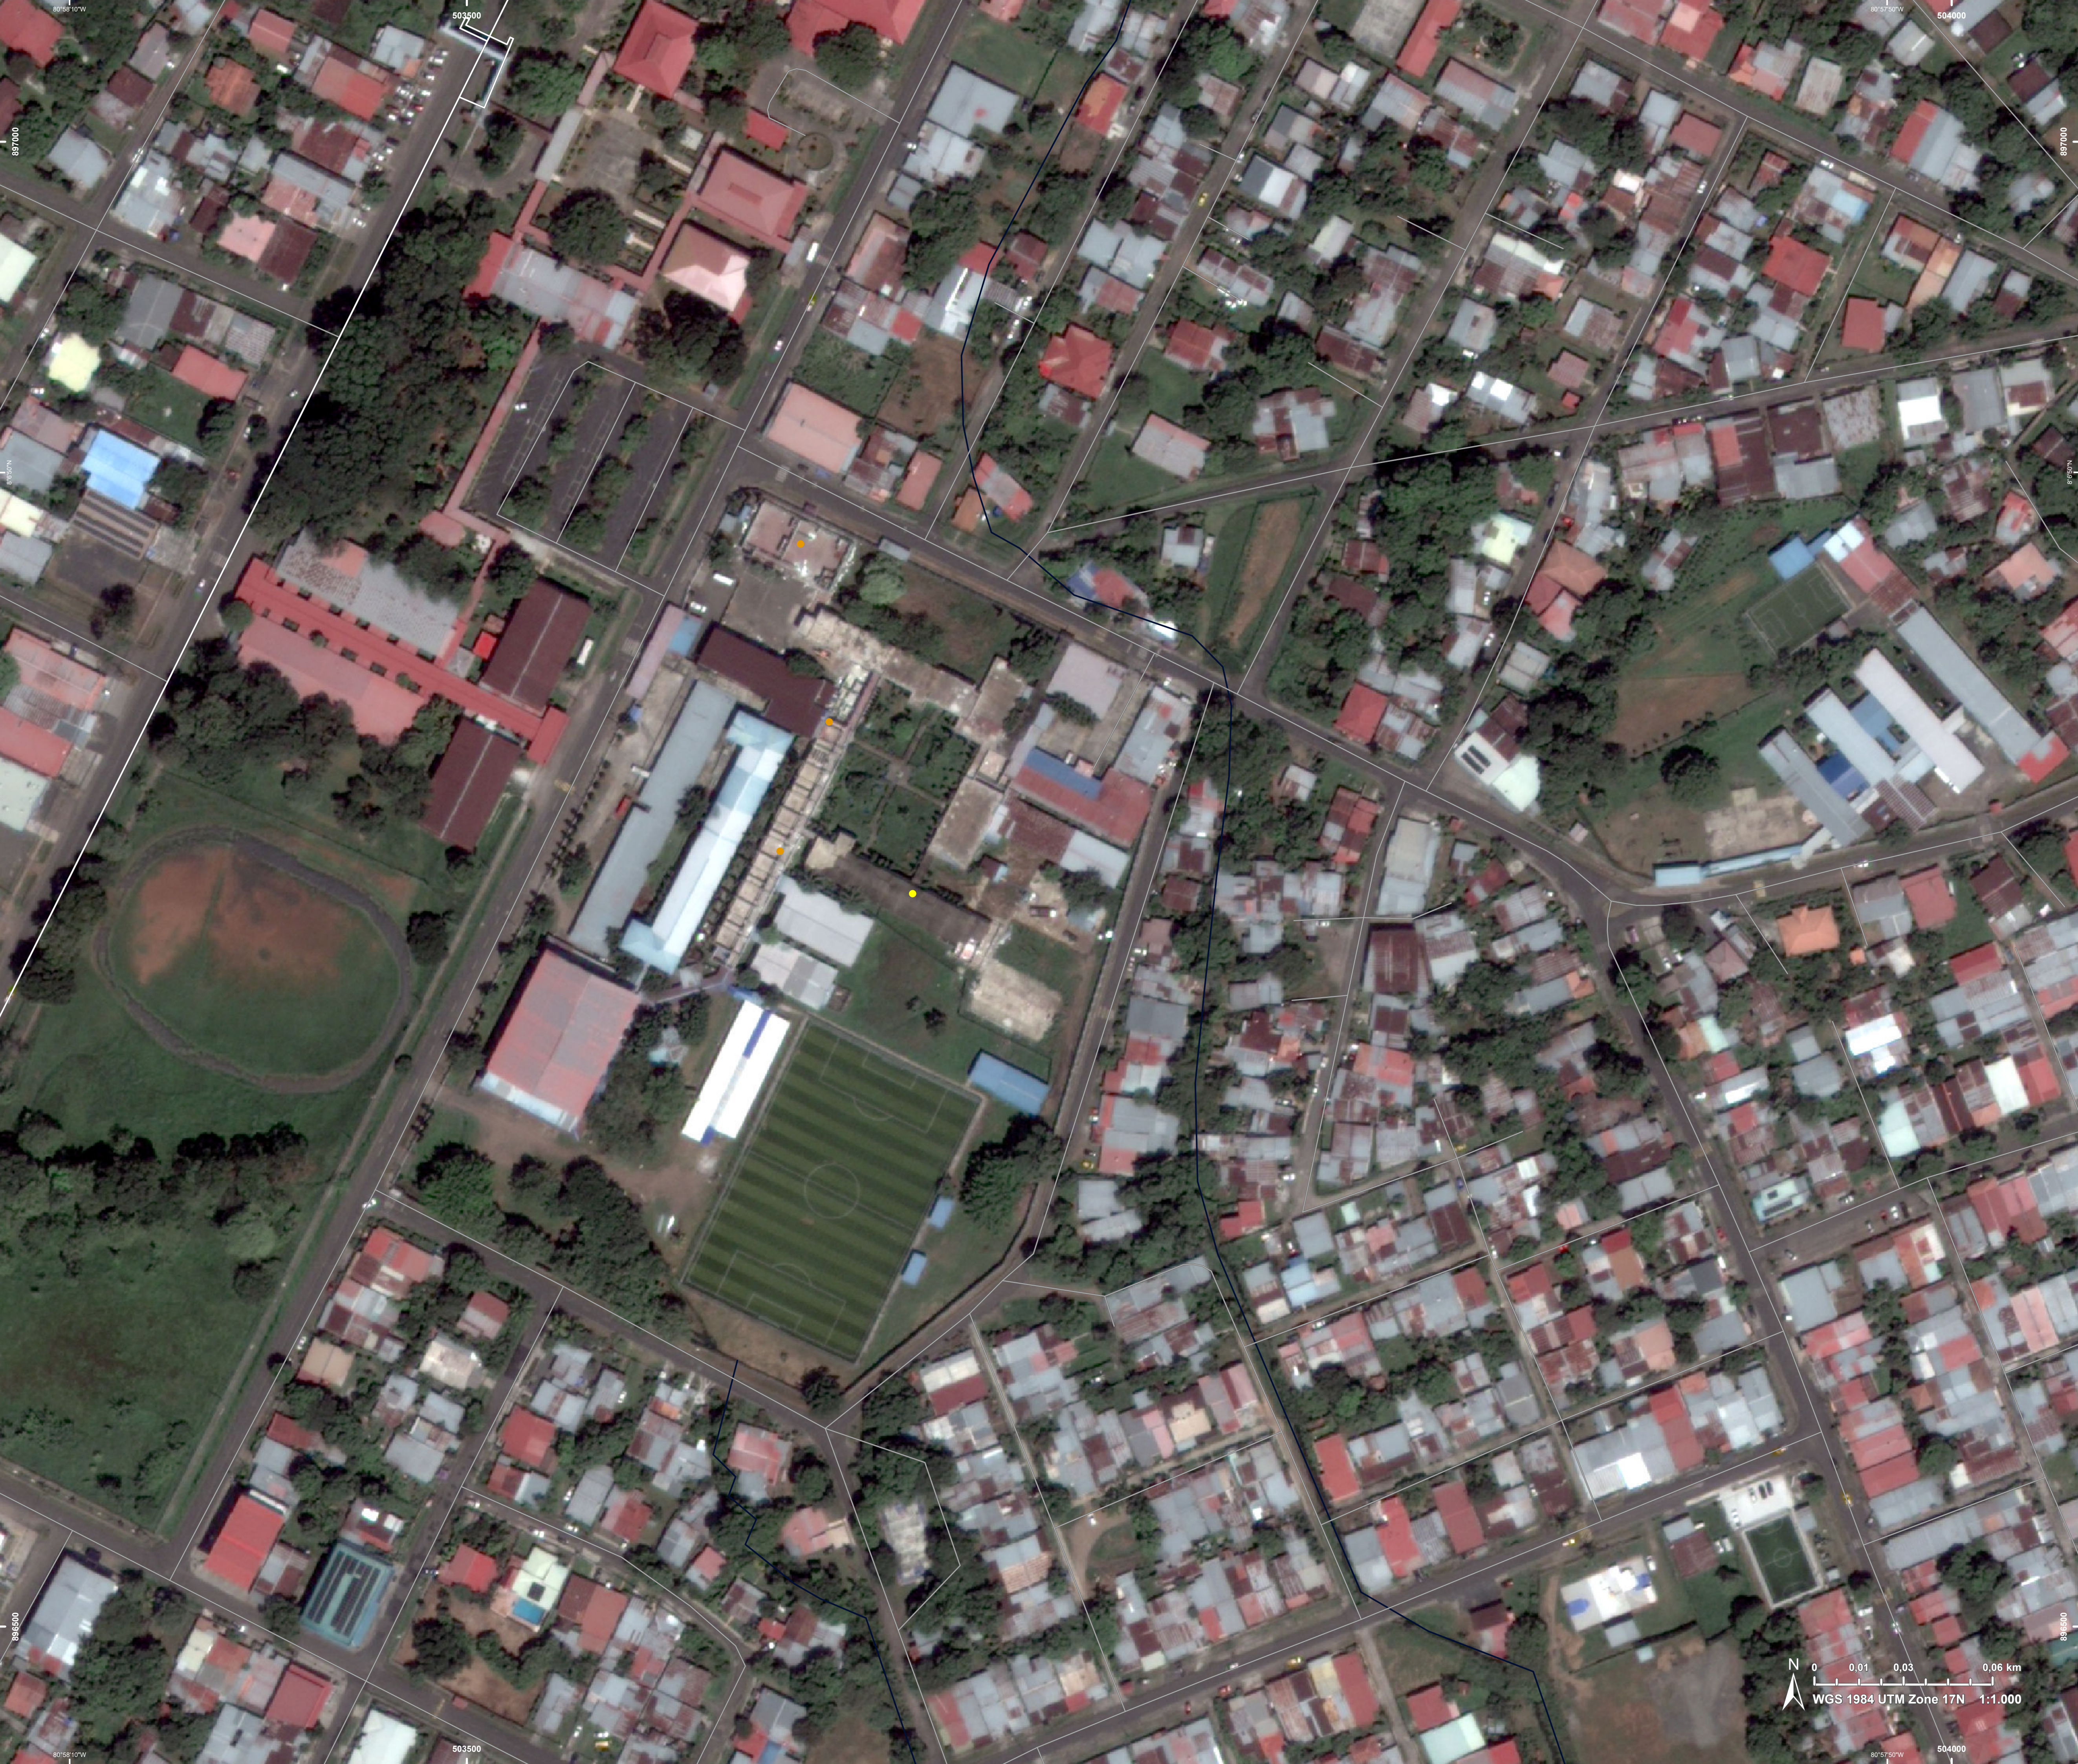
**Situation as of 11/10/2026 15:52 UTC**  
Grading - Detail map 02

- | Built Up Grading                                                                 | Transportation Grading                                                                                             |

| <ul style="list-style-type: none"><li>Damaged</li><li>Possibly damaged</li></ul> | <ul style="list-style-type: none"><li>Main road, No visible damage</li><li>Local road, No visible damage</li></ul> |

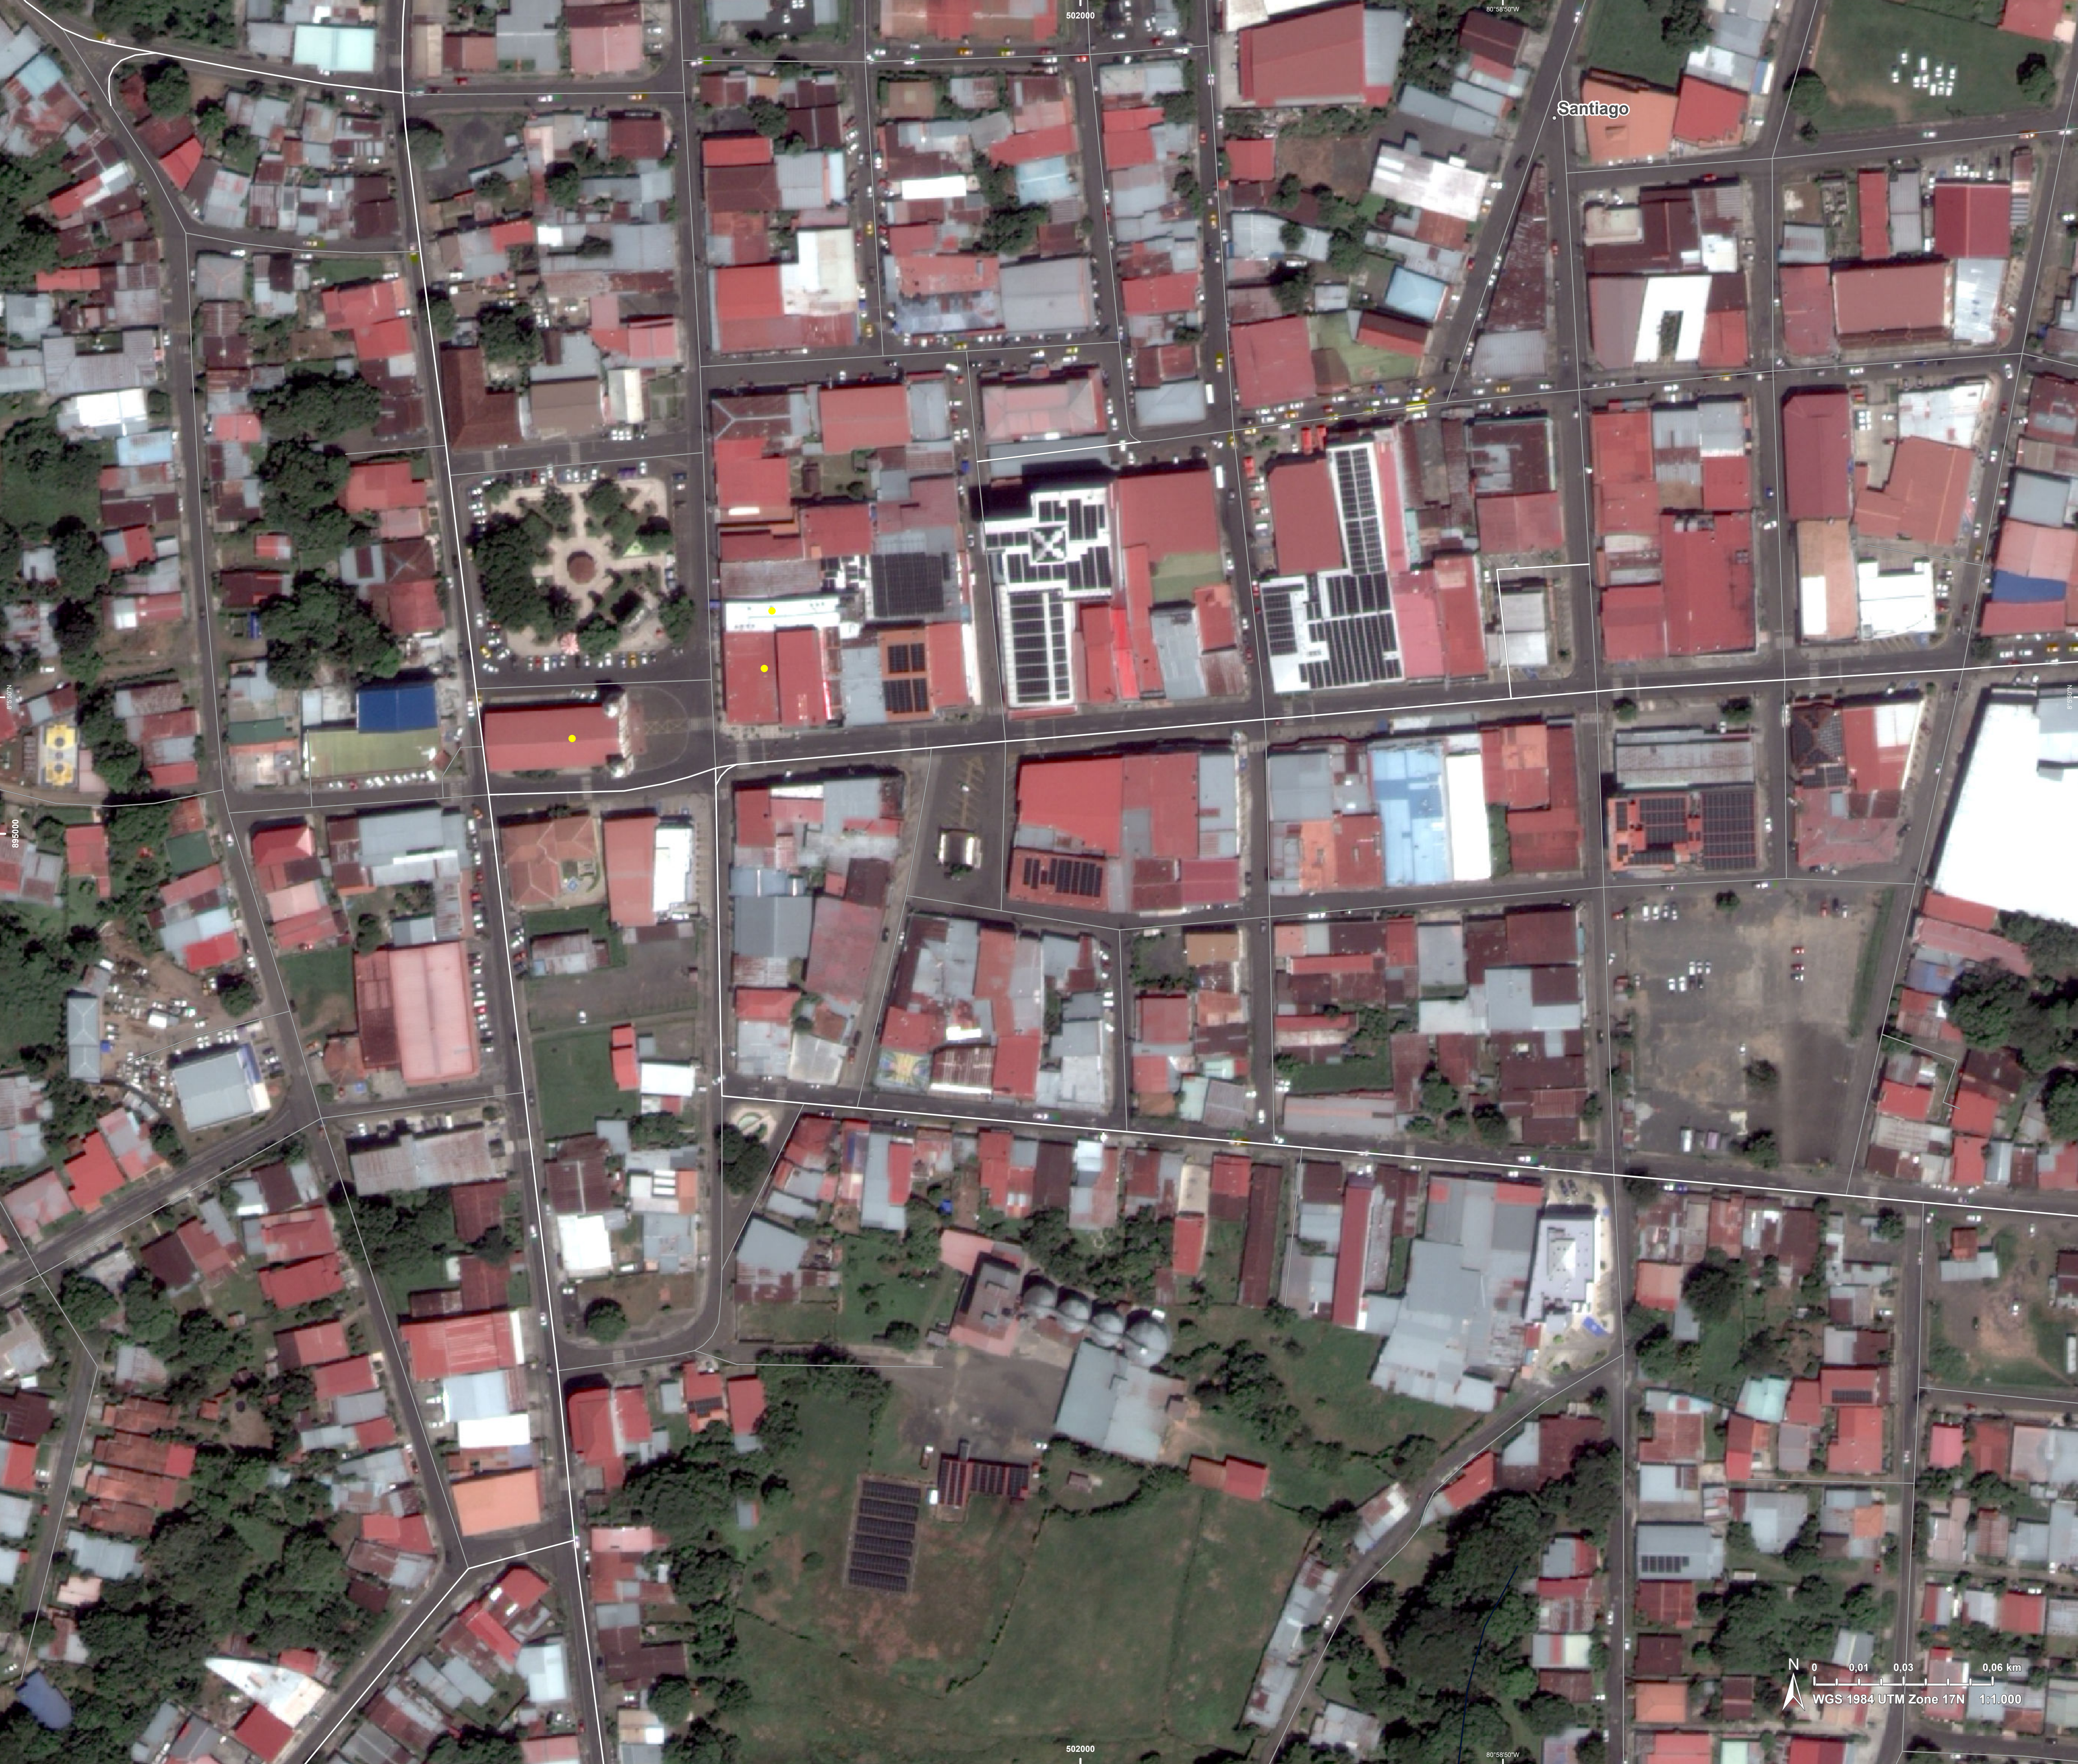
**Situation as of 11/10/2026 15:52 UTC**  
Grading - Detail map 03

- Built Up Grading**
- Possibly damaged
- Transportation Grading**
- Main road, No visible damage
  - Local road, No visible damage
  - Placename
