**EMSR934 - AOI06**  
**Earthquake in Los Santos, Panama**  
**PENONOME**

**Situation as of 15/10/2026 15:53 UTC**  
Grading - Overview map 01

**Situation as of 15/10/2026 15:53 UTC**  
Grading - Detail map 02

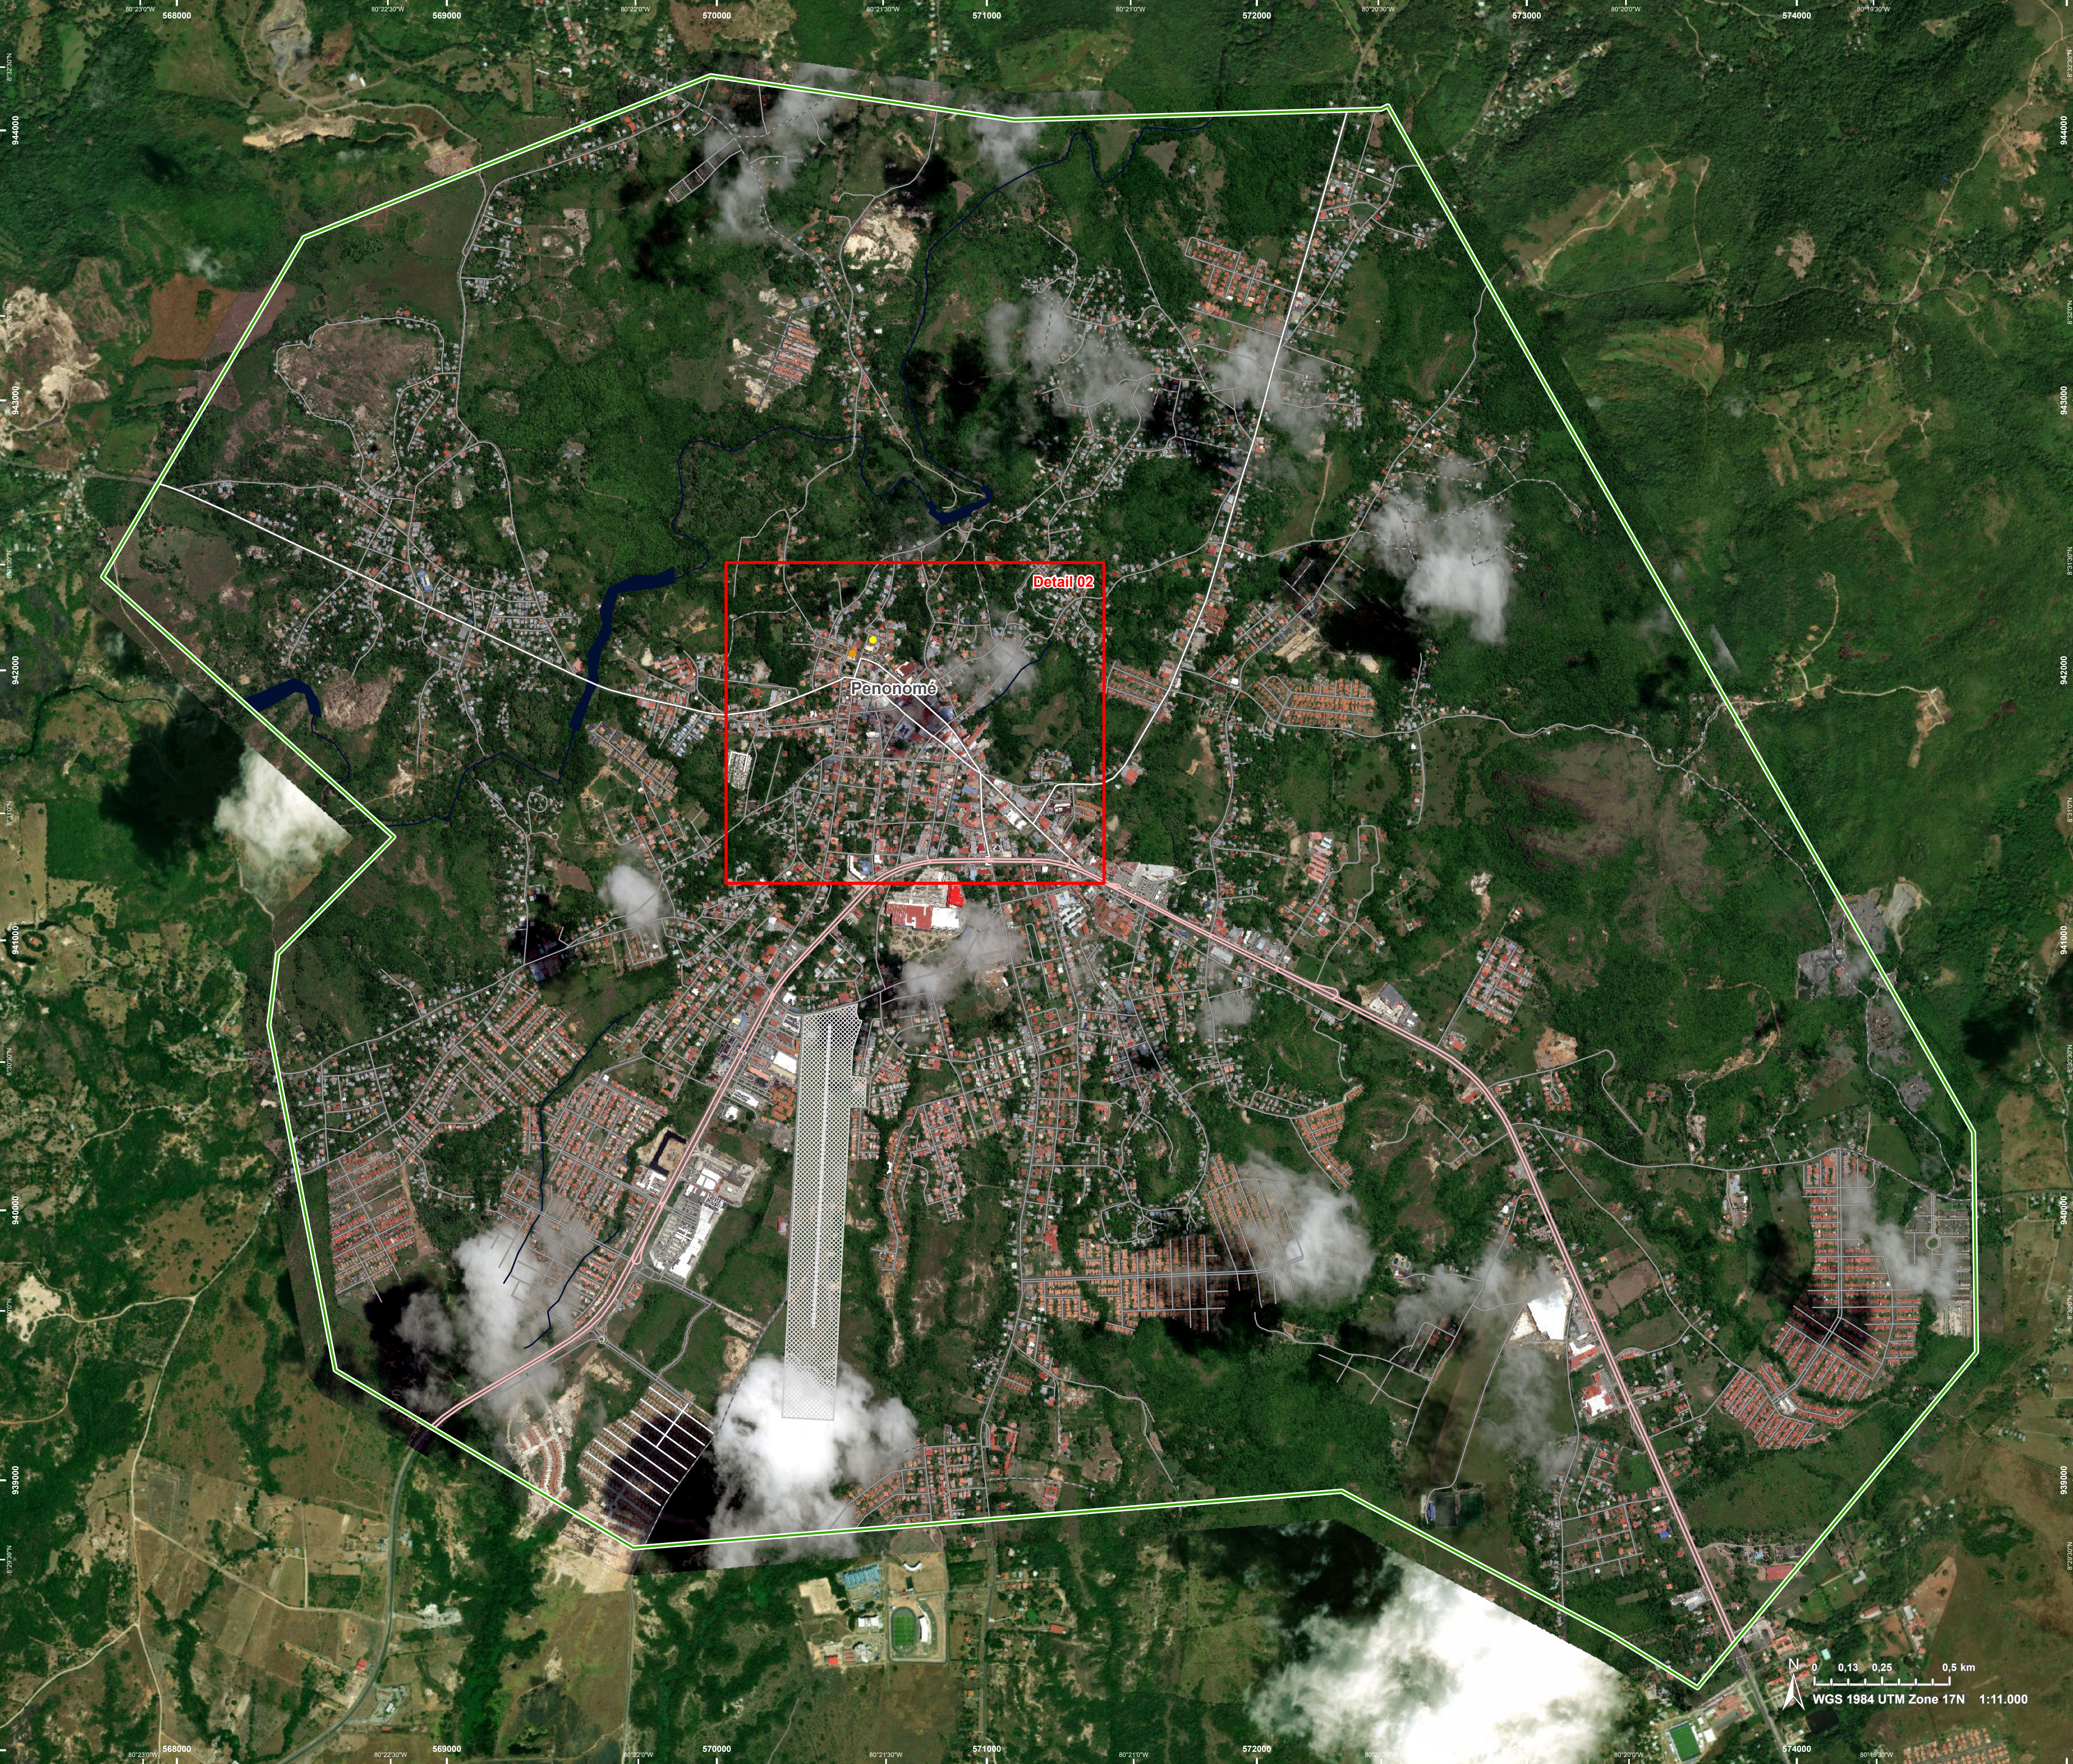
**Built-Up**  
2 No.

**Event:** On 09 October at 17:56 UTC (12:56 Local Time) Panama was struck by a 7.7M earthquake. The epicentre was 12 km west-southwest of Pitaloza Ariba, Panama (inland). Copernicus EMS Rapid Mapping is requested to provide earthquake damage assessment emergency mapping.

The thematic layer has been derived from post-event satellite image by means of visual interpretation.

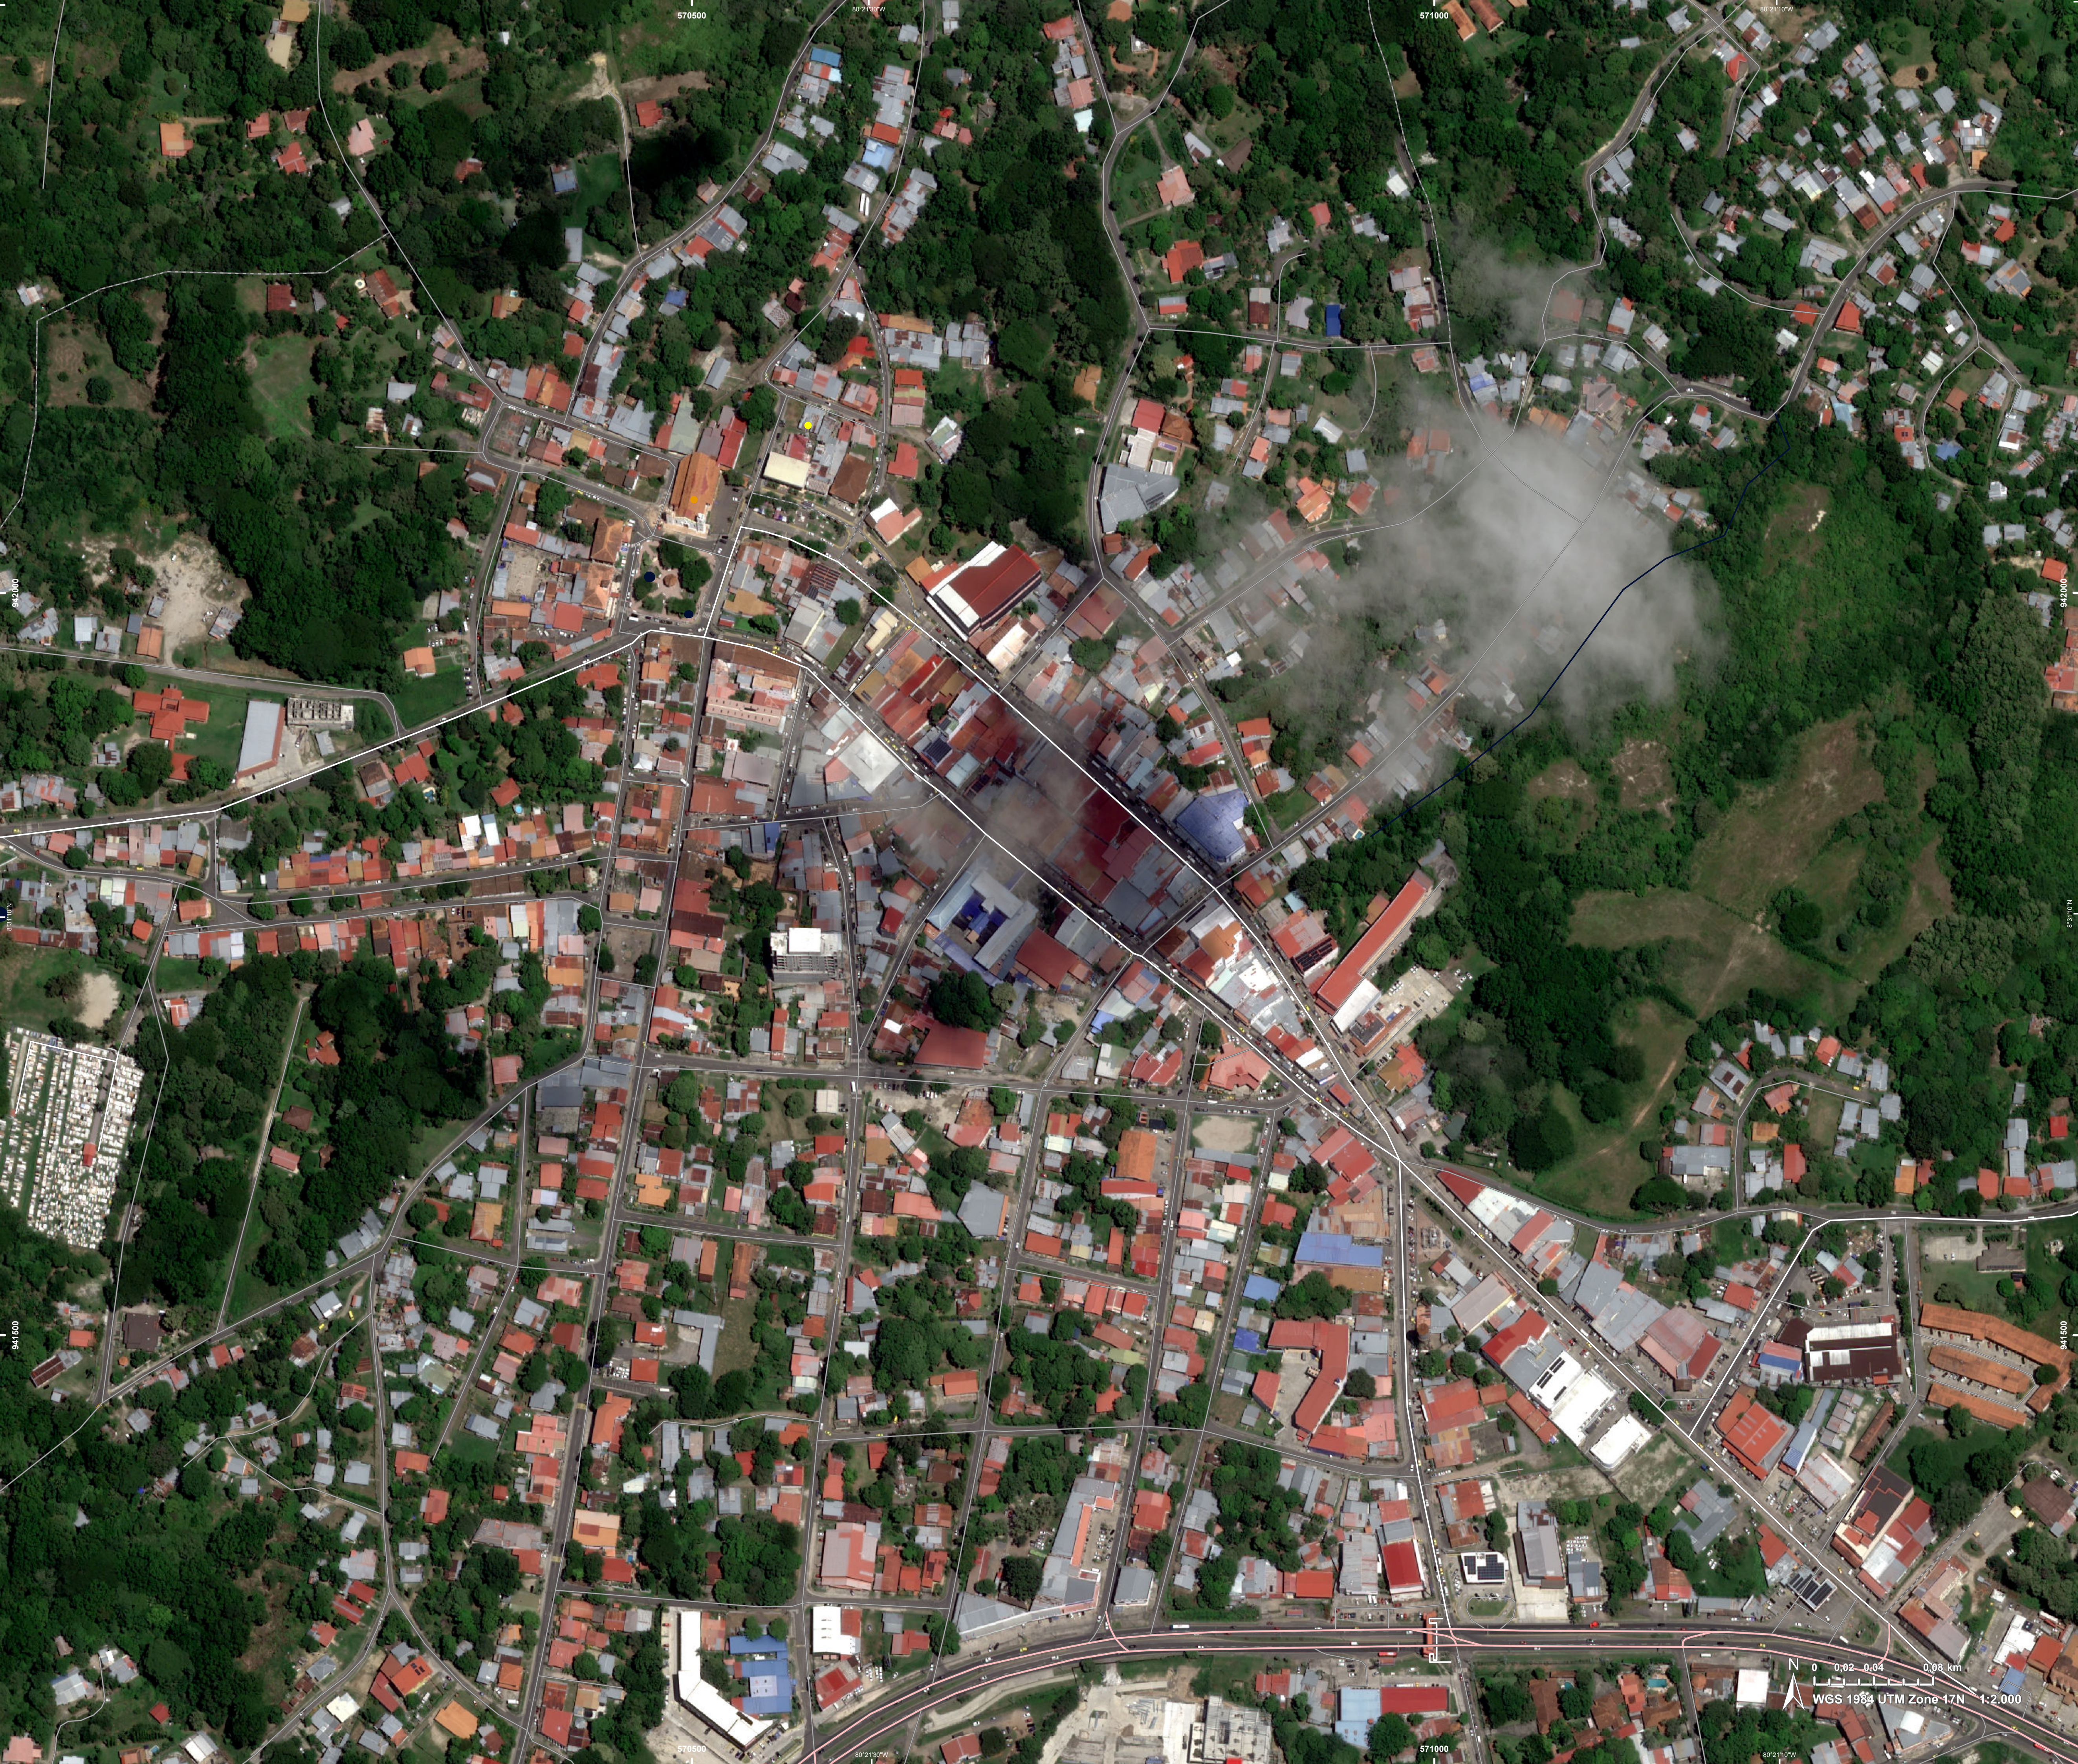
The thematic layer has been derived from post-event satellite image by means of visual interpretation.

| | | | | Destroyed | Damaged | Possibly damaged* | Total affected** | Total in AOI |
|---|---|---|---|---|---|---|---|---|
| | | Unclassified | No. | 0 | 1 | 1 | 2 | 8.793 |
