Situation as of 05/05/2023 10:08 UTC
Grading Consolidation - Overview map 01

Event:
On the 02 May 2023, an intense phase of bad weather, with considerable rainfall, hit Emilia-Romagna, Italy. The event is on-going with river levels very high, the breaking of the Sillaro River embankment and the overflow of the Lamone River producing flooding close to the cities of Massa Lombarda and Conselice. Copernicus EMS Rapid Mapping is requested to provide initial rough estimation, flood extent and damage assessment emergency mapping.

EMSR659 AOI: 03 Bagnacavallo Grading

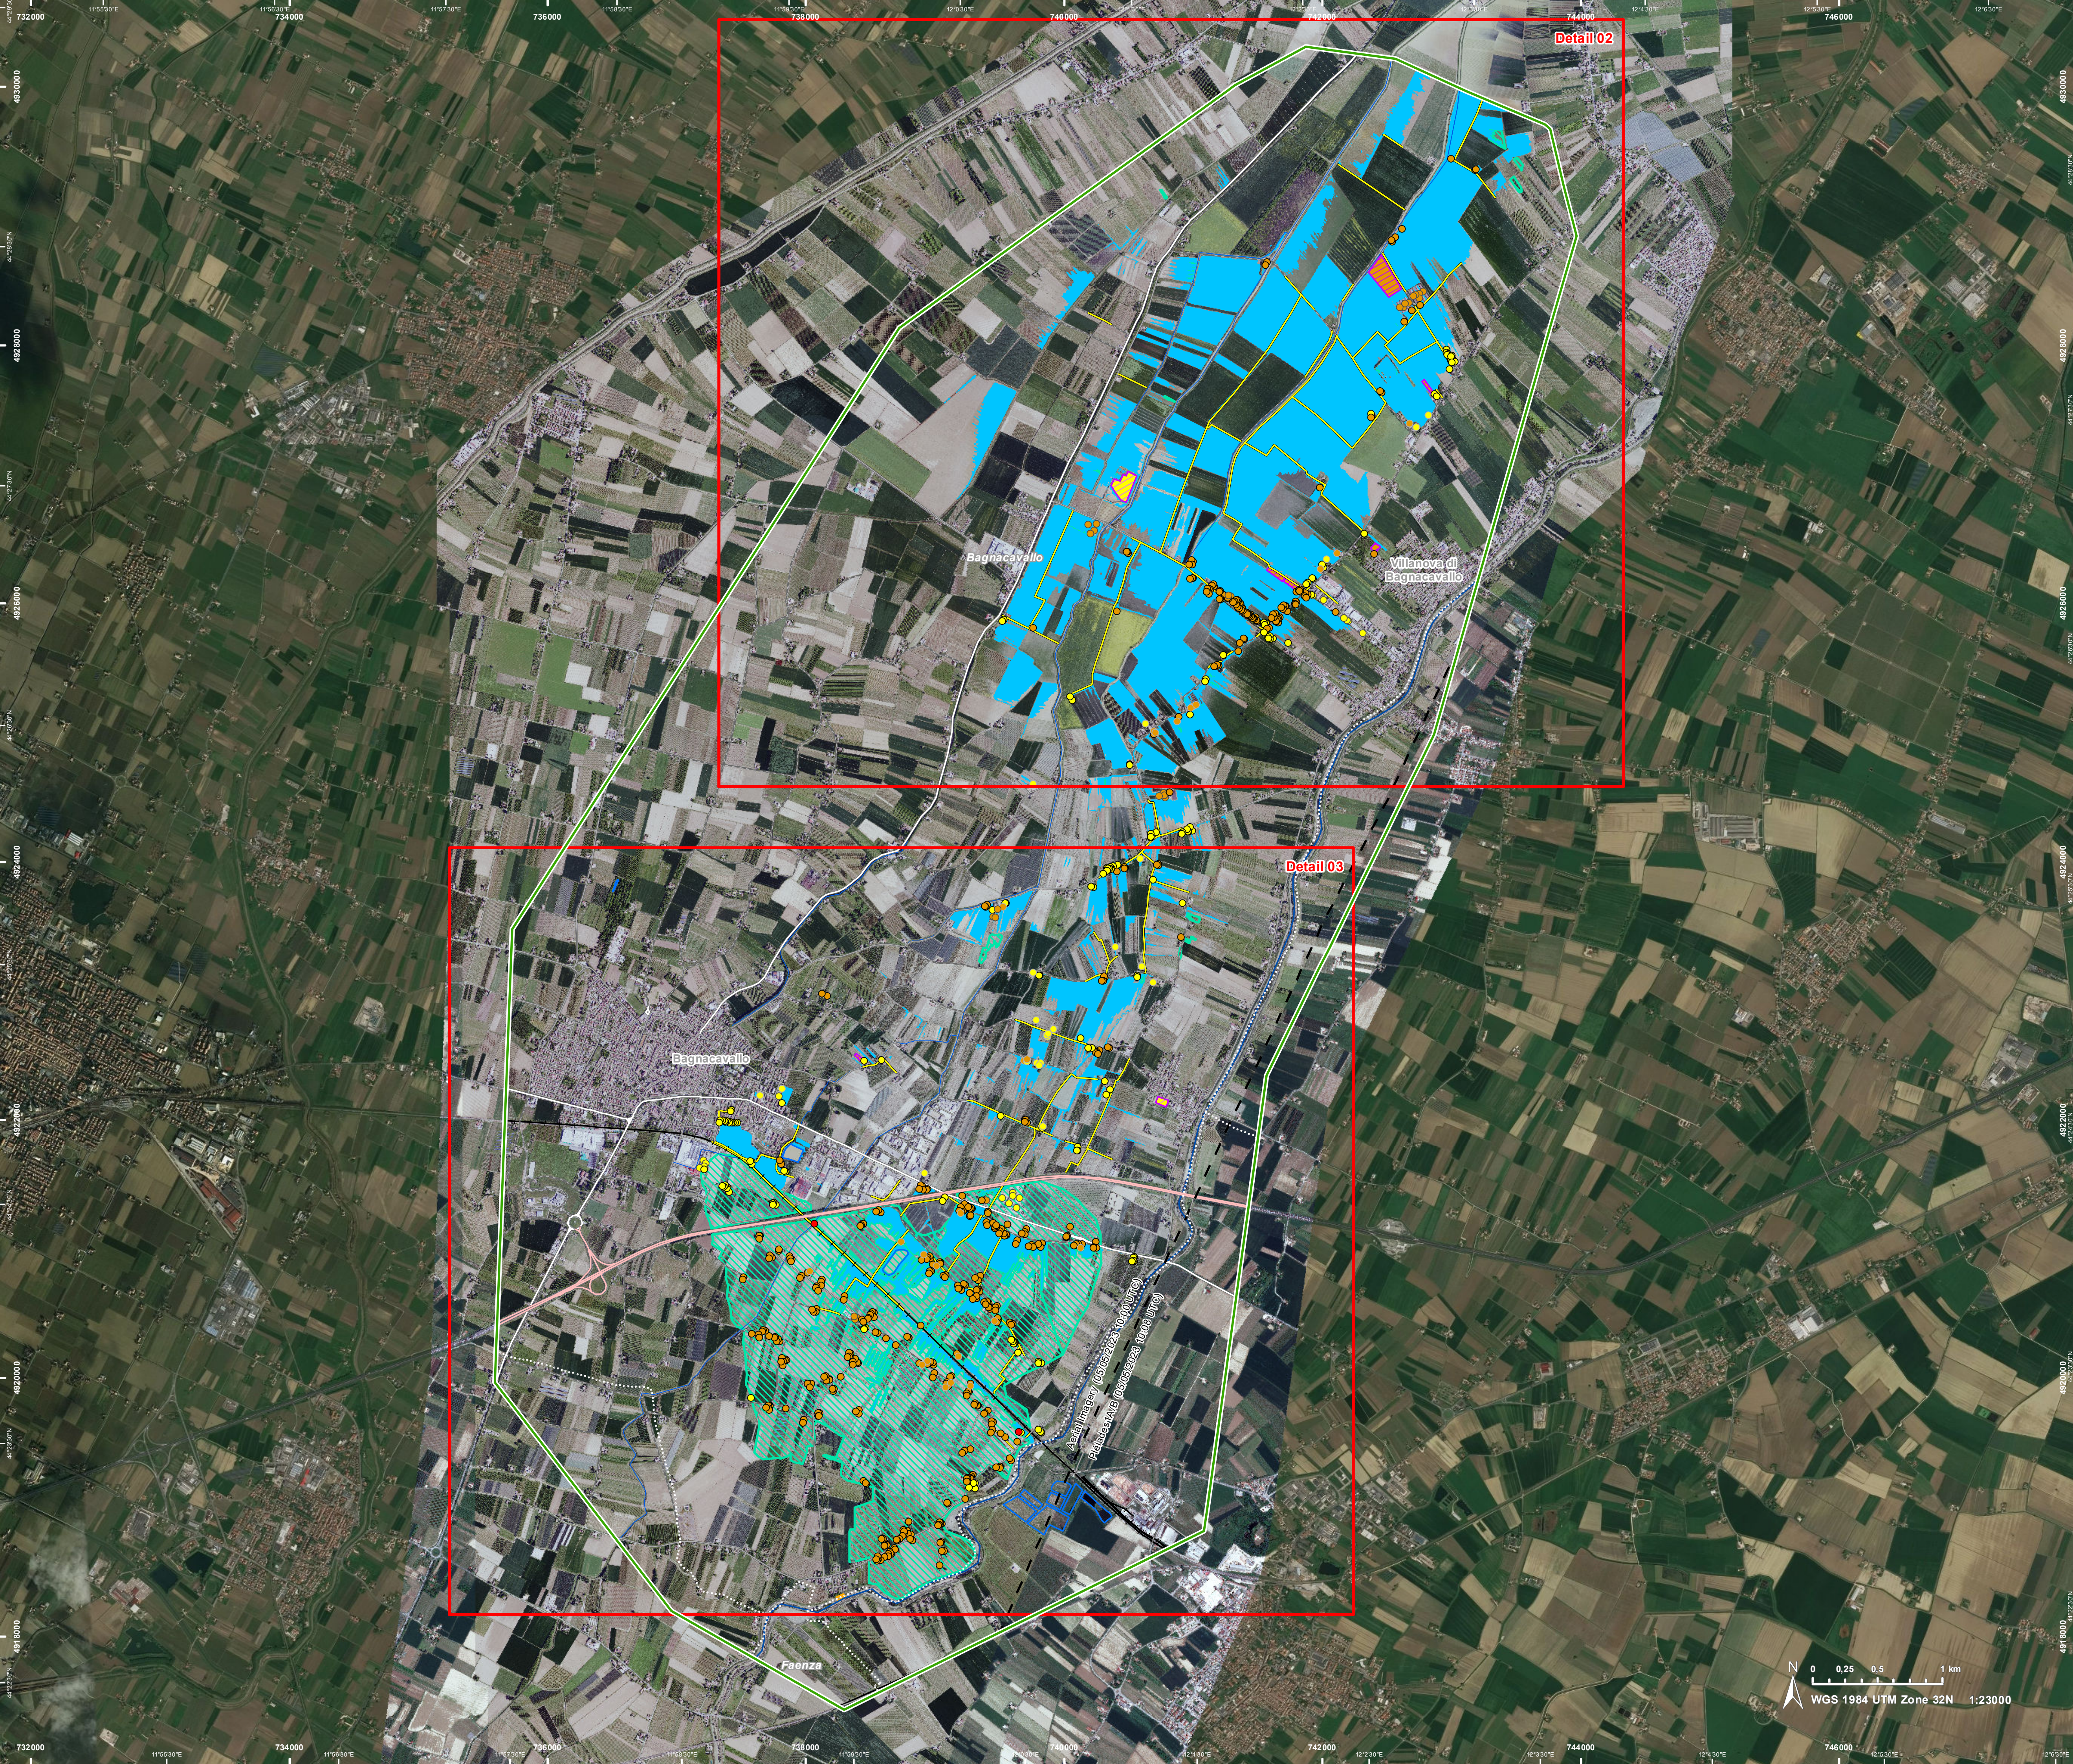
Flood trace 538.7 ha
Flooded area 727.4 ha
Potentially affected population ~ 550

Affected Built-up, Transportations and Facilities

Built-Up 724 No.
Road 32.1 km
Railway 2 km
Power 1.5 ha
