Situation as of 31/10/2024 10:22 UTC
Grading - Overview map 01

Event: On 29 October 2024 at 14:30 UTC, an extraordinary rainfall event affected the Levante region. High water levels in rivers caused flooding in Ribera Alta, Horta, La Plana de Utiel and Letur river. On 31 October 2024, extraordinary precipitation caused flooding in the Castellon Province area. Copernicus EMS Rapid Mapping is requested to provide emergency mapping of flood extent, Monitoring and classification damages emergency mapping.

Situation as of 31/10/2024 10:22 UTC
Grading - Detail map 02

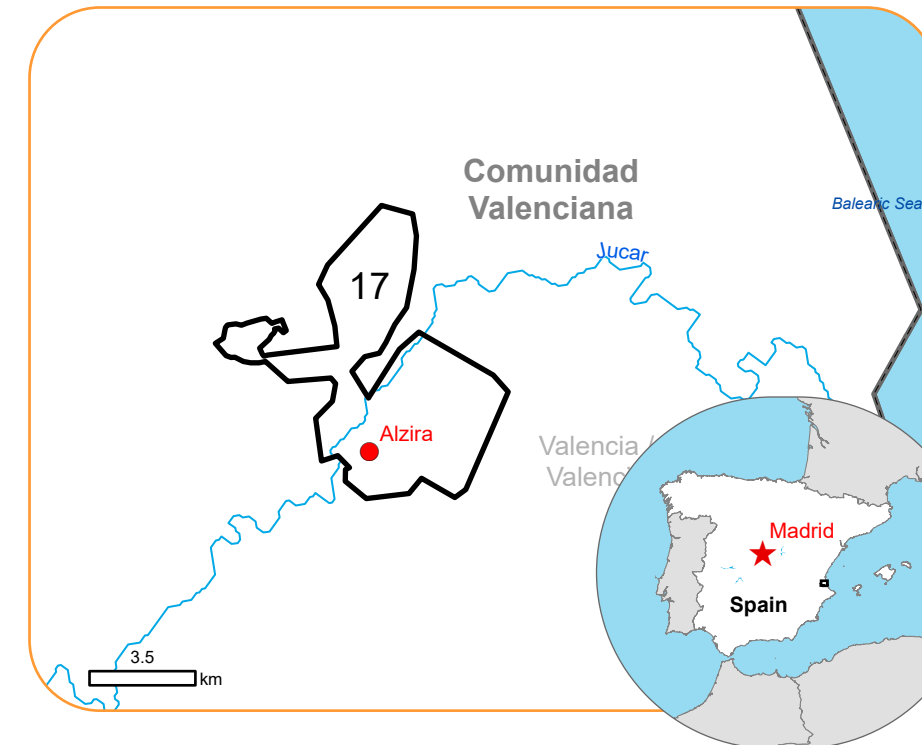
Flooded area 22.9 ha
Flood trace 340.0 ha

Potentially affected population ~9,300

Affected Built-up and Transportations

Built-Up 1,041 No.
Road 107.0 km
Railway 9.9 km

The thematic layer has been derived from post-event satellite image by means of visual interpretation. Please be aware that the thematic accuracy might be lower in urban areas due to limitations of the satellite image, because of the high Off Nadir Angle (43.8°)

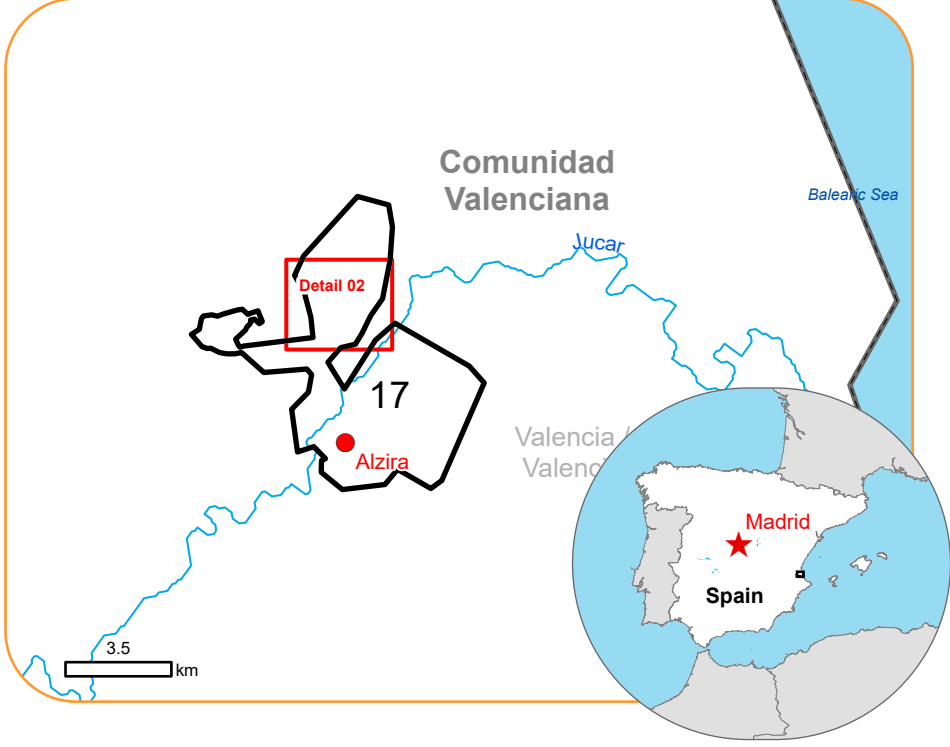
The thematic layer has been derived from post-event satellite image by means of visual interpretation. Please be aware that the thematic accuracy might be lower in urban areas due to limitations of the satellite image, because of the high Off Nadir Angle (43.8°)
