Situation as of 31/10/2024 10:22 UTC
Grading - Overview map 01

Event: On 29 October 2024 at 14:30 UTC, an extraordinary rainfall event affected the Levante region. High water levels in rivers caused flooding in Ribera Alta, Horta, La Plana de Utiel and Letur river. On 31 October 2024, extraordinary precipitation caused flooding in the Castellon Province area. Copernicus EMS Rapid Mapping is requested to provide emergency mapping of flood extent, Monitoring and classification damages emergency mapping.

Situation as of 31/10/2024 10:22 UTC
Grading - Detail map 03

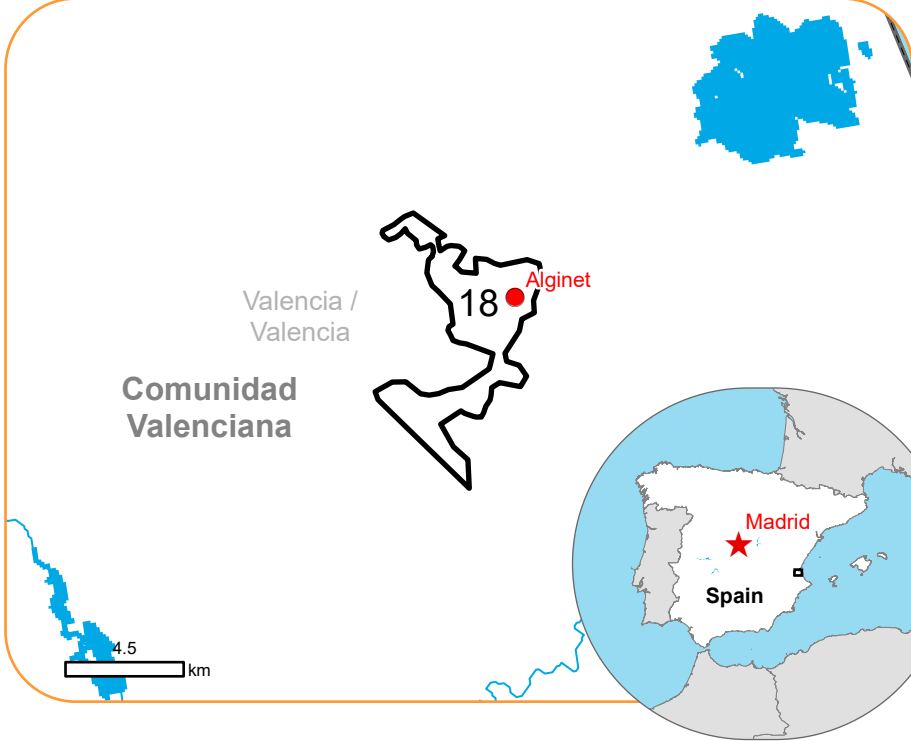
Flooded area 62.0 ha
Potentially affected population ~ 200

Built-Up 449 No.
Road 20.9 km

The thematic layer has been derived from post-event satellite image by means of visual interpretation. Please be aware that the thematic accuracy might be lower in urban areas due to limitations of the satellite image, because of the high Off Nadir Angle (43.8°)

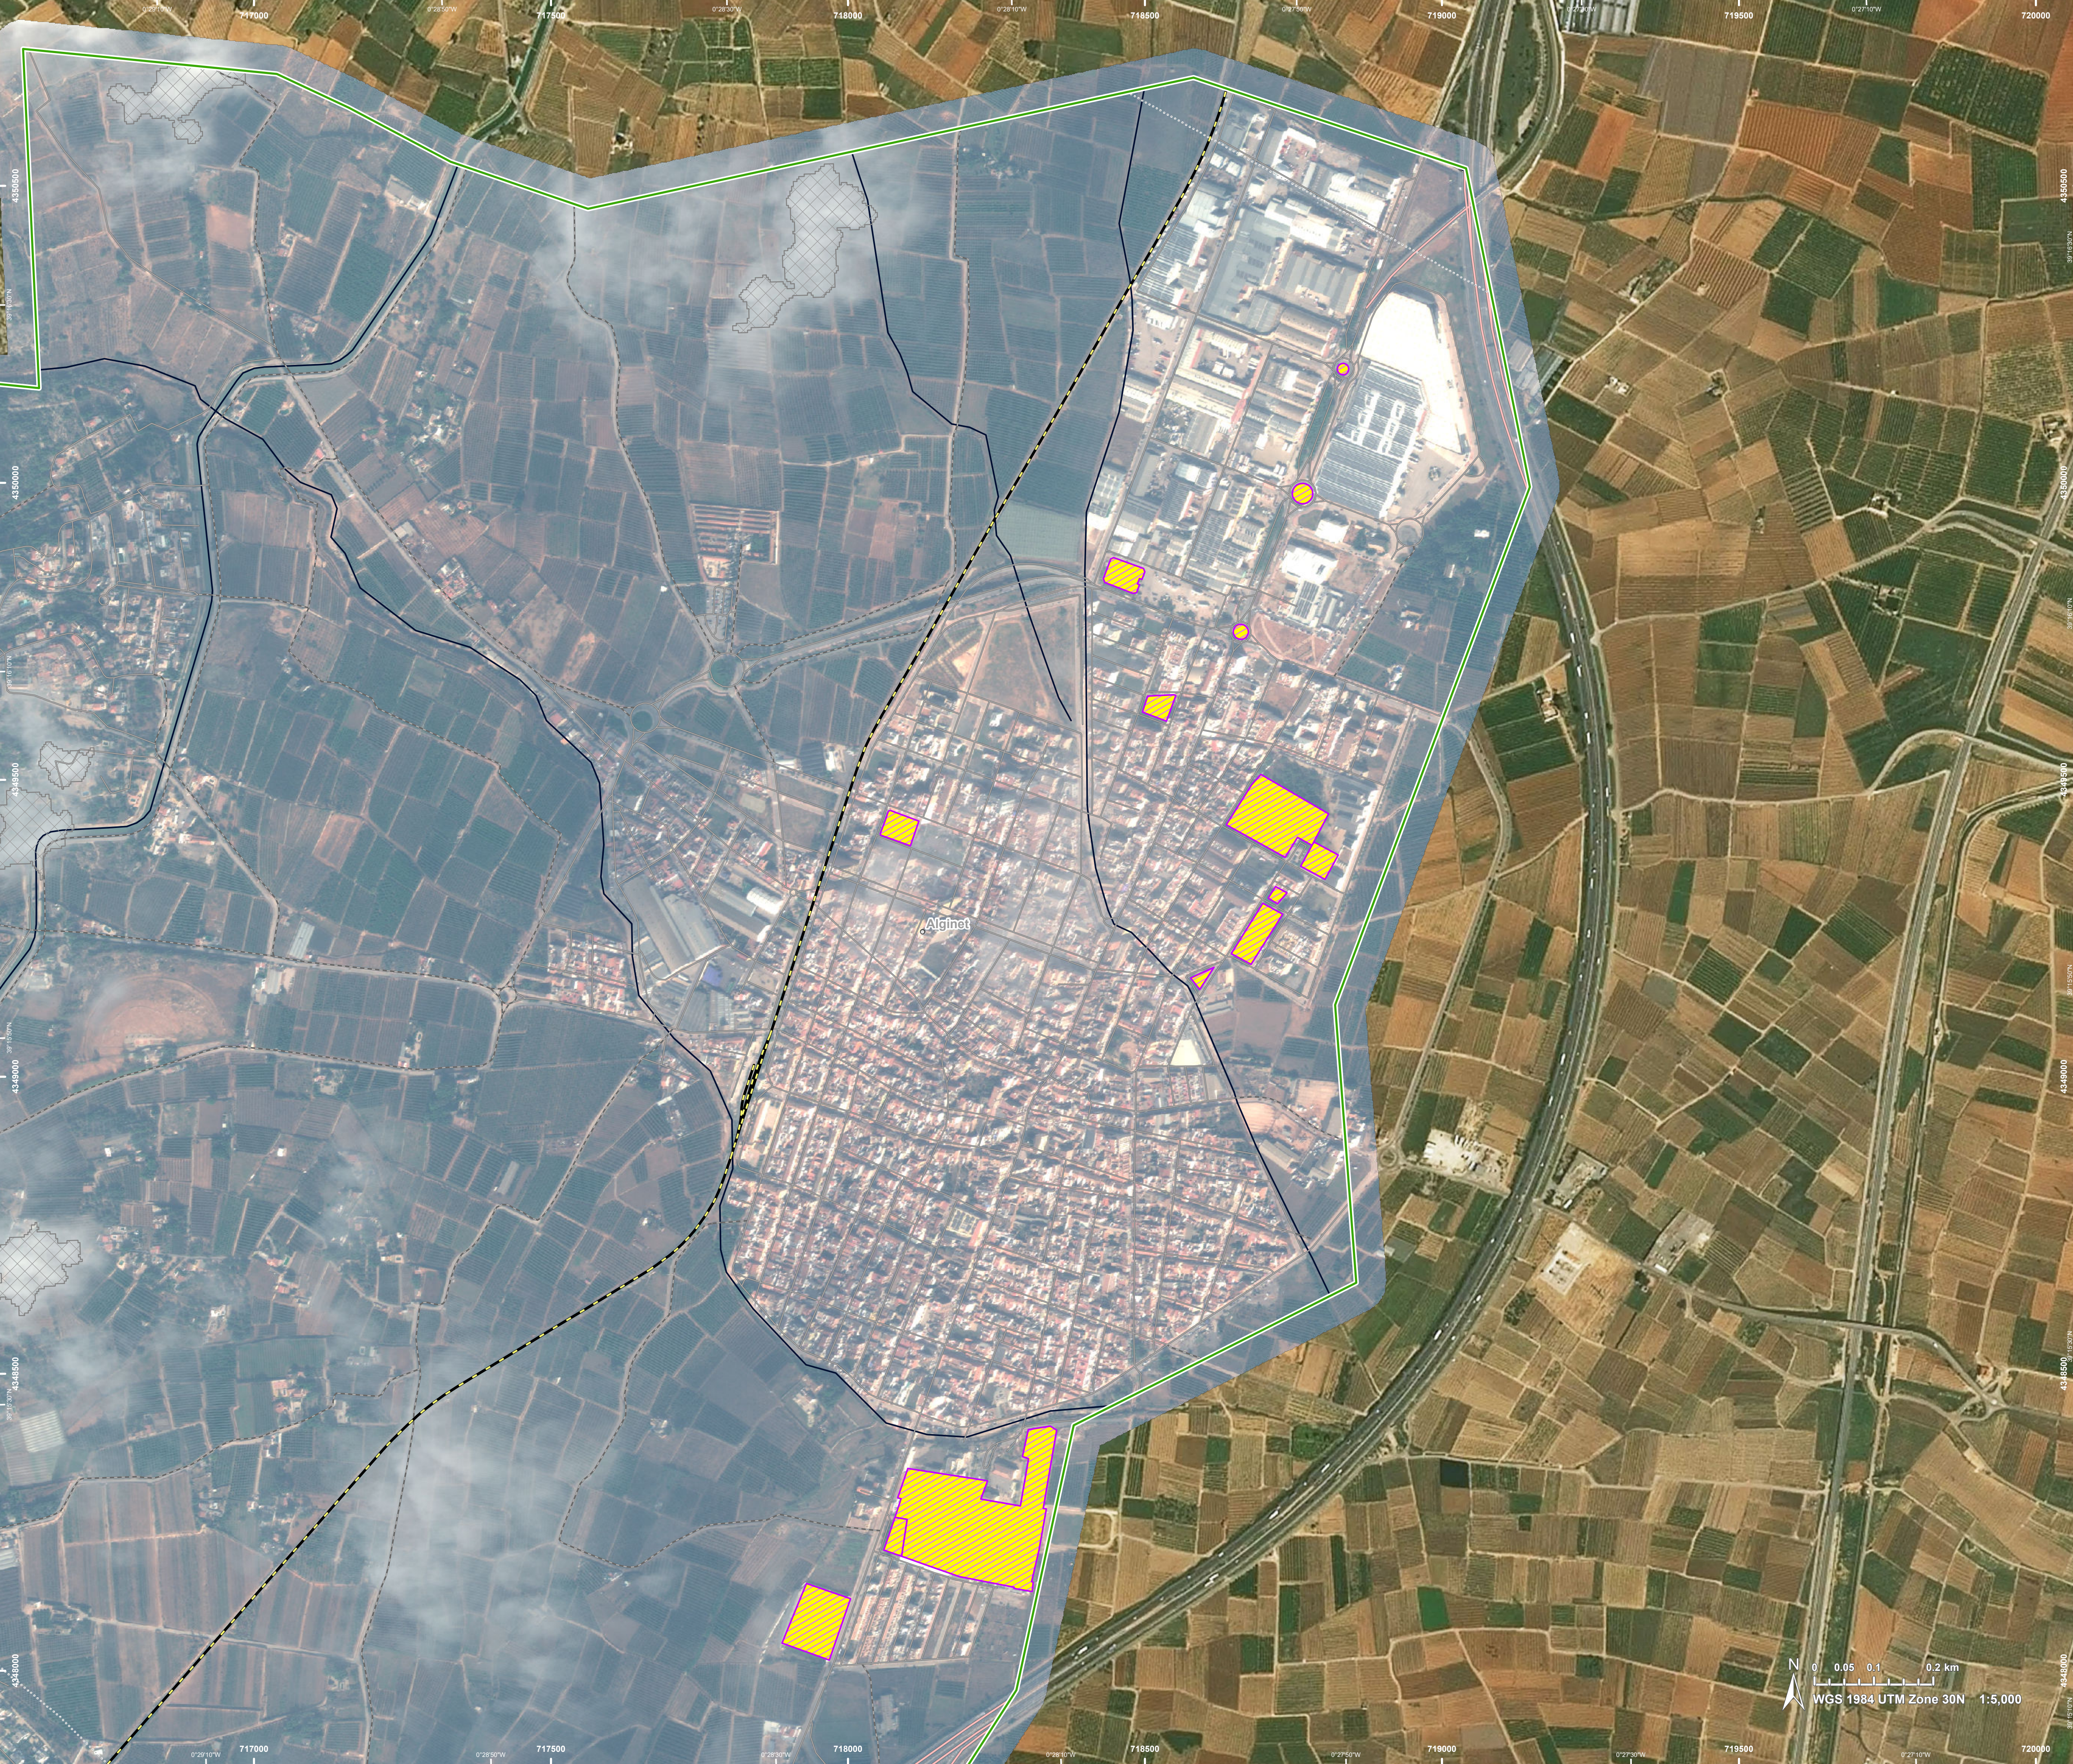
Consequences within the AOI							
	Unit of measurement		Destroyed	Damaged	Possibly damaged*	Total affected**	Total in AOI
Flooded area	ha						62.0
Estimated population	Number of inhabitants					~ 200	~ 23,000
Built-up	Residential Buildings	No.	0	3	434	437	438
	Office buildings	No.	0	0	0	0	1
	Institutional	No.	0	0	0	0	1
	Wholesale and retail trade buildings	No.	0	0	1	1	3
	Industrial buildings	No.	0	0	2	2	22
	Museums and libraries	No.	0	0	0	0	1
	Non-residential farm buildings	No.	6	0	2	8	27
	Buildings used as places of worship and for religious activities	No.	0	0	1	1	3
	Unclassified	No.	0	0	0	0	92
Transportation	Highways	km	0	0	1.5	1.5	14.3
	Primary Road	km	0	0	0	0	3.7
	Secondary Road	km	0	0	0	0	2.2
	Local Road	km	0	4.8	3.4	8.2	144.6
	Cart Track	km	0	6.2	3.0	9.2	50.6
	No Driveway	km	0	1.6	0.3	2.0	2.0
	Subway	km	0	0.3	0	0.3	6.4
Facilities	Settling Basin	ha	0	0	1.2	1.2	1.2
	Sport and recreation constructions	ha	20.3	1.2	25.3	46.8	46.8

Not Applicable	ha	0	0	0.2	0.2	0.2
	Long-distance pipelines, communication and electricity lines	km	0	0	0	0	6.3
	Dams	km	0	0	0	0	0.1
Land use	Shrub and/or herbaceous vegetation association	ha				46.6	300.2
	Open spaces with little or no vegetation	ha				8.0	8.5
	Other	ha				6.4	704.0
	Permanent crops	ha				1.0	945.4
	Arable land	ha				0	1.0
	Heterogeneous agricultural areas	ha				0	177.5
