EMSR773 - AOI20
Flood in Spain
MONTROI

Situation as of 09/11/2024 10:47 UTC
Grading - Overview map 01

Situation as of 09/11/2024 10:47 UTC
Grading - Detail map 02

Situation as of 09/11/2024 10:47 UTC
Grading - Detail map 03

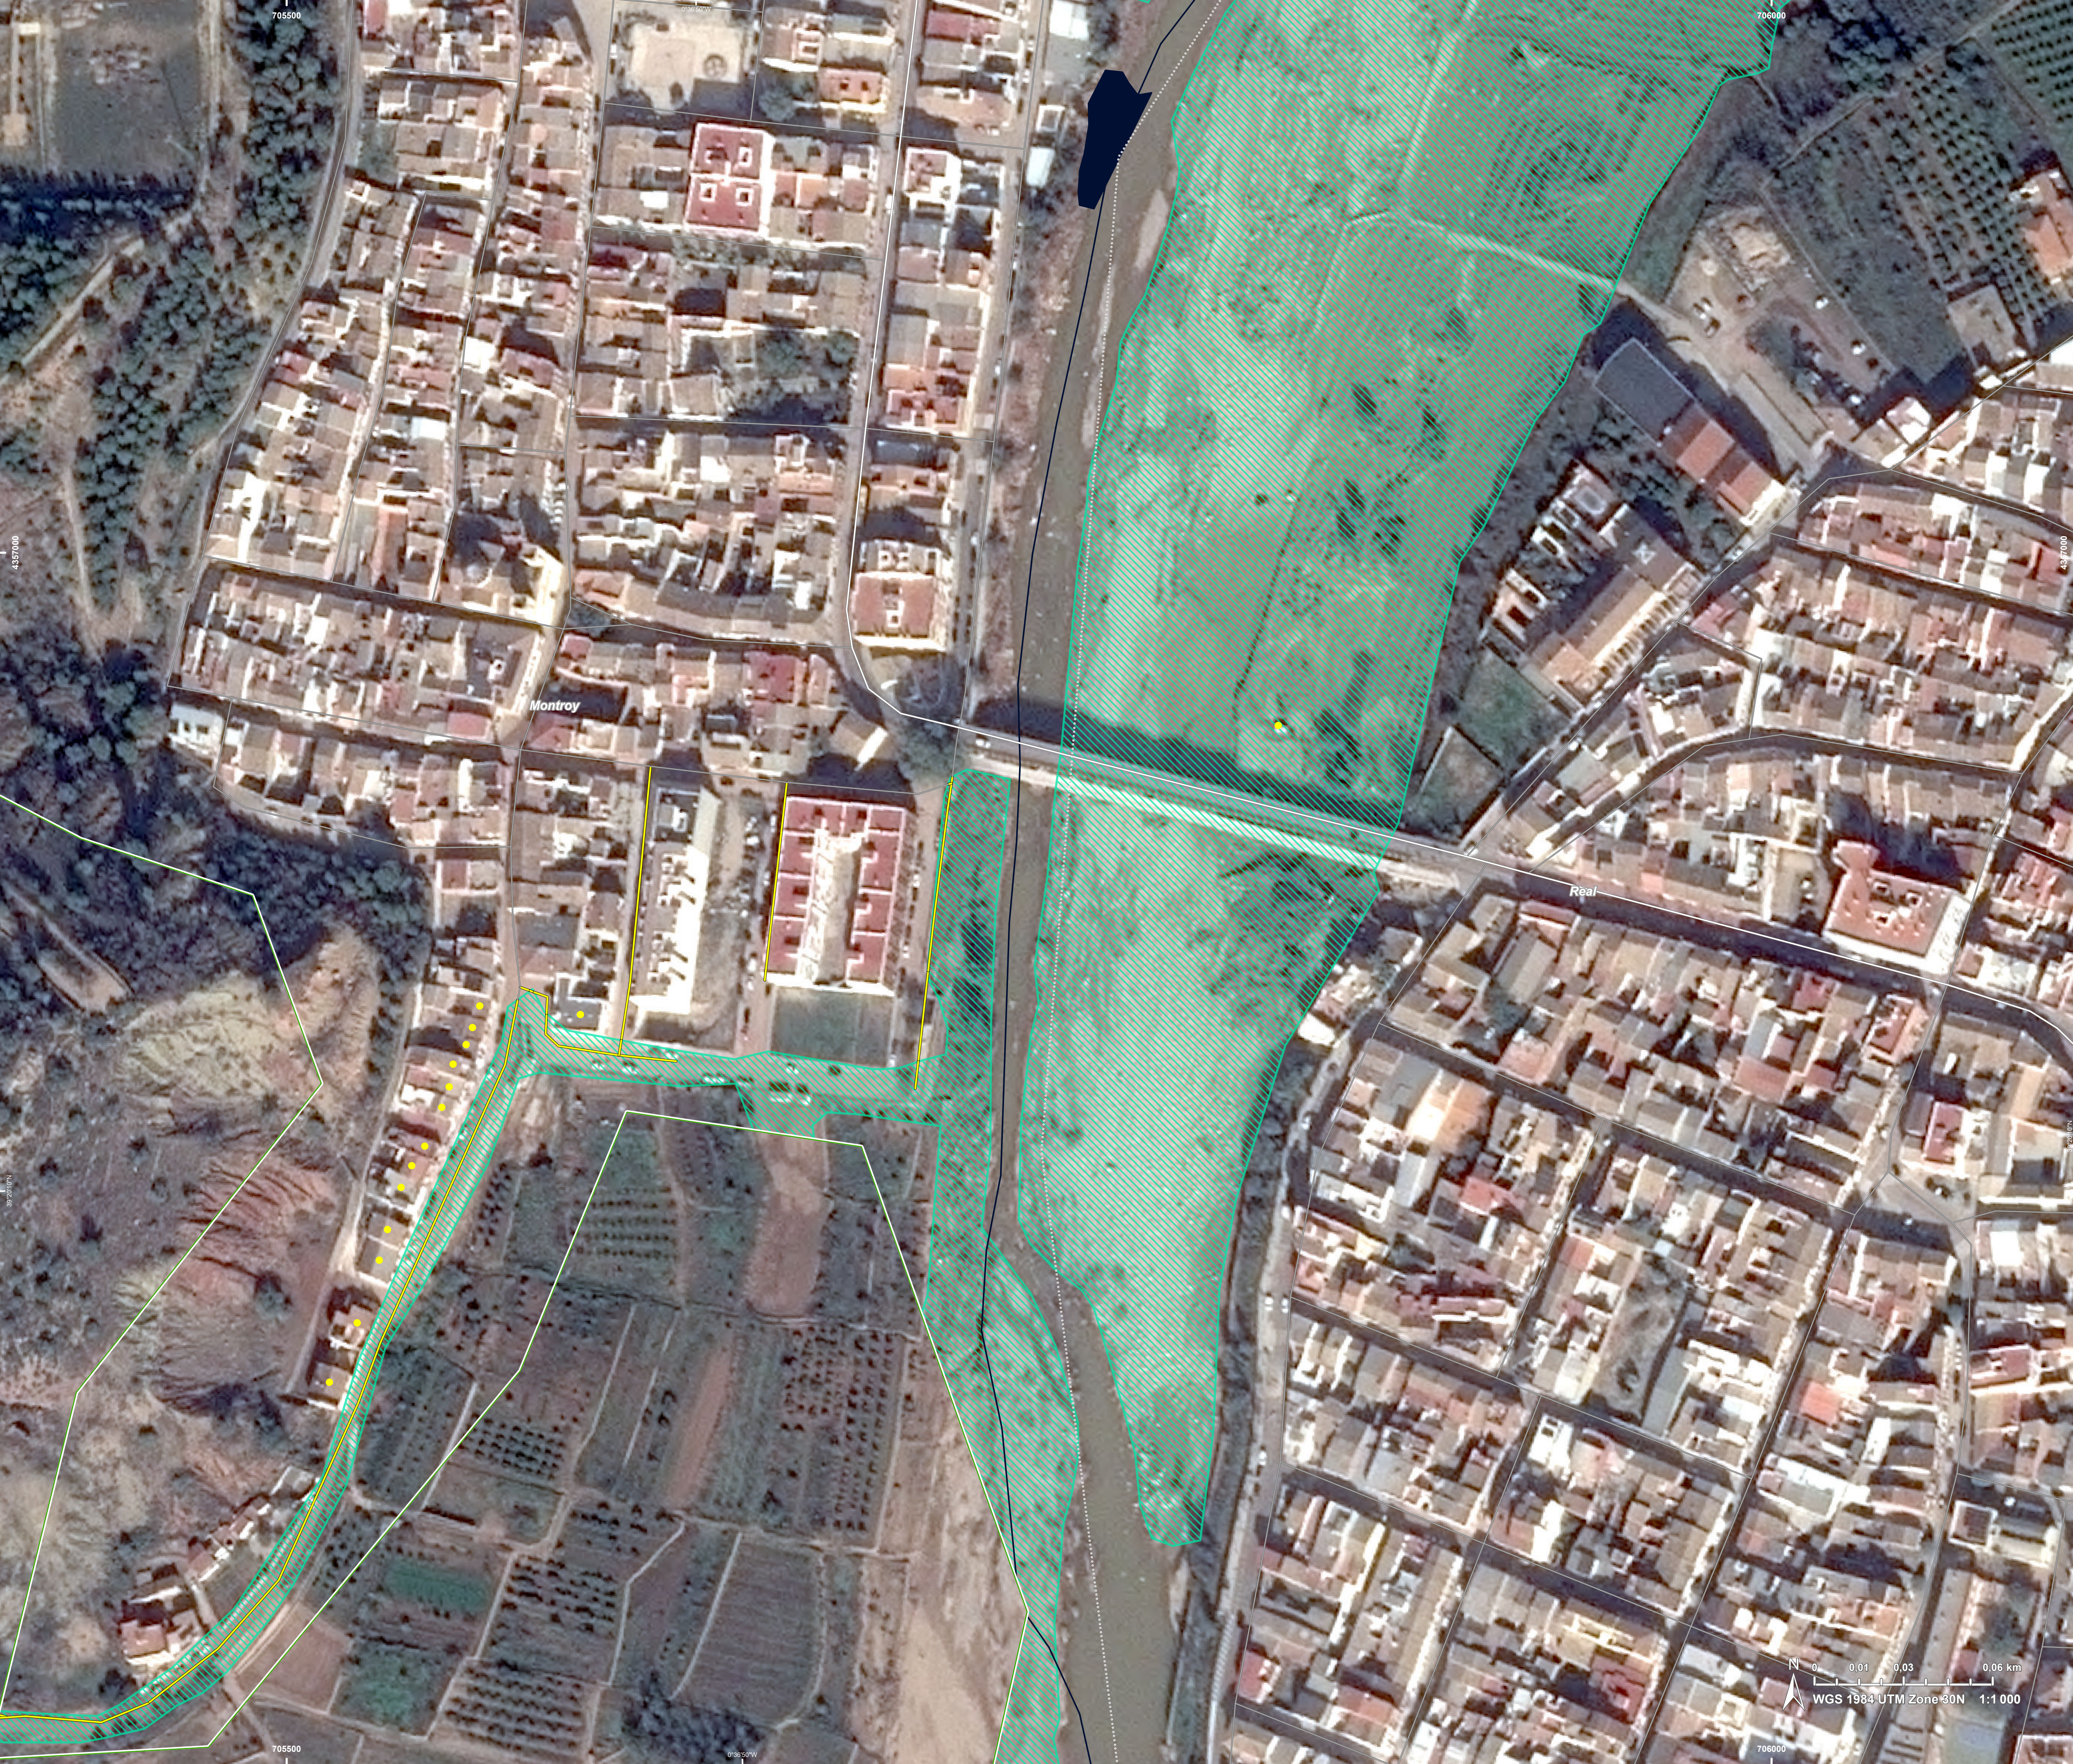
Flooded area 14.7 ha
Flood trace 51 ha

Potentially affected population ~ 100

Built-Up 22 No.
Road 3.3 km

The thematic layer has been derived from post-event satellite image using a semi-automatic approach.

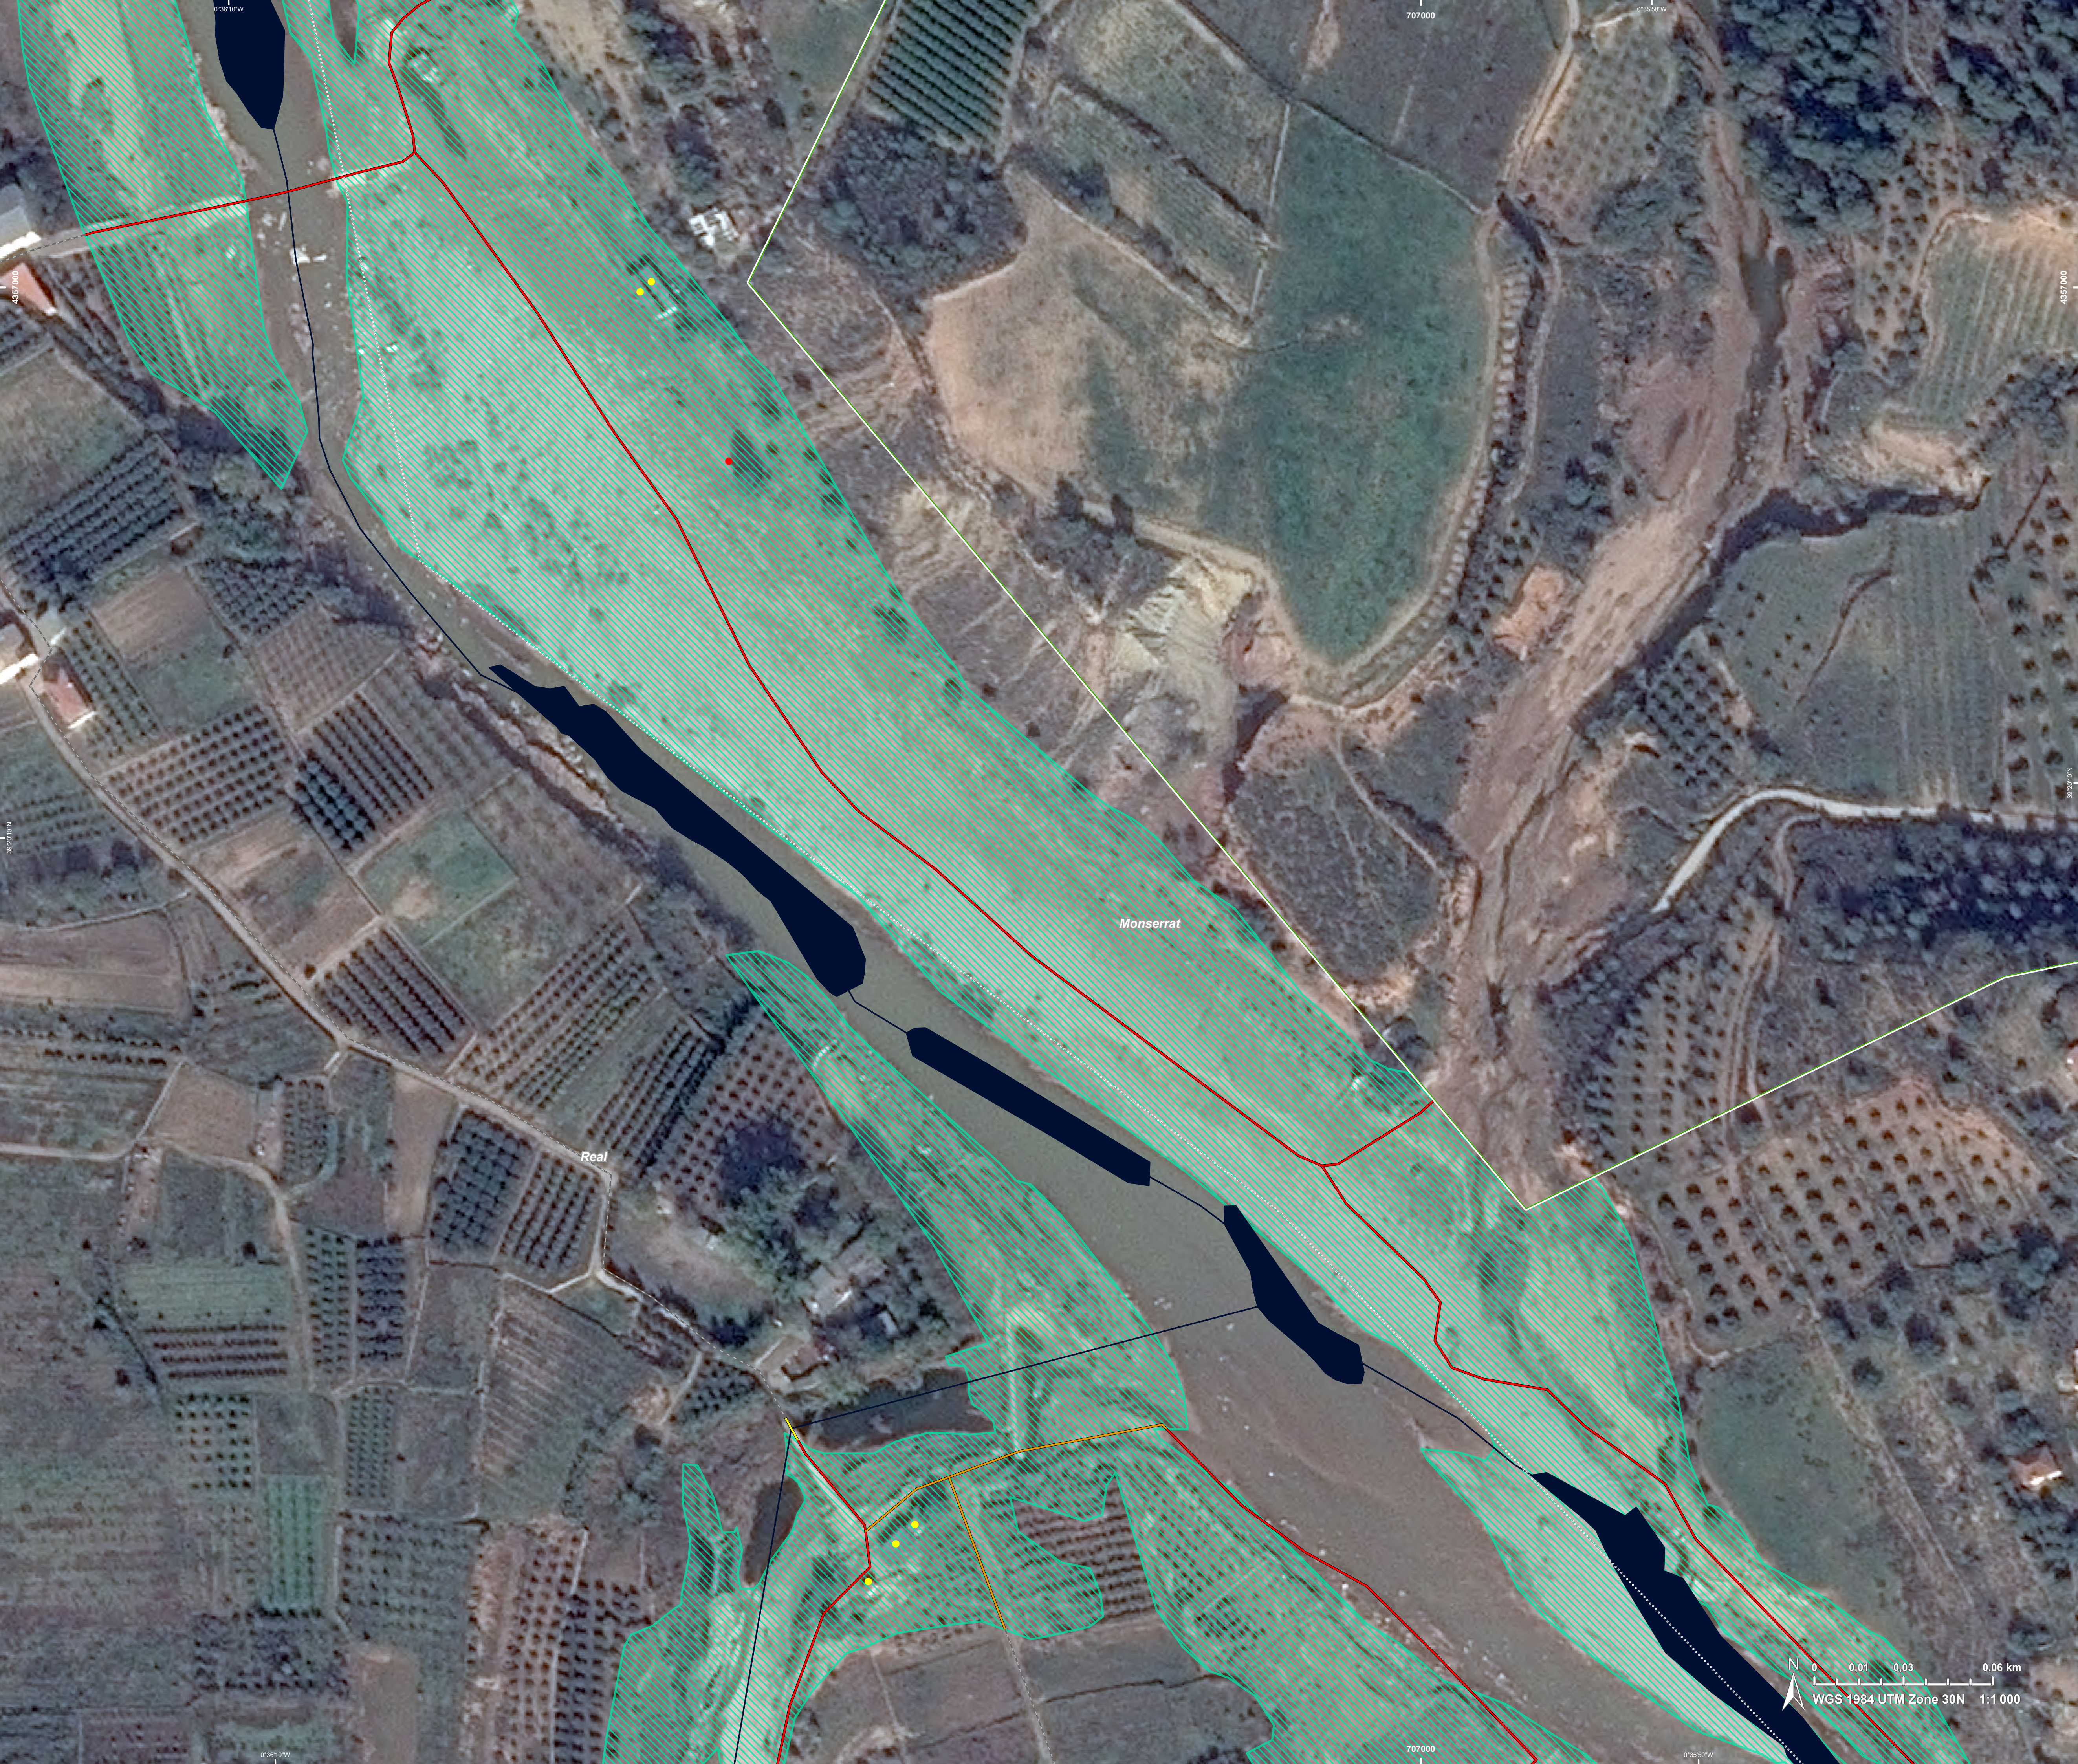
Possibly damaged

Road, Possibly damaged
