Situation as of 31/10/2024 10:22 UTC
Grading - Overview map 01

Event: On 29 October 2024 at 14:30 UTC, an extraordinary rainfall event affected the Valencia region. High water levels in rivers caused flooding in Ribera Alta, Horta, La Plana de Utiel and Letur river. On 31 October 2024, extraordinary precipitation caused flooding in the Castellon Province area. Copernicus EMS Rapid Mapping is requested to provide emergency mapping of flood extent, Monitoring and classification damages emergency mapping.

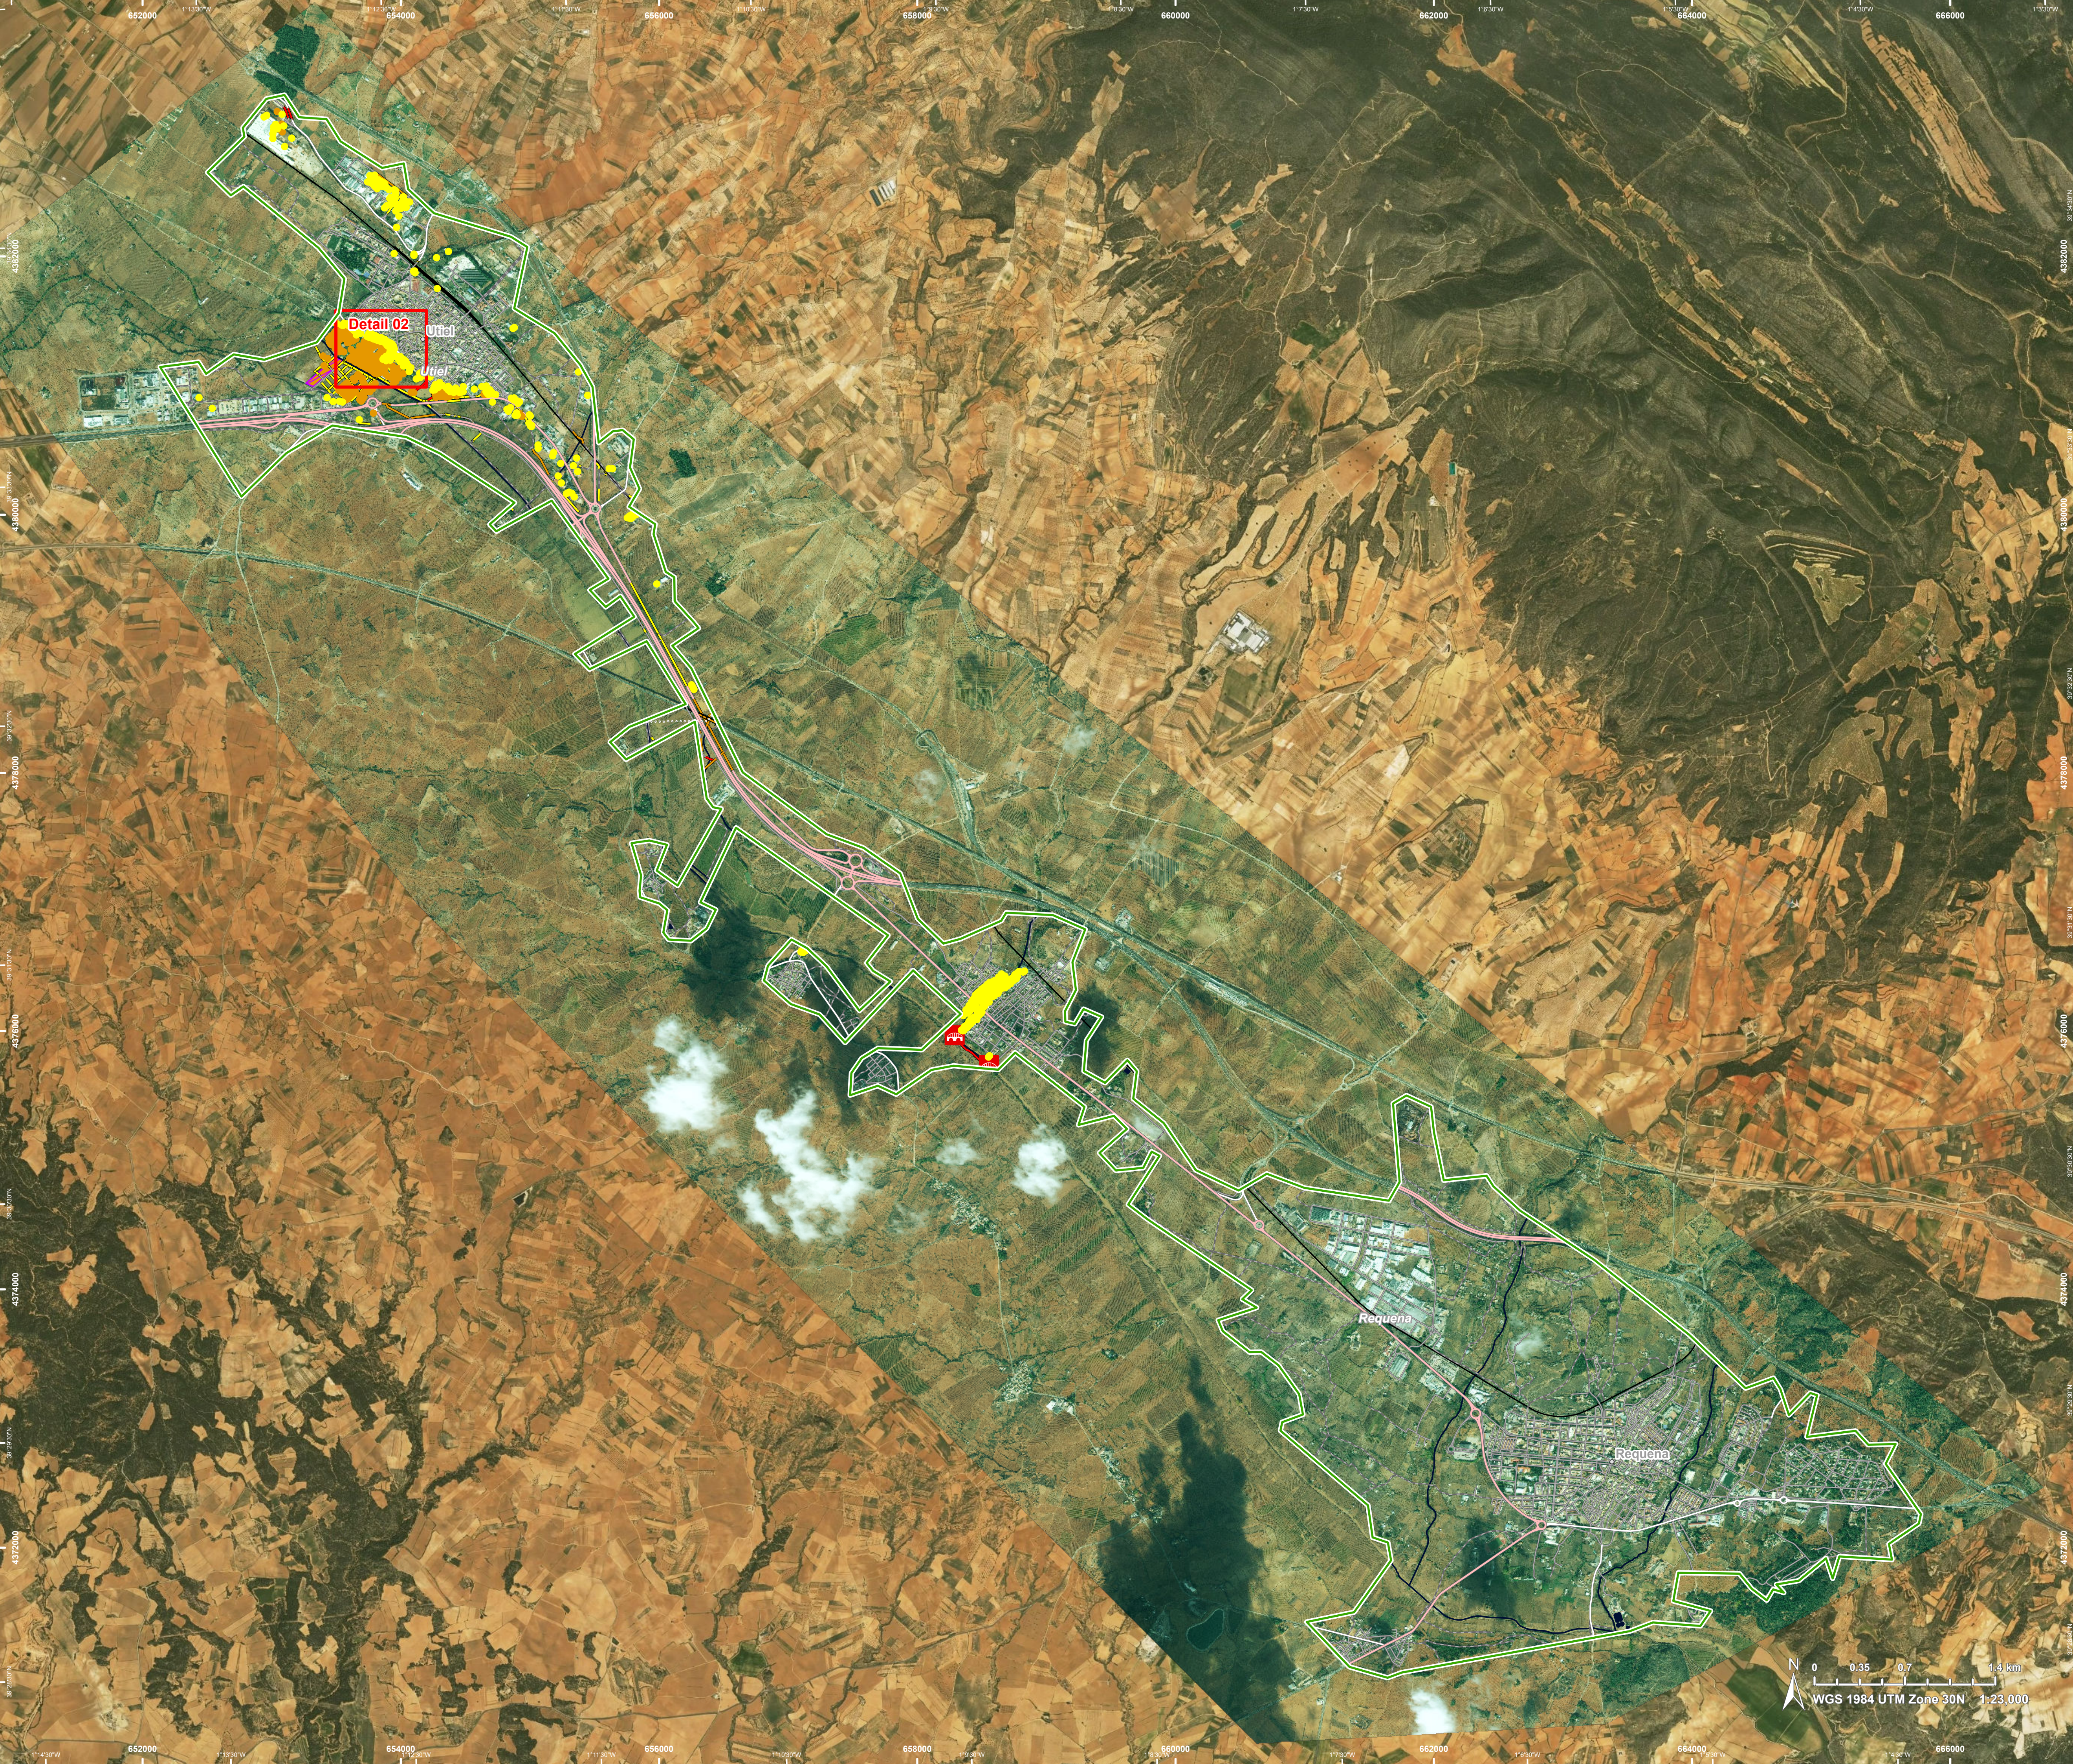
Flooded area 20.1 ha
Flood trace 52.2 ha
Mudflow 20.2 ha

Potentially affected population ~ 1200

Affected Built-up and Transportations

Built-Up 750 No.
Road 15.0 km
Railway 0.3 km

The thematic layer has been derived from post-event satellite image using a semi-automatic approach.

The flood depth information is based on the analysis of post-event satellite imagery and on Digital Elevation Model data. The flooded area corresponds to the water observed in the most recent satellite imagery, excluding the permanent water.

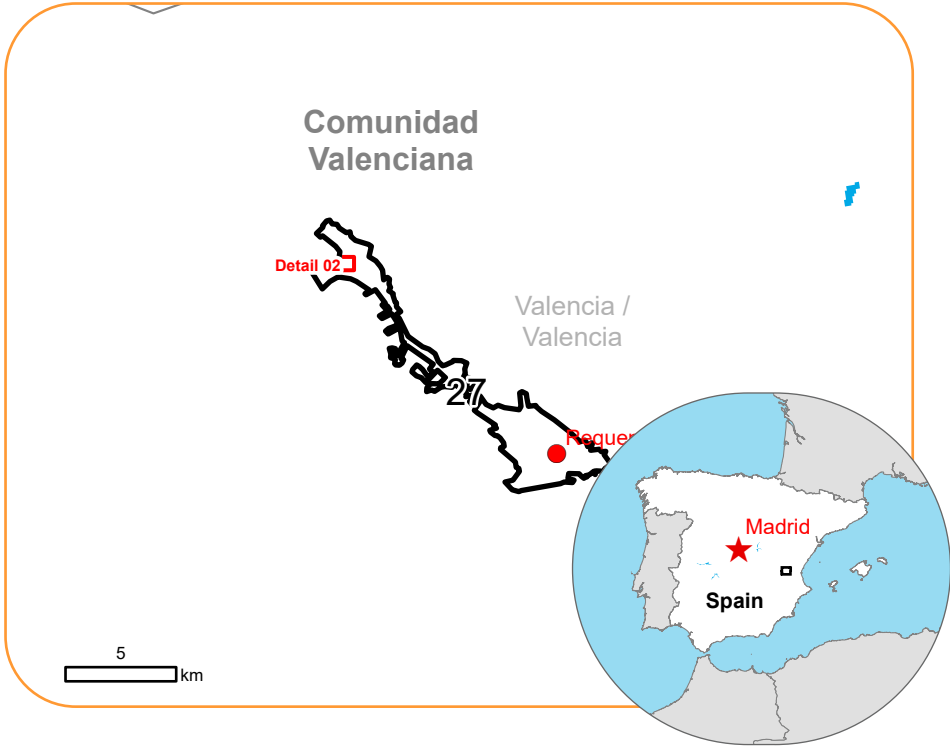
The flood depth information is based on the analysis of post-event satellite imagery and on Digital Elevation Model data. The flooded area corresponds to the water observed in the most recent satellite imagery, excluding the permanent water.
