EMSR773 - AOI31
Flood in Spain
CASES DEL RIU

Situation as of 11/11/2024 13:00 UTC
Grading - Overview map 01

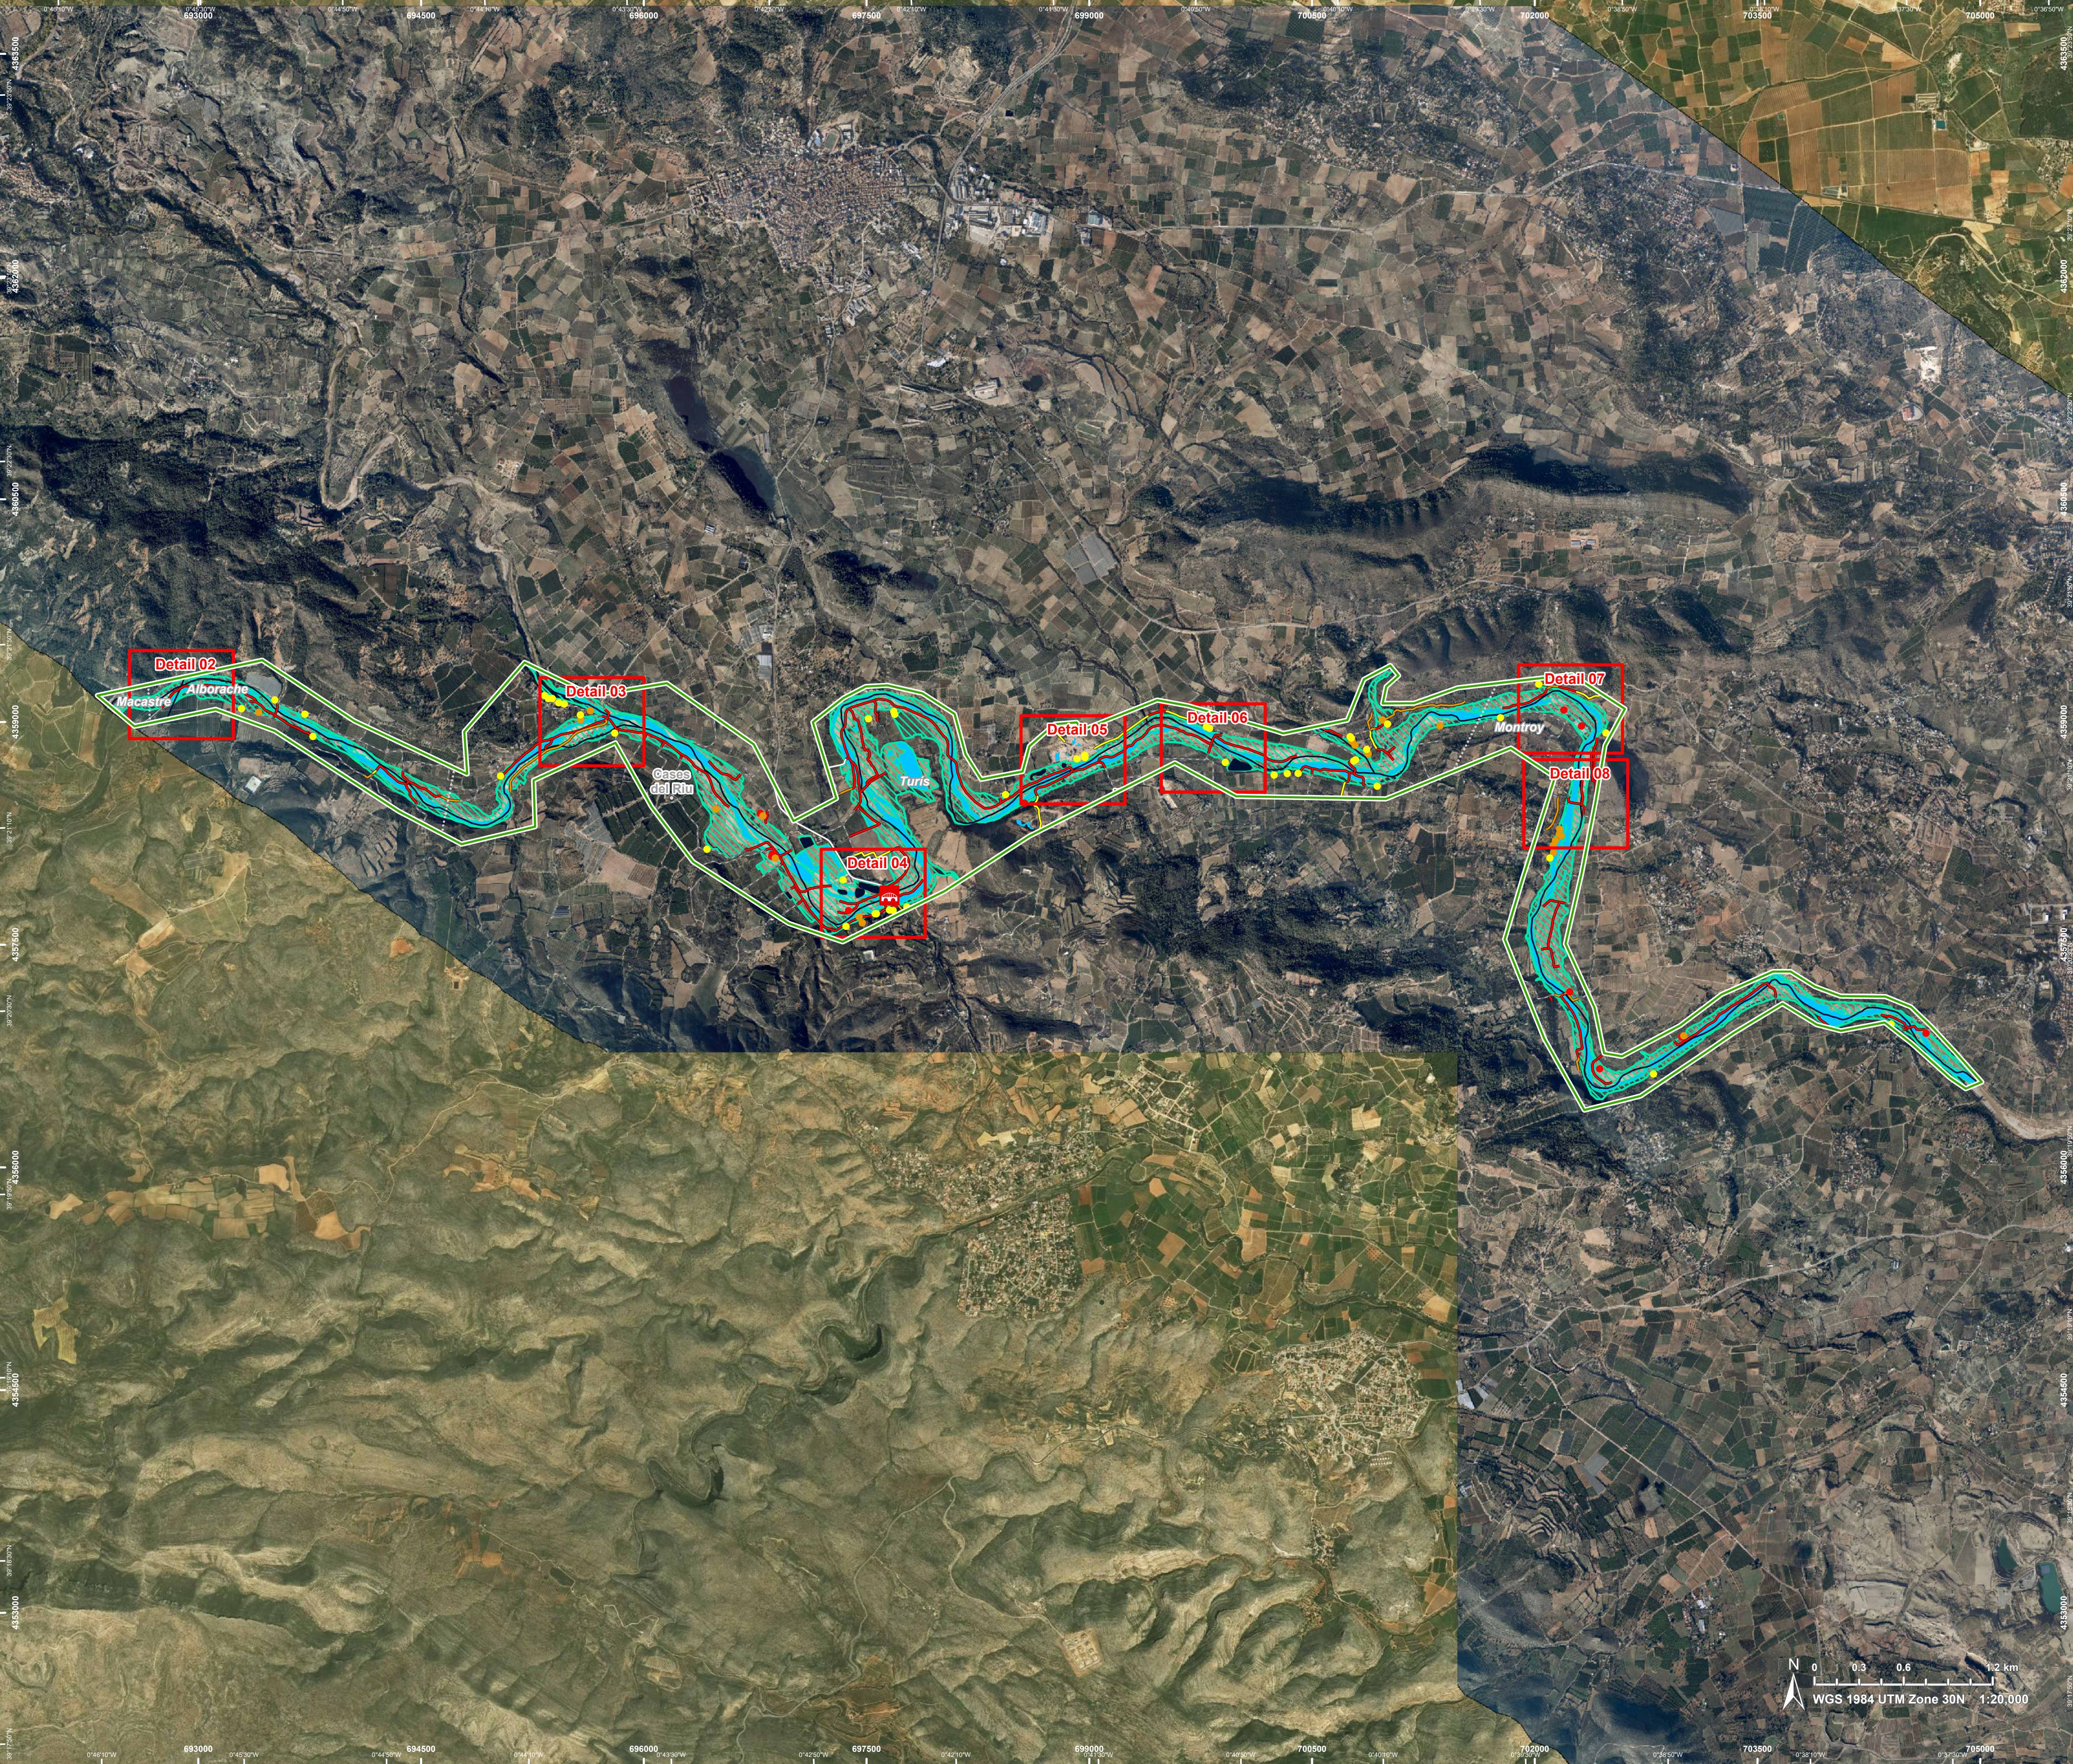
Flooded area 64.3 ha
Flood trace 254.0 ha

Potentially affected population
~ 60

Built-Up
78 No.

Road
20.8 km

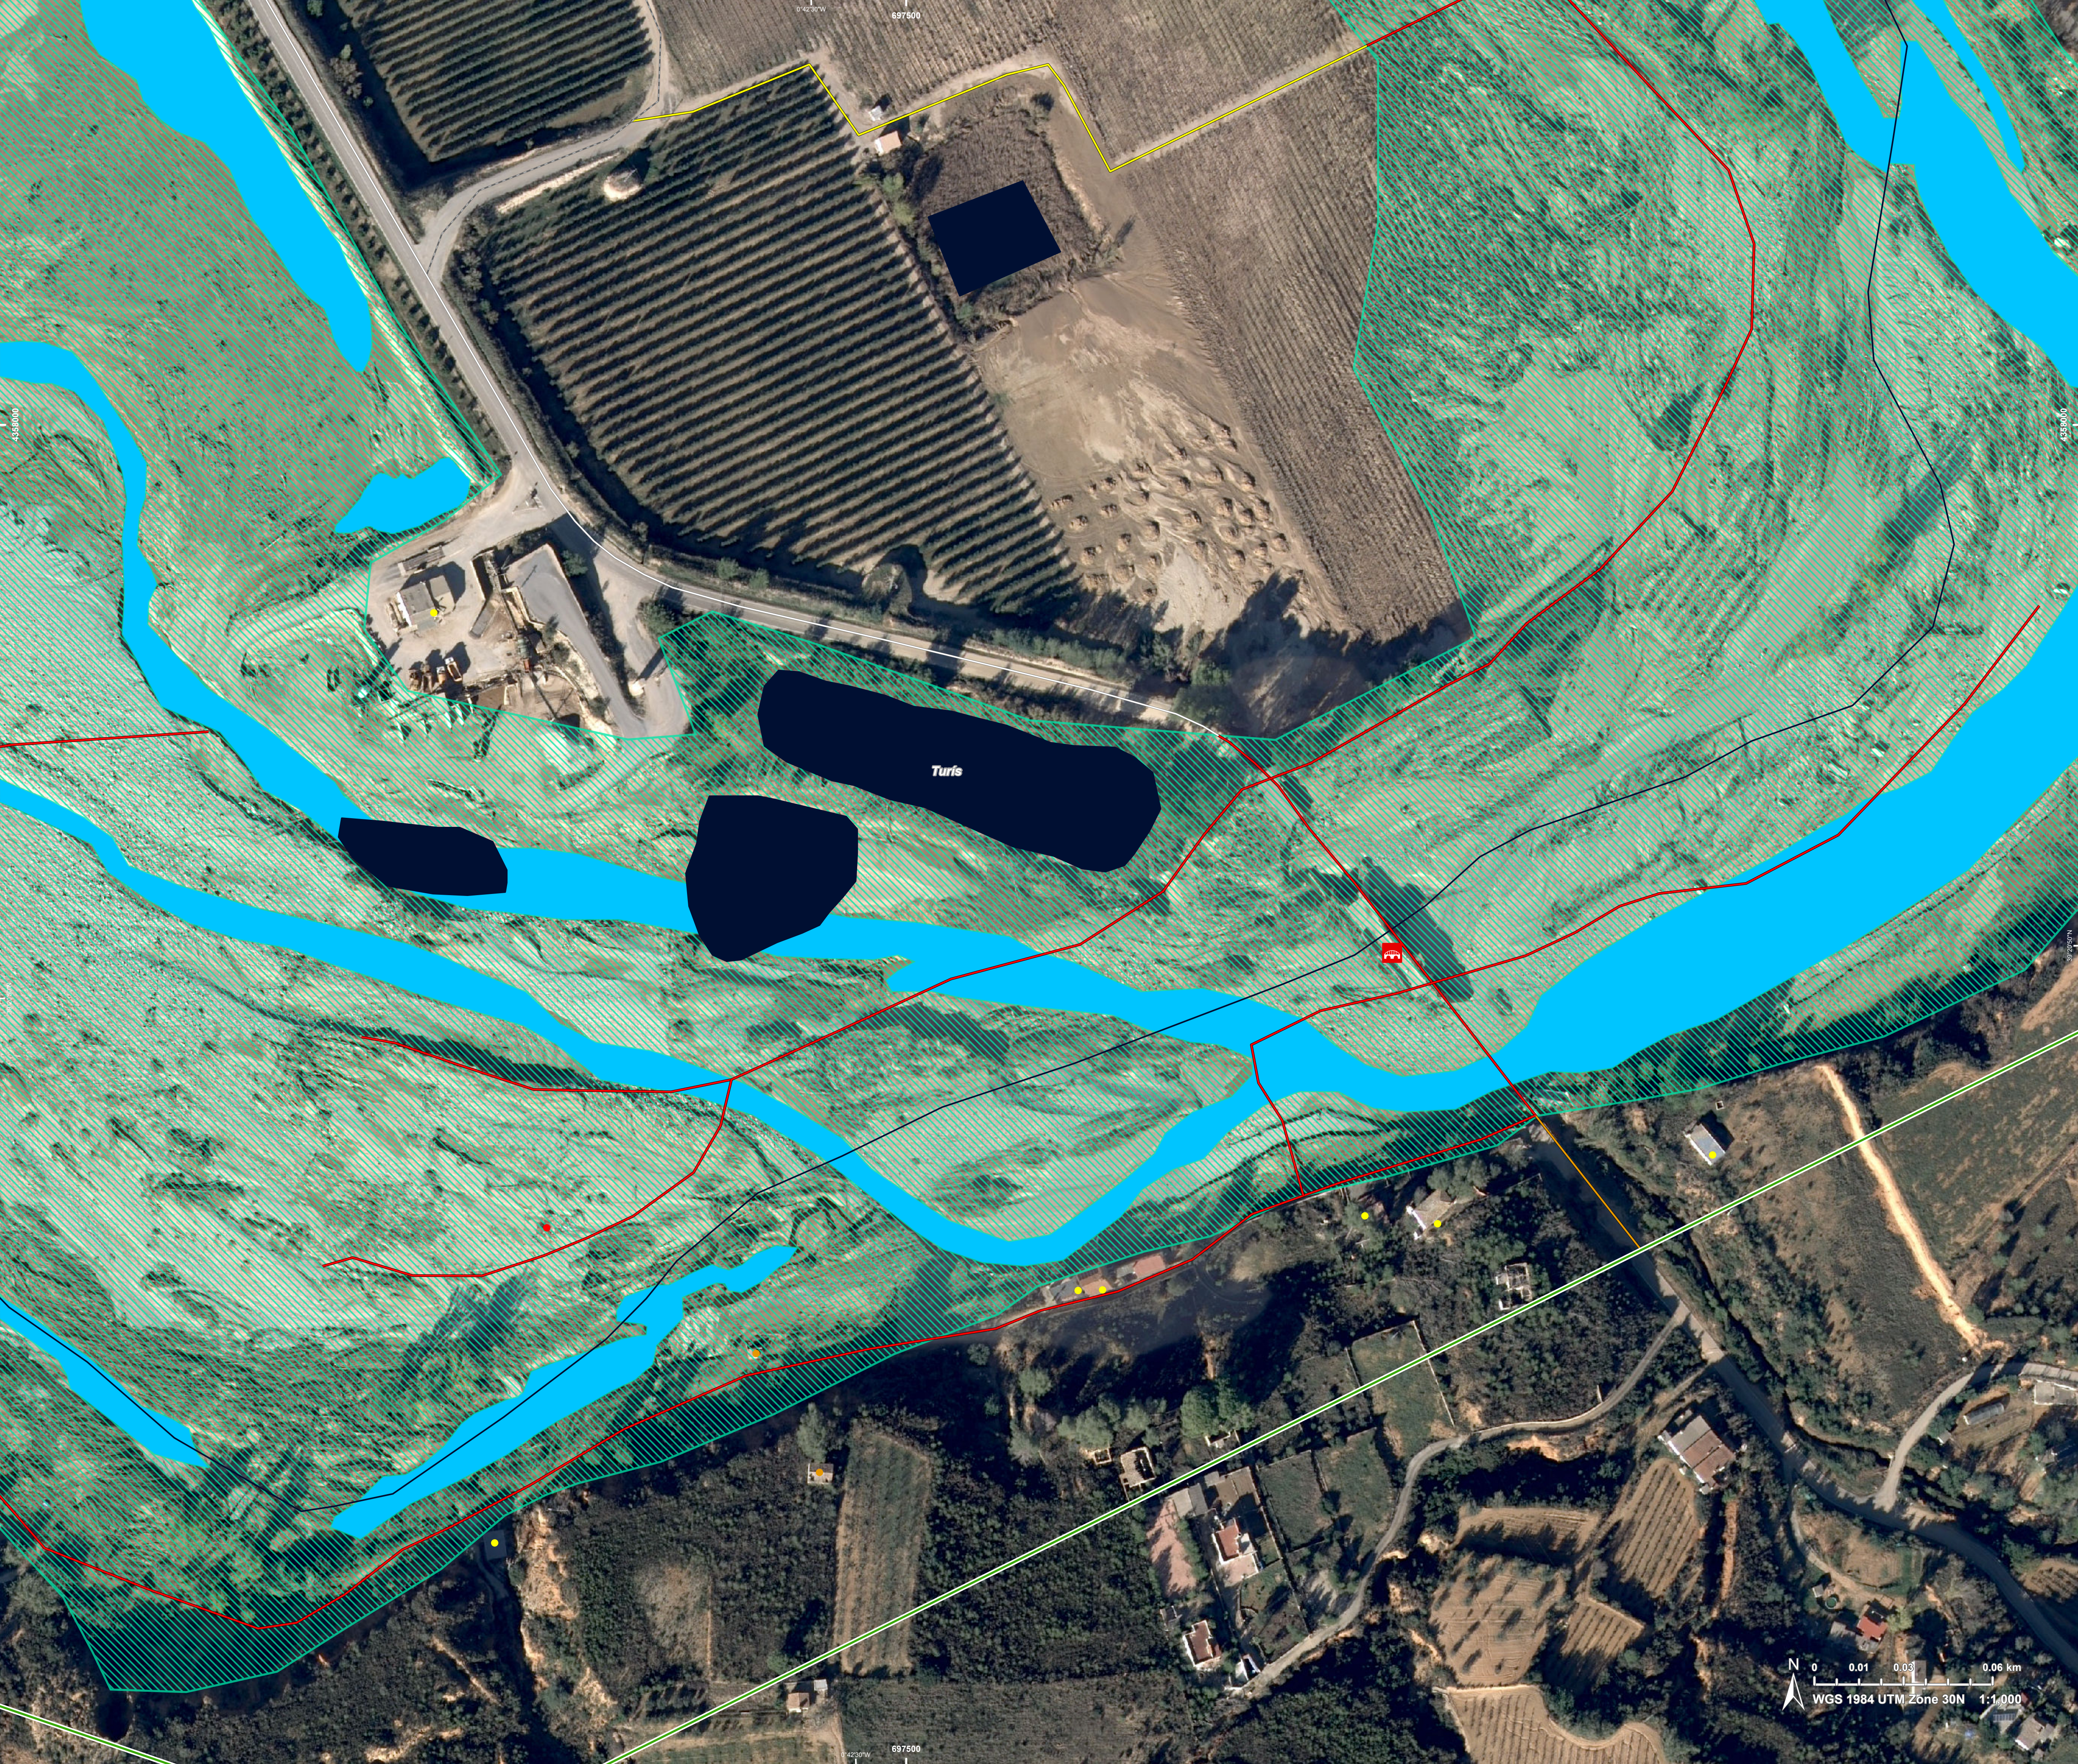
Situation as of 11/11/2024 13:00 UTC
Grading - Detail map 04

- Destroyed
- Damaged
- Possibly damaged

- Bridge and elevated highway, Destroyed
- Road, Destroyed
- Road, Damaged
- Road, Possibly damaged

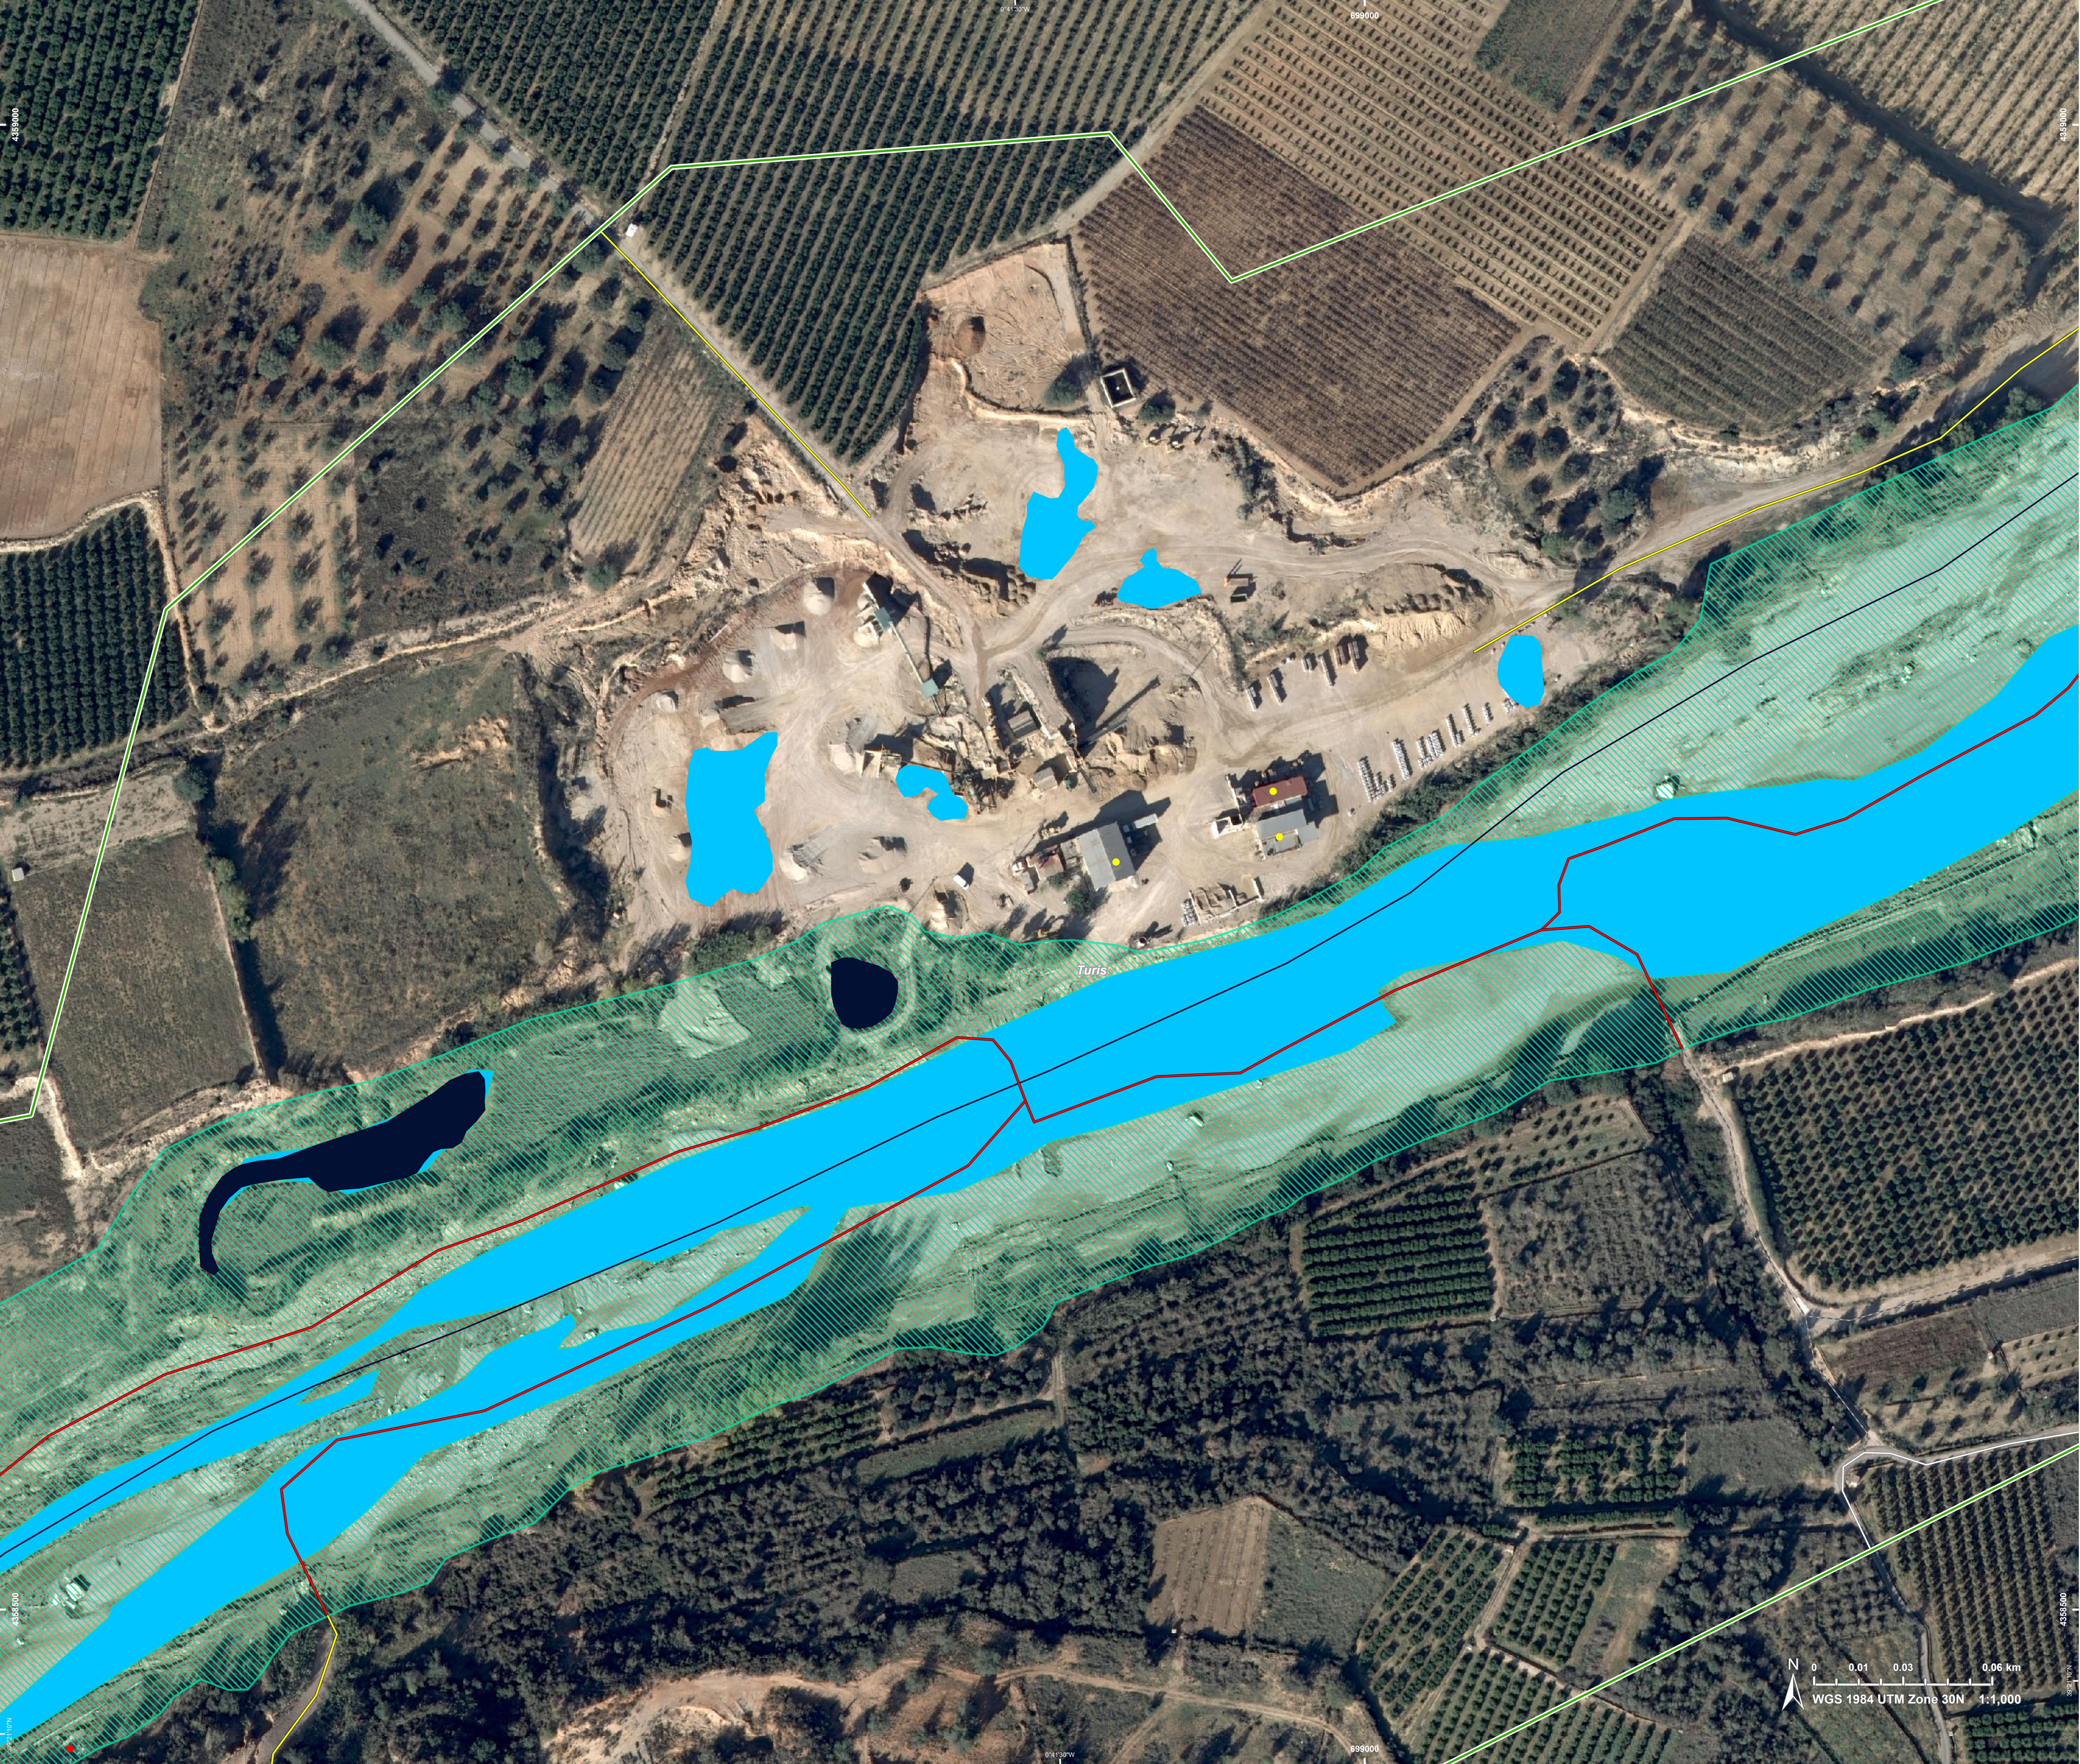
Situation as of 11/11/2024 13:00 UTC
Grading - Detail map 06

Possibly damaged

Road, Destroyed
-

Road, Damaged
-

Road, Possibly damaged
-
