**EMSR773 - AOI36**
Flood in Spain
PATERNA

Situation as of 18/11/2024 12:16 UTC
Grading - Overview map 01

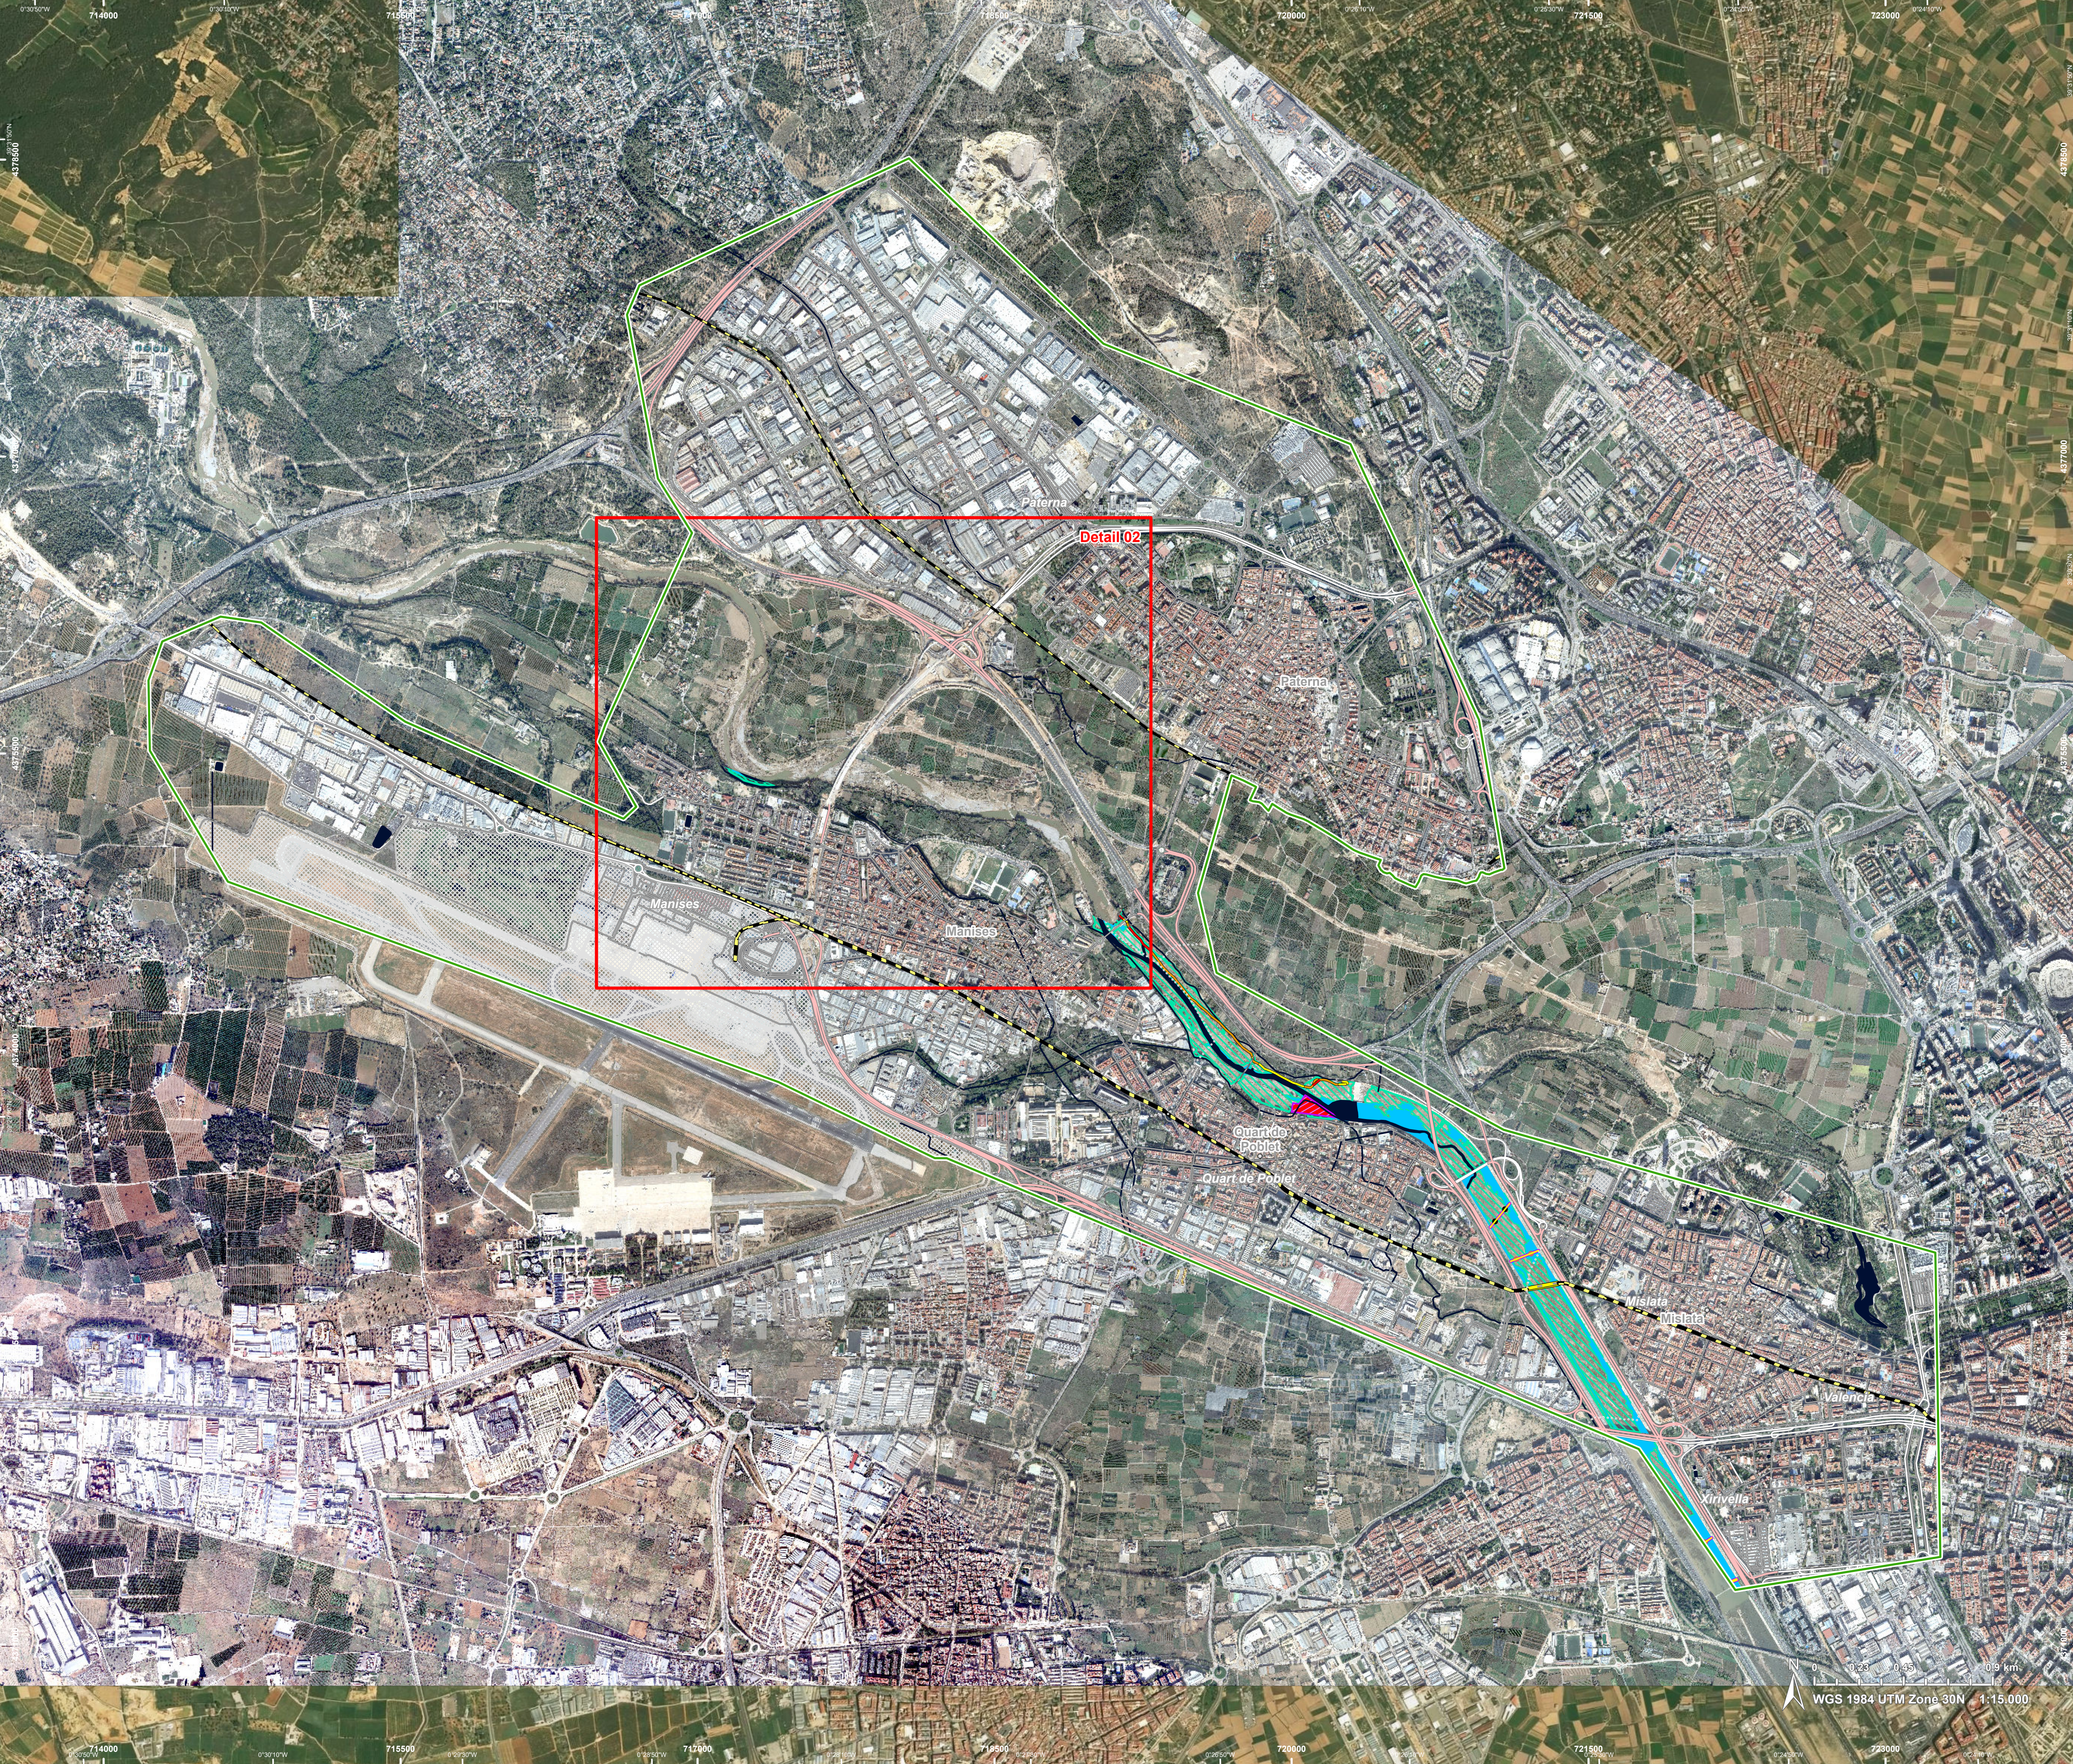
**Flooded area 13.4 ha**
Flood trace 44.6 ha

**Potentially affected population ~ 300**

**Road**
4.7 km
