EMSR845 - AOI02
Flood in Mexico
CAZONES DE HERRERA

Situation as of 18/10/2025 17:04 UTC

Grading - Detail map 02

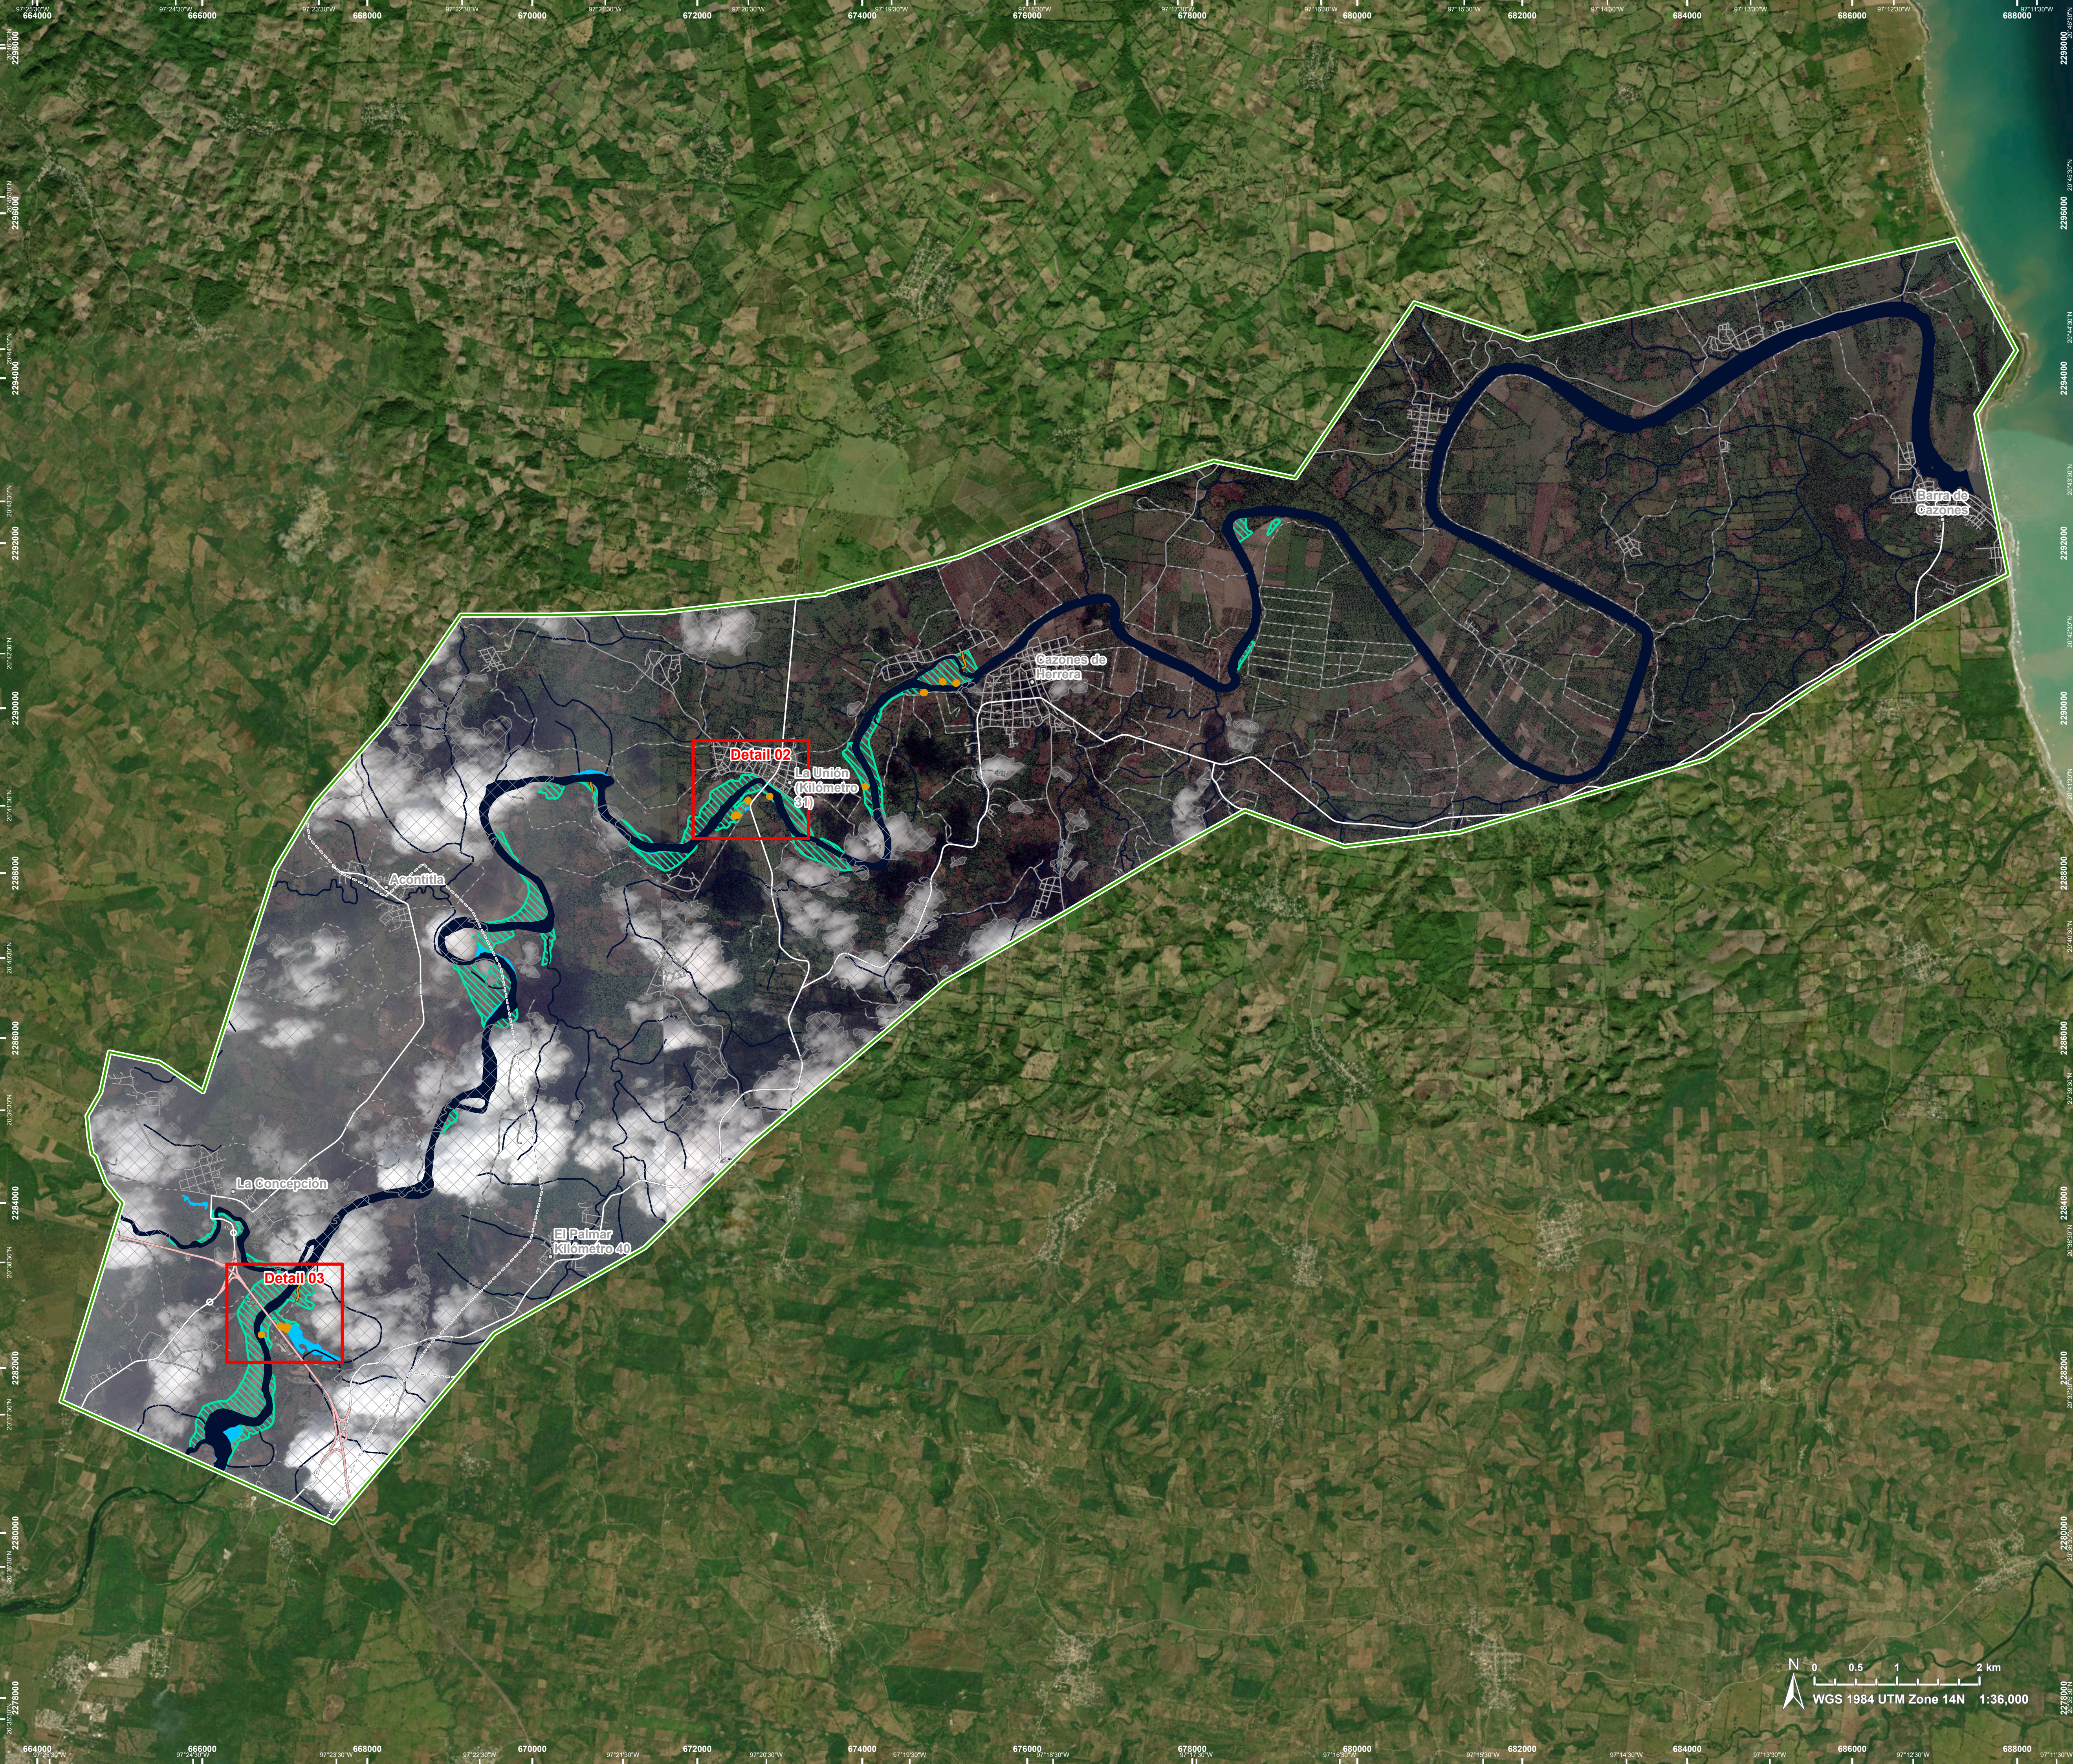
Flooded area 20.8 ha
Flood trace 260.7 ha
  Potentially affected population ~ 80

Affected Built-up and Transportations

Built-Up 18 No.

Road 0.7 km

Event: On the 11 October 2025, heavy rains are reported to have affected multiple states across Mexico, leading to a major humanitarian crisis. The event is on-going and increasing with severe flooding and landslides; according to media tens of thousands of houses have been flooded or damaged by mud and debris. Copernicus EMS Rapid Mapping was requested to provide flood extent and damage assessment emergency mapping.

The thematic layer has been derived from post-event satellite image by means of visual interpretation.

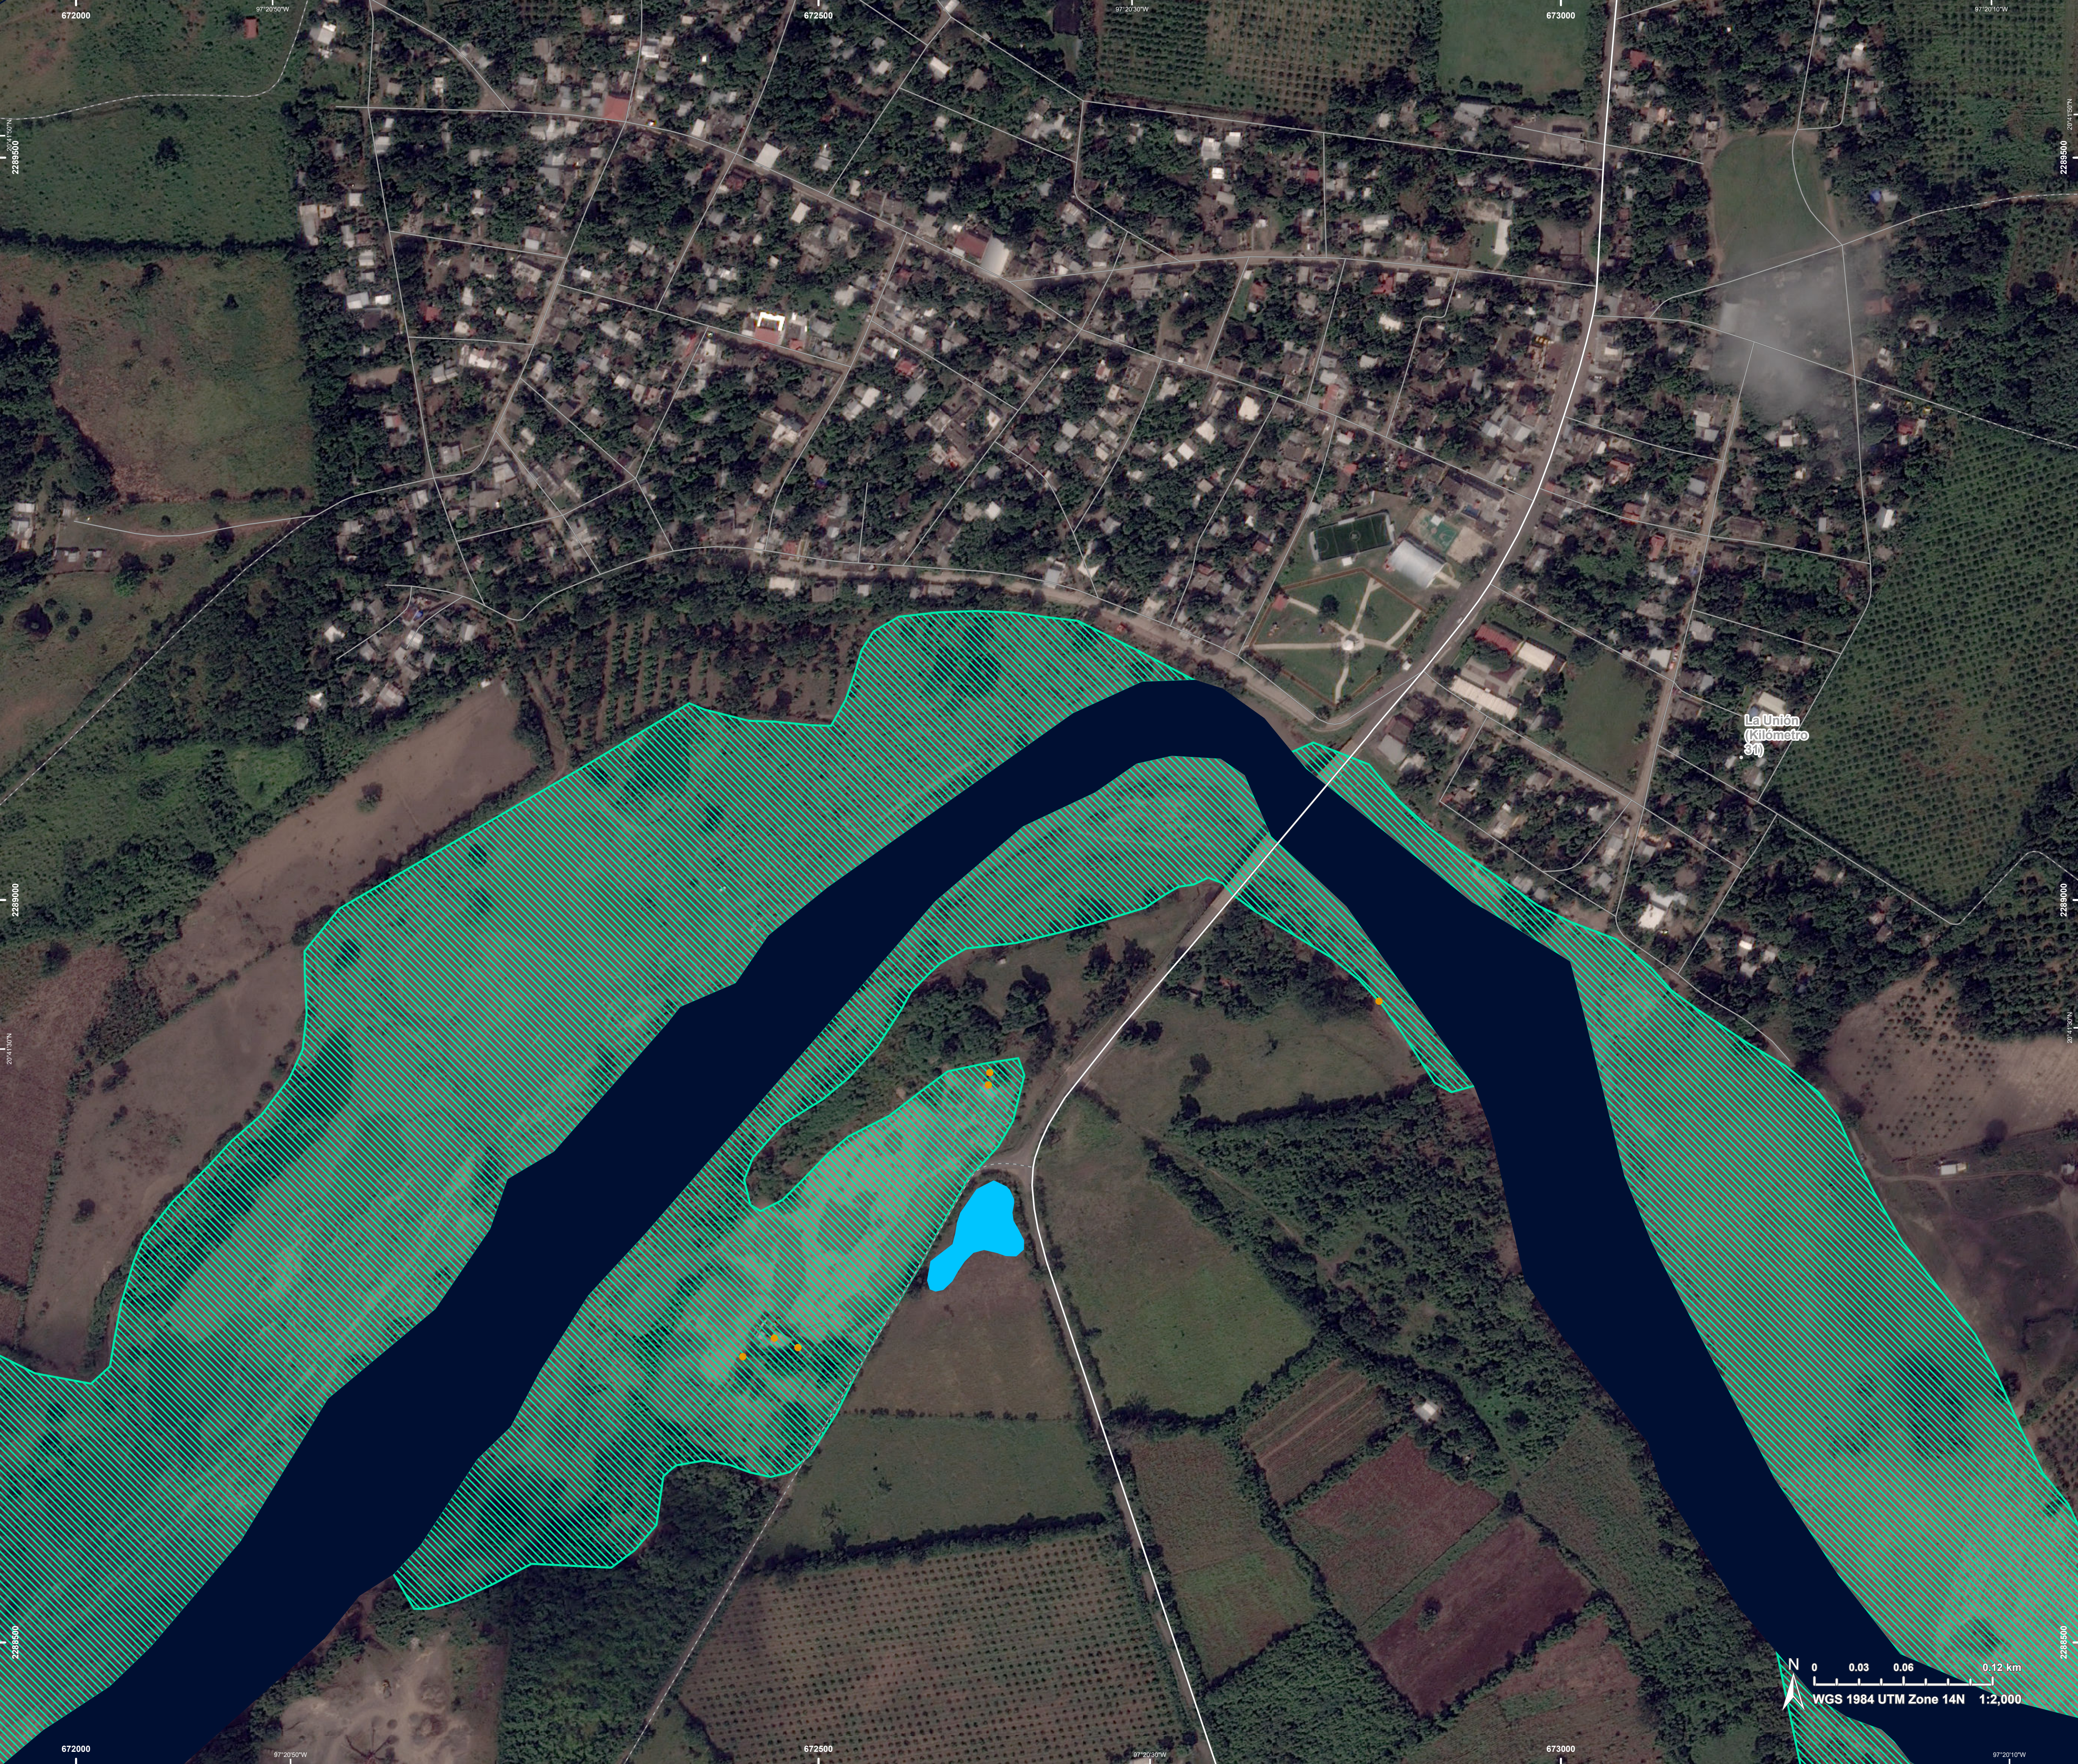
Event: On the 11 October 2025, heavy rains are reported to have affected multiple states across Mexico, leading to a major humanitarian crisis. The event is on-going and increasing with severe flooding and landslides; according to media tens of thousands of houses have been flooded or damaged by mud and debris. Copernicus EMS Rapid Mapping was requested to provide flood extent and damage assessment emergency mapping.

The thematic layer has been derived from post-event satellite image by means of visual interpretation.

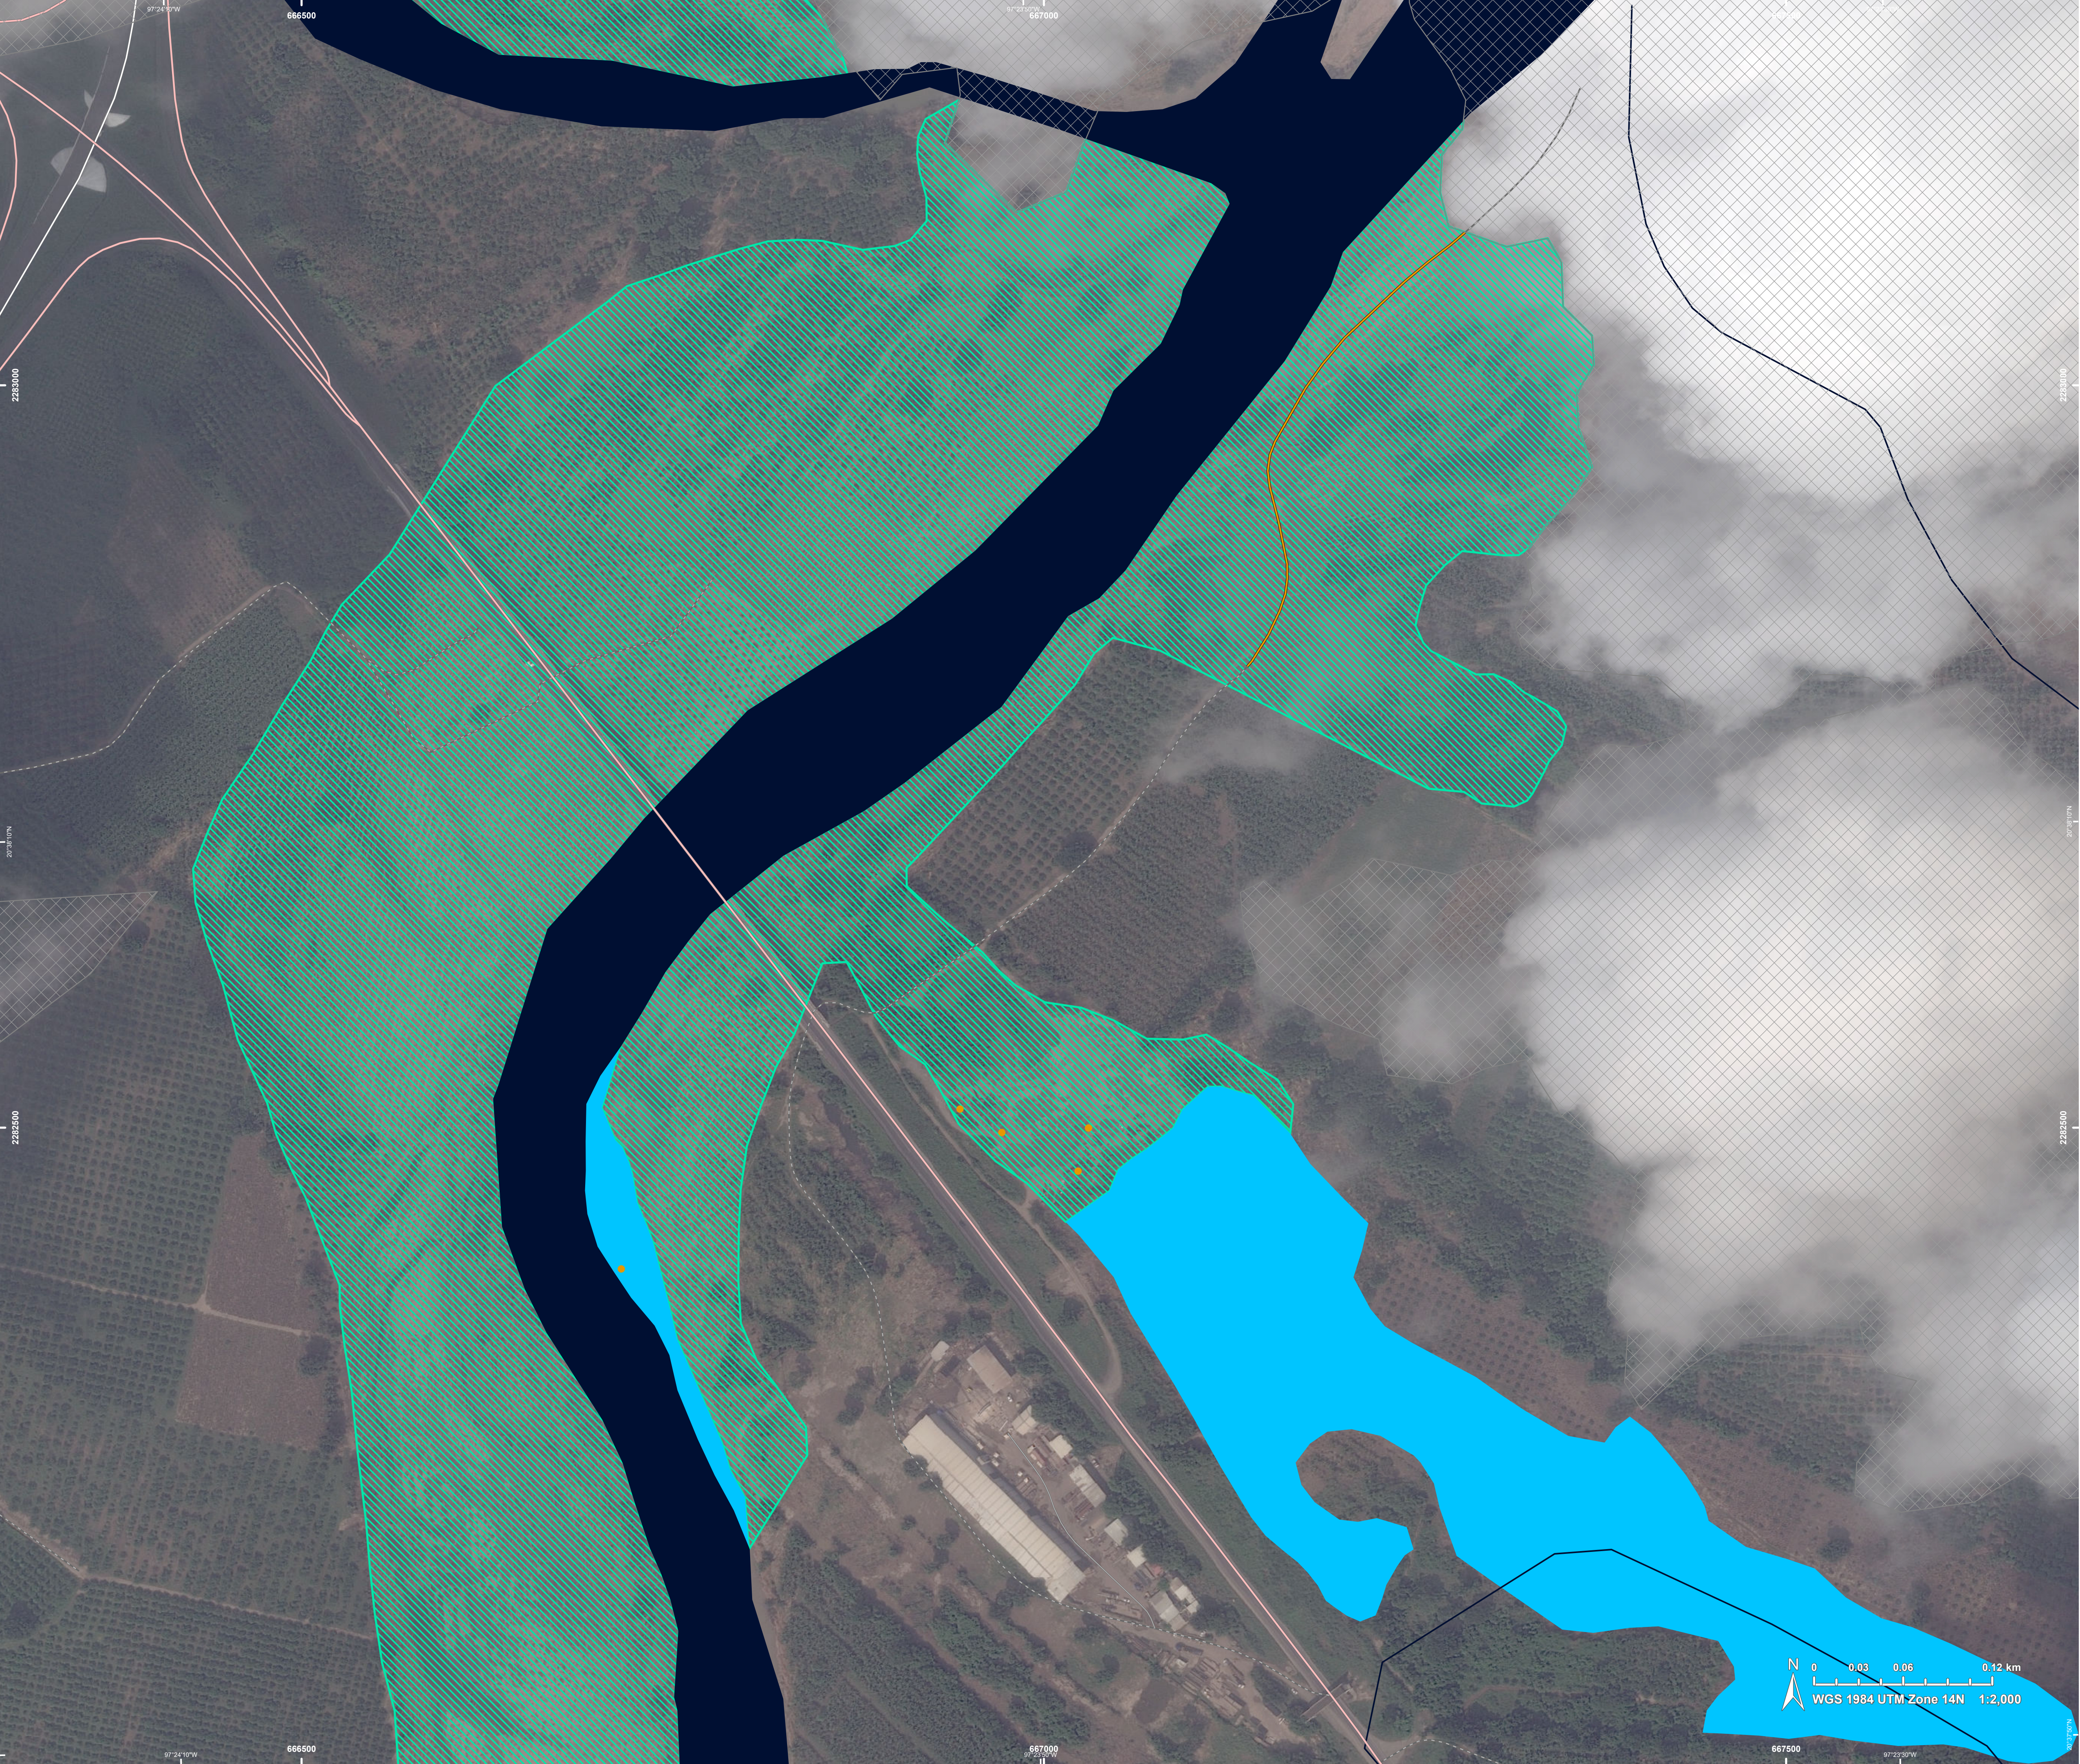
Consequences within the AOI

LATEST IMPACT	
			Unit of measurement	EO-based observation*
Crisis information	Flood trace		ha	260.7
	Flooded area		ha	20.8
	Maximum of all extents**		ha	281.5

Destroyed	Damaged	Possibly damaged***	Total affected****	Total in AOI
Estimated population		Inhabitants	No.				~ 80	~ 20,000
Assets	Built-up	Residential Buildings	No.	0	9	0	9	14,555
		Institutional	No.	0	0	0	0	1
		Industrial buildings	No.	0	9	0	9	153
		School, university and research buildings	No.	0	0	0	0	3
		Unclassified	No.	0	0	0	0	2
	Transportation	Highways	km	0	0	0	0	8.4
		Primary Road	km	0	0	0	0	1.0
		Secondary Road	km	0	0	0	0	44.3
		Local Road	km	0	0	0	0	125.8
		Cart Track	km	0	0.7	0	0.7	196.5
	Facilities	Sport and recreation constructions	ha	0	0	0	0	0.3
		Long-distance pipelines, communication and electricity lines	km	0	0	0	0	4.8
	Land use	Heterogeneous agricultural areas	ha	0	0	0	41.6	2,112.9
		Forests	ha	0	0	0	187.7	9,774.9
		Shrub and/or herbaceous vegetation association	ha	0	0	0	6.0	894.0
		Inland wetlands	ha	0	0	0	18.8	134.1
		Other	ha	0	0	0	27.5	842.5
