Situation as of 20/11/2025 08:16 UTC
Delineation - Overview map 01

Event: During the night of 18-19 November 2025, heavy and moderate rainfall has affected several regions of Albania, causing localized flooding, road blockages, landslides, and power outages. Operational structures at both local and national levels remain engaged in monitoring, clearing works, and response interventions. Given the evolving situation, Copernicus EMS Rapid Mapping is requested to provide flood extent and damage assessment emergency mapping.

Map produced by ITHACA released by SERTIT on the 21/11/2025.

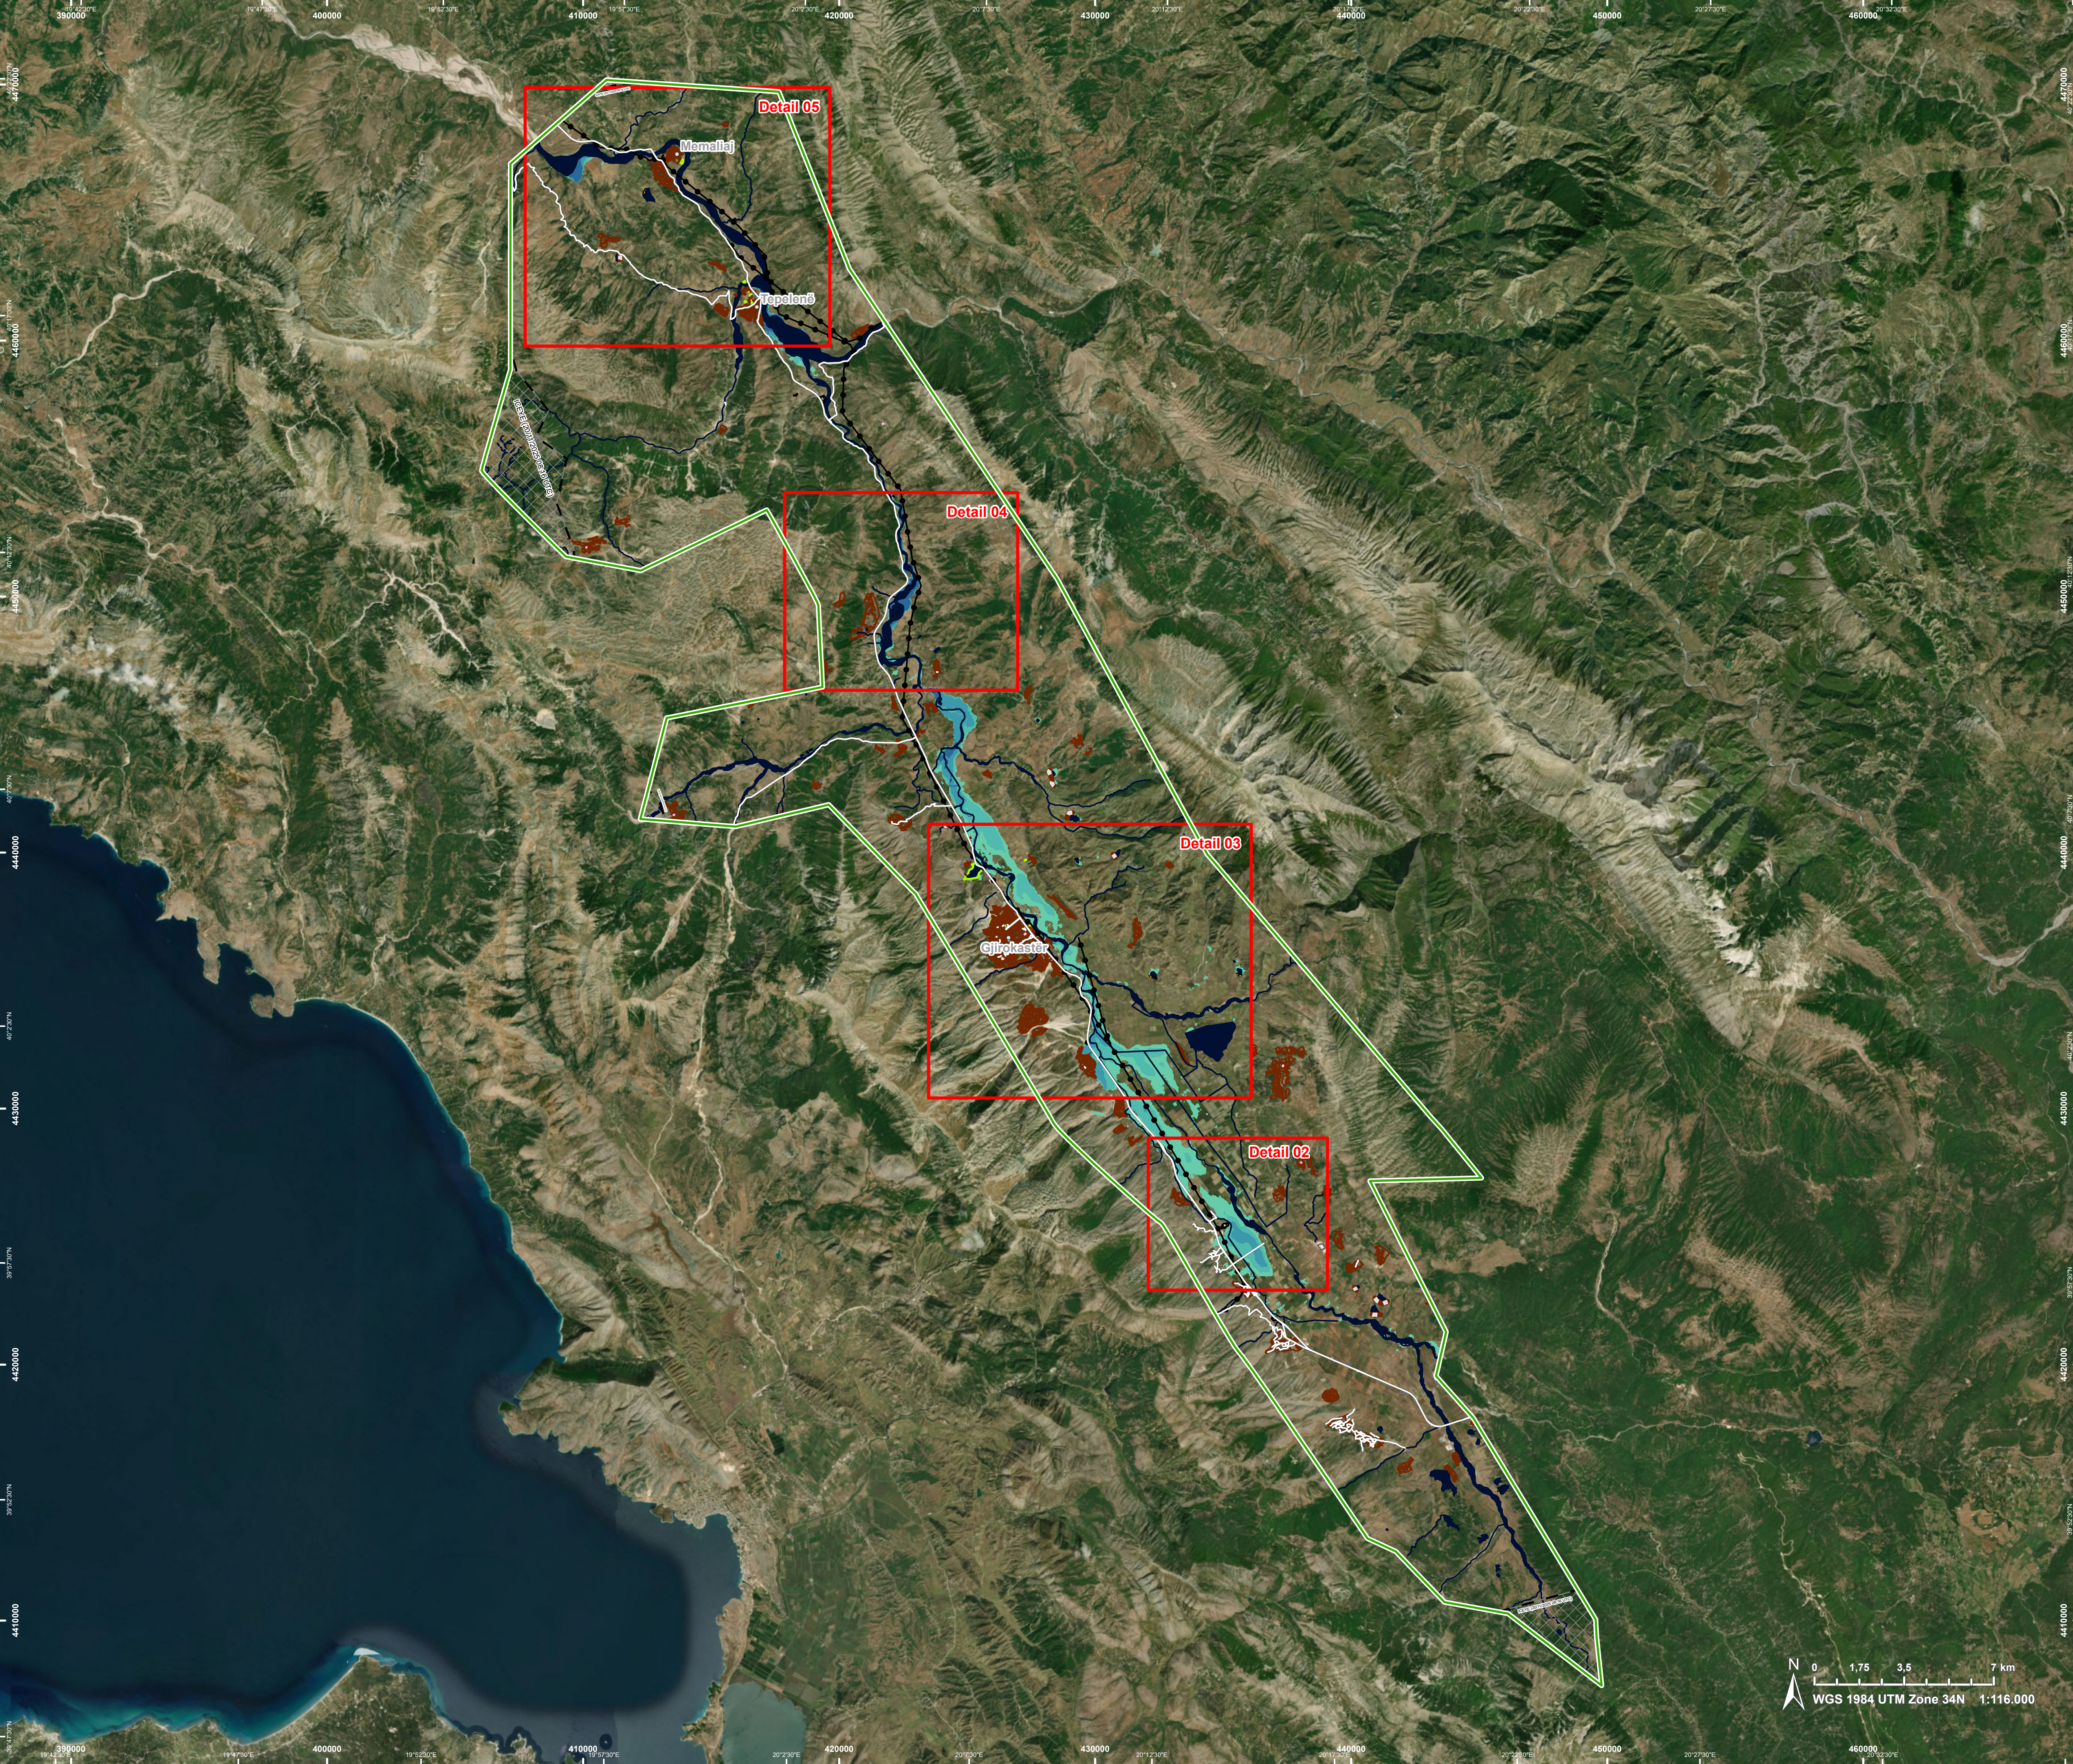
**Flooded area**
EO-based 720.0 ha
Model-based 2,217.7 ha

**Potentially affected population**
~ 320

**Built-Up**
7.0 ha

**Road**
68.2 km

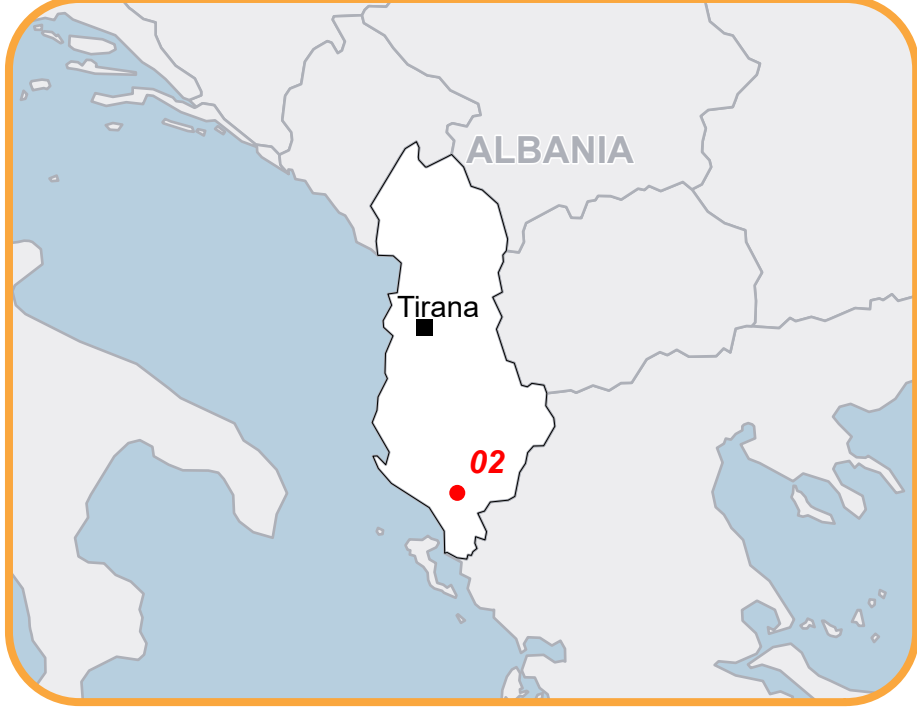
The flooded area corresponds to the water observed in the most recent satellite imagery, excluding the permanent water.
An extrapolated flood extent is generated by integrating observed flood areas with a Digital Terrain Model (DTM). The model's accuracy and spatial coverage depend on DTM resolution and quality, enabling the prediction of potentially flooded areas in regions with limited visibility in imagery, such as urban and forested zones.

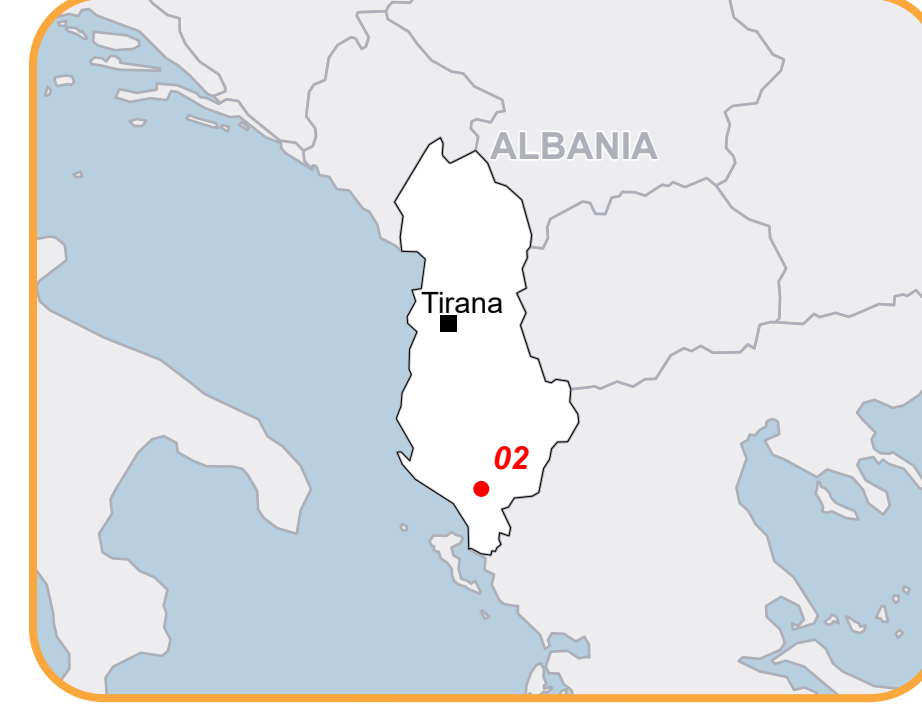
The flooded area corresponds to the water observed in the most recent satellite imagery, excluding the permanent water.
An extrapolated flood extent is generated by integrating observed flood areas with a Digital Terrain Model (DTM). The model's accuracy and spatial coverage depend on DTM resolution and quality, enabling the prediction of potentially flooded areas in regions with limited visibility in imagery, such as urban and forested zones.

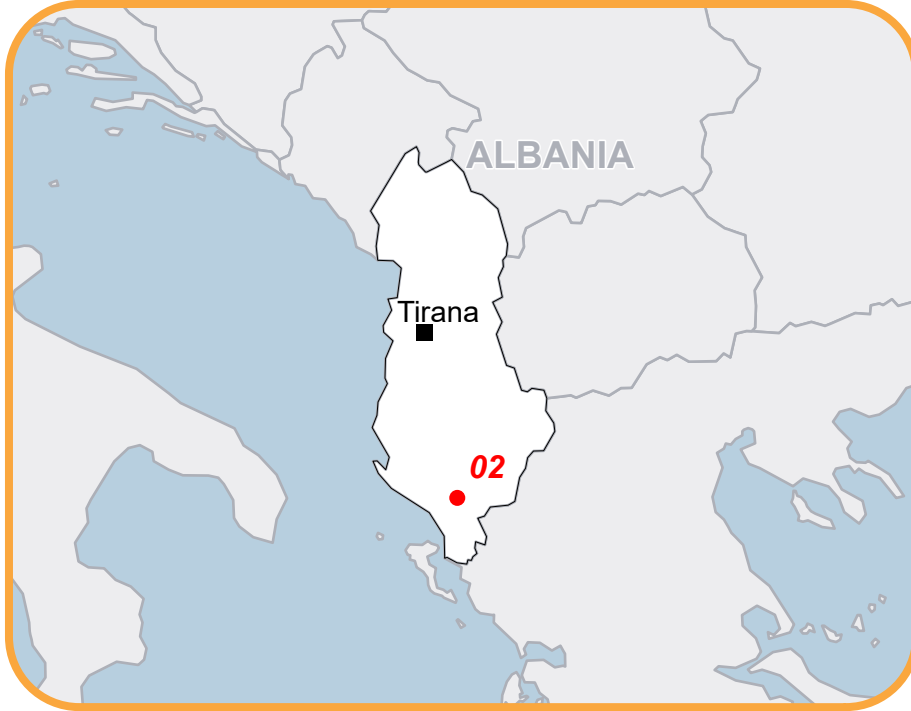
Situation as of 20/11/2025 08:16 UTC
Delineation - Detail map 03

The flooded area corresponds to the water observed in the most recent satellite imagery, excluding the permanent water.
An extrapolated flood extent is generated by integrating observed flood areas with a Digital Terrain Model (DTM). The model's accuracy and spatial coverage depend on DTM resolution and quality, enabling the prediction of potentially flooded areas in regions with limited visibility in imagery, such as urban and forested zones.

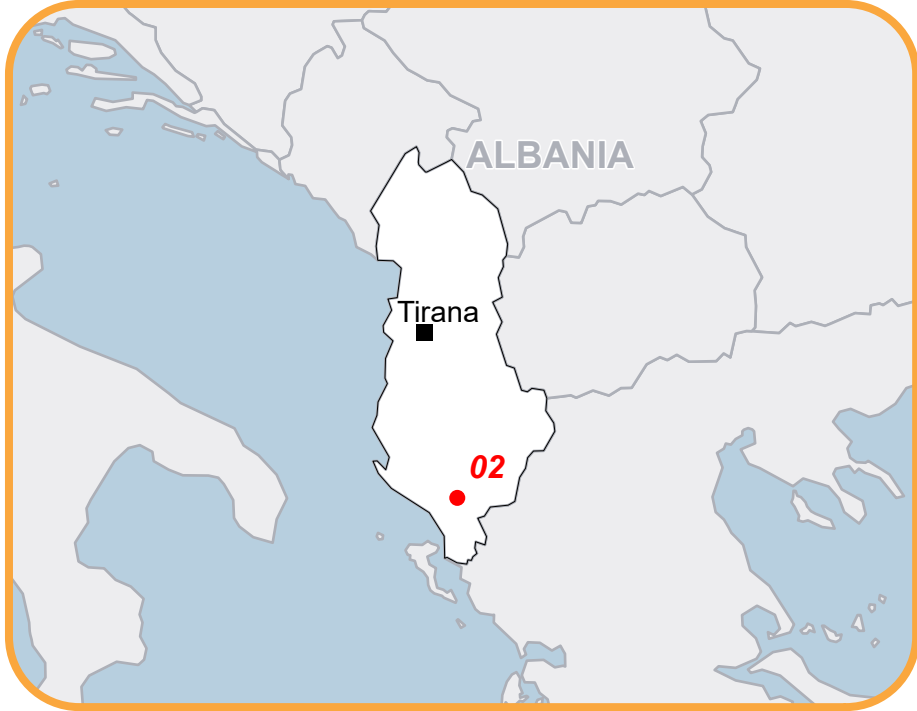
Situation as of 20/11/2025 08:16 UTC
Delineation - Detail map 04

The flooded area corresponds to the water observed in the most recent satellite imagery, excluding the permanent water.
An extrapolated flood extent is generated by integrating observed flood areas with a Digital Terrain Model (DTM). The model's accuracy and spatial coverage depend on DTM resolution and quality, enabling the prediction of potentially flooded areas in regions with limited visibility in imagery, such as urban and forested zones.

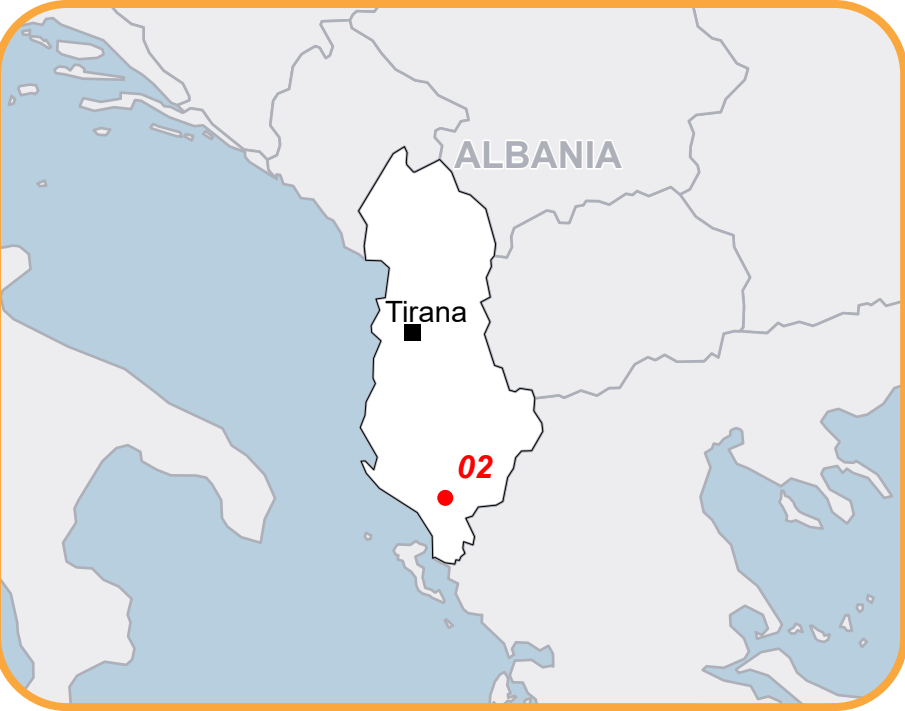
Situation as of 20/11/2025 08:16 UTC
Delineation - Detail map 05

The flooded area corresponds to the water observed in the most recent satellite imagery, excluding the permanent water.
An extrapolated flood extent is generated by integrating observed flood areas with a Digital Terrain Model (DTM). The model's accuracy and spatial coverage depend on DTM resolution and quality, enabling the prediction of potentially flooded areas in regions with limited visibility in imagery, such as urban and forested zones.
