Situation as of 24/11/2025 16:33 UTC  
Delineation - Overview map 01

**Event:** During the night of 18-19 November 2025, heavy and moderate rainfall has affected several regions of Albania, causing localized flooding, road blockages, landslides, and power outages. Operational structures at both local and national levels remain engaged in monitoring, clearing works, and response interventions. Given the evolving situation, Copernicus EMS Rapid Mapping is requested to provide flood extent and damage assessment emergency mapping.

Map produced by ITHACA released by e-GEOS on the 25/11/2025.

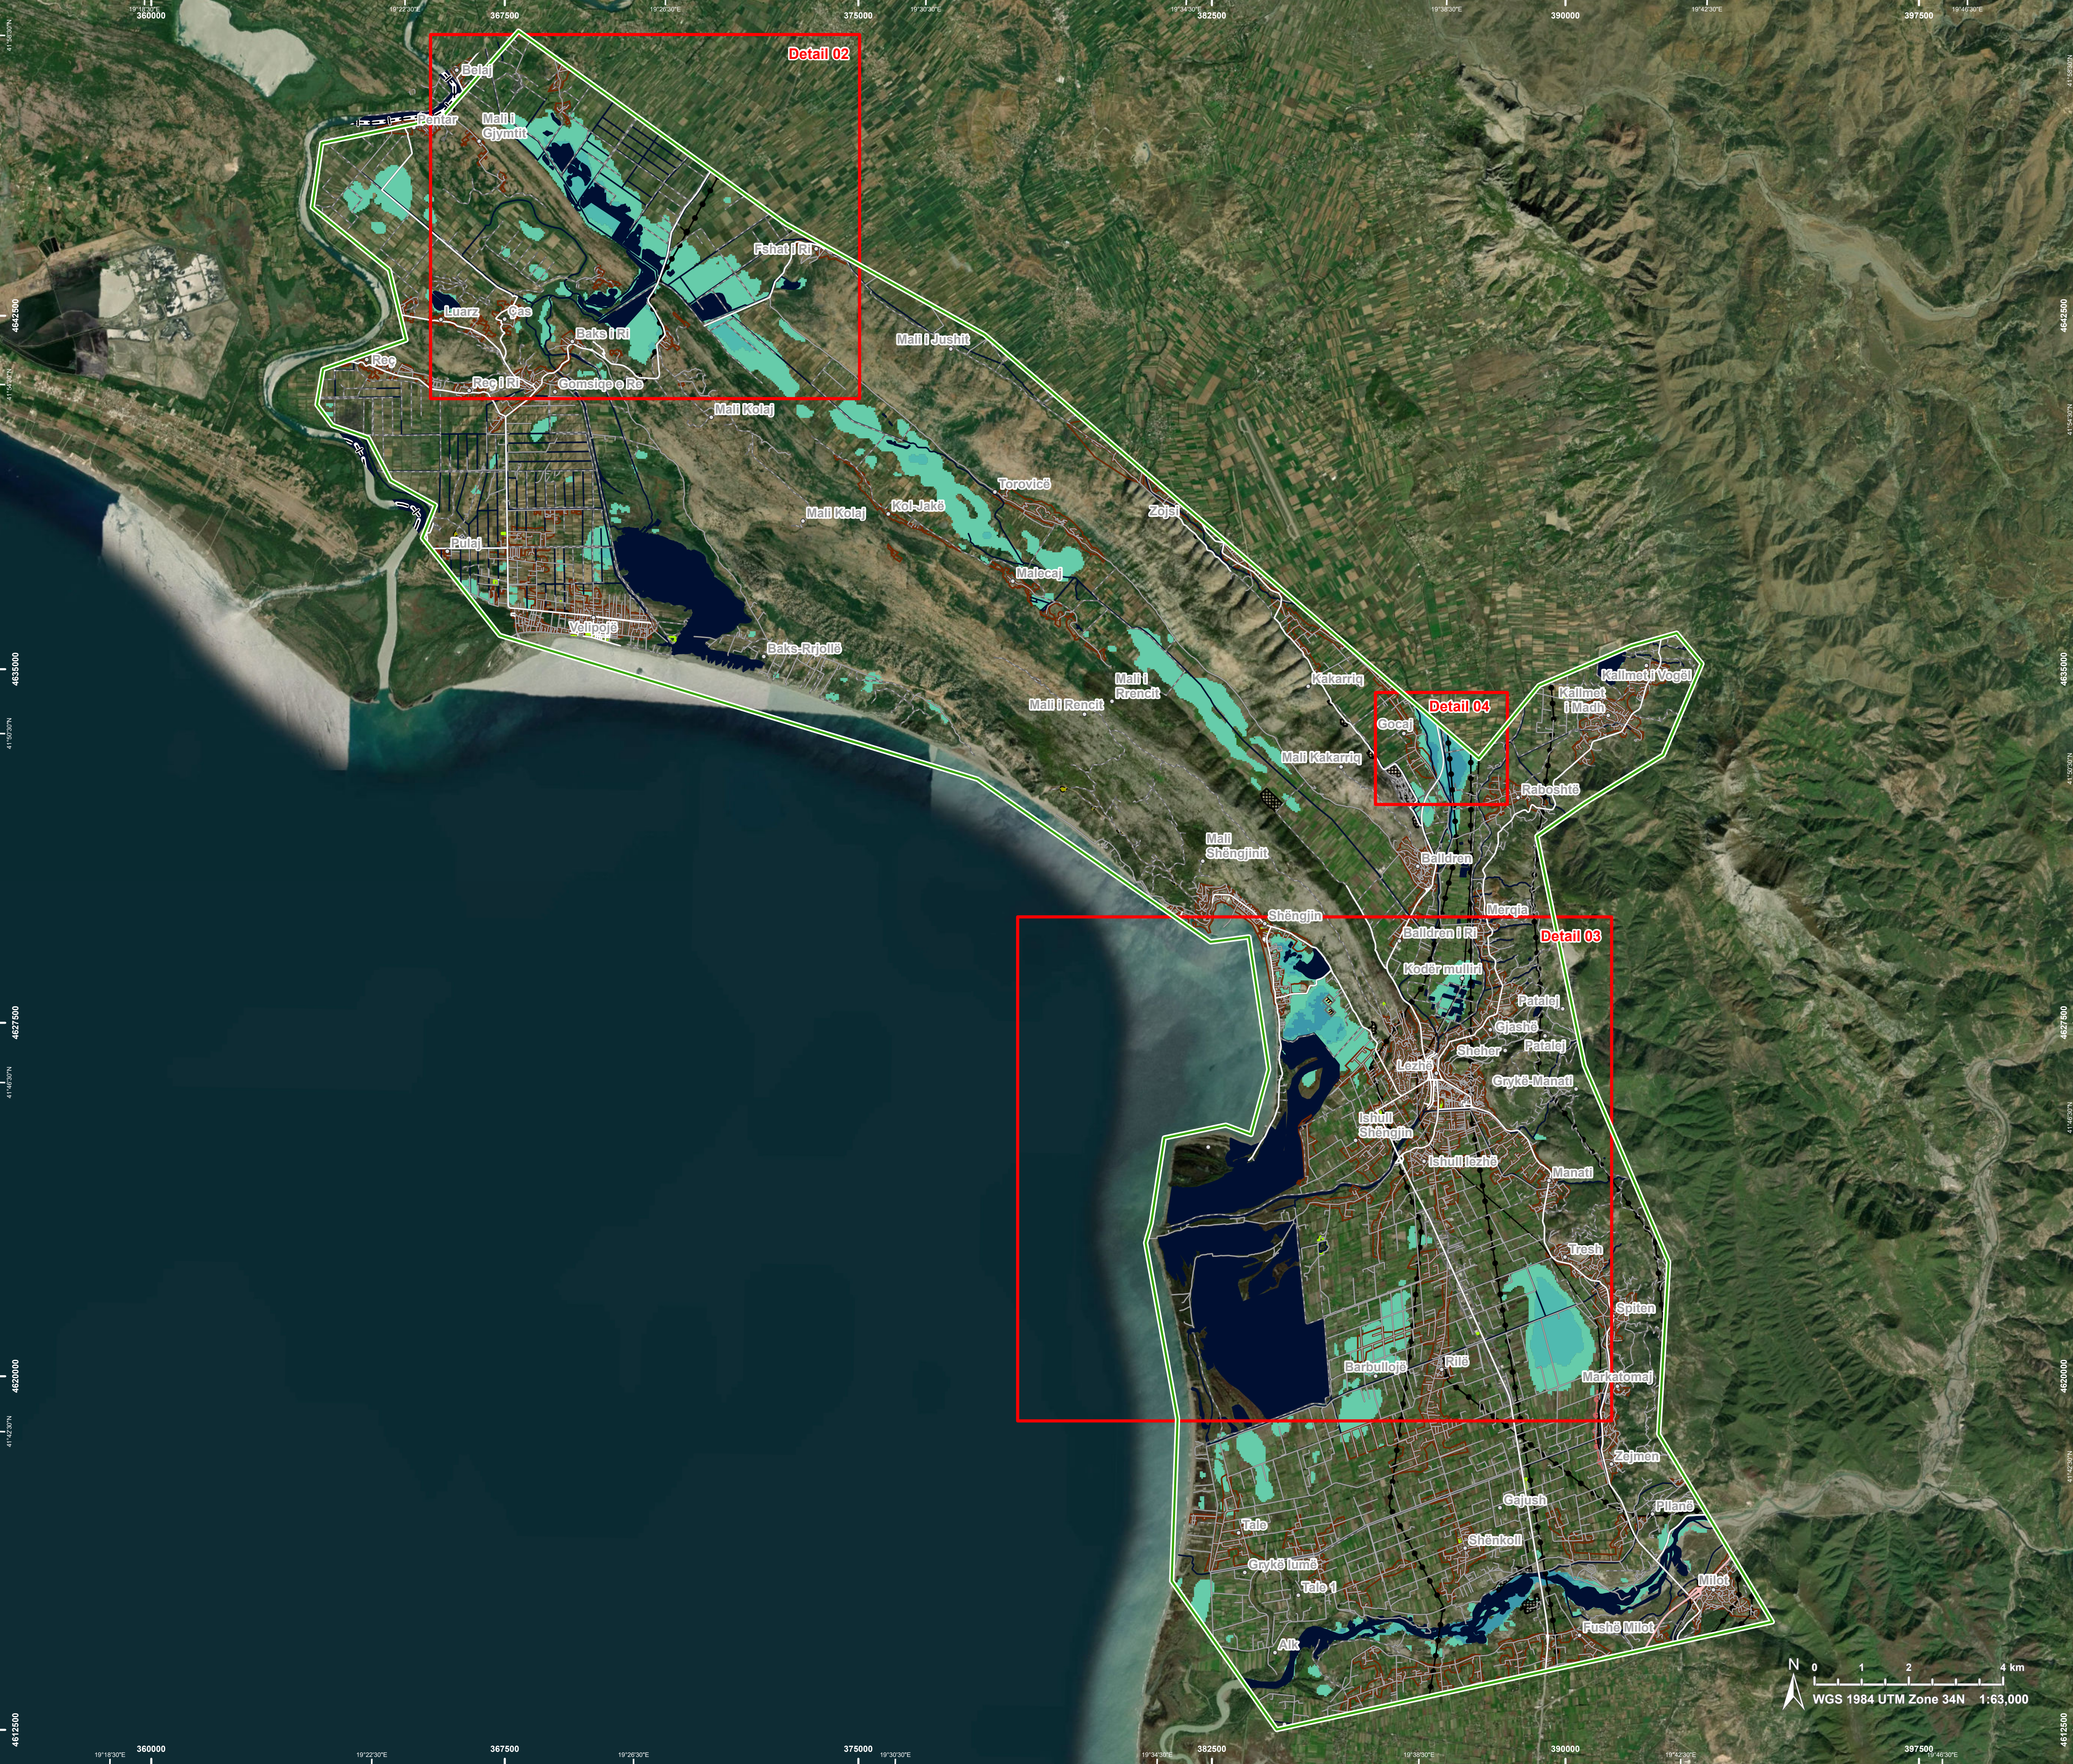
Flooded area  
EO-based 1,177.0 ha  
Model-based 2,007.1 ha

Potentially affected population  
~ 2,050

Railway  
1.3 km

Built-Up  
109.6 ha

Road  
73.6 km

The flooded area corresponds to the water observed in the most recent satellite imagery, excluding the permanent water.  
An extrapolated flood extent is generated by integrating observed flood areas with a Digital Terrain Model (DTM). The model's accuracy and spatial coverage depend on DTM resolution and quality, enabling the prediction of potentially flooded areas in regions with limited visibility in imagery, such as urban and forested zones.

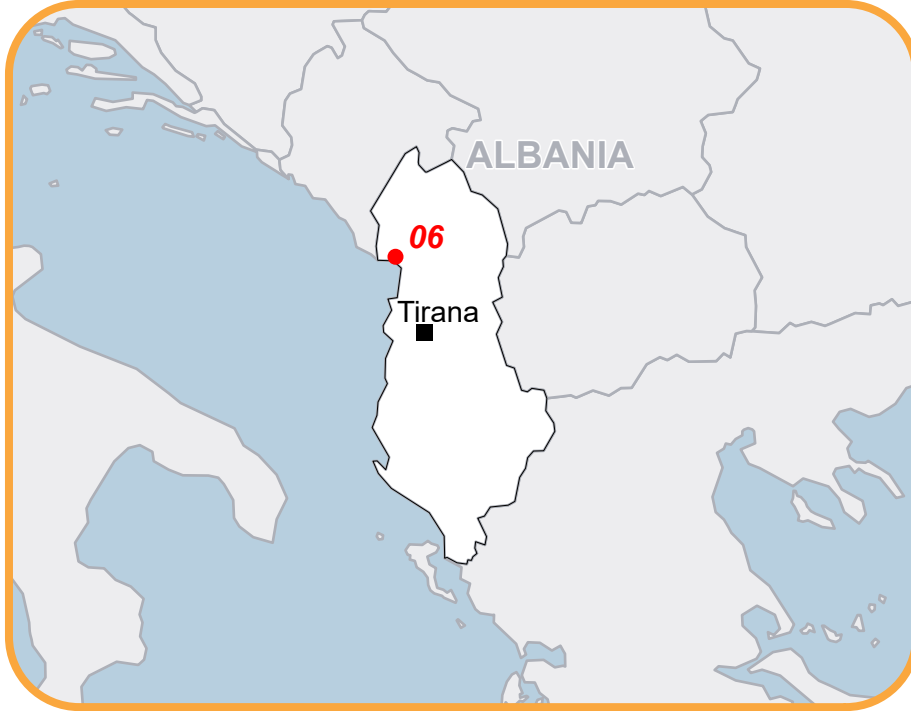
The thematic layer has been derived from post-event satellite image using a semi-automatic approach. Please be aware that the thematic accuracy might be lower in urban and forested areas due to inherent limitations of the SAR analysis technique.

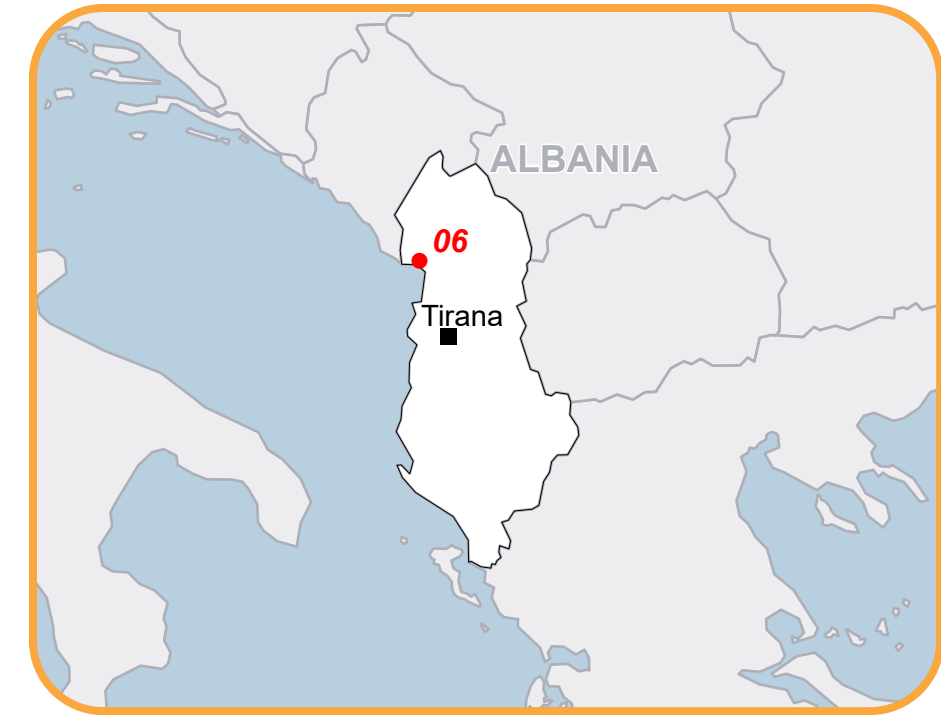
Situation as of 24/11/2025 16:33 UTC  
Delineation - Detail map 02

The flooded area corresponds to the water observed in the most recent satellite imagery, excluding the permanent water.  
An extrapolated flood extent is generated by integrating observed flood areas with a Digital Terrain Model (DTM). The model's accuracy and spatial coverage depend on DTM resolution and quality, enabling the prediction of potentially flooded areas in regions with limited visibility in imagery, such as urban and forested zones.

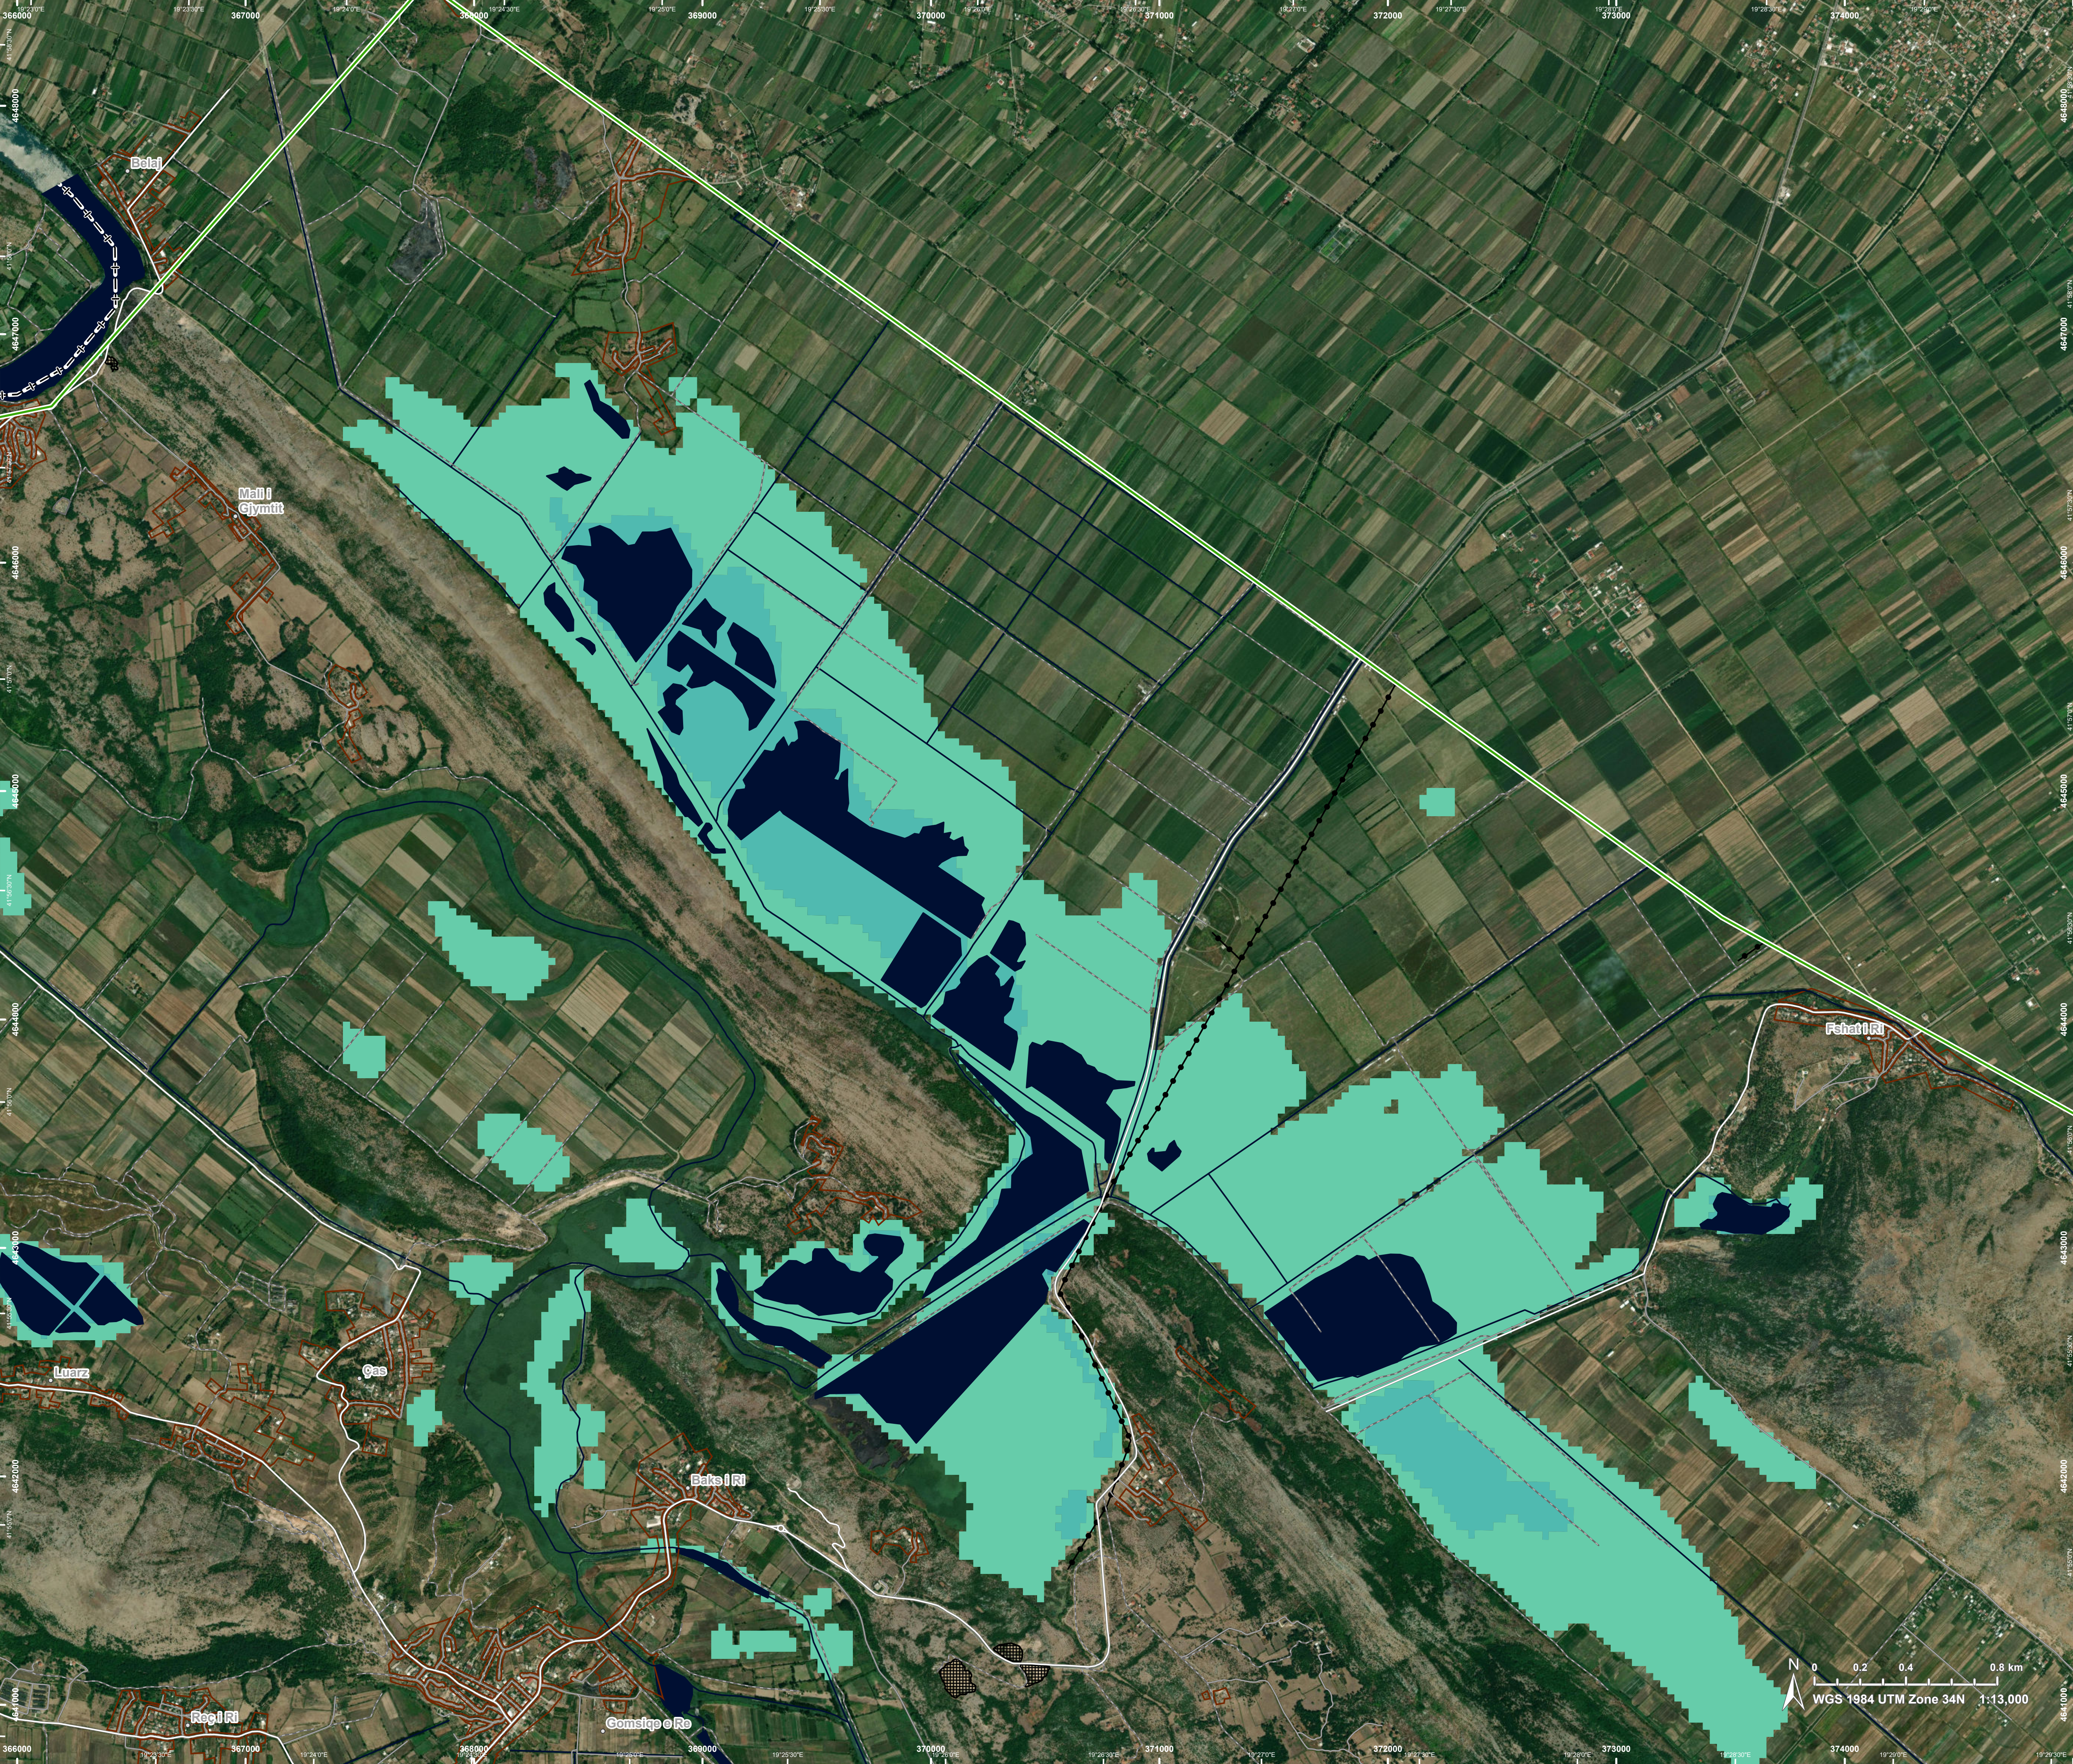
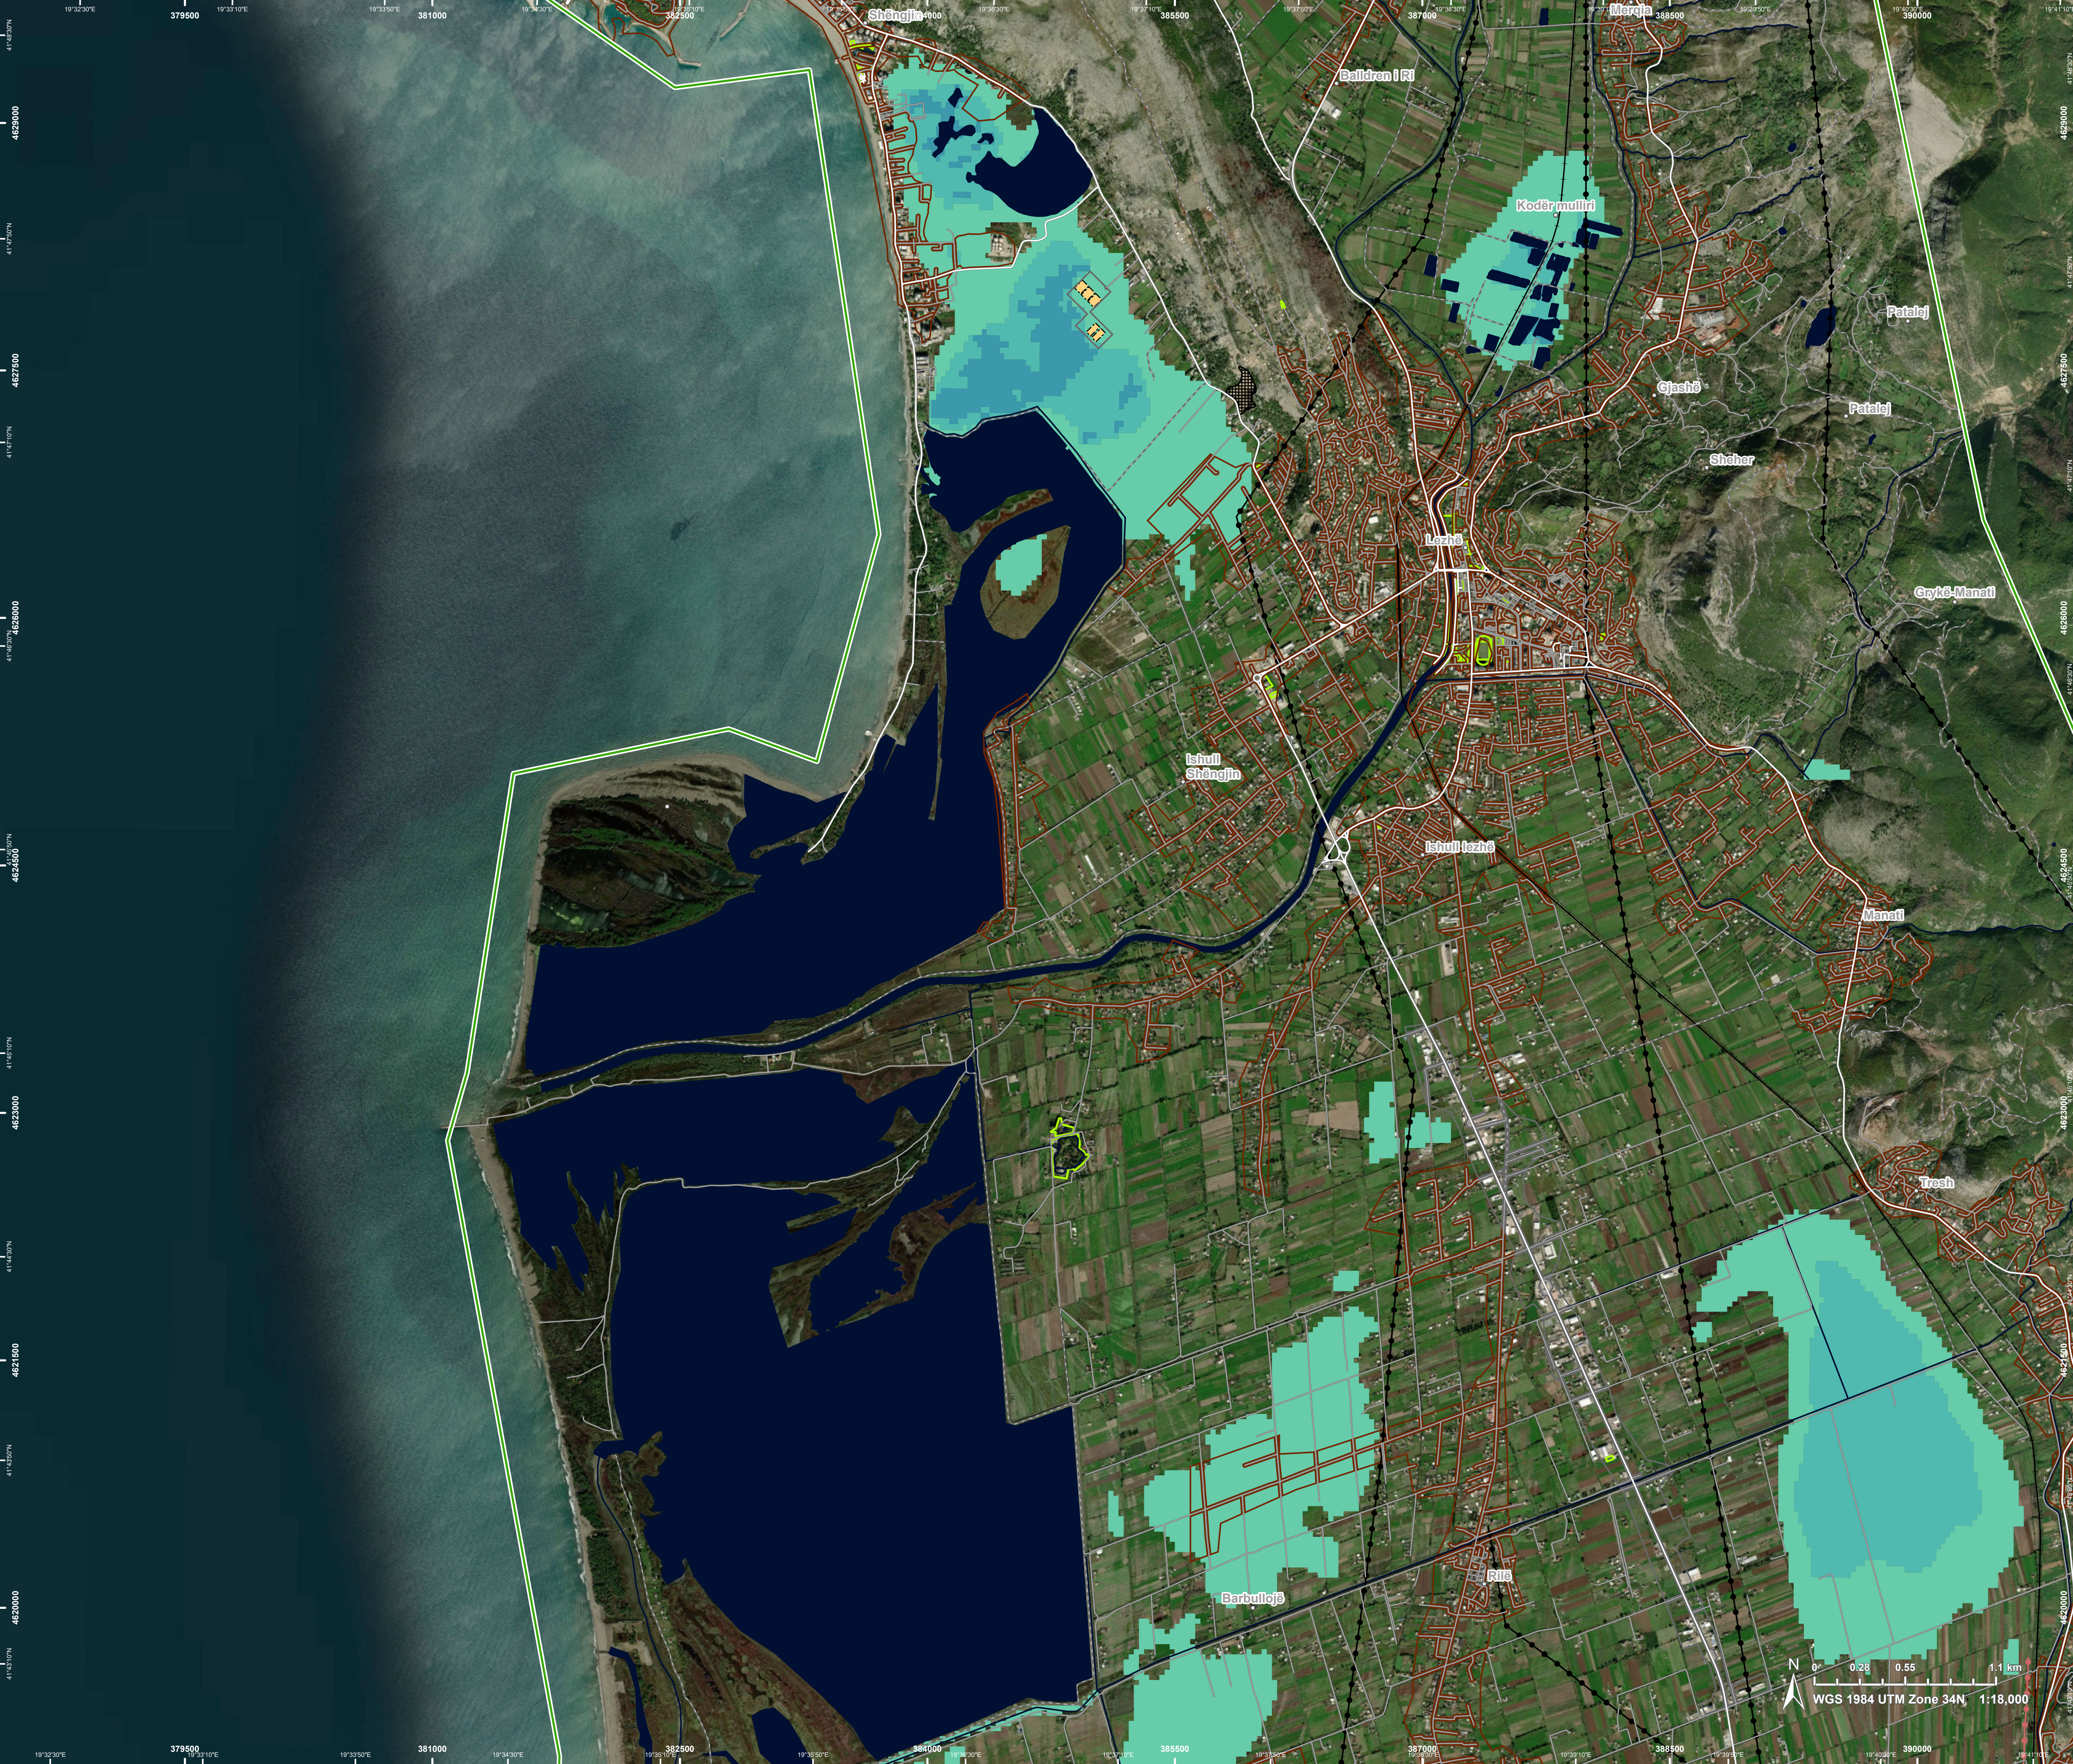
Situation as of 24/11/2025 16:33 UTC  
Delineation - Detail map 03

The flooded area corresponds to the water observed in the most recent satellite imagery, excluding the permanent water.  
An extrapolated flood extent is generated by integrating observed flood areas with a Digital Terrain Model (DTM). The model's accuracy and spatial coverage depend on DTM resolution and quality, enabling the prediction of potentially flooded areas in regions with limited visibility in imagery, such as urban and forested zones.

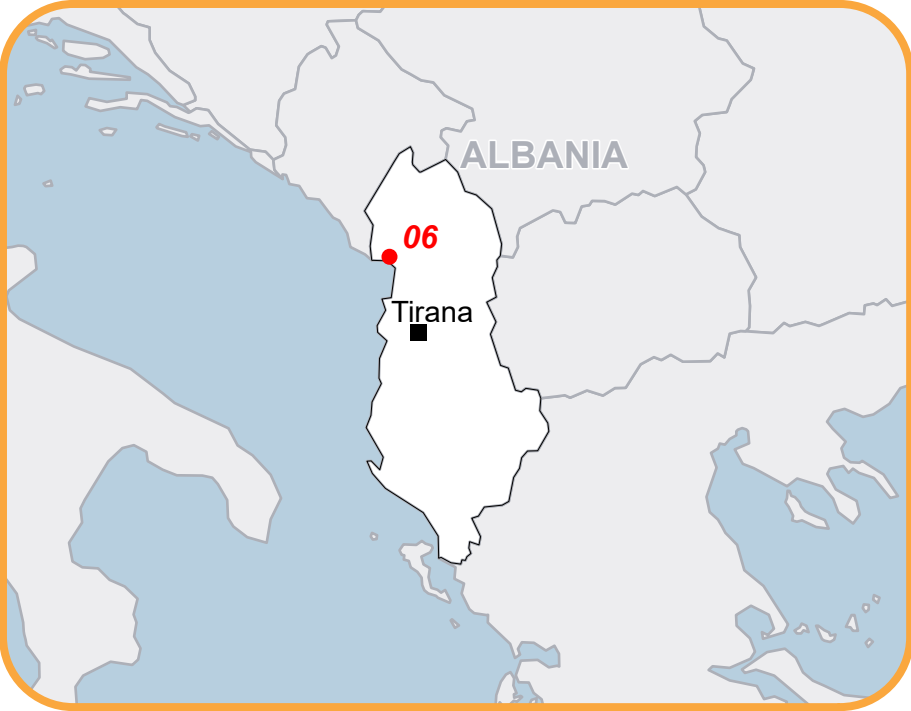
The flooded area corresponds to the water observed in the most recent satellite imagery, excluding the permanent water.  
An extrapolated flood extent is generated by integrating observed flood areas with a Digital Terrain Model (DTM). The model's accuracy and spatial coverage depend on DTM resolution and quality, enabling the prediction of potentially flooded areas in regions with limited visibility in imagery, such as urban and forested zones.
