EMSR851 - AOI20

Flood in Sri Lanka

KALUWA VAADI

Grading - Overview map 01

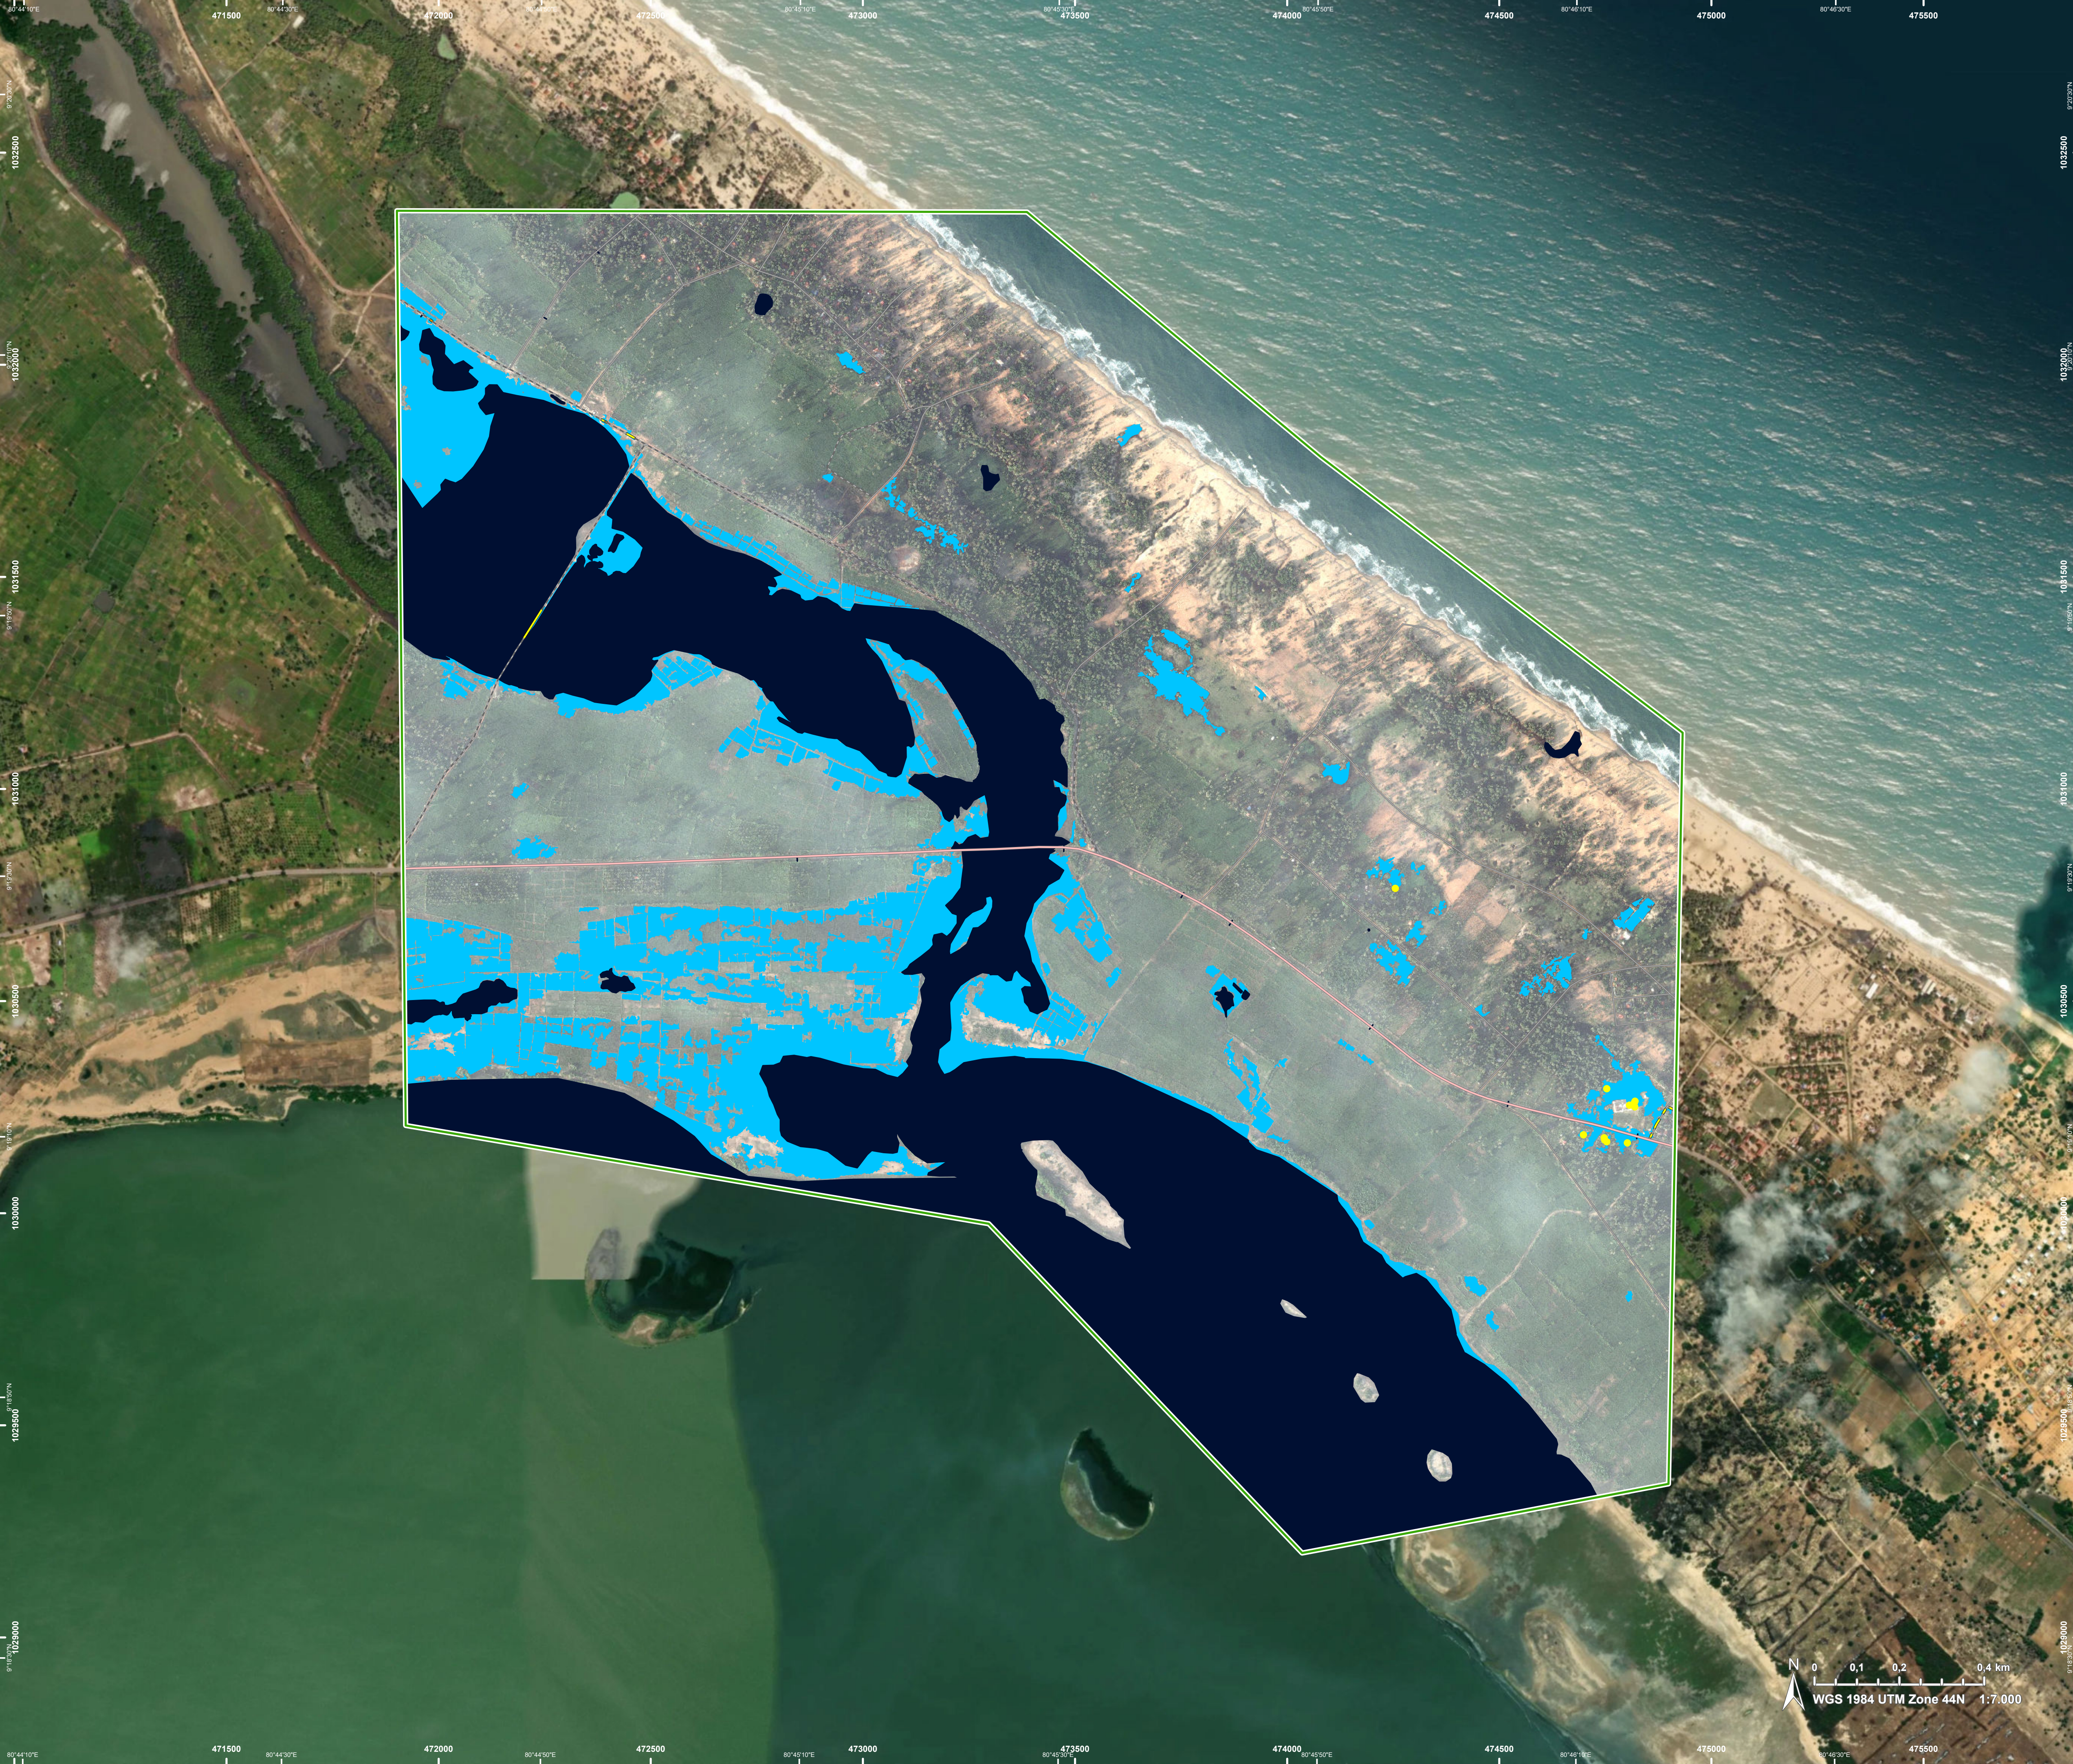
Flooded area

67.6 ha

Road

0.2 km

Built-up

11 No.

Event: On the 27 November 2025, Tropical Cyclone DITWAH-25 formed over Sri Lanka. The event caused heavy damage across the country, with floods, landslides and mudslides reported. Copernicus EMS Rapid Mapping was requested to provide flood extent and damage assessment emergency mapping.

The thematic layer has been derived from post-event satellite image by means of visual interpretation.
