Situation as of 19/12/2025 12:24 UTC
Grading MONIT01 - Overview map 01

Event: On the 14 December 2025, intense rainfall is reported to have a significantly affected provinces of Andrés Ibáñez and Sara, Bolivia. The event caused rivers to overflow. Copernicus EMS Rapid Mapping is requested to provide initial rough estimation, flood extent and damage assessment emergency mapping.

EMSR853 - AOI06
Flood in Bolivia
MONTERO

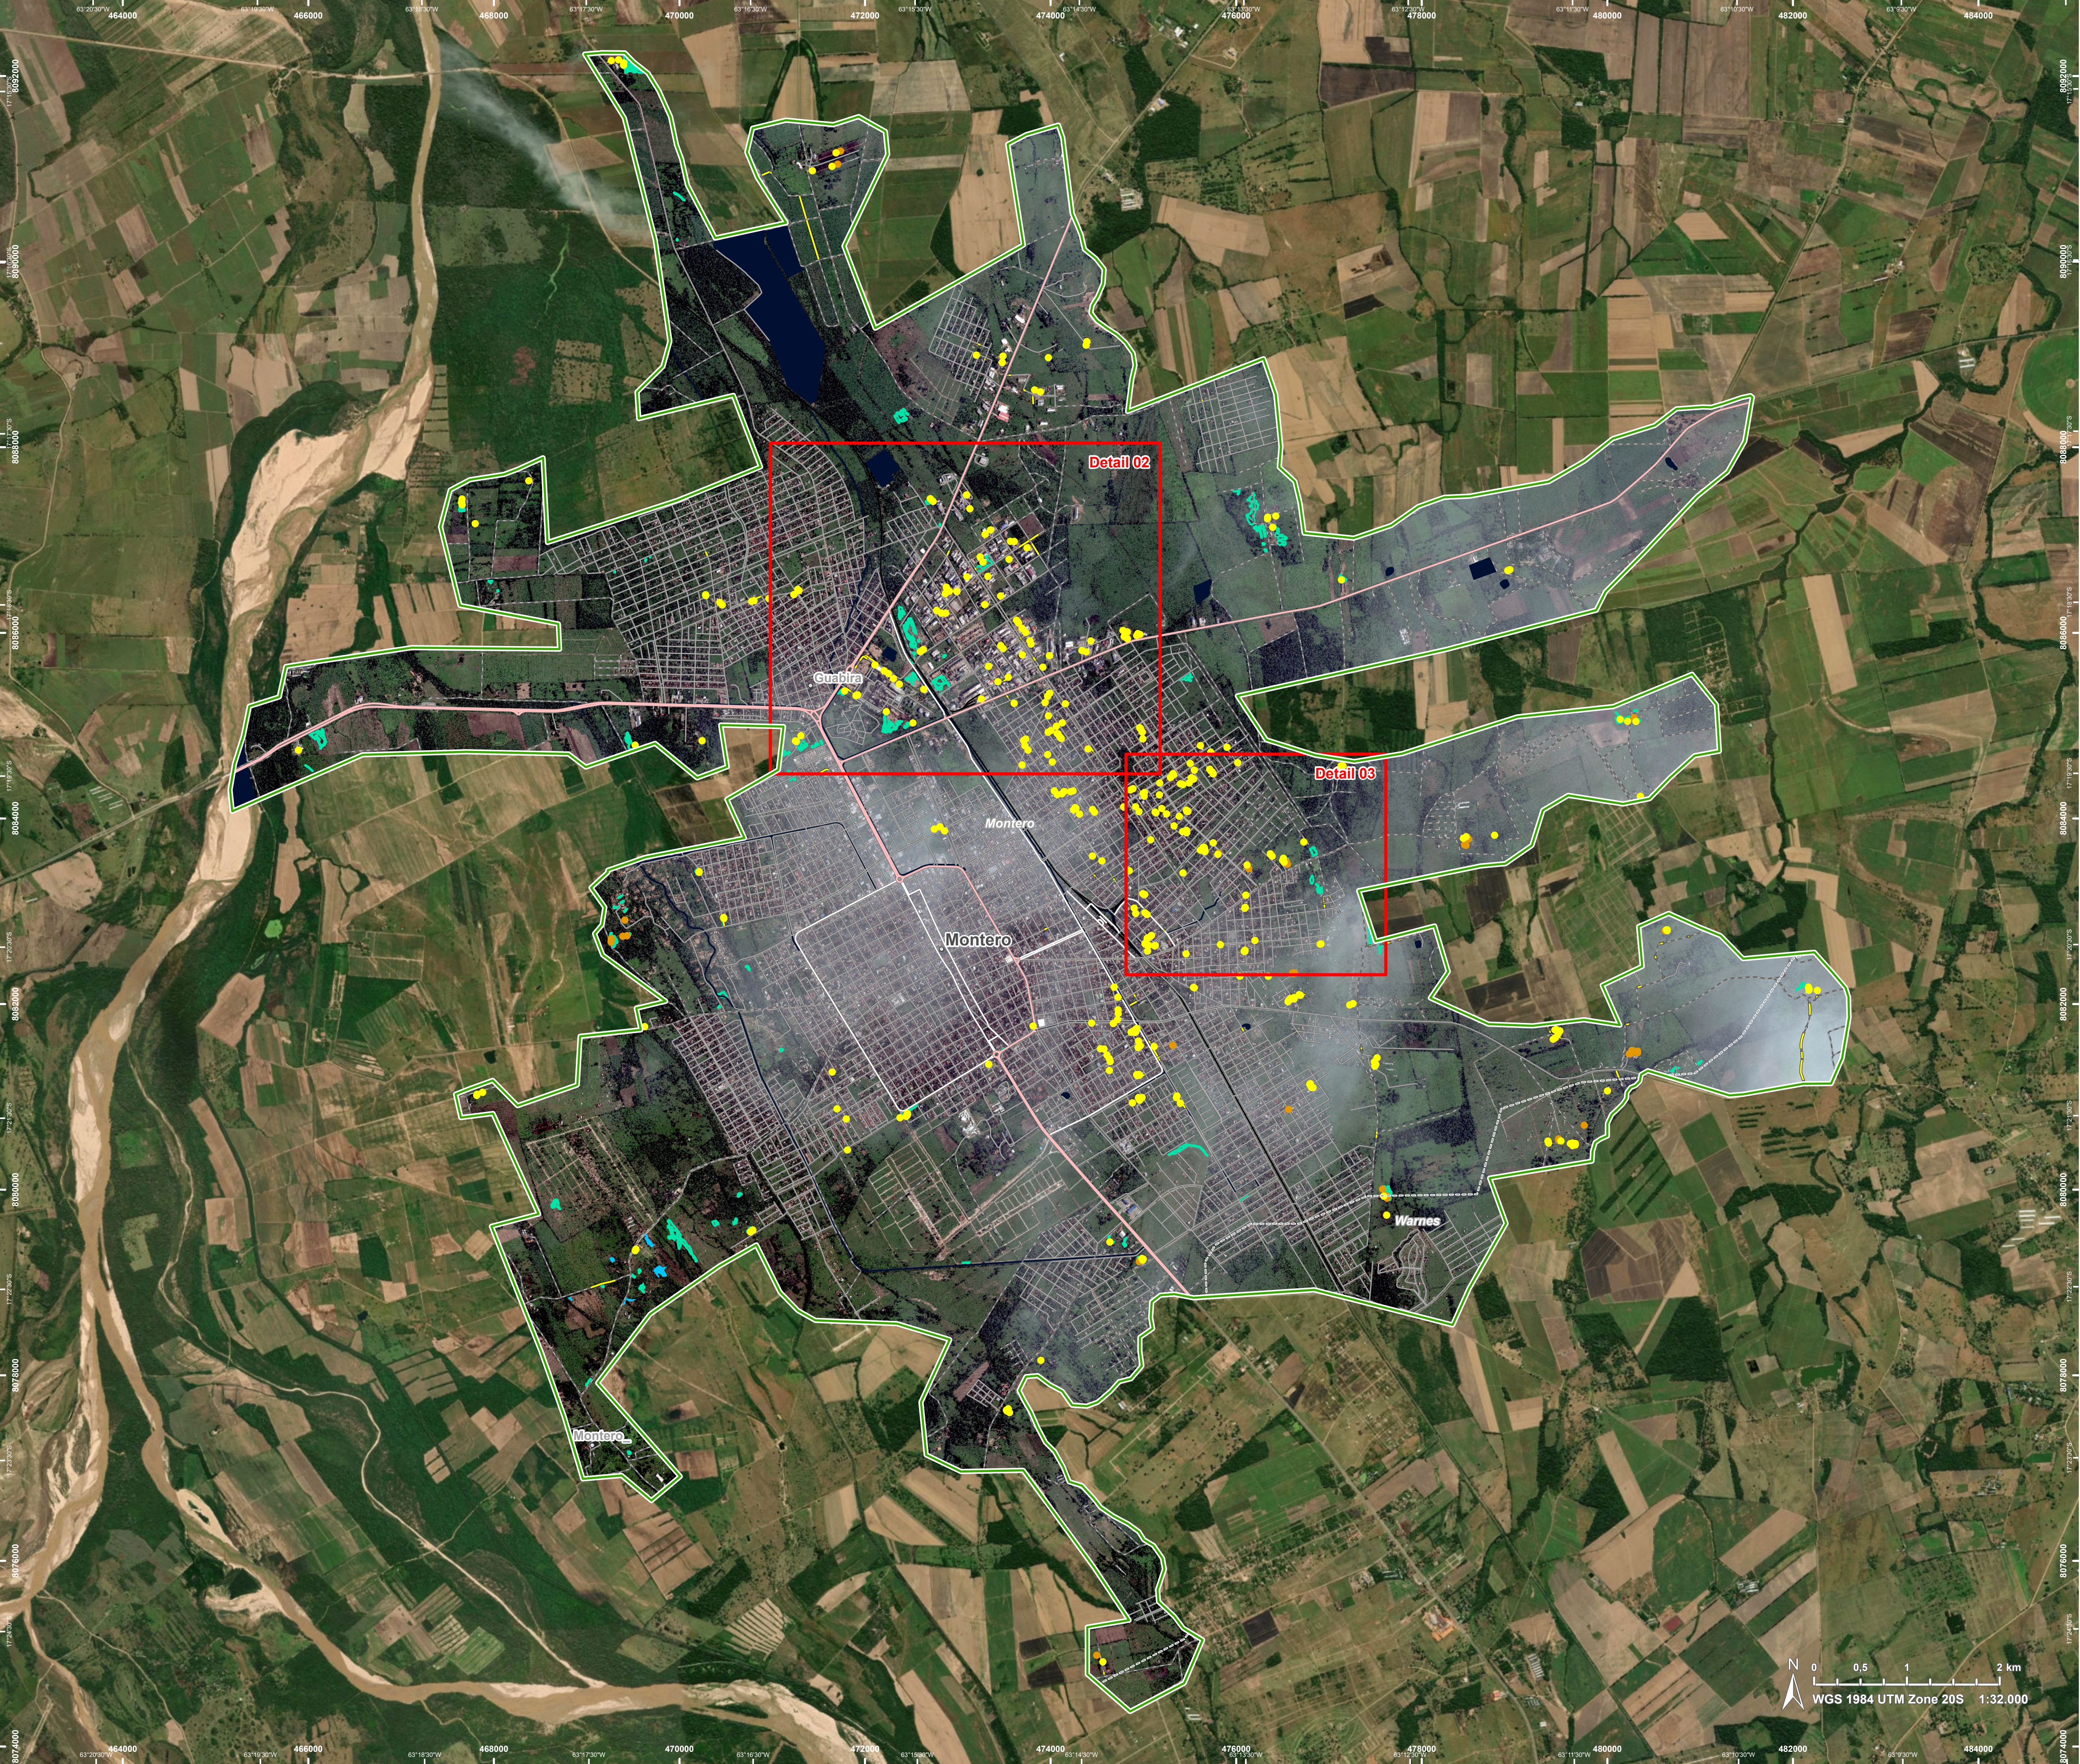
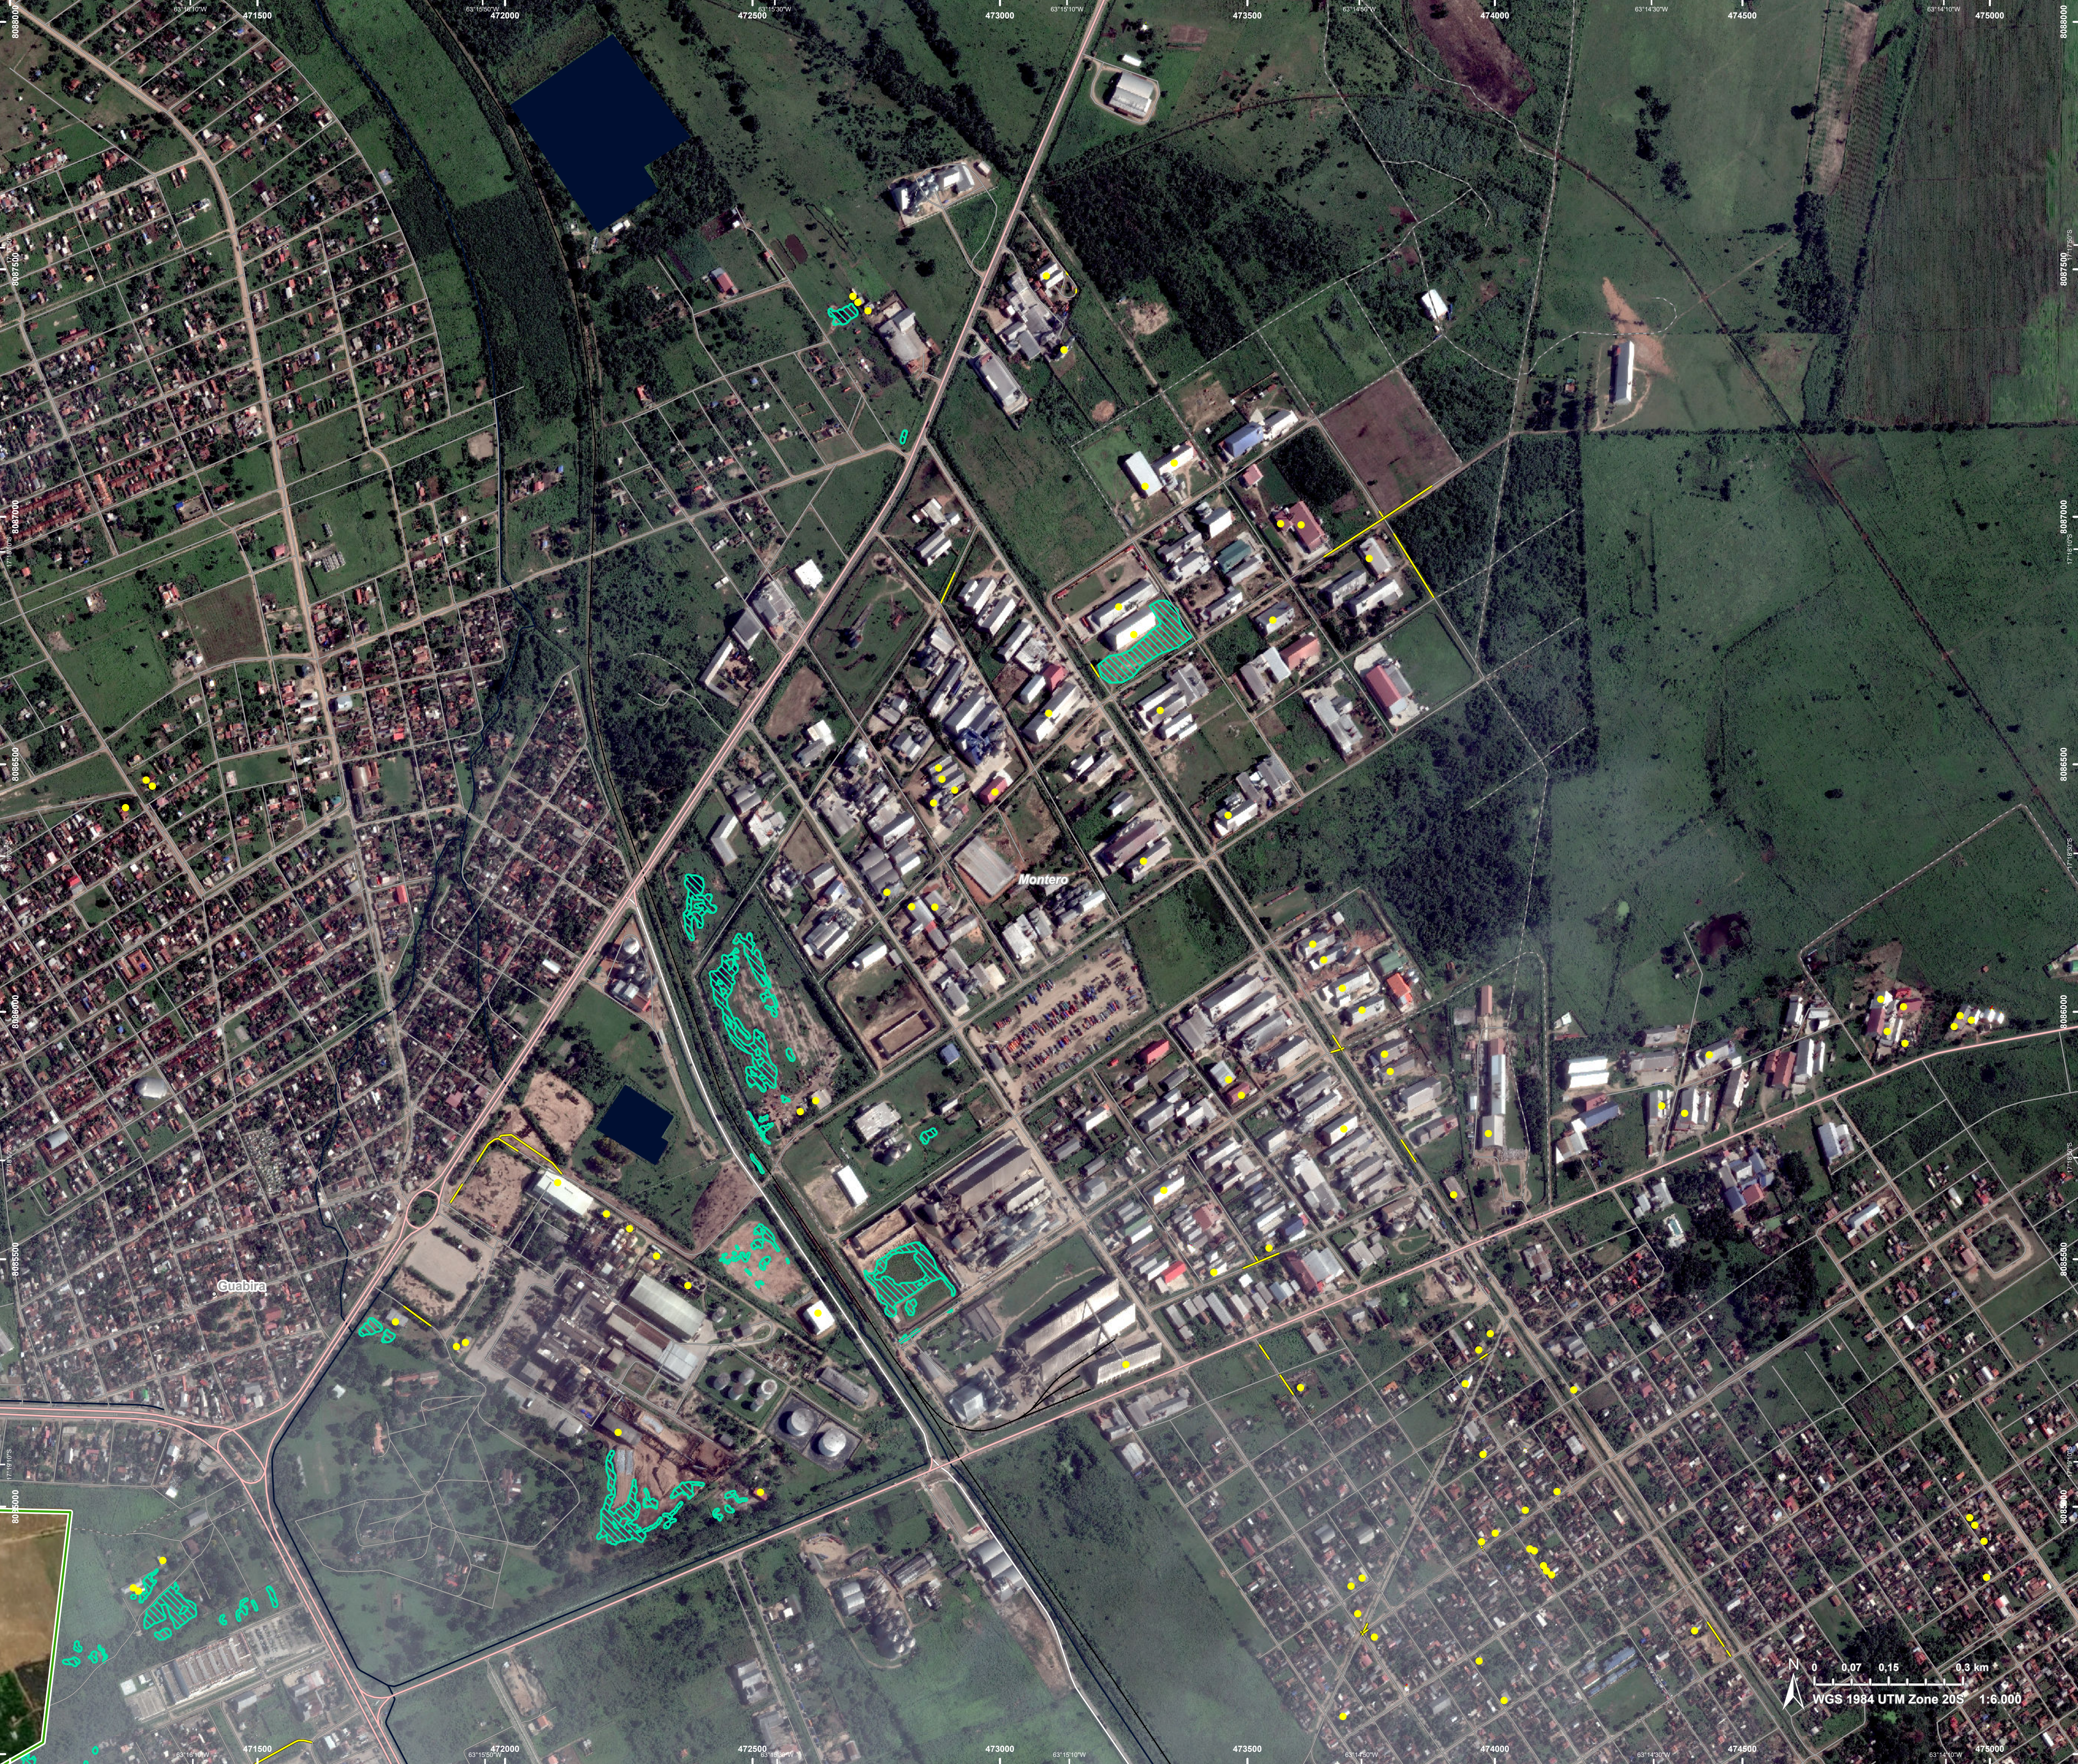
Flood trace
24.8 ha
Flooded area
2.5 ha

Potentially affected population
~ 100

Built-Up
405 No.

Road
7.1 km

The thematic layer has been derived from post-event satellite image using a semi-automatic approach.

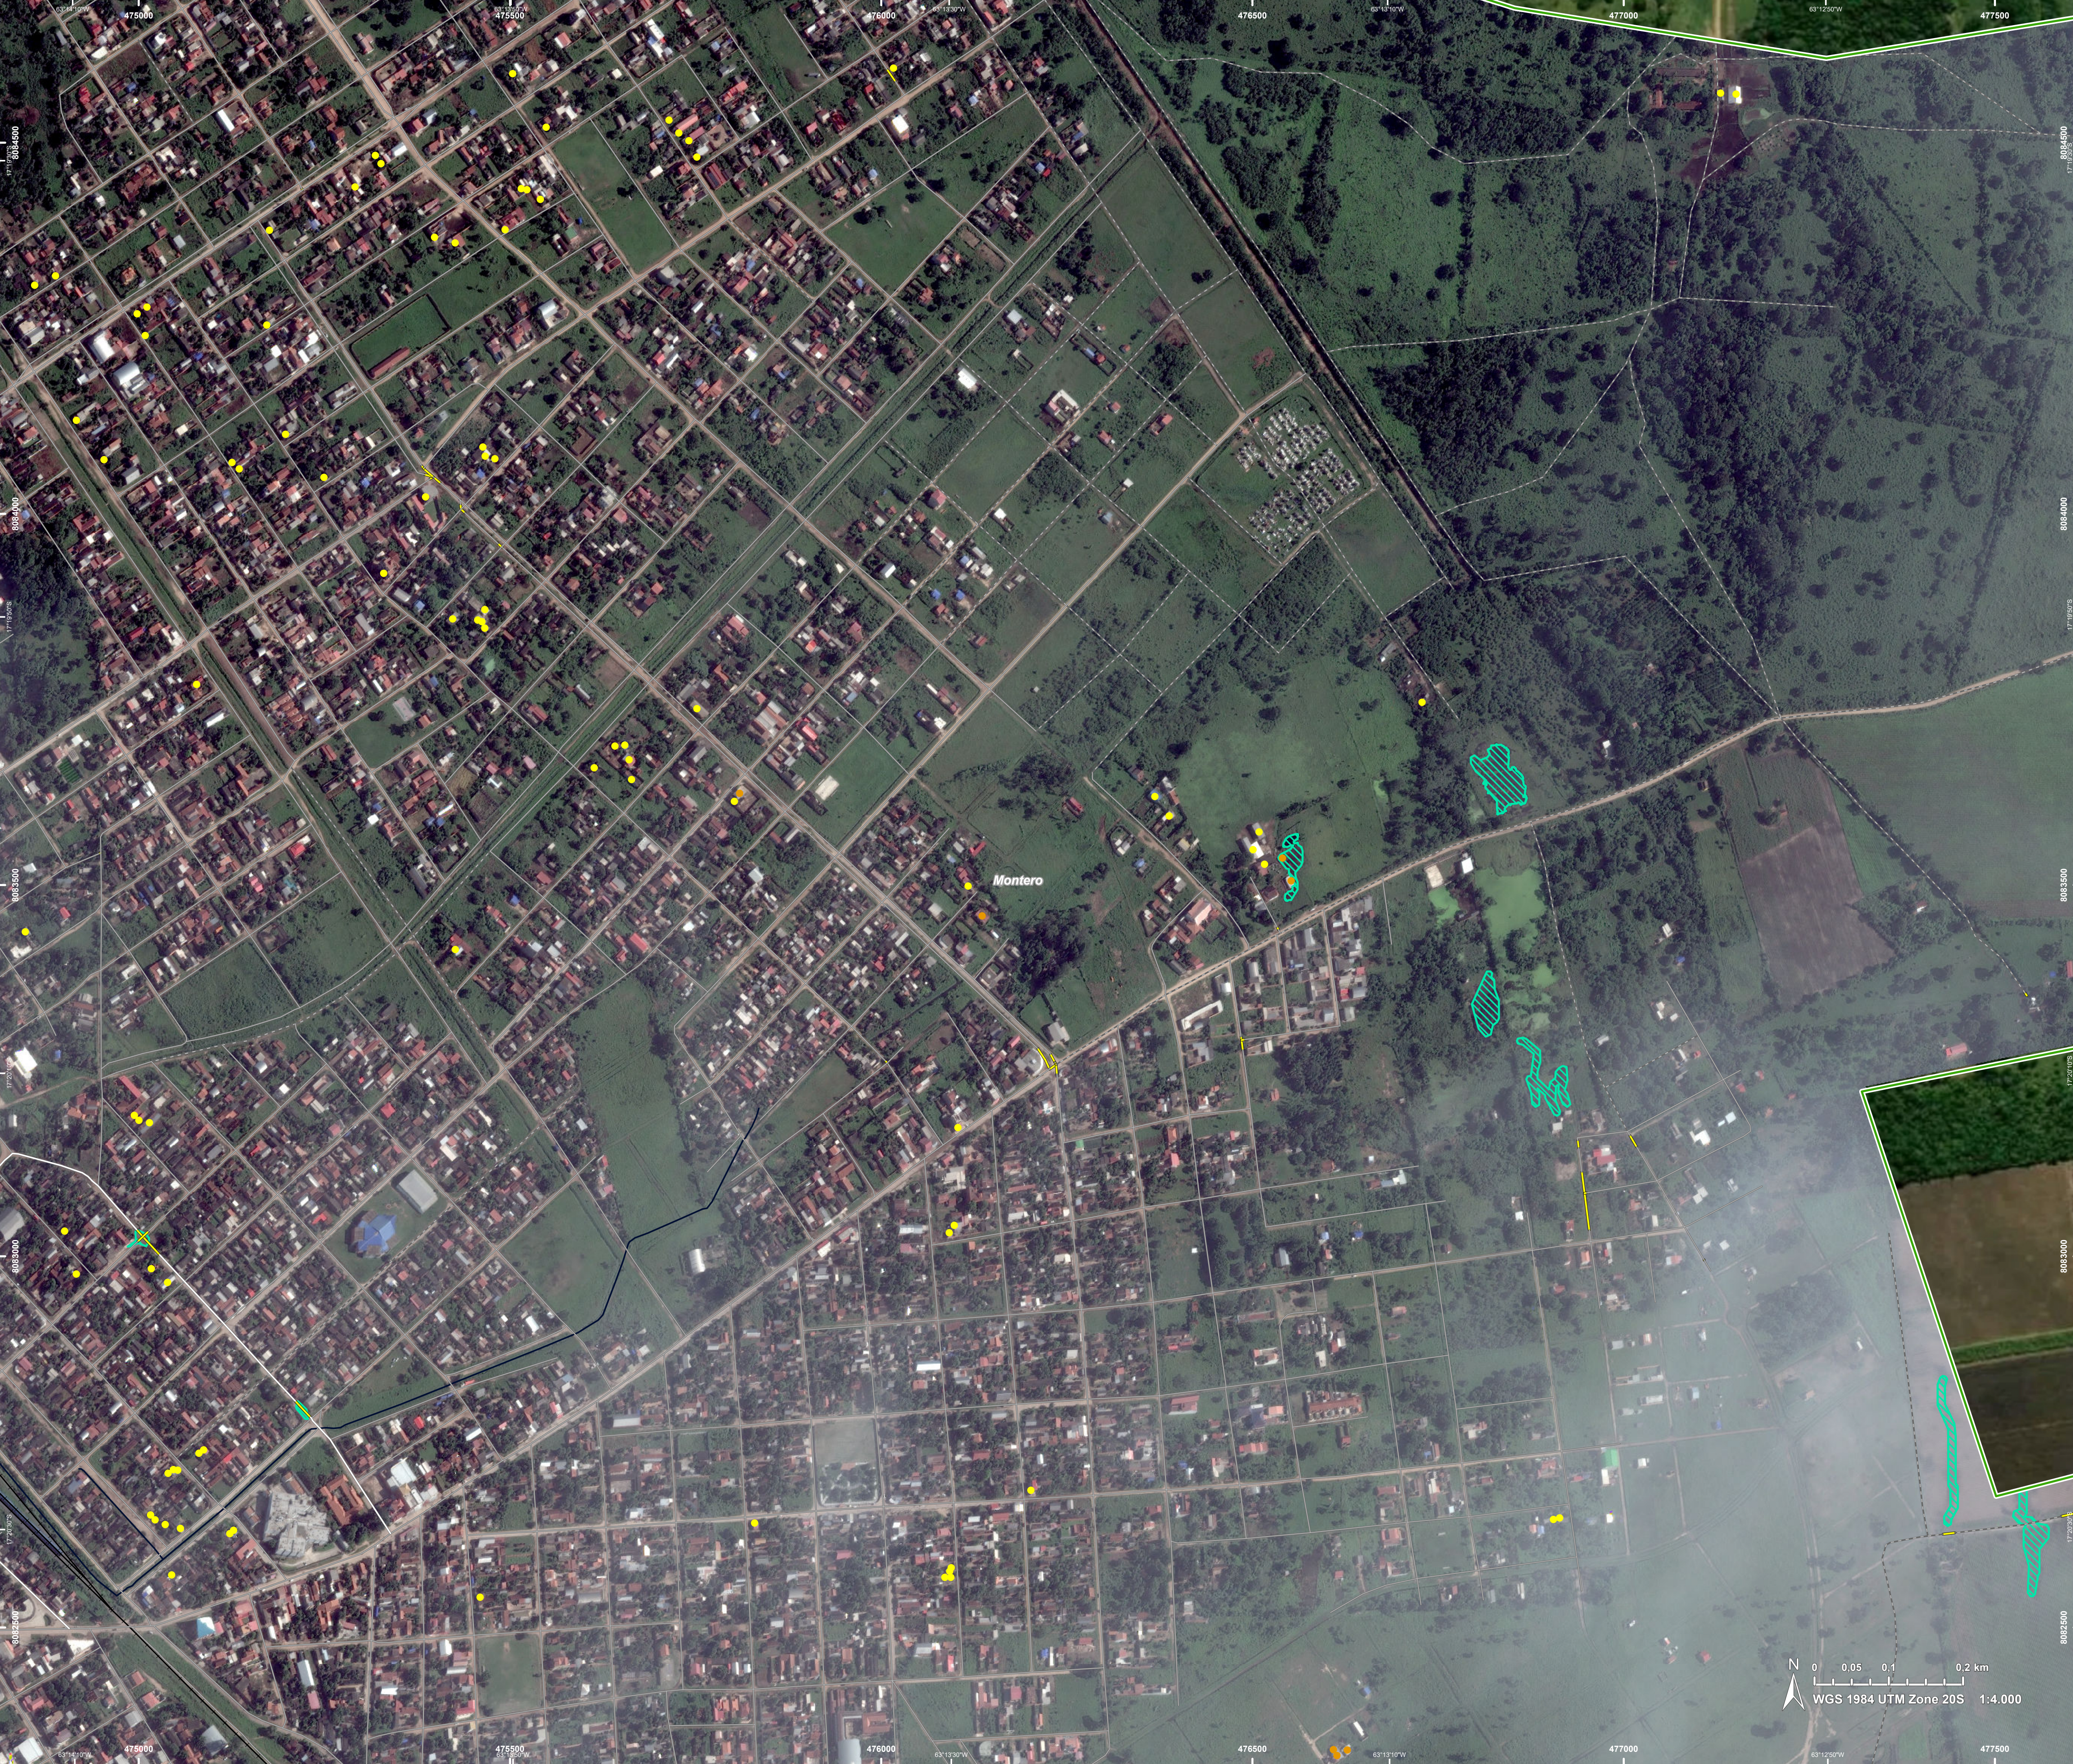
Situation as of 19/12/2025 12:24 UTC
Grading MONIT01 - Detail map 02

The thematic layer has been derived from post-event satellite image using a semi-automatic approach.
