Situation as of 18/12/2025 14:34 UTC
Grading - Overview map 01

Event: On the 14 December 2025, intense rainfall is reported to have a significantly affected provinces of Andrés Ibáñez and Sara, Bolivia. The event caused rivers to overflow. Copernicus EMS Rapid Mapping is requested to provide initial rough estimation, flood extent and damage assessment emergency mapping.

EMSR853 - AOI06
Flood in Bolivia
MONTERO

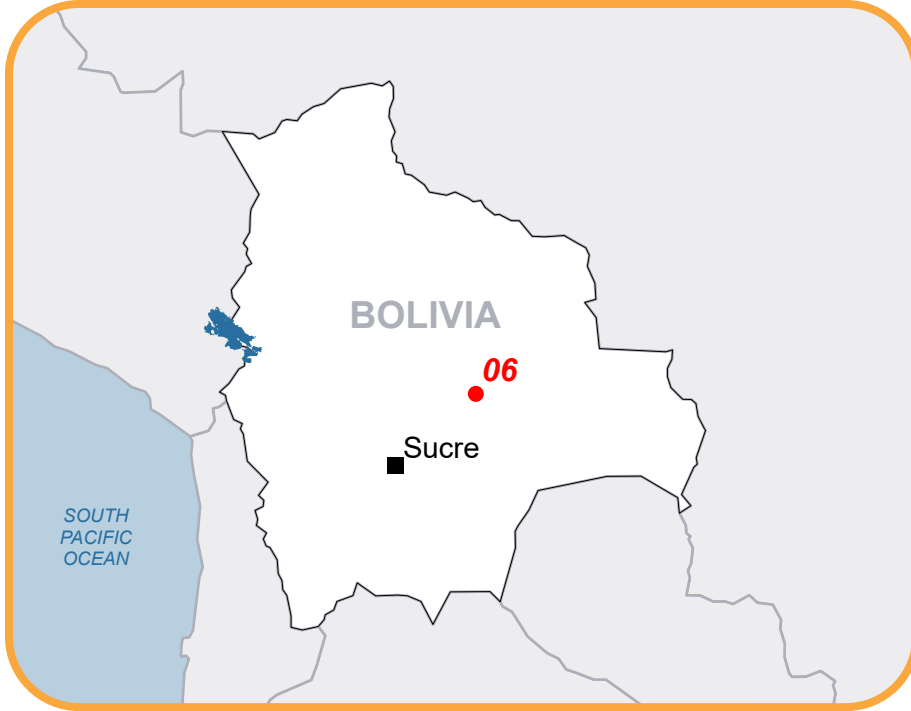
Flood trace 49.2 ha
Flooded area 1.7 ha
Potentially affected population ~ 850

Affected Built-up and Transportations

Road 31.2 km
Railway 0.02 km
Built-Up 333.7 ha

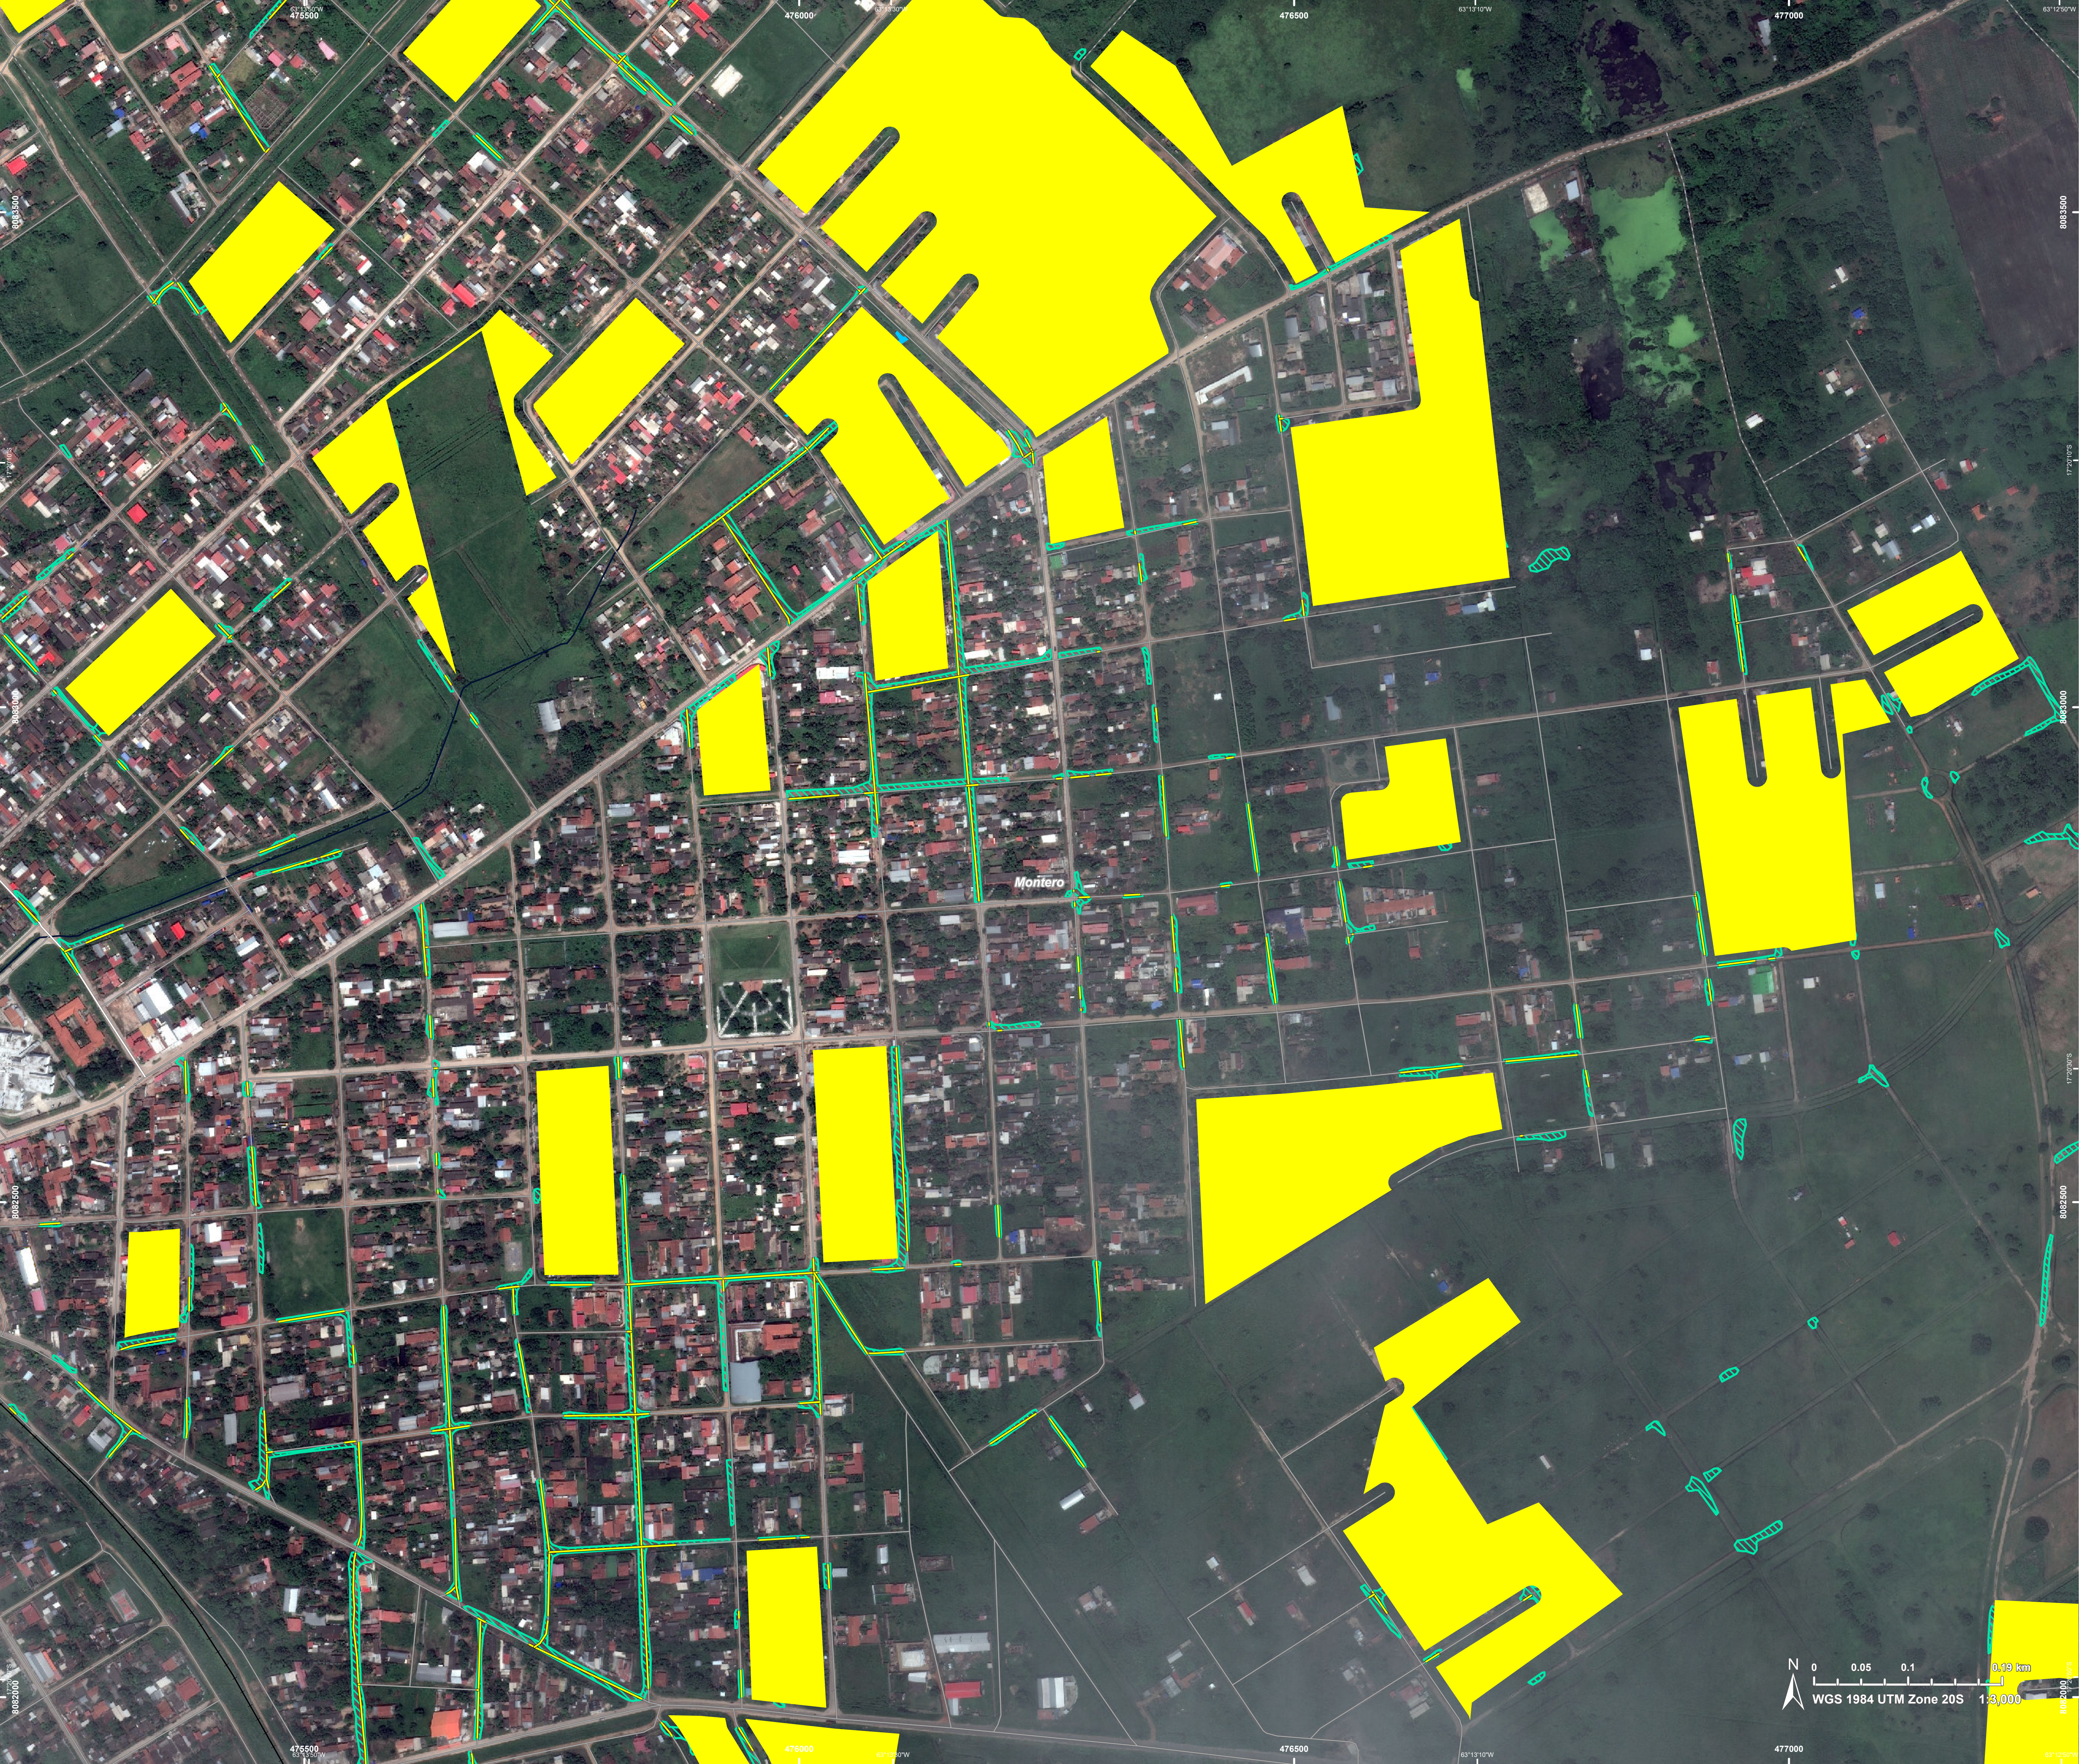
Situation as of 18/12/2025 14:34 UTC
Grading - Detail map 03

LATEST IMPACT	
			Unit of measurement	EO-based observation*
Crisis information	Flood trace		ha	49.2
	Flooded area		ha	1.7
	Maximum of all extents**		ha	50.9

Estimated population		Inhabitants	No.	Destroyed	Damaged	Possibly damaged***	Total affected****	Total in AOI
Assets		Built-up					~ 850	~ 130,000
		Residential Buildings	ha	0	0	169.4	169.4	2,575.9
		Industrial buildings	ha	0	0	164.3	164.3	269.2
	Transportation	Highways	km	0	0	0	0	47.2
		Primary Road	km	0	0	0.2	0.2	7.5
		Secondary Road	km	0	0	0.04	0.04	13.5
		Local Road	km	0	0	28.9	28.9	776.3
		Cart Track	km	0	0	2.0	2.0	183.0
		Long-distance railways	km	0	0	0.02	0.02	17.0
	Facilities	Settling Basin	ha	0	0	0	0	82.7
		Sport and recreation constructions	ha	0	0	2.7	2.7	45.7
	Land use	Shrub and/or herbaceous vegetation association	ha				27.8	8,465.7
		Other	ha				18.0	1,793.4
		Heterogeneous agricultural areas	ha				4.1	983.8
		Forests	ha				1.0	853.3
		Open spaces with little or no vegetation	ha				0	6.1
		Inland wetlands	ha				0	95.8
