Situation as of 16/01/2026 16:22 UTC
First Estimate Product - Overview map 01

Event: Heavy rain that started in December, has caused several floods in Mozambique. The event is ongoing. Copernicus EMS Rapid Mapping is requested to provide initial rough estimation and flood extent emergency mapping

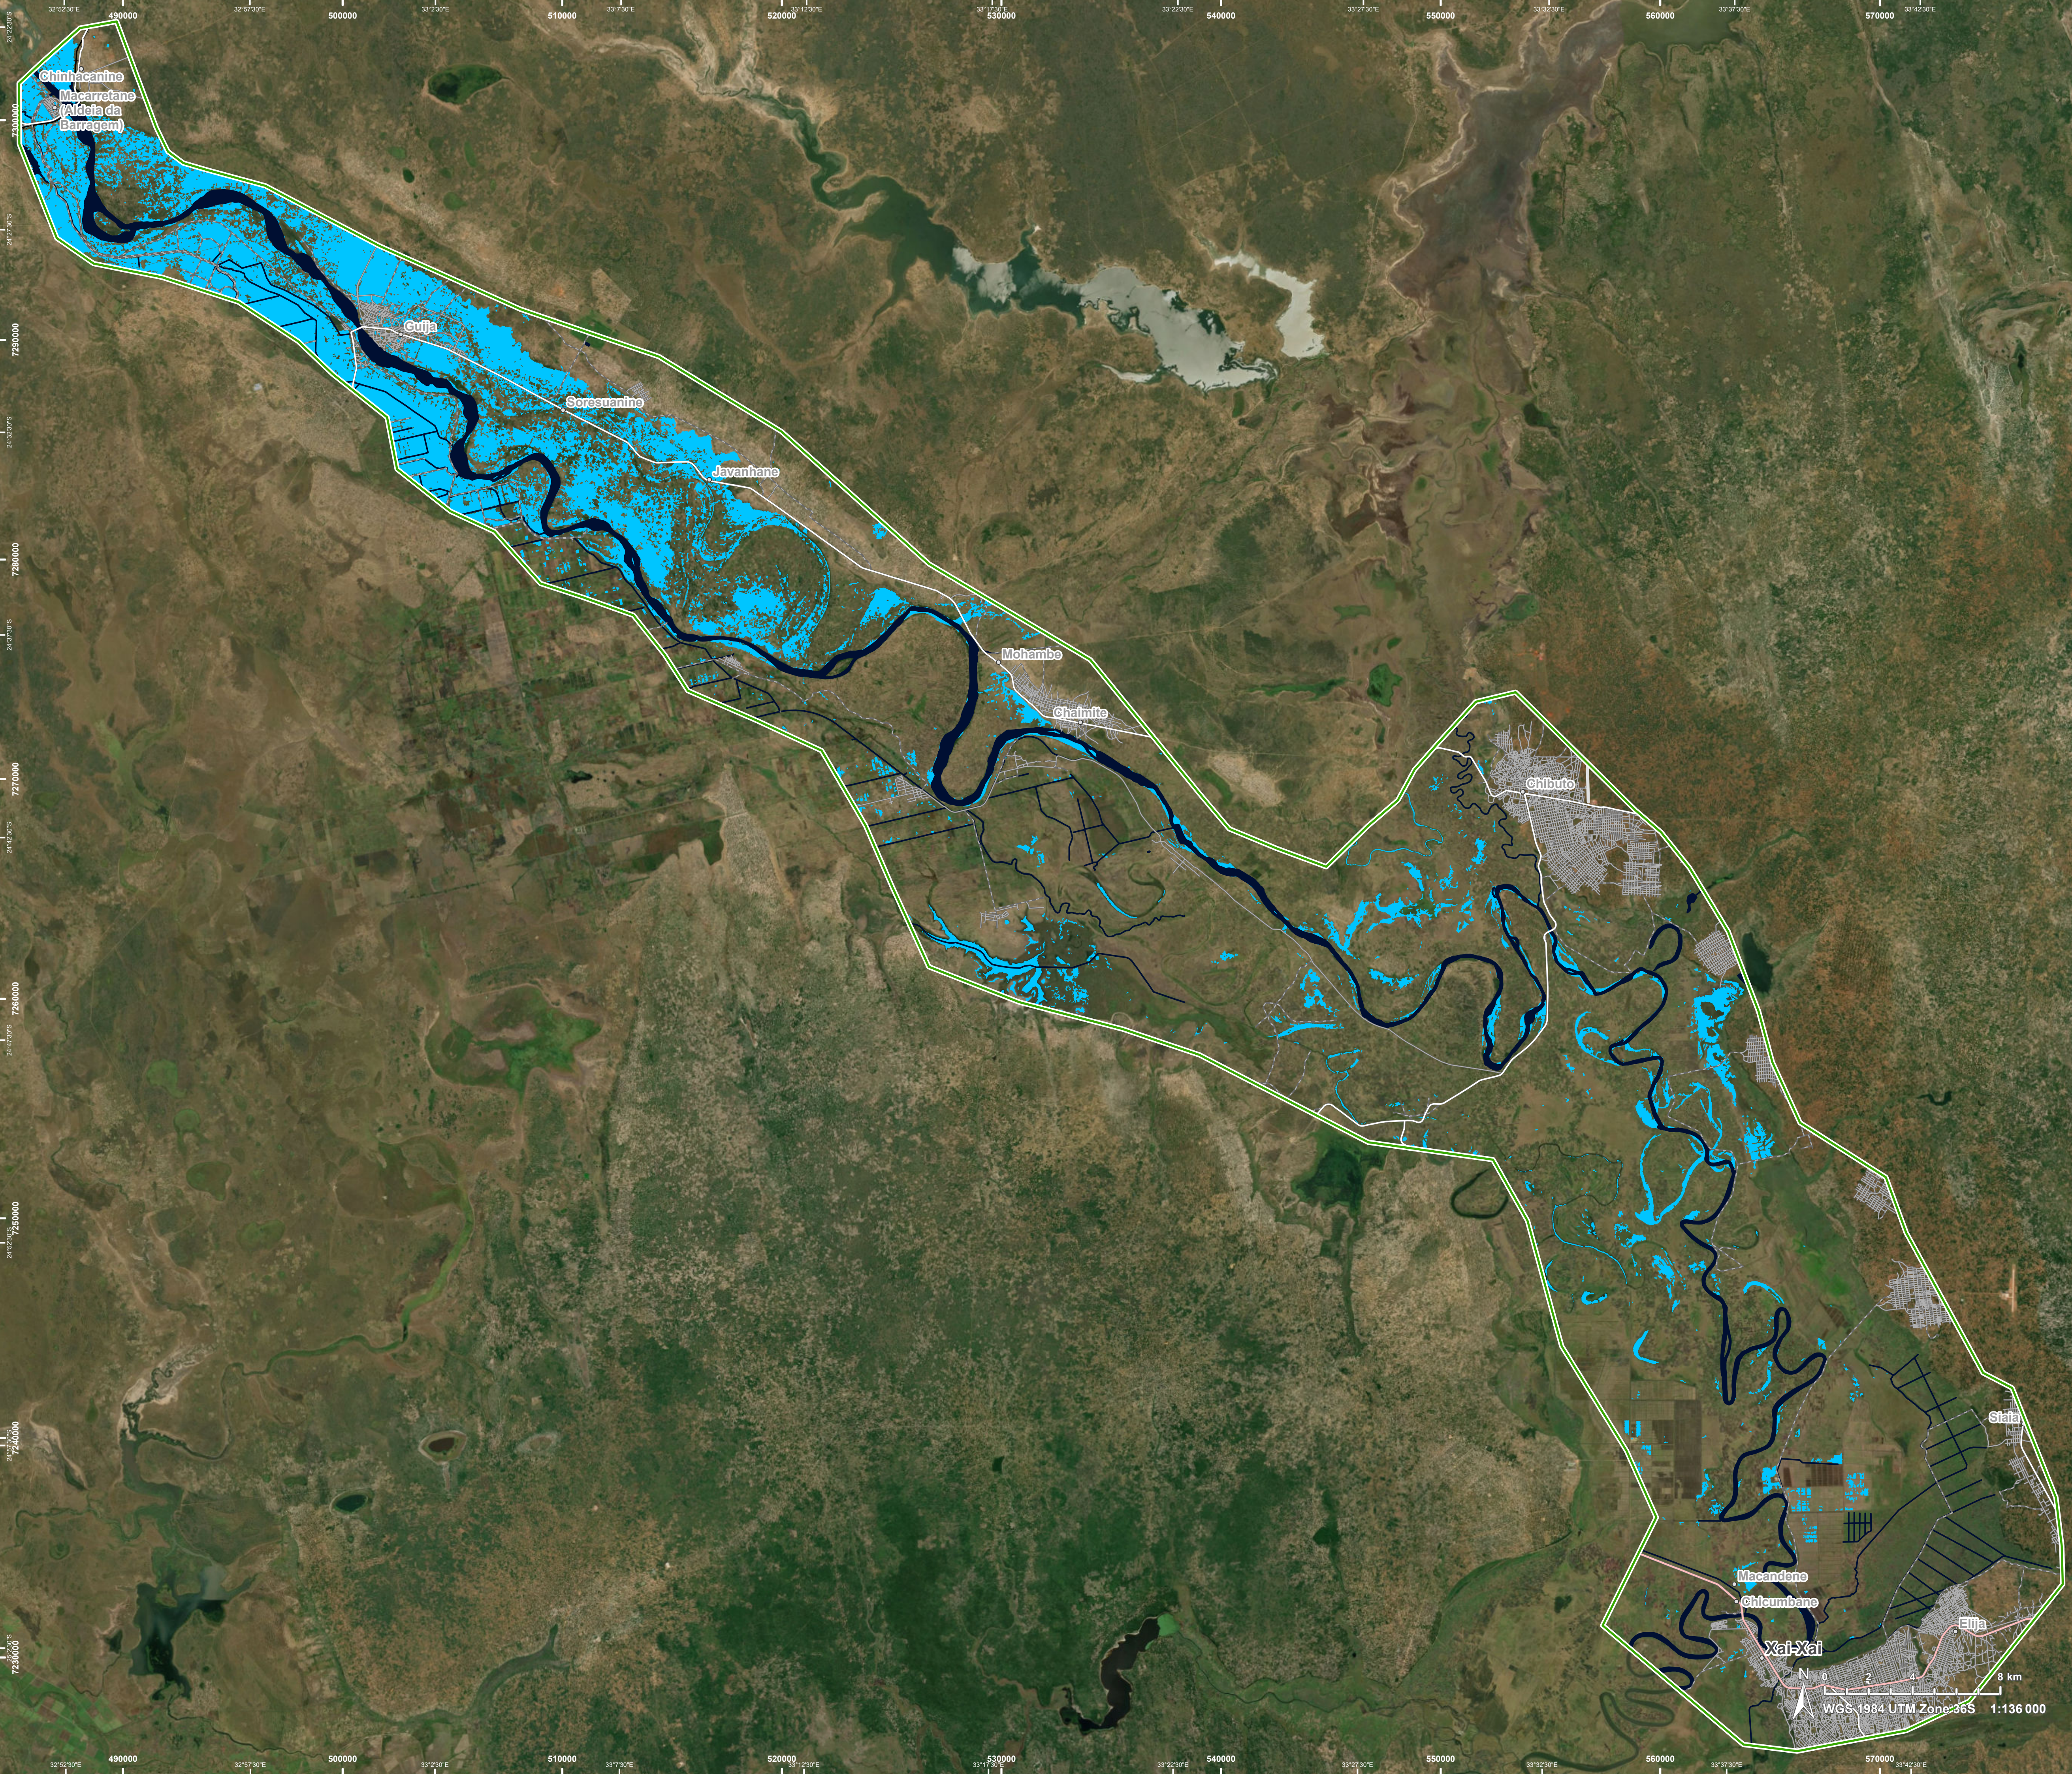
**Flooded area**
20,126.9 ha

**Potentially affected population**
~ 1,300

Data sources and analysis:
Post-event image: Sentinel-1 (2026) (acquired on 16/01/2026 at 16:22 UTC and 16:23 UTC resolution 10.0 m).
All images are provided under COPERNICUS by the European Union and ESA, all rights reserved.
All images are provided under COPERNICUS by the European Union and ESA, all rights reserved.

The thematic layer has been derived from post-event satellite image using a semi-automatic approach. Please be aware that the thematic accuracy might be lower in urban and forested areas due to inherent limitations of the SAR analysis technique.
