Situation as of 17/01/2026 03:19 UTC
First Estimate Product - Overview map 01

Event: Heavy rain that started in December, has caused several floods in Mozambique. The event is ongoing. Copernicus EMS Rapid Mapping is requested to provide initial rough estimation and flood extent emergency mapping

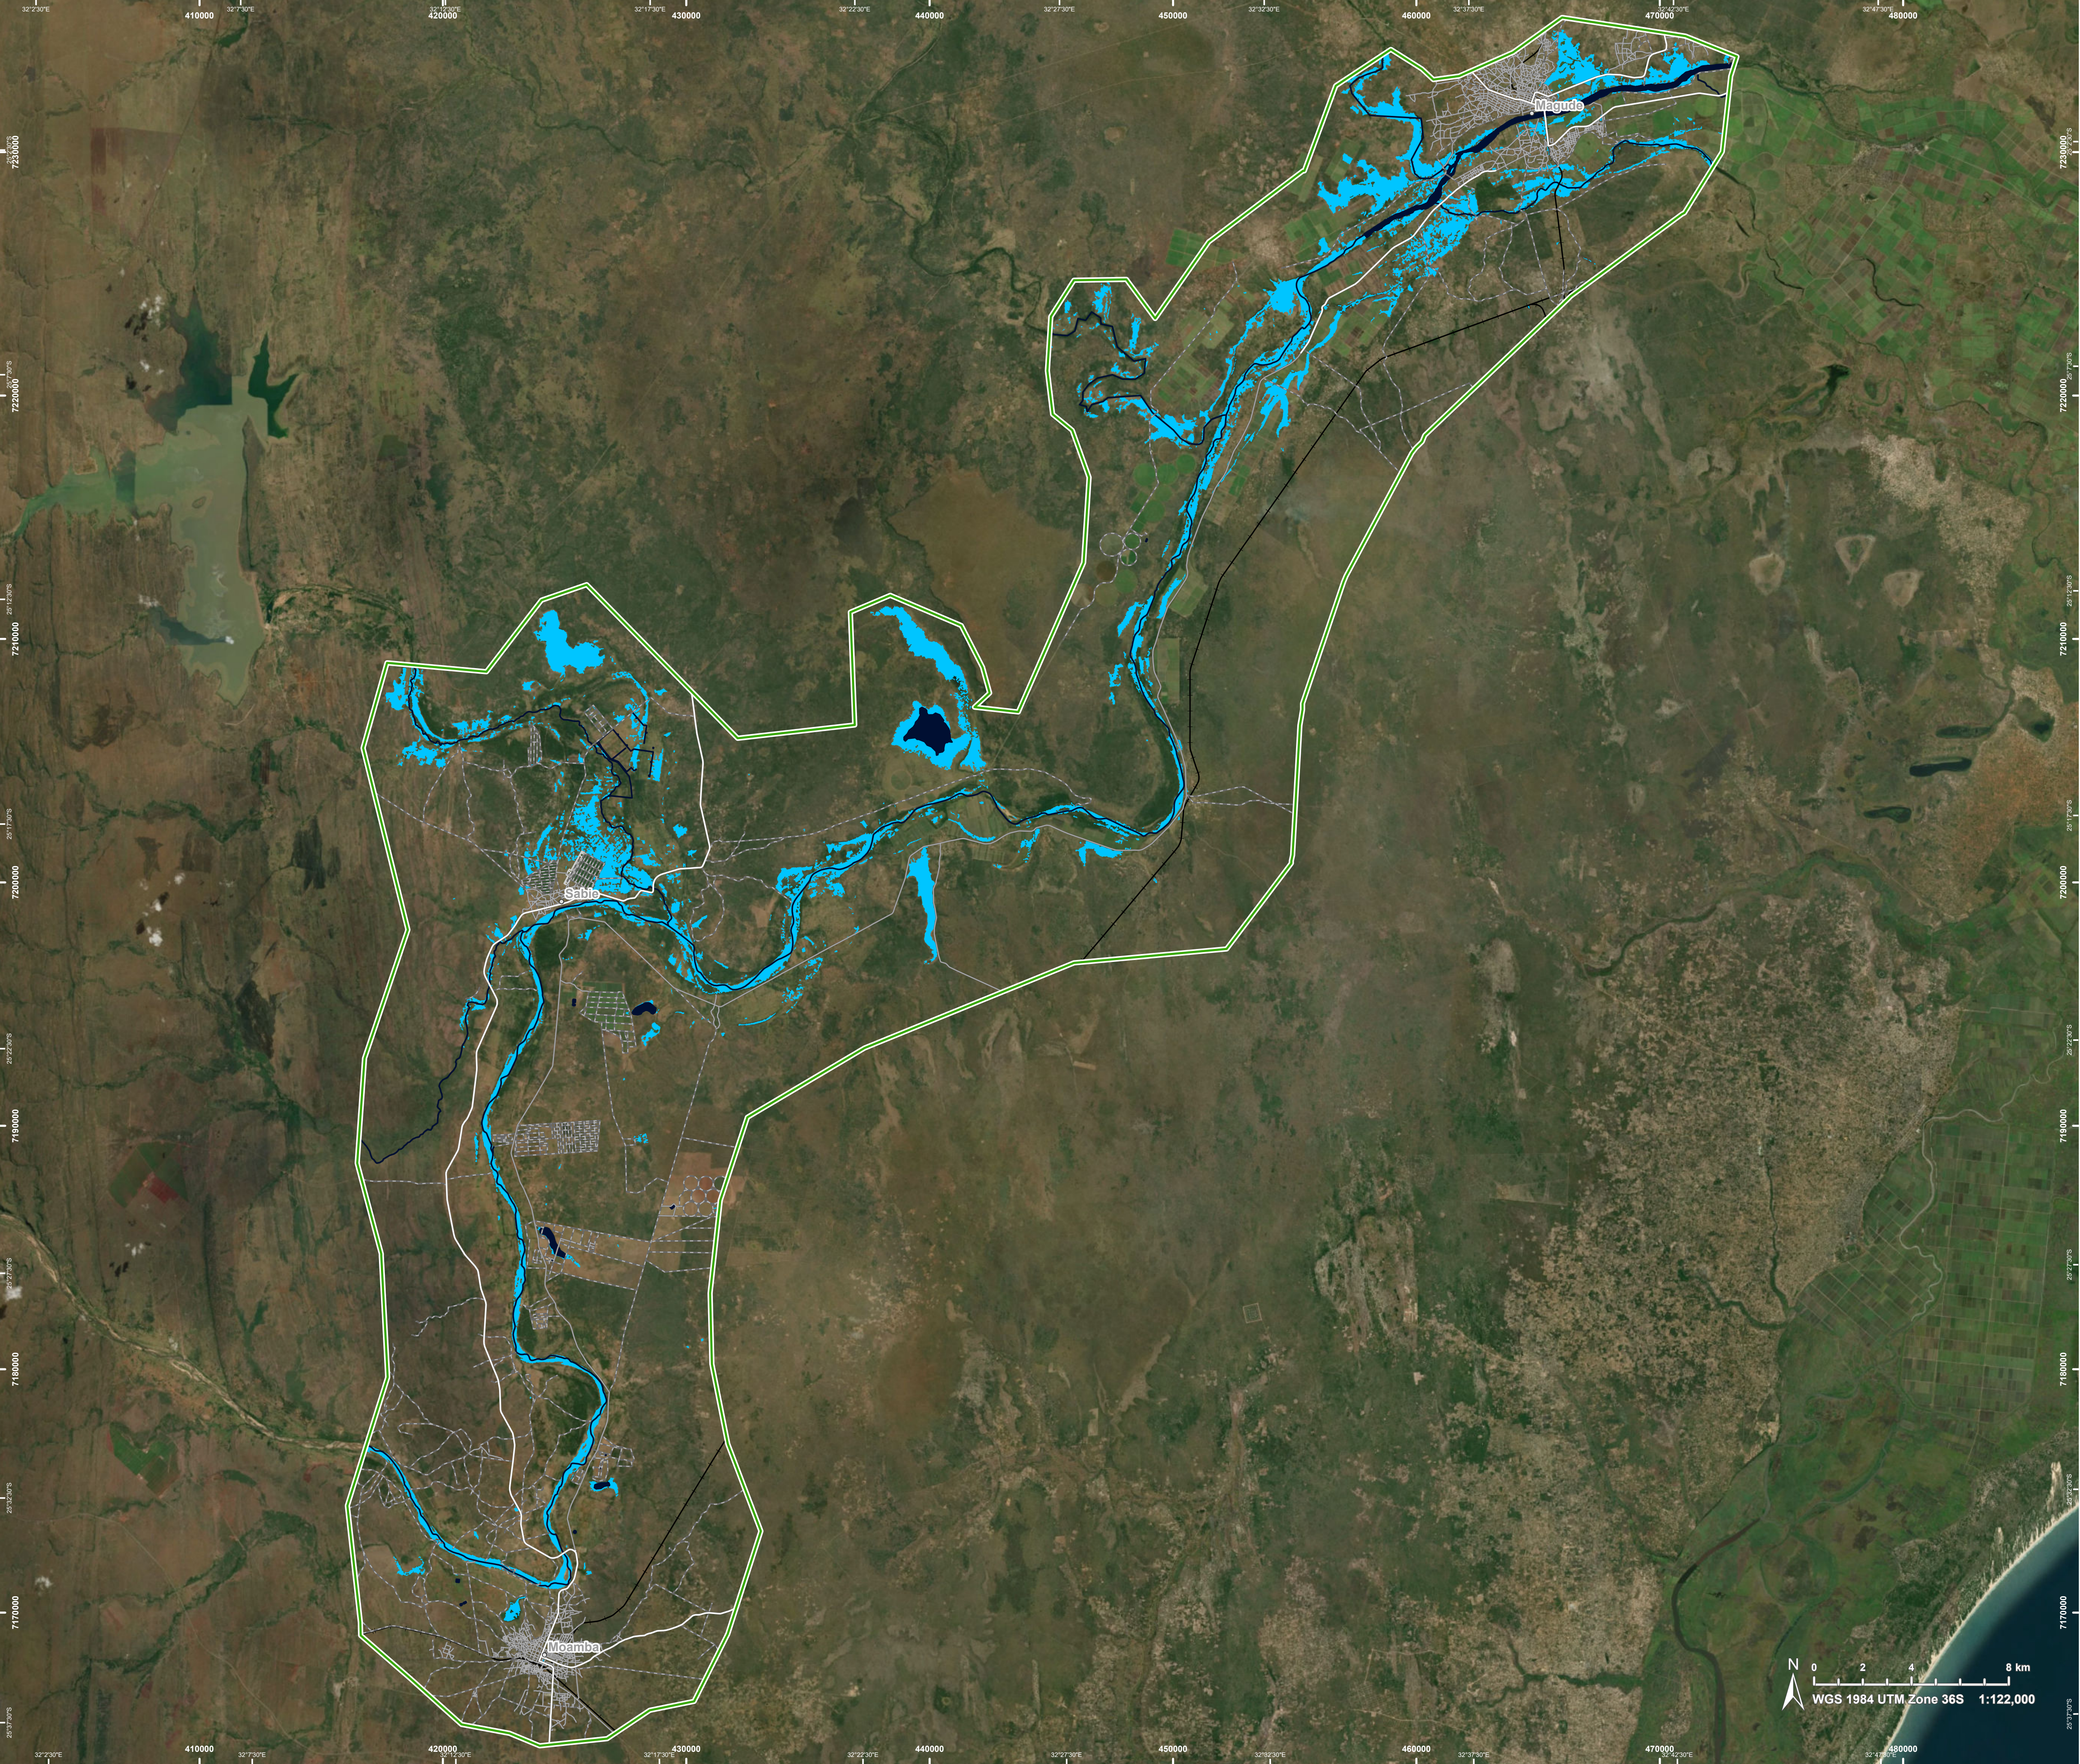
Flooded area
9,311.4 ha

Potentially affected population
~ 250

Data sources and analysis:
Post-event image: Sentinel-1 (2026) (acquired on 17/01/2026 at 03:19 UTC, resolution 10.0 m).
All images are provided under COPERNICUS by the European Union and ESA, all rights reserved.

The thematic layer has been derived from post-event satellite image using a semi-automatic approach. Please be aware that the thematic accuracy might be lower in urban and forested areas due to inherent limitations of the SAR analysis technique.
