EMSR857 - AOI03
Flood in Mozambique
BOANE

Situation as of 17/01/2026 03:19 UTC

First Estimate Product - Overview map 01

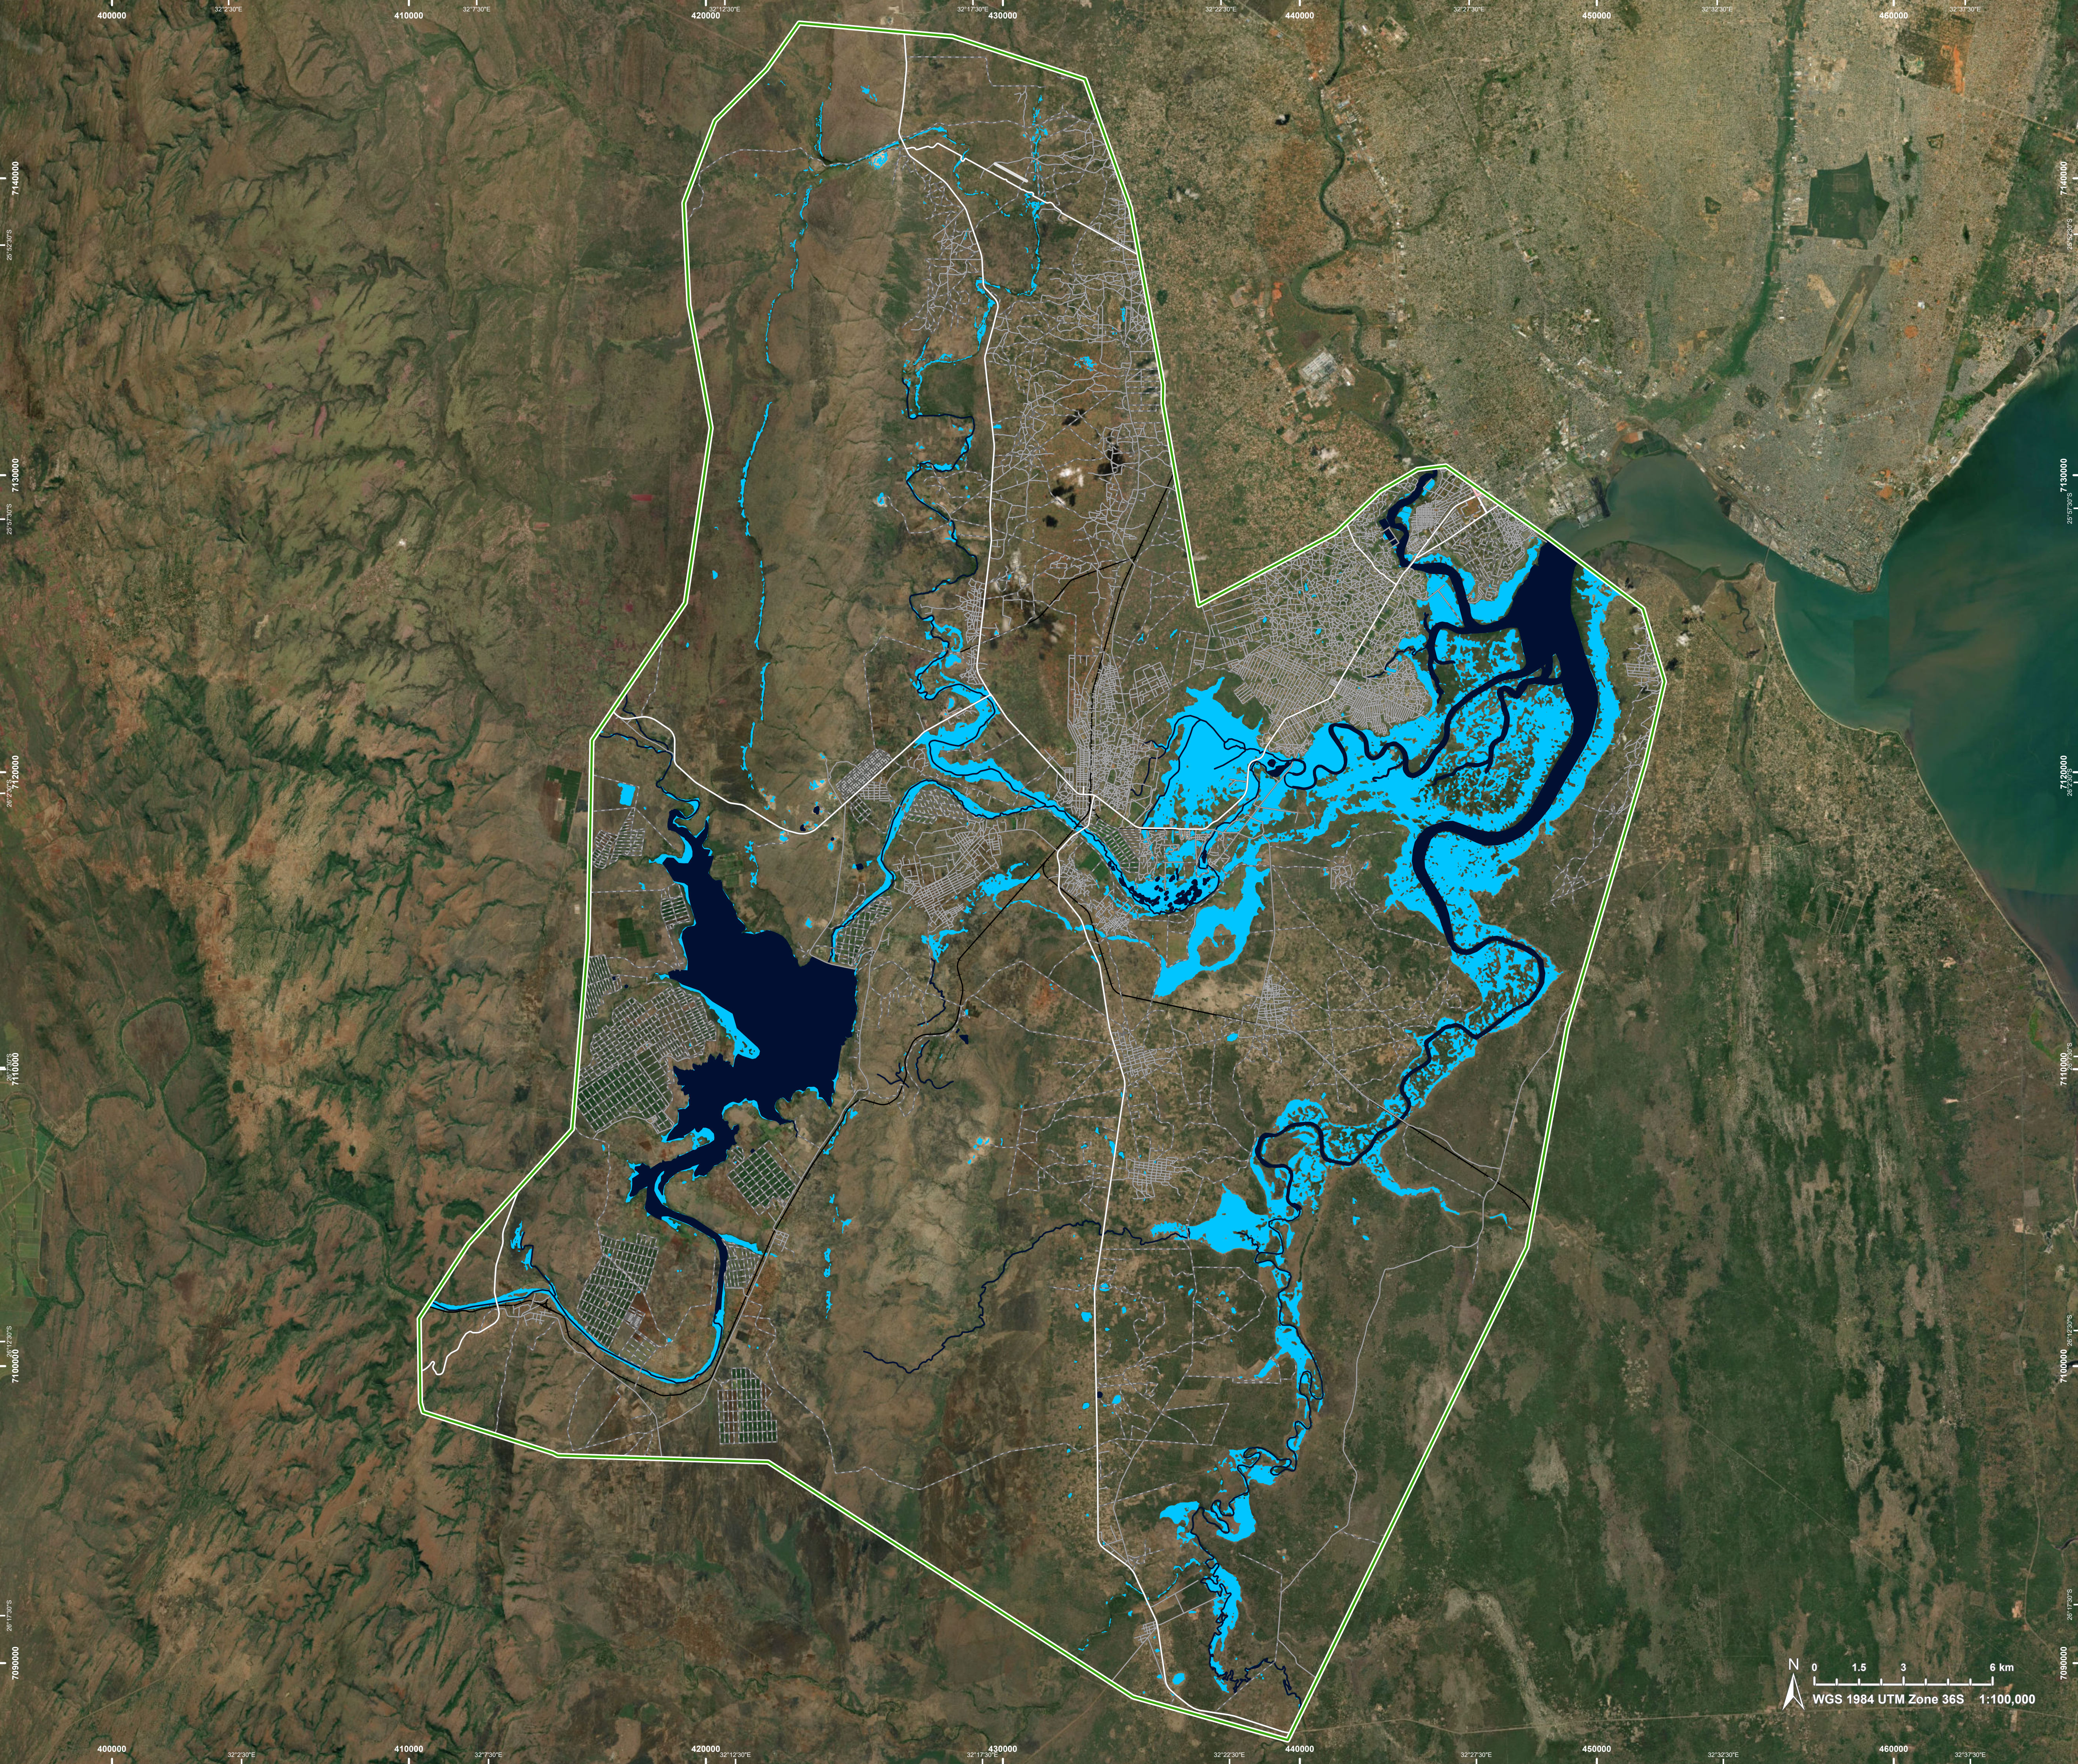
Flooded area
11,719.4 ha

Potentially affected
population
~ 1,700

Event: Heavy rain that started in December, has caused several floods in Mozambique. The event is ongoing. Copernicus EMS Rapid Mapping is requested to provide initial rough estimation and flood extent emergency mapping

Data sources and analysis:
Post-event image: Sentinel-1 (2026) (acquired on 17/01/2026 at 03:19 UTC, resolution 20.0 m)
All images are provided under COPENICUS by the European Union and ESA, all rights reserved.

The thematic layer has been derived from post-event satellite image using a semi-automatic approach. Please be aware that the thematic accuracy might be lower in urban and forested areas due to inherent limitations of the SAR analysis technique
