**Situation as of 16/01/2026 16:22 UTC**  
First Estimate Product - Overview map 01

**Event:** Heavy rain that started in December, has caused several floods in Mozambique. The event is ongoing. Copernicus EMS Rapid Mapping is requested to provide initial rough estimation and flood extent emergency mapping.

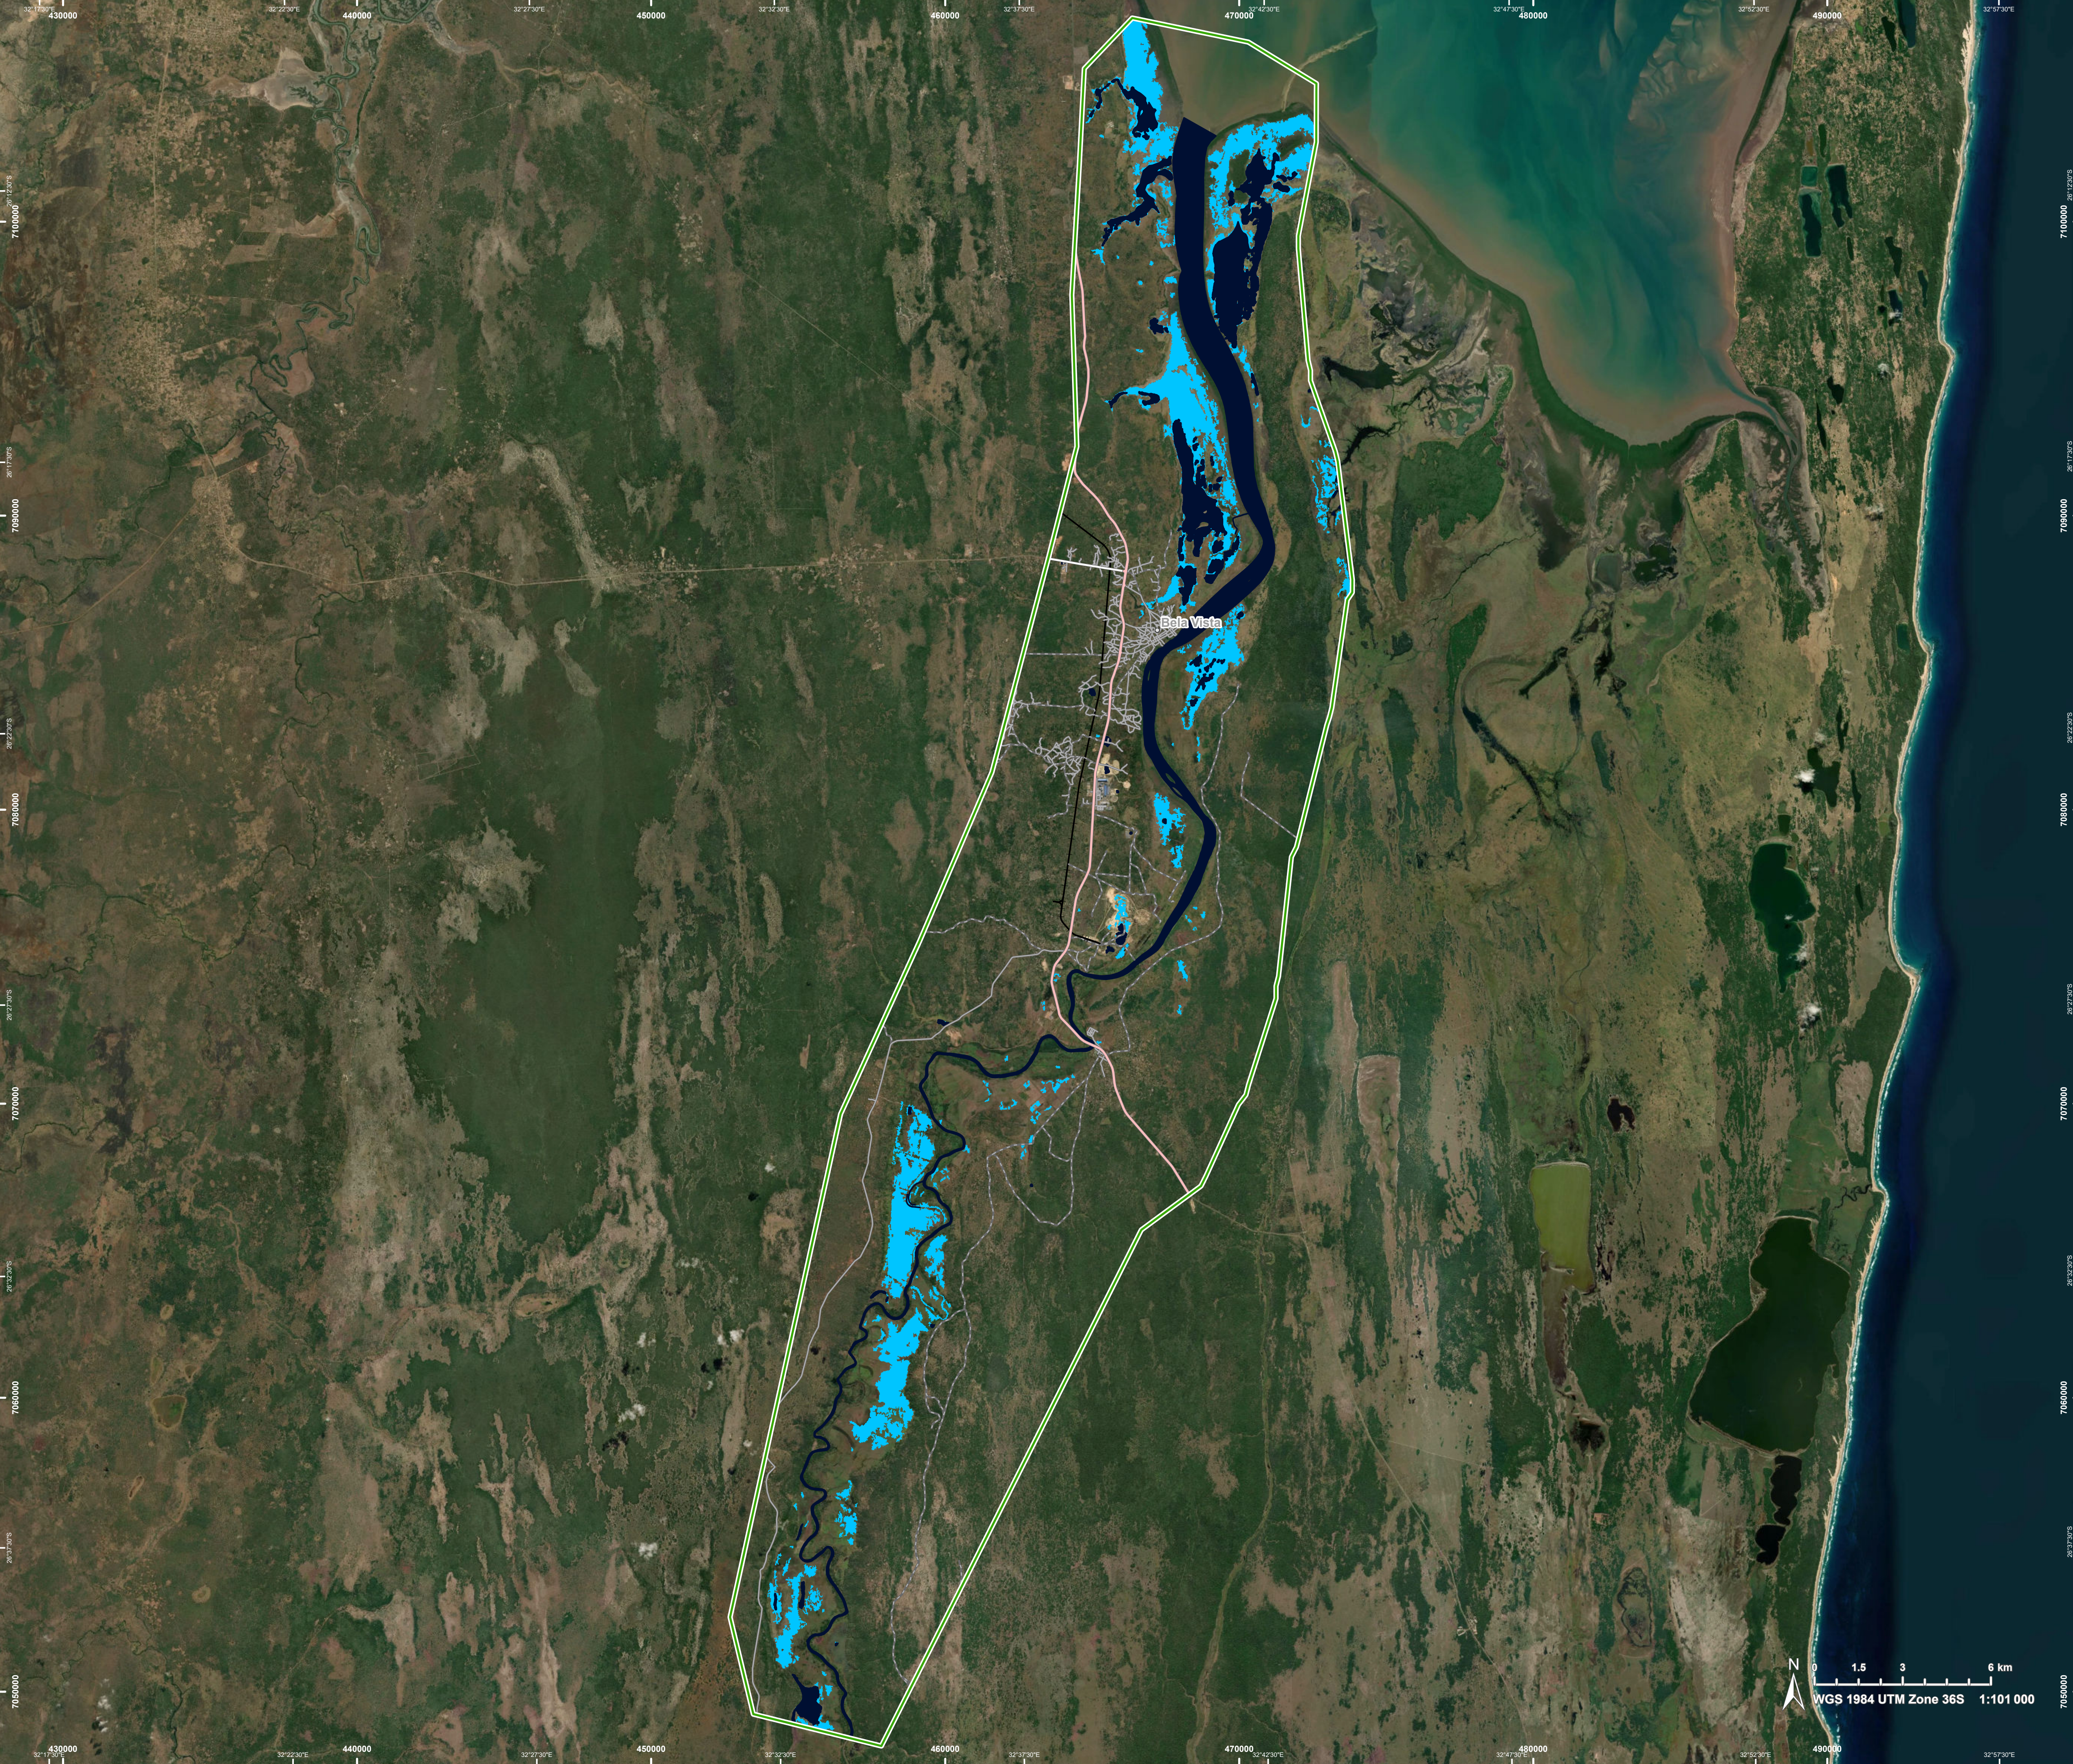
**Flooded area**  
3,954.9 ha

The thematic layer has been derived from post-event satellite image using a semi-automatic approach. Please be aware that the thematic accuracy might be lower in urban and forested areas due to inherent limitations of the SAR analysis technique.

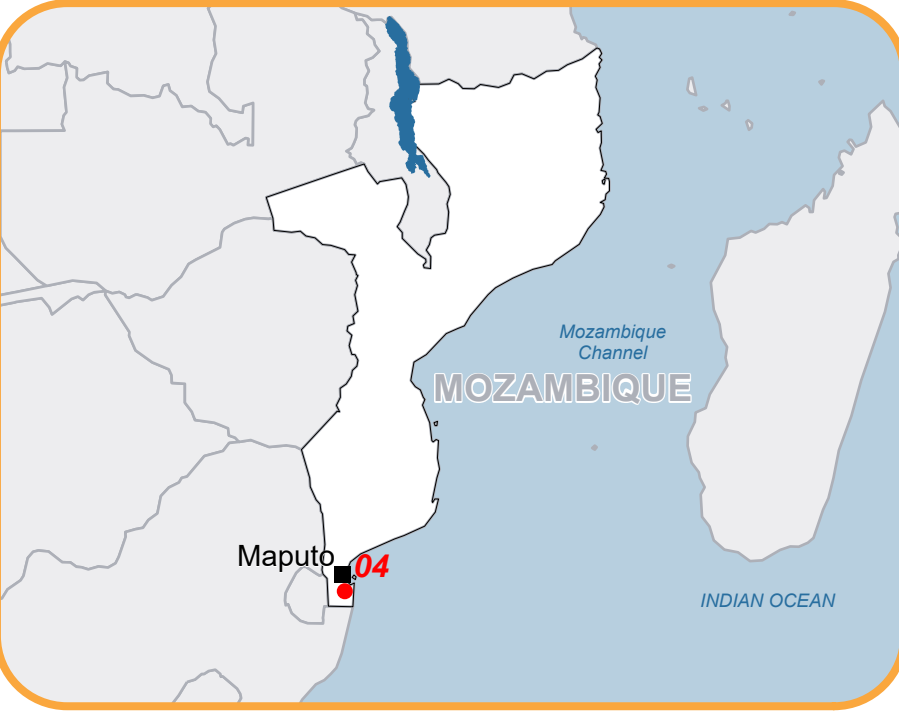
**Data sources and analysis:**  
Post-event image: Sentinel-1(2026) (acquired on 16/01/2026 at 16:22 UTC, resolution 20m).  
All images are provided under COPENICUS by the European Union and ESA, all rights reserved.
