Situation as of 12/01/2026 03:09 UTC
First Estimate Product - Overview map 01

Event Heavy rain that started in December, has caused several floods in Mozambique. The event is ongoing. Copernicus EMS Rapid Mapping is requested to provide initial rough estimation and flood extent emergency mapping

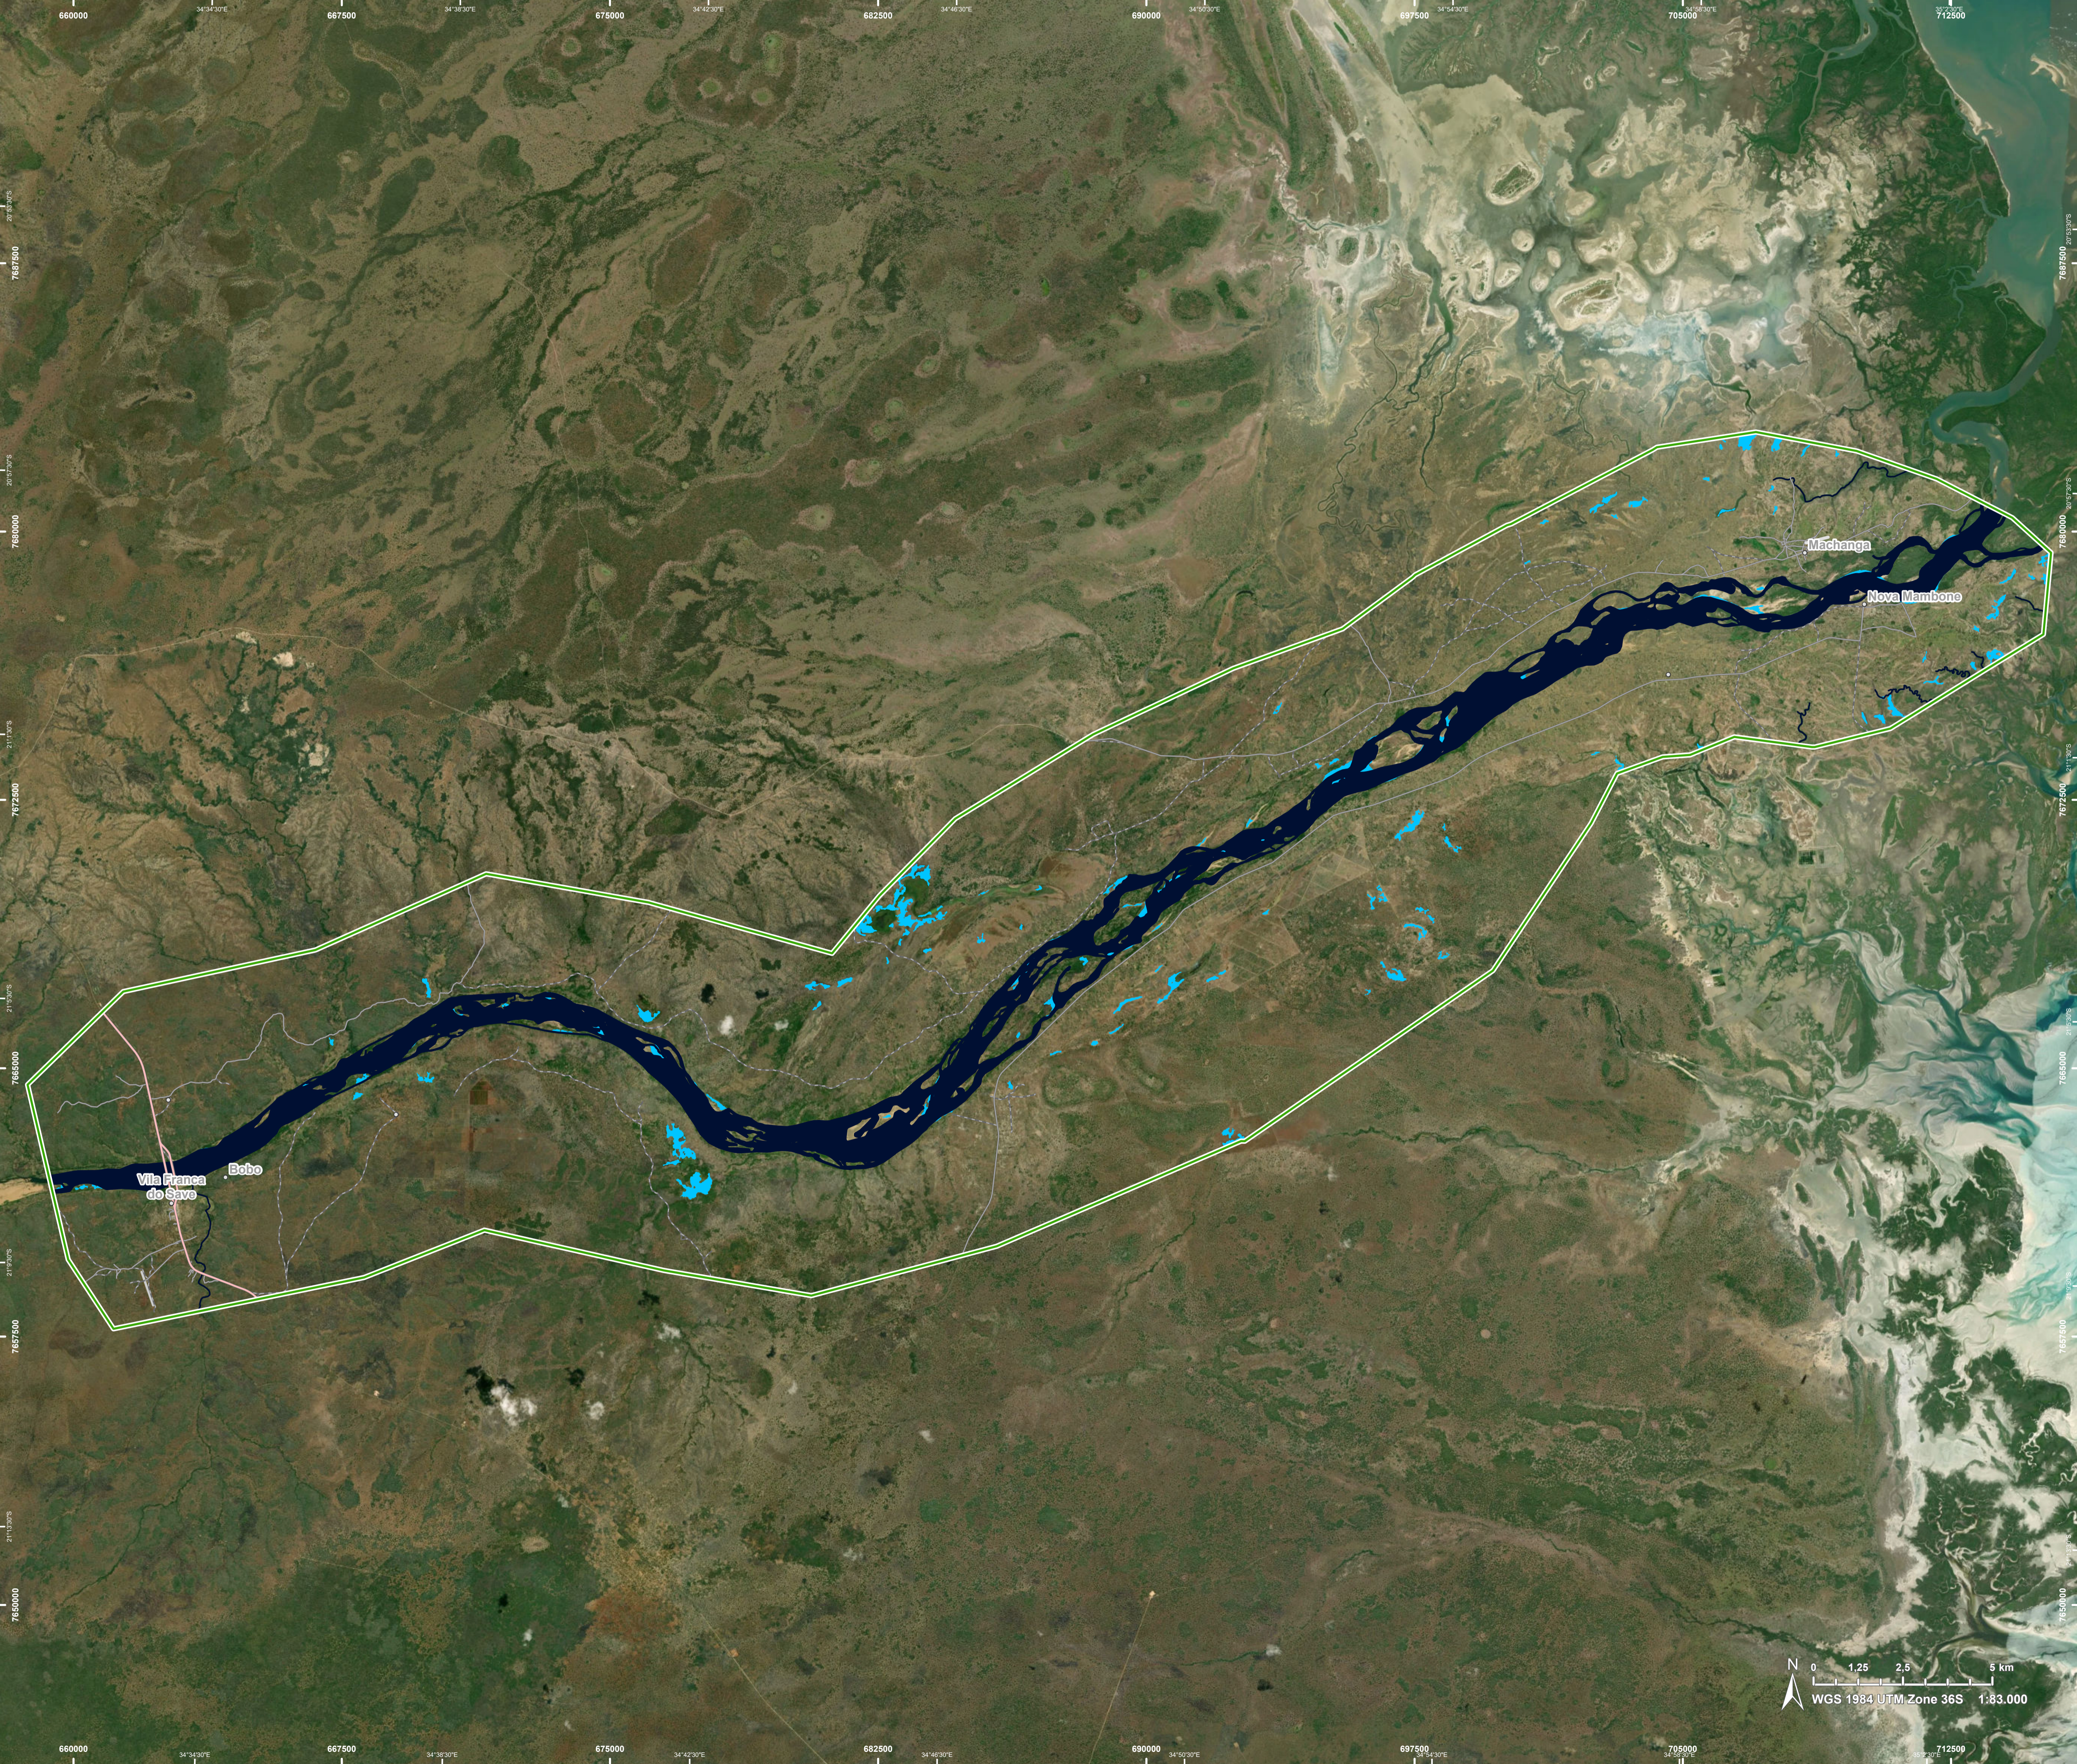
**Flooded area**
639.5 ha

**Potentially affected population**
~ 60

Data sources and analysis:
Post-event image: Sentinel-1 (2026) (acquired on 12/01/2026 at 03:09 UTC, resolution 20 m). All images are provided under COPERNICUS by the European Union and ESA, all rights reserved.

The thematic layer has been derived from post-event satellite image using a semi-automatic approach. Please be aware that the thematic accuracy might be lower in urban and forested areas due to inherent limitations of the SAR analysis technique.
