EMSR857 - AOI13  
Flood in Mozambique and South Africa  
PEQUENOS LIBOMBOS DAM

Situation as of 27/01/2026 10:00 UTC  
Grading MONIT01 - Overview map 01

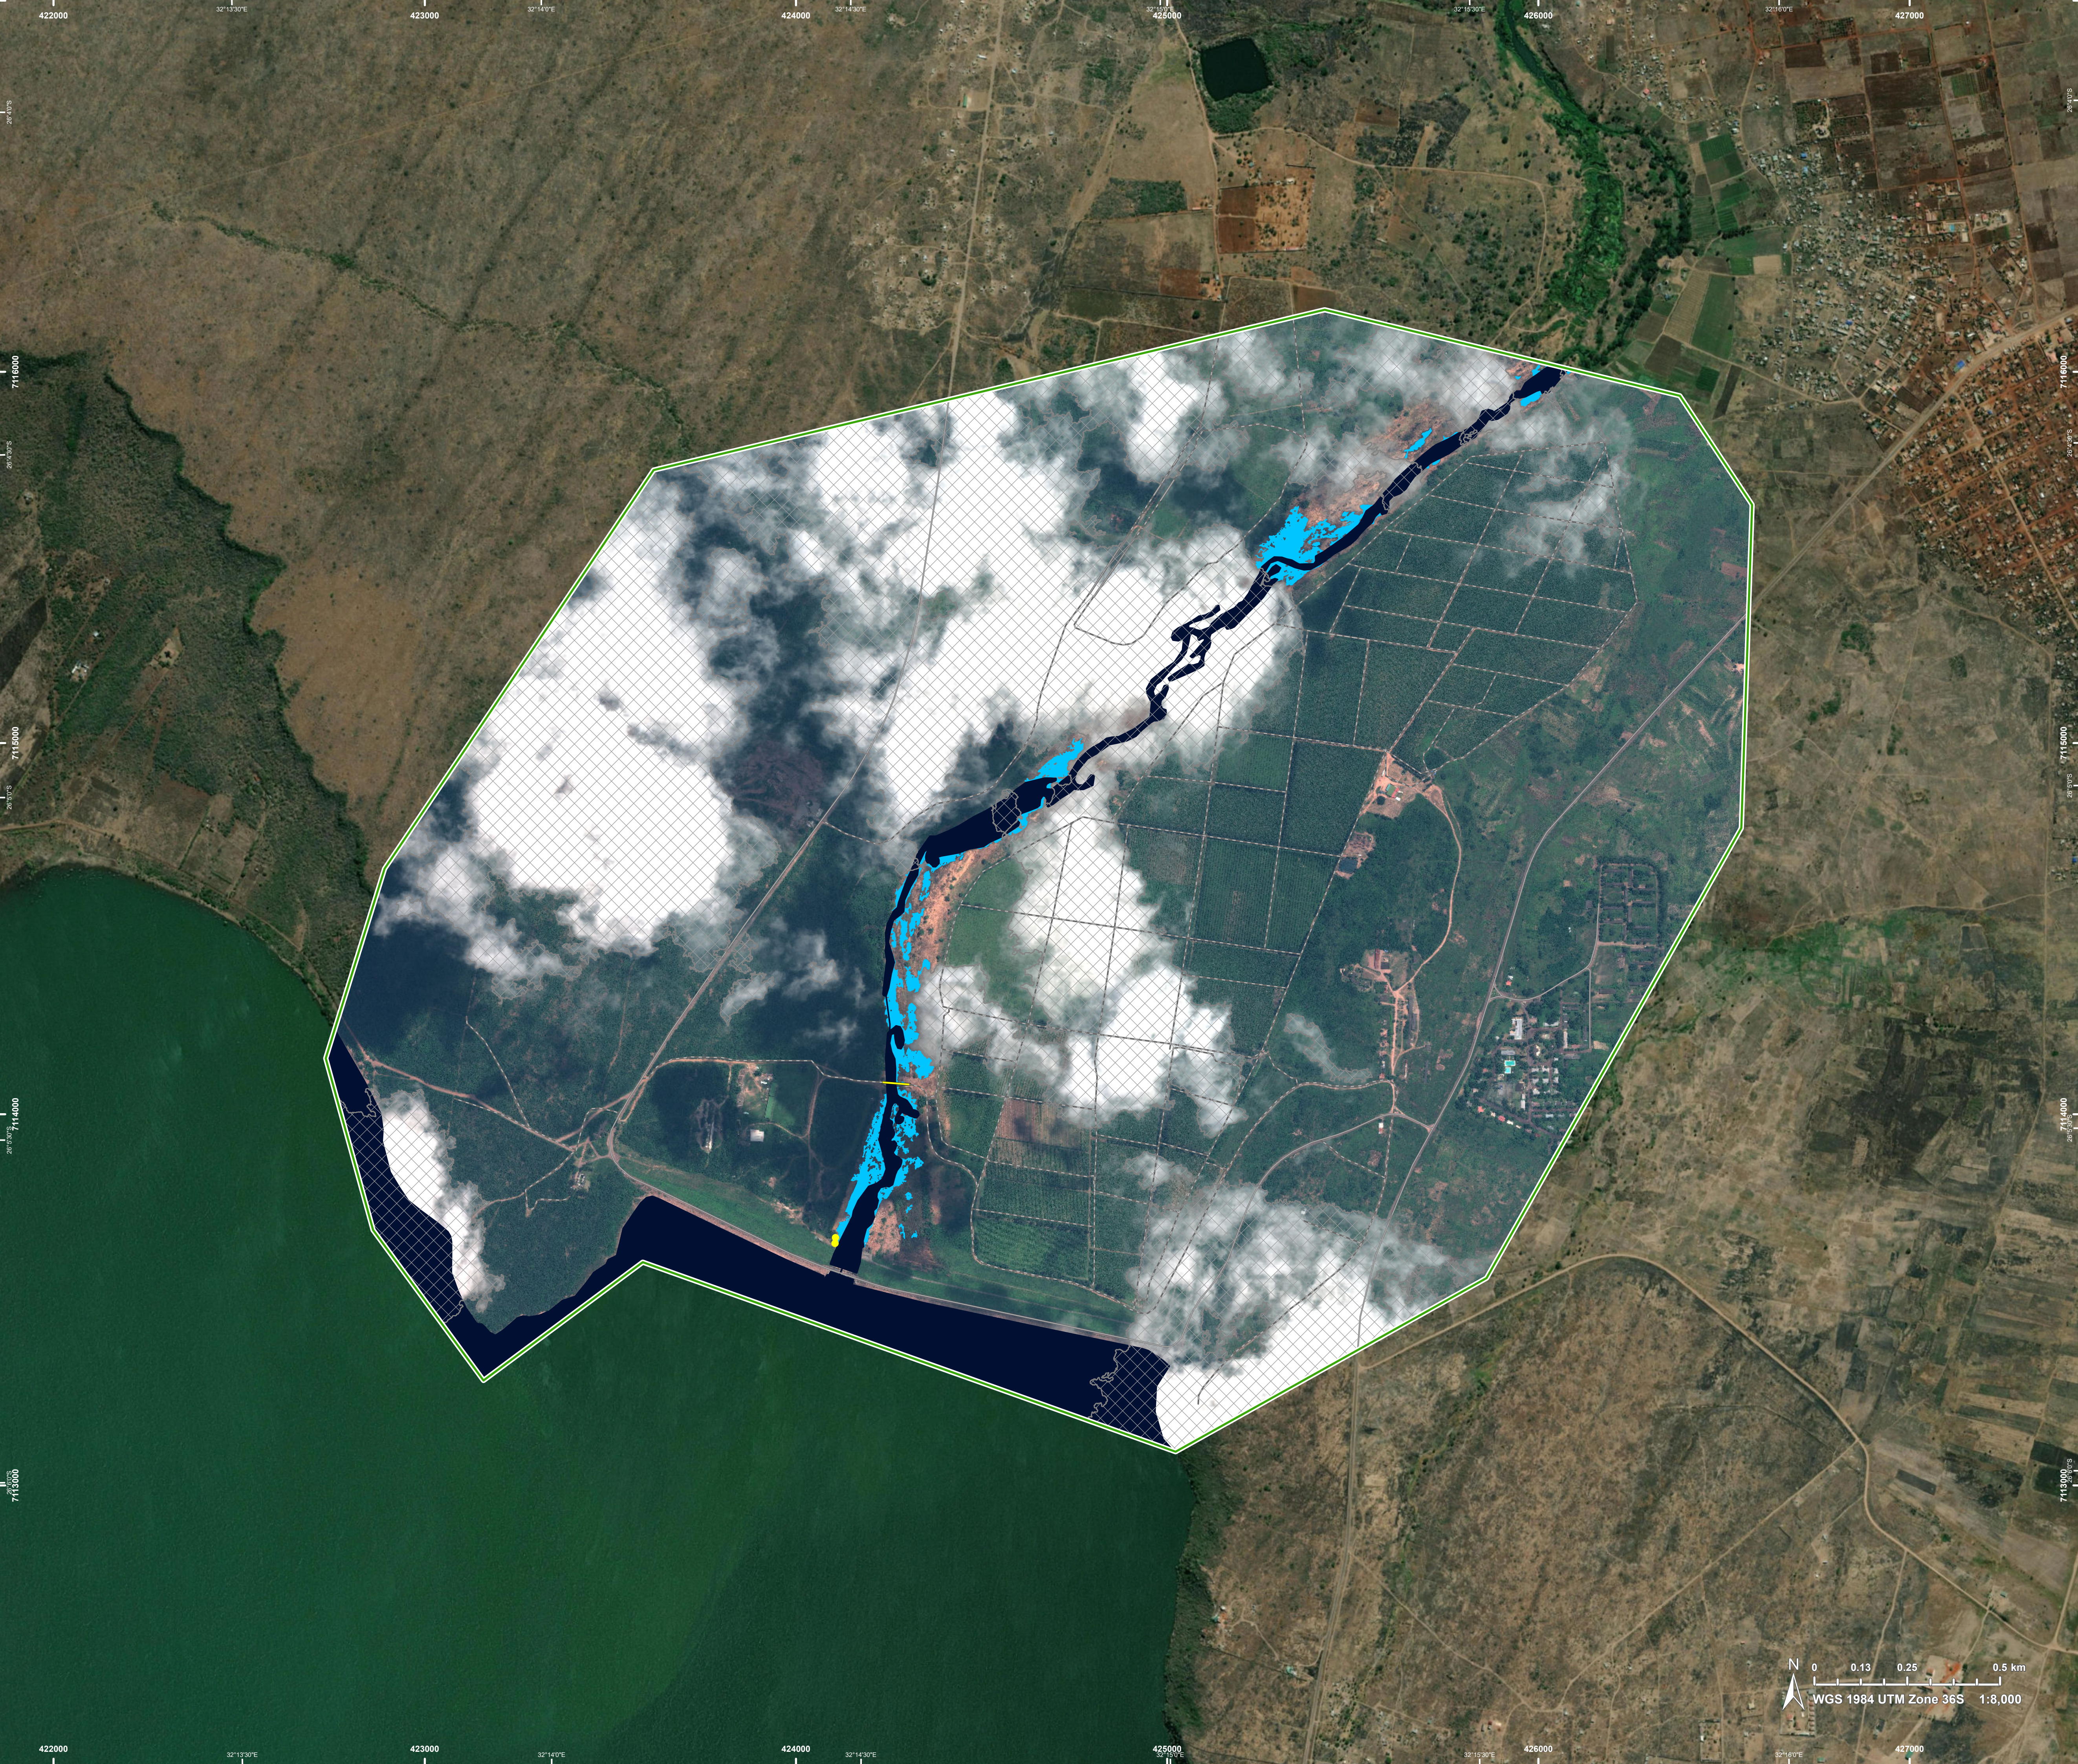
Flooded area  
8.1 ha

Built-Up  
2 No.

Road  
0.1 km

**Event:** Heavy rain that started in December, has caused several floods in Mozambique. The event is ongoing. Copernicus EMS Rapid Mapping is requested to provide initial rough estimation and flood extent emergency mapping

The thematic layer has been derived from post-event satellite image using a semi-automatic approach.
