EMSR857 - AOI17
Flood in Mozambique and
South Africa
SENTEEKO DAM

Situation as of 25/01/2026 07:49 UTC
Grading - Overview map 01

Situation as of 25/01/2026 07:49 UTC
Grading - Detail map 02

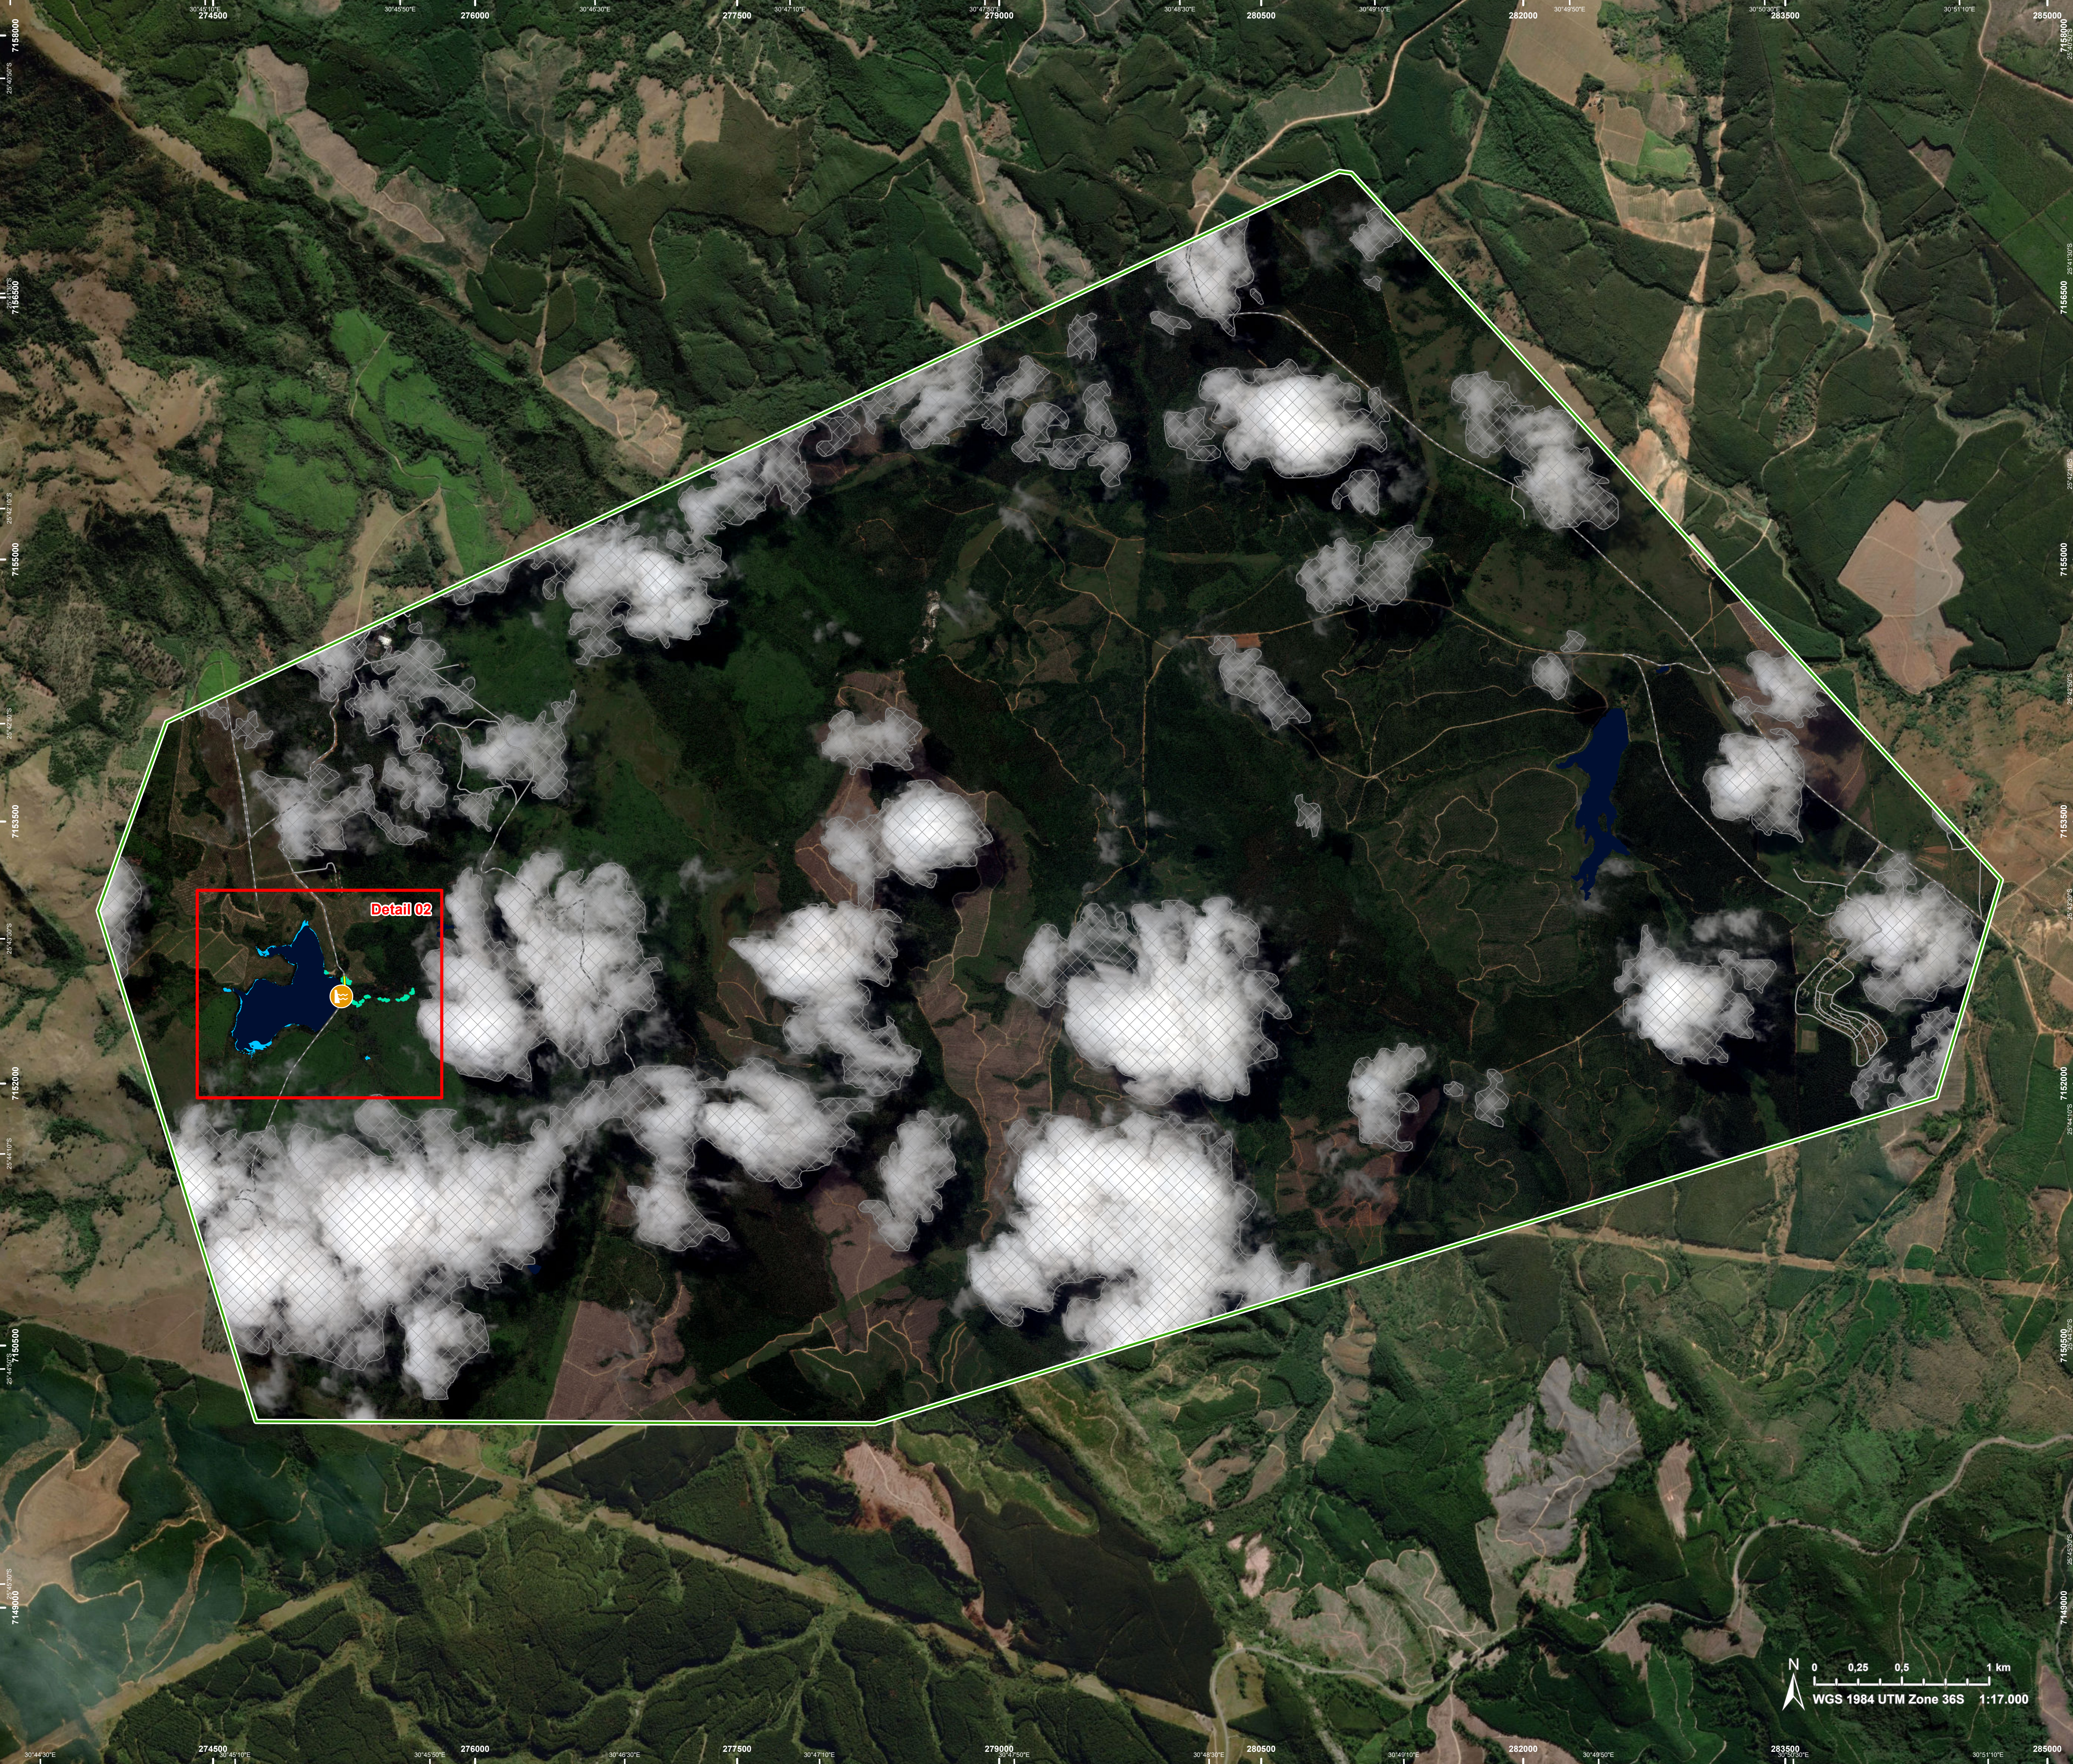
Flood trace
0.3 ha
Flooded area
2.4 ha

Road
0.2 km

Water infrastructure
1 No.

- Flooded Area
- Flood trace
- Dam, Damaged

- Road, Damaged
- Road, Possibly damaged

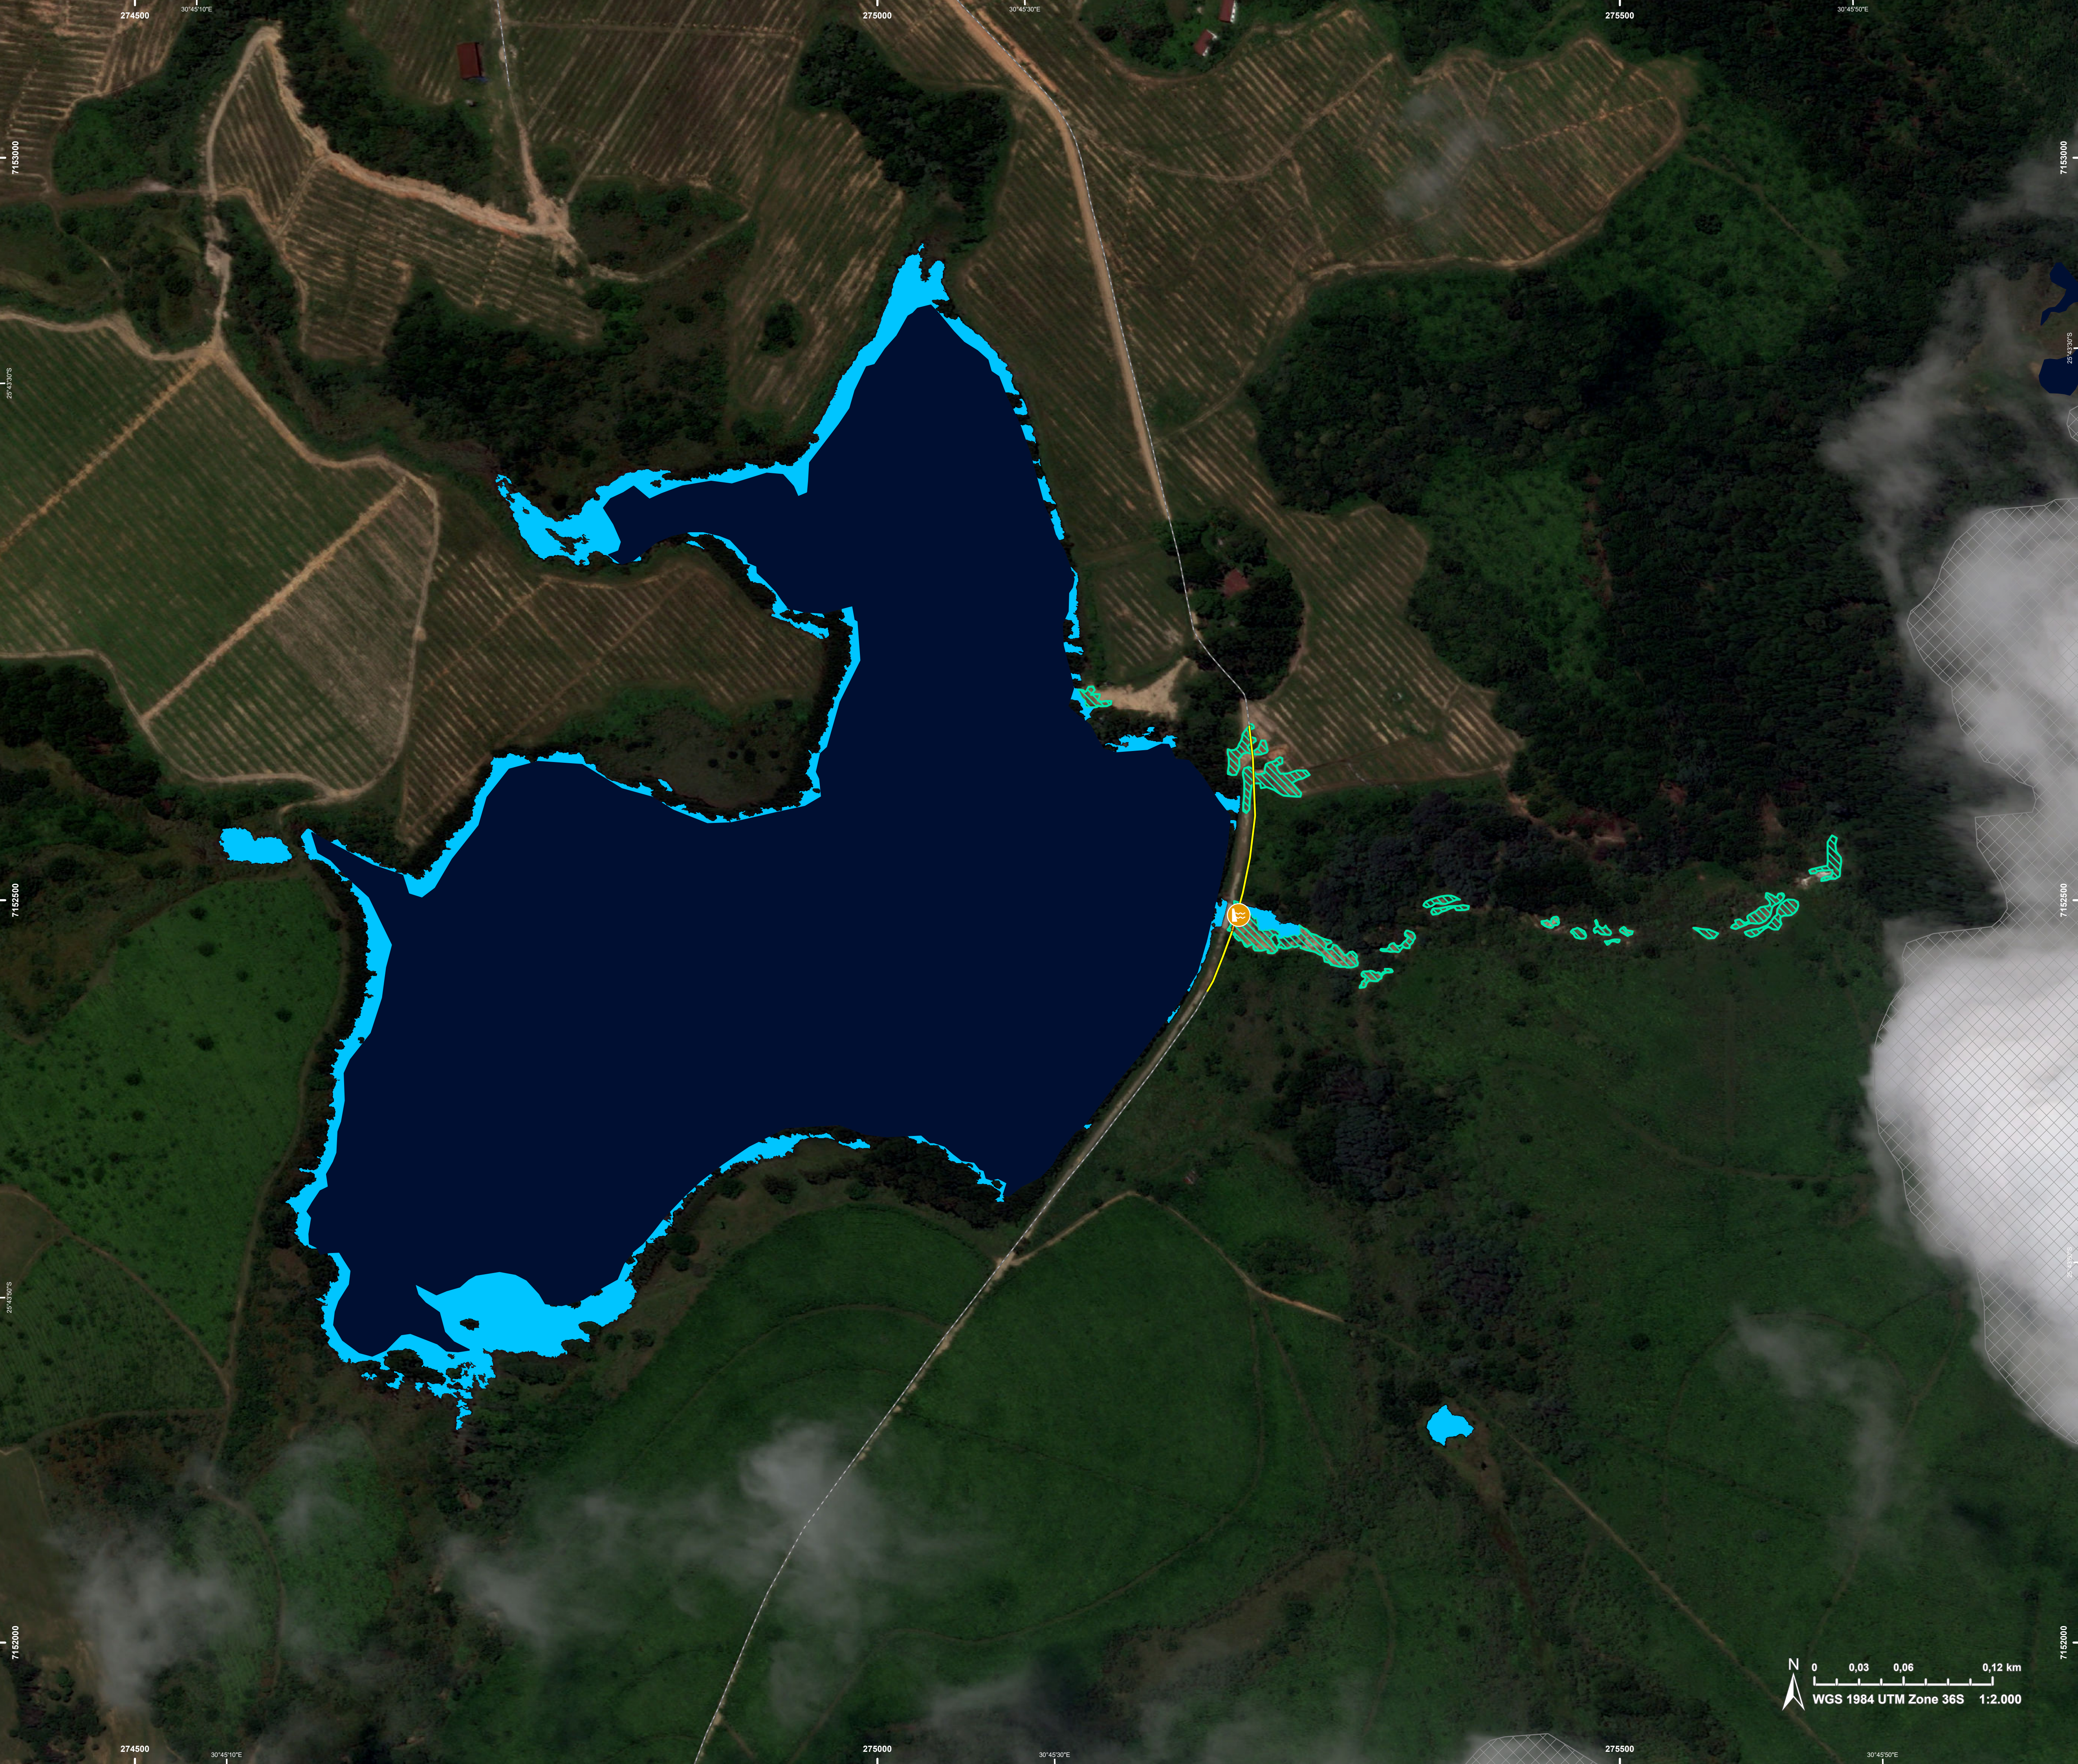
- Crisis Information**
- Flooded Area
 - Flood trace
 - Dam, Damaged
- Transportation Grading**
- Road, Damaged
- General Information**
- Track, No visible damage
 - Not Analysed
- Hydrography**
- Lake, River
- Legend**
- Road, Possibly damaged

LATEST IMPACT	
			Unit of measurement	Imagery-based observation*
Crisis information	Flood trace		ha	0.3
	Flooded area		ha	2.4
	Maximum of all extents**		ha	2.7
