Map produced by ITHACA released by e-GEOS on the 09/02/2026.

EMSR861 - AOI03
Storm Kristin and Flooding in Central Portugal,
Galicia and Andalusia, Spain
MENGIBAR

Situation as of 08/02/2026 09:38 UTC
Delineation MONIT02 - Detail map 02

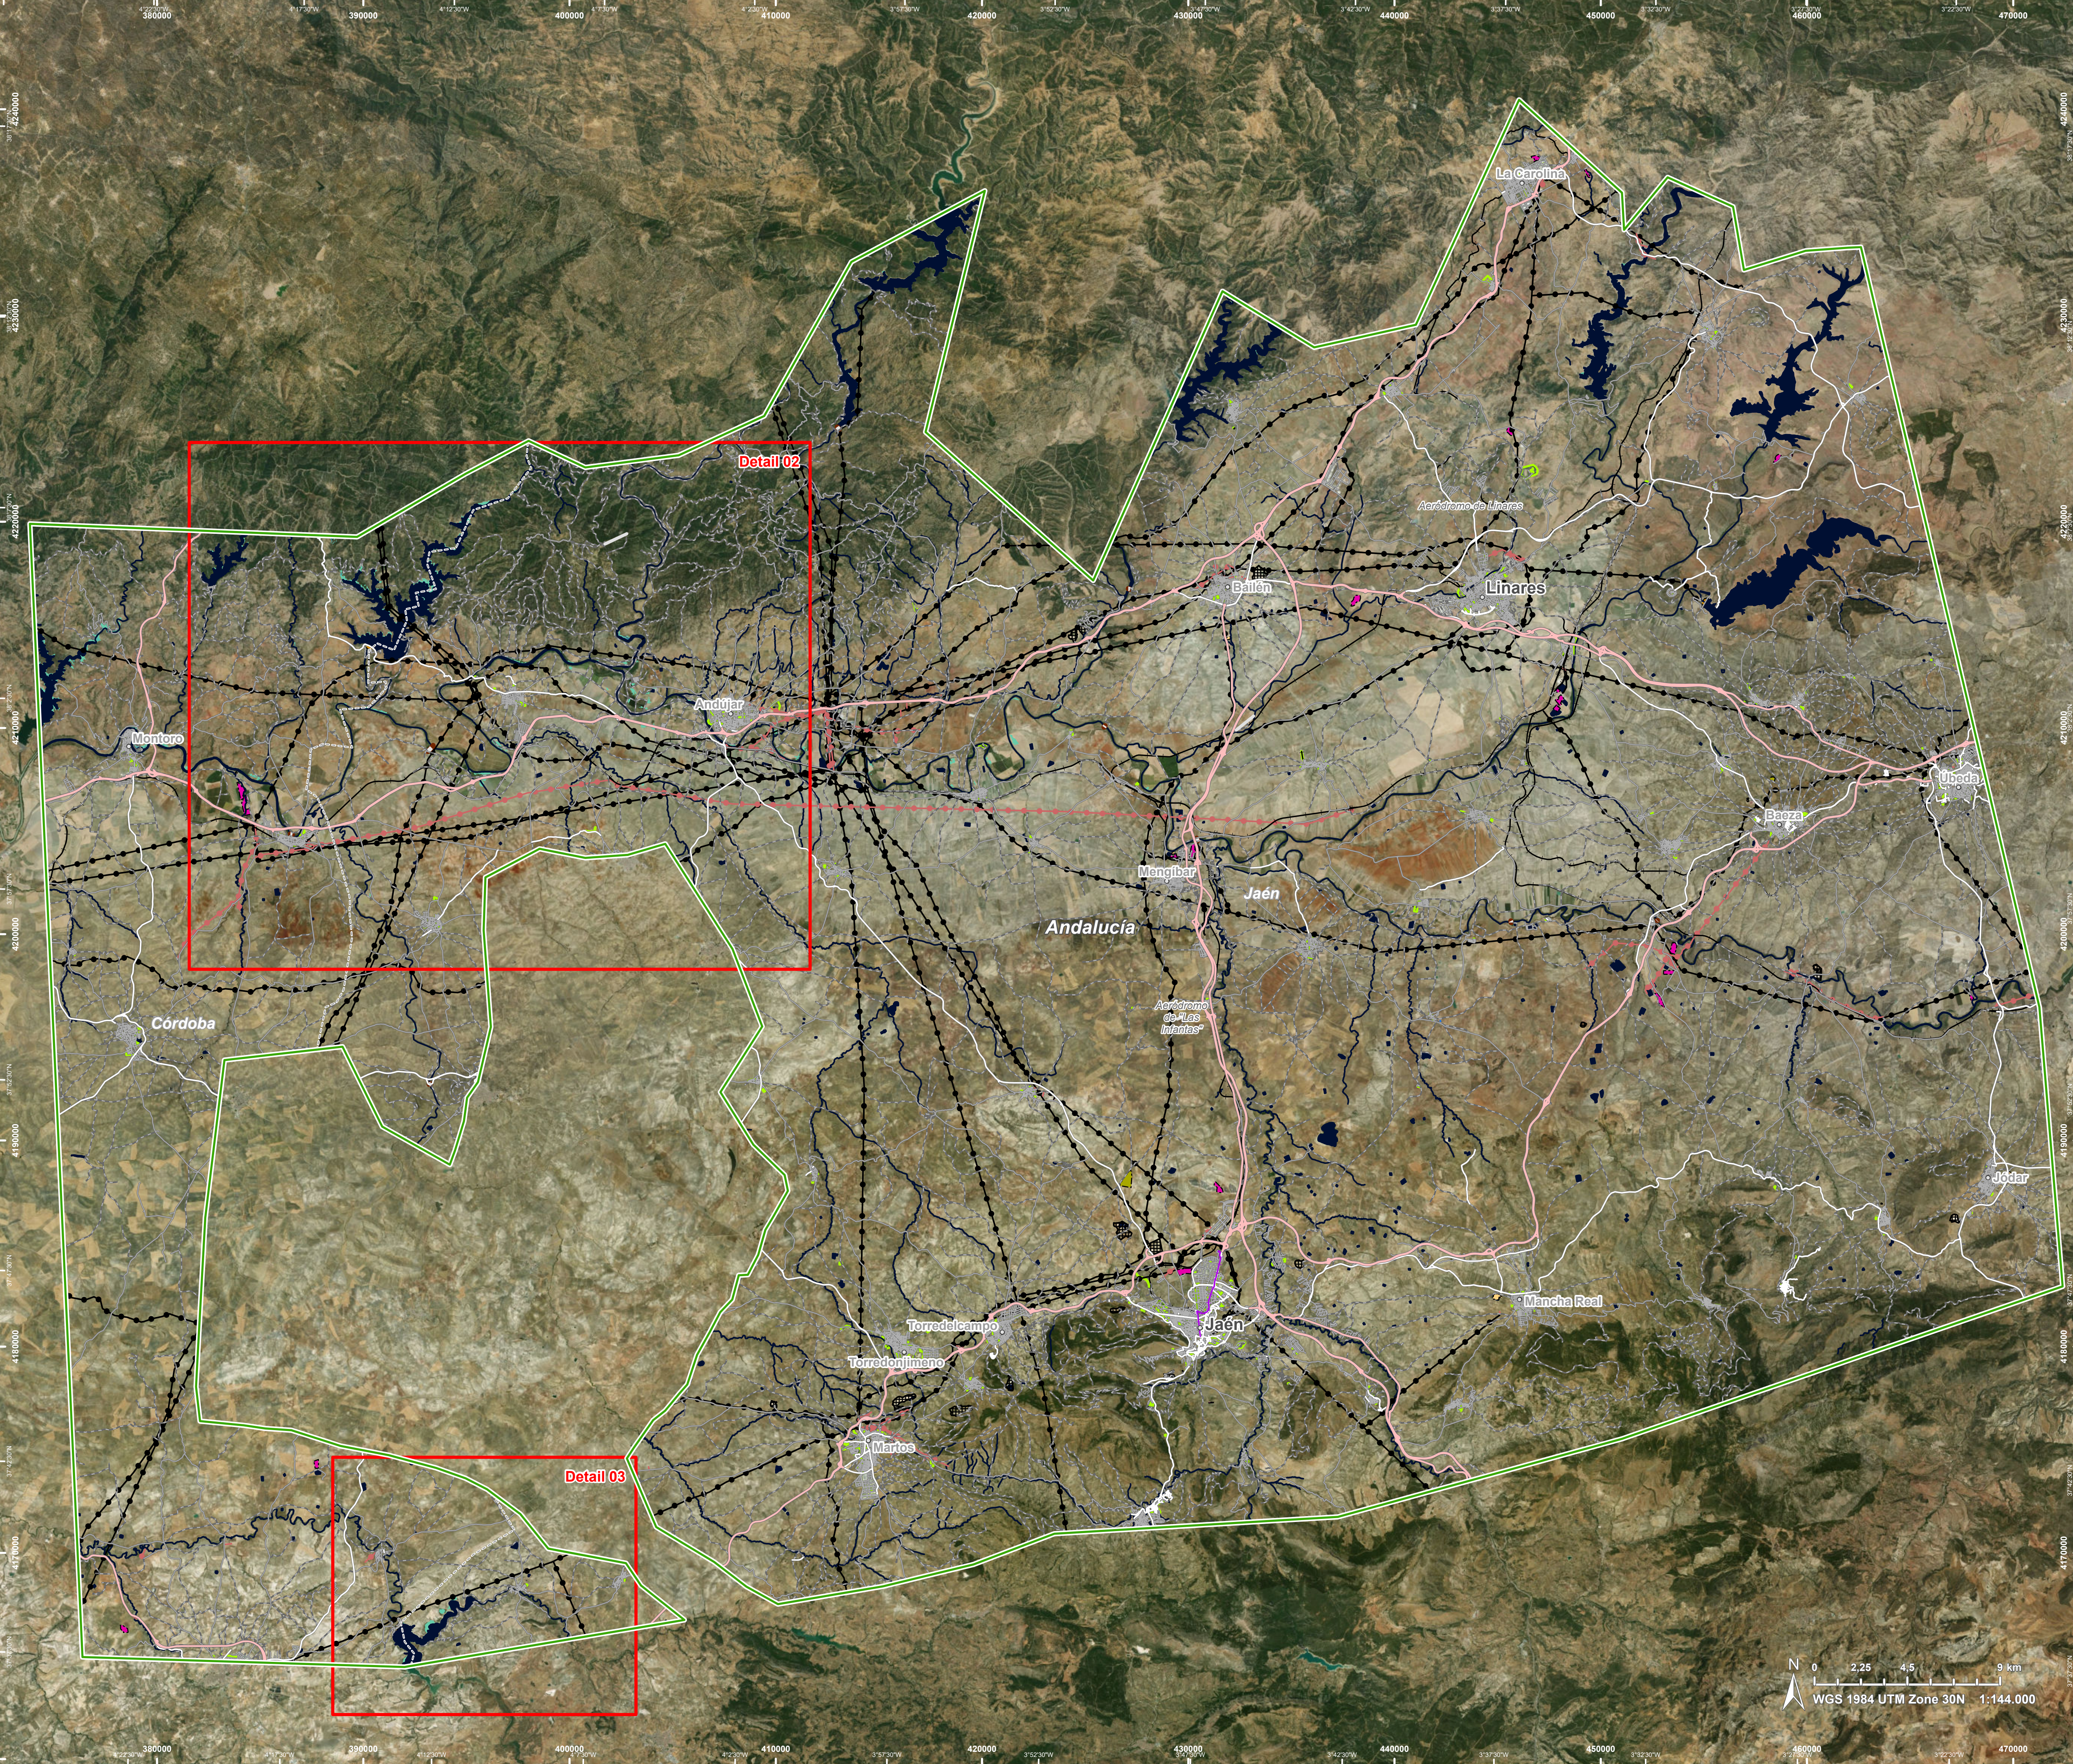
Flooded area
EO-based 327.7 ha
Model-based 709.6 ha

Potentially affected population
~ 60

Potentially Affected Built-up and Transportations

Water infrastructure
0.2 ha

Road
3.1 km

Built-Up
0.5 ha

The flooded area corresponds to the water observed in the most recent satellite imagery, excluding the permanent water. An extrapolated flood extent is generated by integrating observed flood areas with a Digital Terrain Model (DTM). The model's accuracy and spatial coverage depend on DTM resolution and quality, enabling the prediction of potentially flooded areas in regions with limited visibility in imagery, such as urban and forested zones.

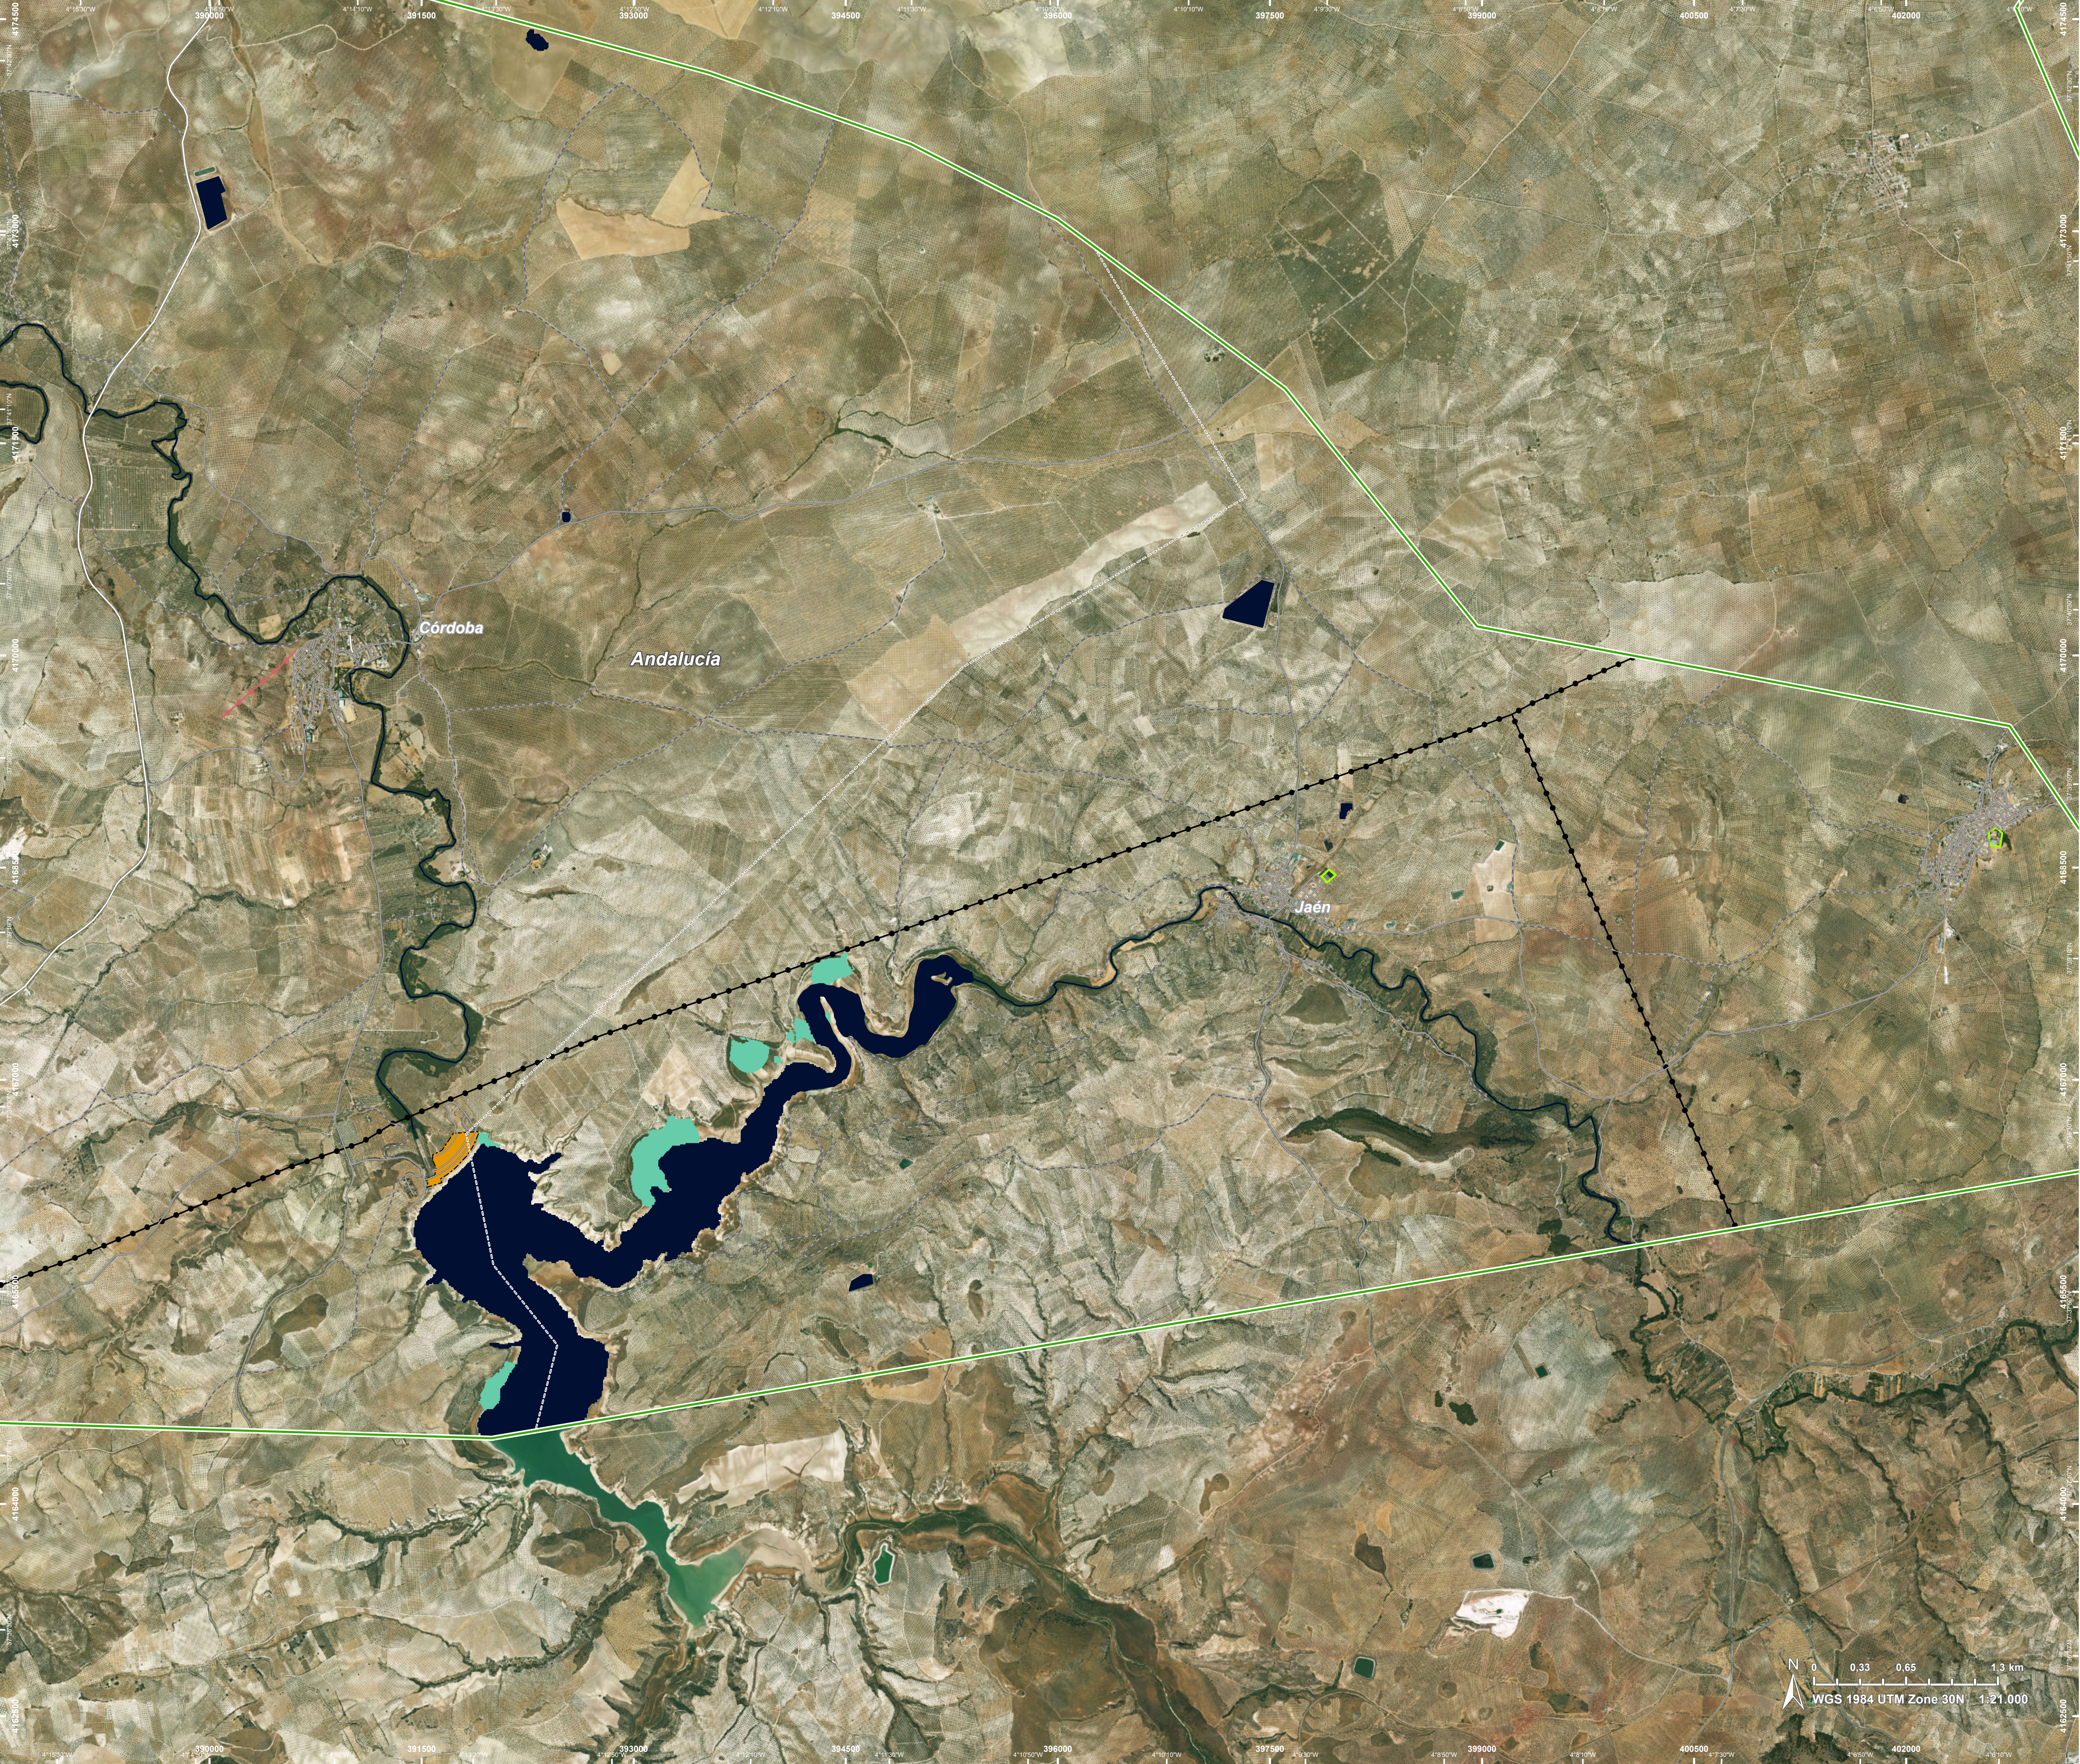
The flooded area corresponds to the water observed in the most recent satellite imagery, excluding the permanent water. An extrapolated flood extent is generated by integrating observed flood areas with a Digital Terrain Model (DTM). The model's accuracy and spatial coverage depend on DTM resolution and quality, enabling the prediction of potentially flooded areas in regions with limited visibility in imagery, such as urban and forested zones.

Unit of measurement	LATEST IMPACT		
				Imagery-based observation*	Model-based output	Imagery- and Model-based results
Crisis information	Flooded area		ha	327.7	709.6	1,037.3
	Maximum of all extents**		ha	327.7	709.6	1,037.3

POTENTIALLY AFFECTED		TOTAL POTENTIALLY AFFECTED	Total in AOI
Estimated population		Inhabitants	No.	~ 30	~ 30	~ 60	~ 460,000
Assets	Built-up	Residential Buildings	ha	0.04	0.01	0.05	3,424.1
		Office buildings	ha	0	0	0	97.8
		Wholesale and retail trade buildings	ha	0	0	0	9.2
		Industrial buildings	ha	0.2	0.3	0.5	1,718.1
		School, university and research buildings	ha	0	0	0	147.9
		Hospital or institutional care buildings	ha	0	0	0	14.2
		Military	ha	0	0	0	118.8
		Cemetery	ha	0	0	0	49.5
	Transportation	Airfield runways	ha	0	0	0	5.5
		Helipad	ha	0	0	0	7.8
		Airfield runways	km	0	0	0	3.1
		Highways	km	0.2	0.1	0.3	774.3
		Primary Road	km	0	0	0	299.8
		Secondary Road	km	0	0	0	280.1
		Local Road	km	0.4	0.2	0.5	3,368.1
		Cart Track	km	1.1	1.2	2.3	5,123.2
		Tramway	km	0	0	0	10.0
		Long-distance railways	km	0	0	0	372.7
	Facilities	Settling Basin	ha	0	0.2	0.2	32.5
		Dams	ha	0	0.04	0.04	24.5
		Constructions for mining or extraction	ha	0	0	0	315.7

Power plant constructions	ha	0	0	0	199.6
		Sport and recreation constructions	ha	0	0.1	0.1	585.3
		Other civil engineering works not elsewhere classified	ha	0	0	0	33.4
		Long-distance pipelines, communication and electricity lines	km	0.5	1.0	1.5	1,106.0
		Local pipelines and cables	km	0.03	0.03	0.1	142.9
		Dams	km	0	0	0	1.1
			Land use	Other	ha	181.2	578.9
Shrub and/or herbaceous vegetation association	ha			42.6	19.3	61.9	42,561.3
Permanent crops	ha			41.0	33.5	74.5	316,338.9
Arable land	ha			33.6	56.4	90.0	41,488.9
Forests	ha			15.2	13.5	28.7	17,212.6
Heterogeneous agricultural areas	ha			12.4	4.1	16.5	25,168.4
Pastures	ha			1.8	3.9	5.7	1,146.8
Open spaces with little or no vegetation	ha			0	0	0	1,314.1
