EMSR927 - AOI02

Flood in Nepal

TIMURE

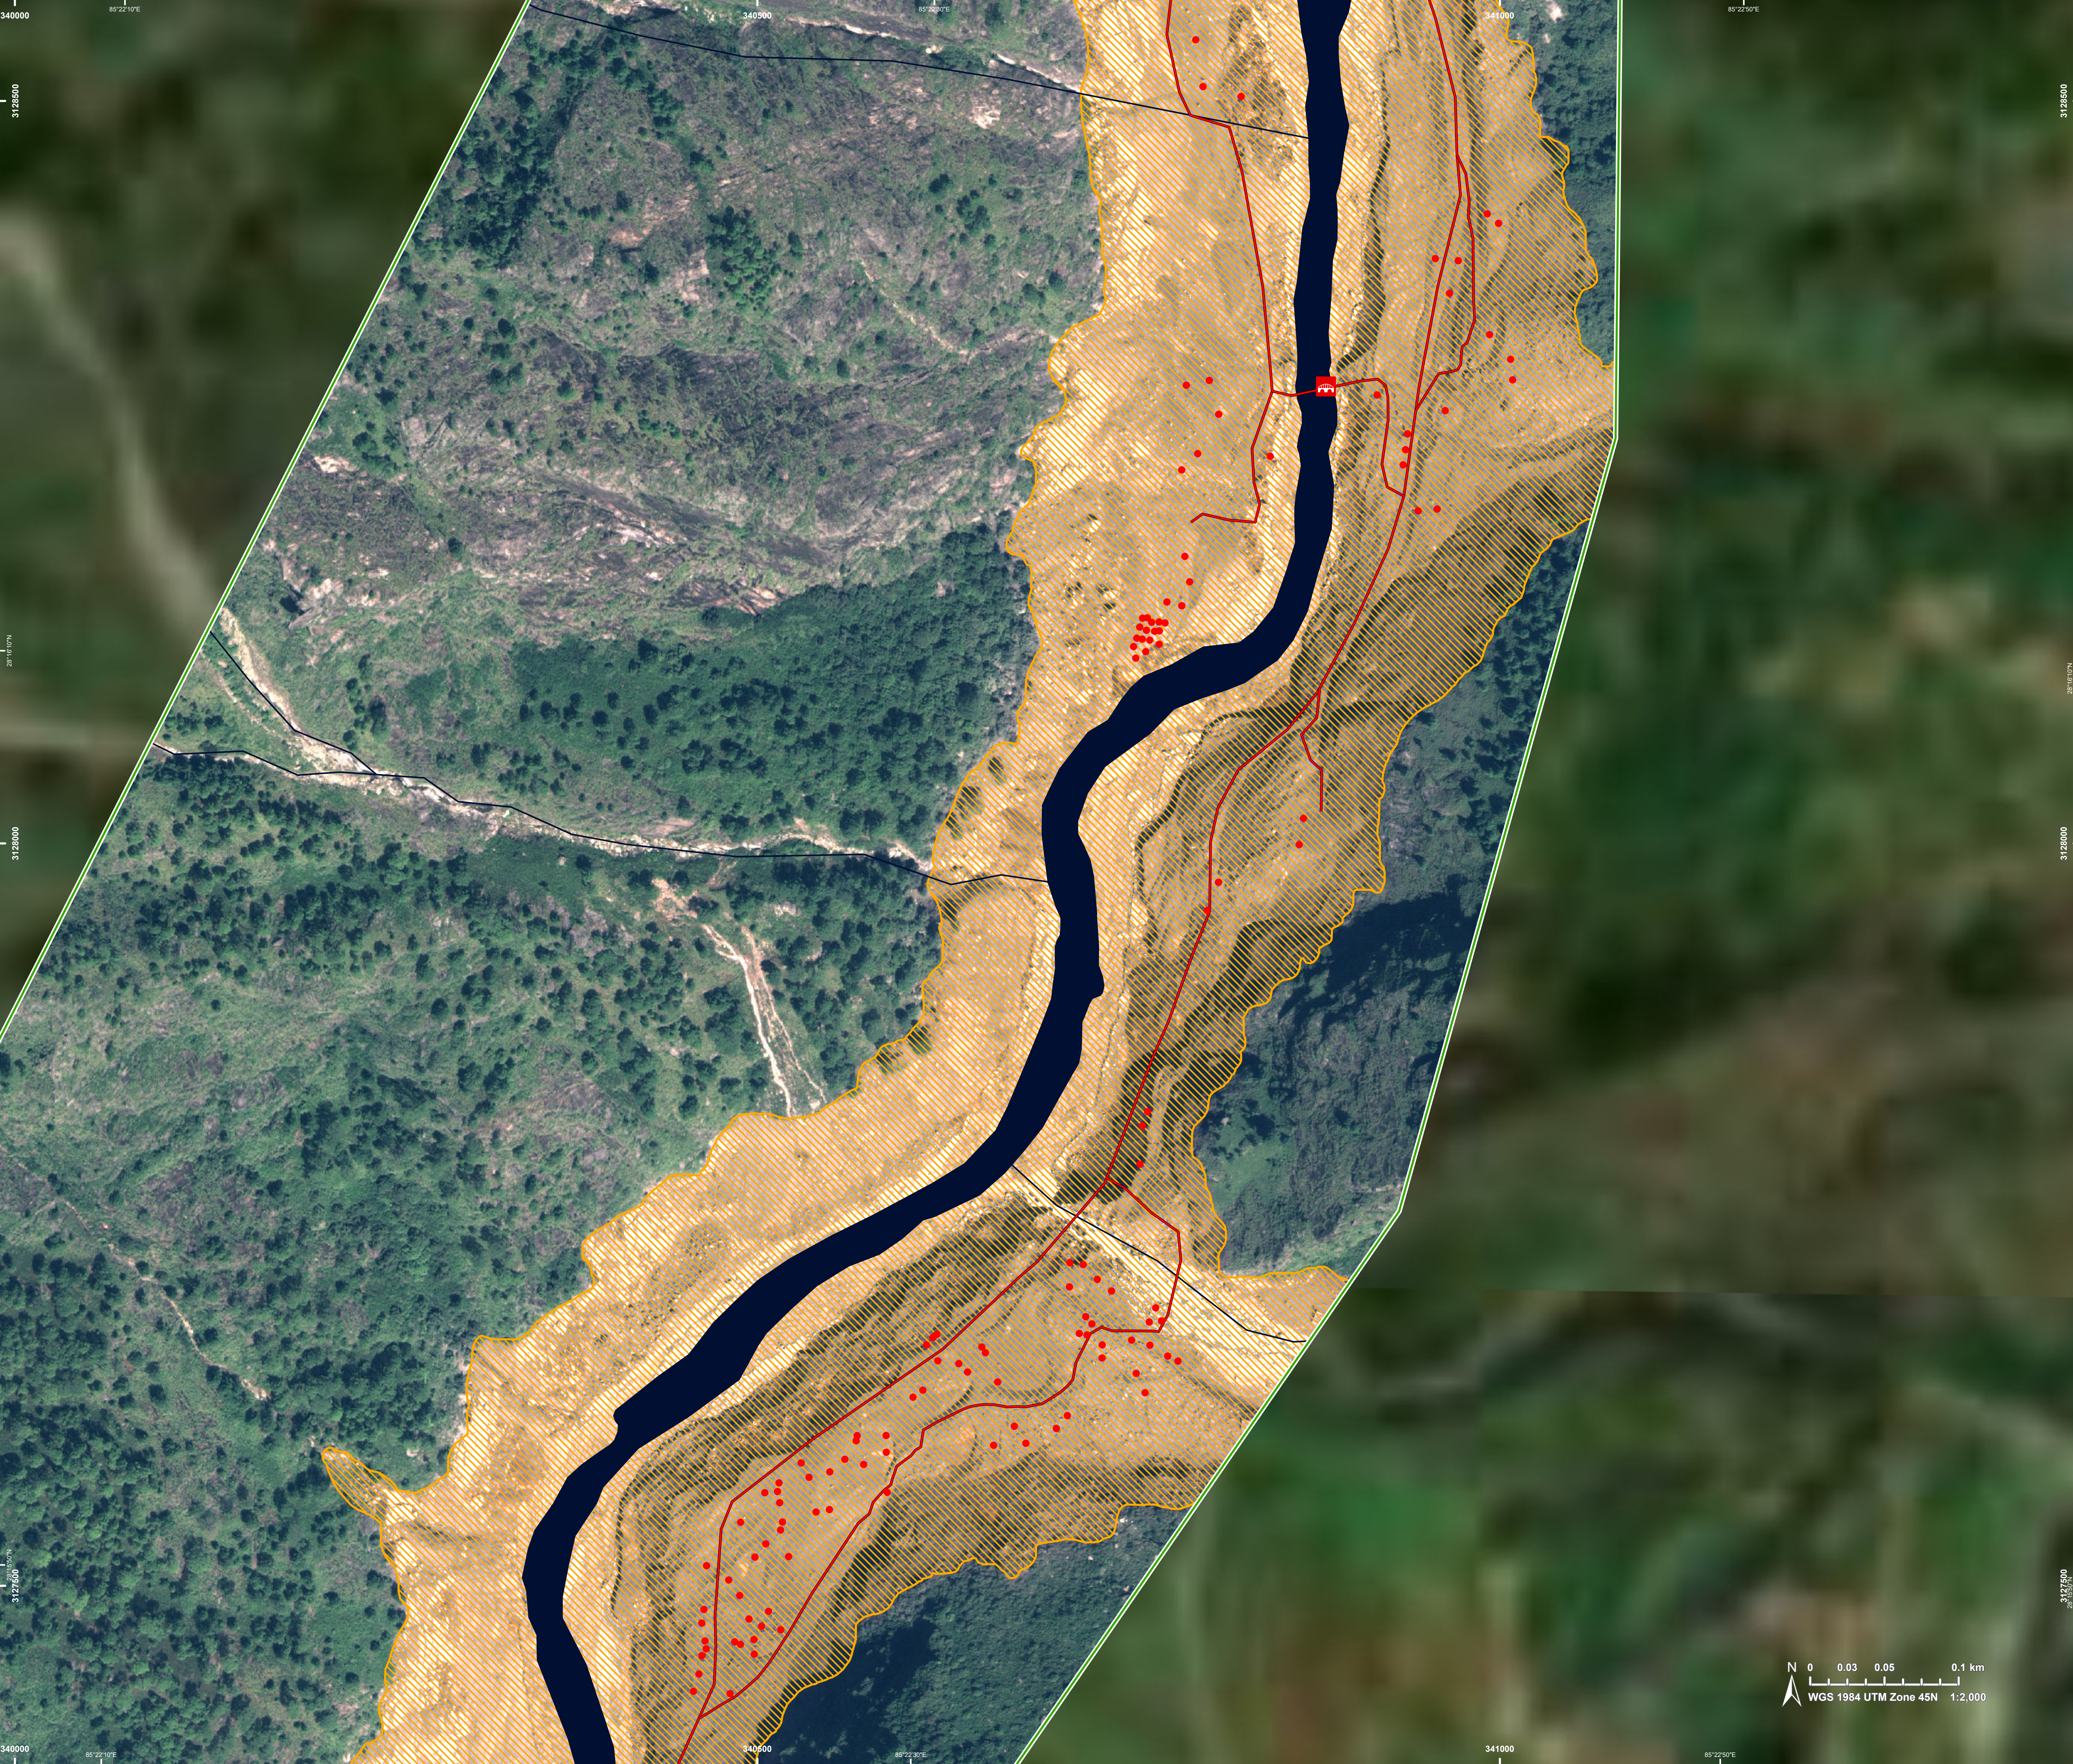
**Situation as of 27/08/2026 05:05 UTC**  
Grading - Detail map 02

**Event:** On the 26 August 2026, a flash flood reportedly triggered by a Glacial Lake Outburst Flood (GLOF) in Nepal has caused significant damage in Rasuwa District. There is a 7 m-deep water level recorded by monitoring stations. Copernicus EMS Rapid Mapping is requested to provide flood extent and damage assessment emergency mapping.

The thematic layer has been derived from post-event satellite image by means of visual interpretation.

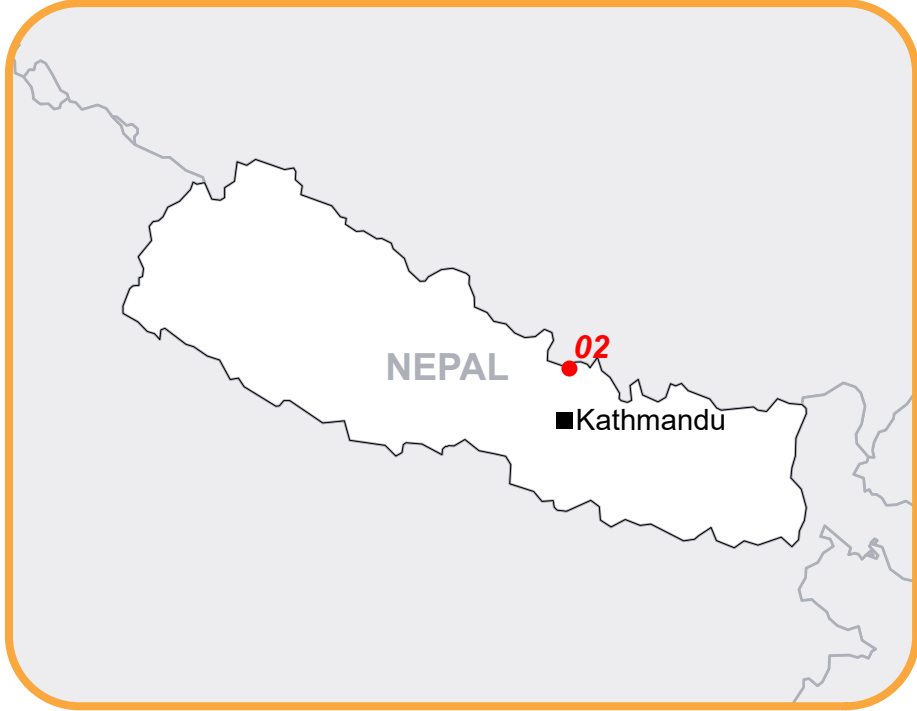
Landslide

Destroyed

Bridge and elevated highway, Destroyed

Road, Destroyed

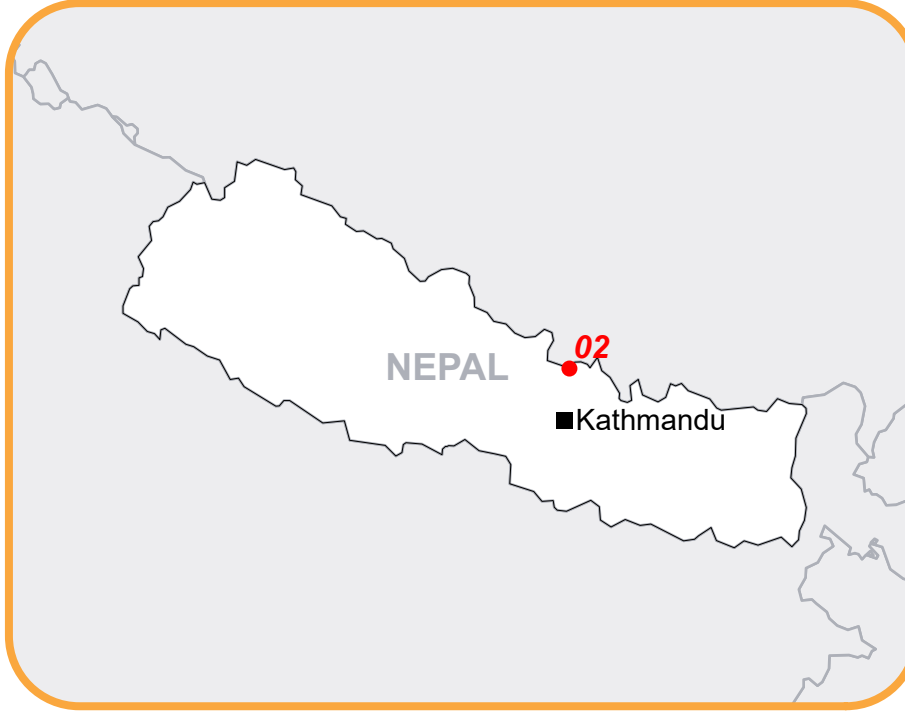
Situation as of 27/08/2026 05:05 UTC  
Grading - Detail map 03

Damaged

Road, Possibly damaged
