**Event:** On the 26 August 2026, a flash flood reportedly triggered by a Glacial Lake Outburst Flood (GLOF) in Nepal has caused significant damage in Rasuwa District. There is a 7 m-deep water level recorded by monitoring stations. Copernicus EMS Rapid Mapping is requested to provide flood extent and damage assessment emergency mapping.

Situation as of 27/08/2026 05:05 UTC  
Grading - Detail map 02

Situation as of 27/08/2026 05:05 UTC  
Grading - Detail map 03

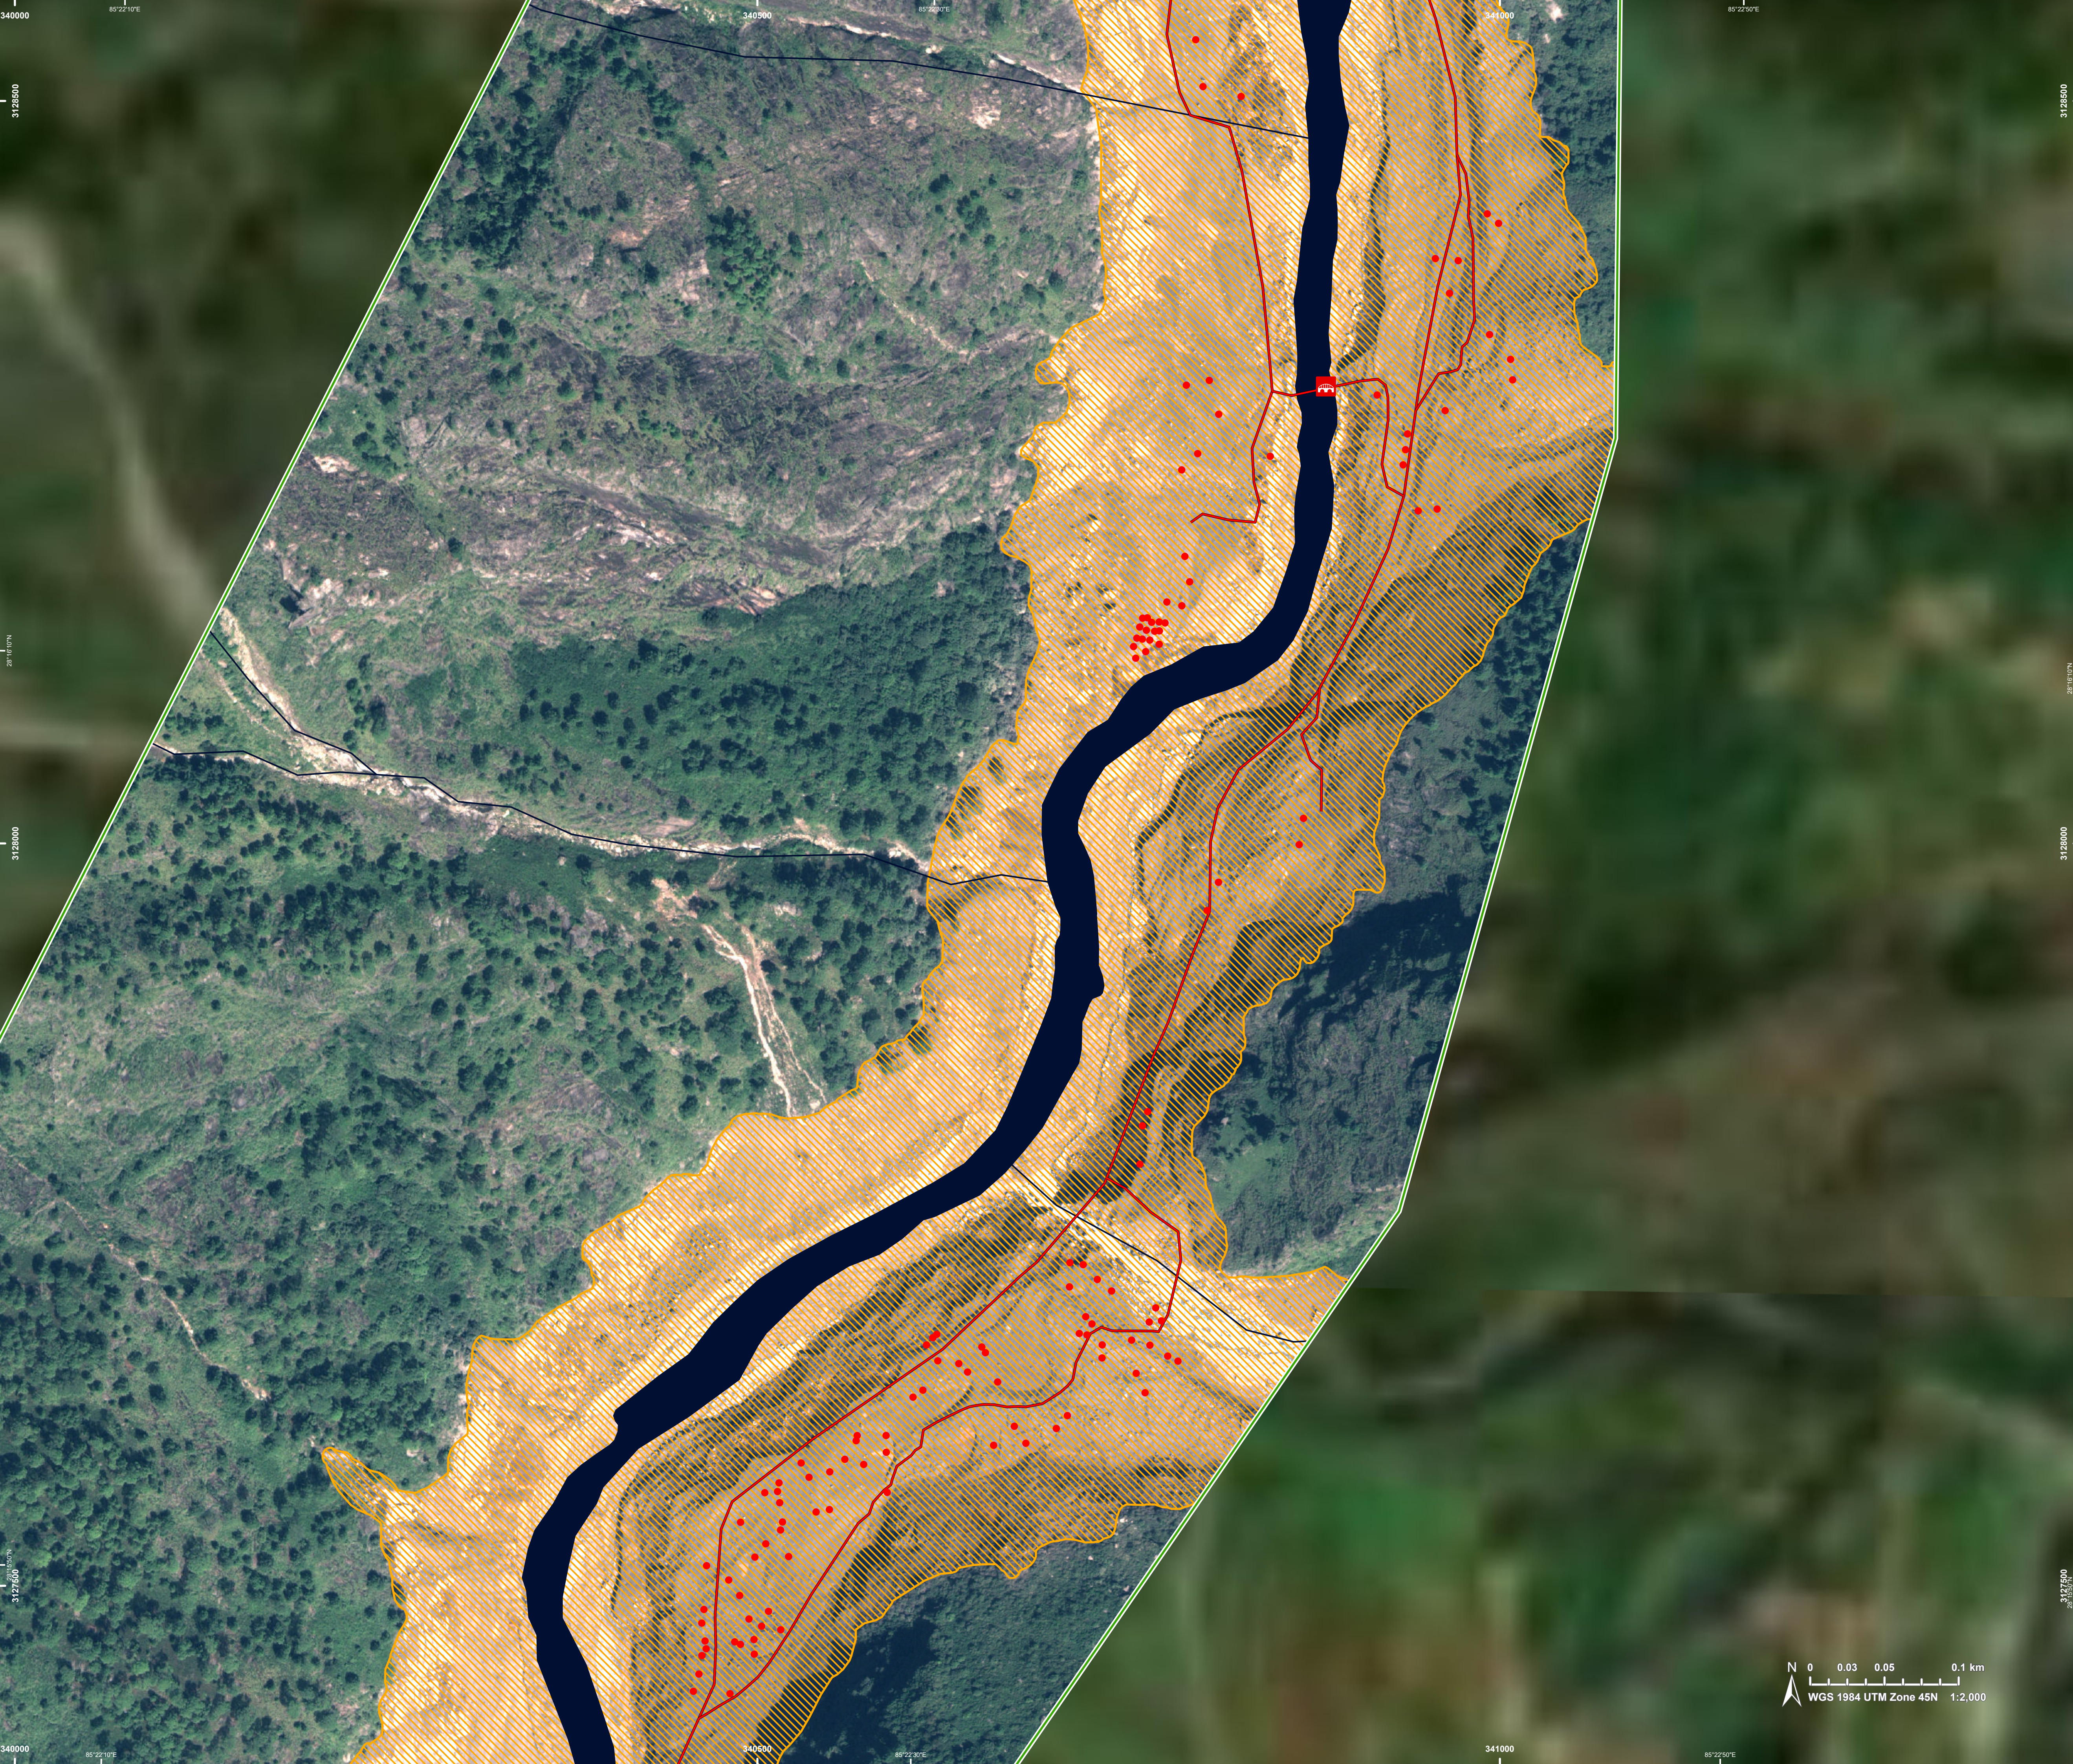
**Event:** On the 26 August 2026, a flash flood reportedly triggered by a Glacial Lake Outburst Flood (GLOF) in Nepal has caused significant damage in Rasuwa District. There is a 7 m-deep water level recorded by monitoring stations. Copernicus EMS Rapid Mapping is requested to provide flood extent and damage assessment emergency mapping.

The thematic layer has been derived from post-event satellite image by means of visual interpretation.
