**EMSR927 - AOI05**  
Flood in Nepal  
PHOSRETAR

**Situation as of 05/09/2026 06:32 UTC**  
Grading MONIT01 - Overview map 01

**Event:** On the 26 August 2026, a flash flood reportedly triggered by a Glacial Lake Outburst Flood (GLOF) in Nepal has caused significant damage in Rasuwa District. There is a 7 m-deep water level recorded by monitoring stations. Copernicus EMS Rapid Mapping is requested to provide flood extent and damage assessment emergency mapping.

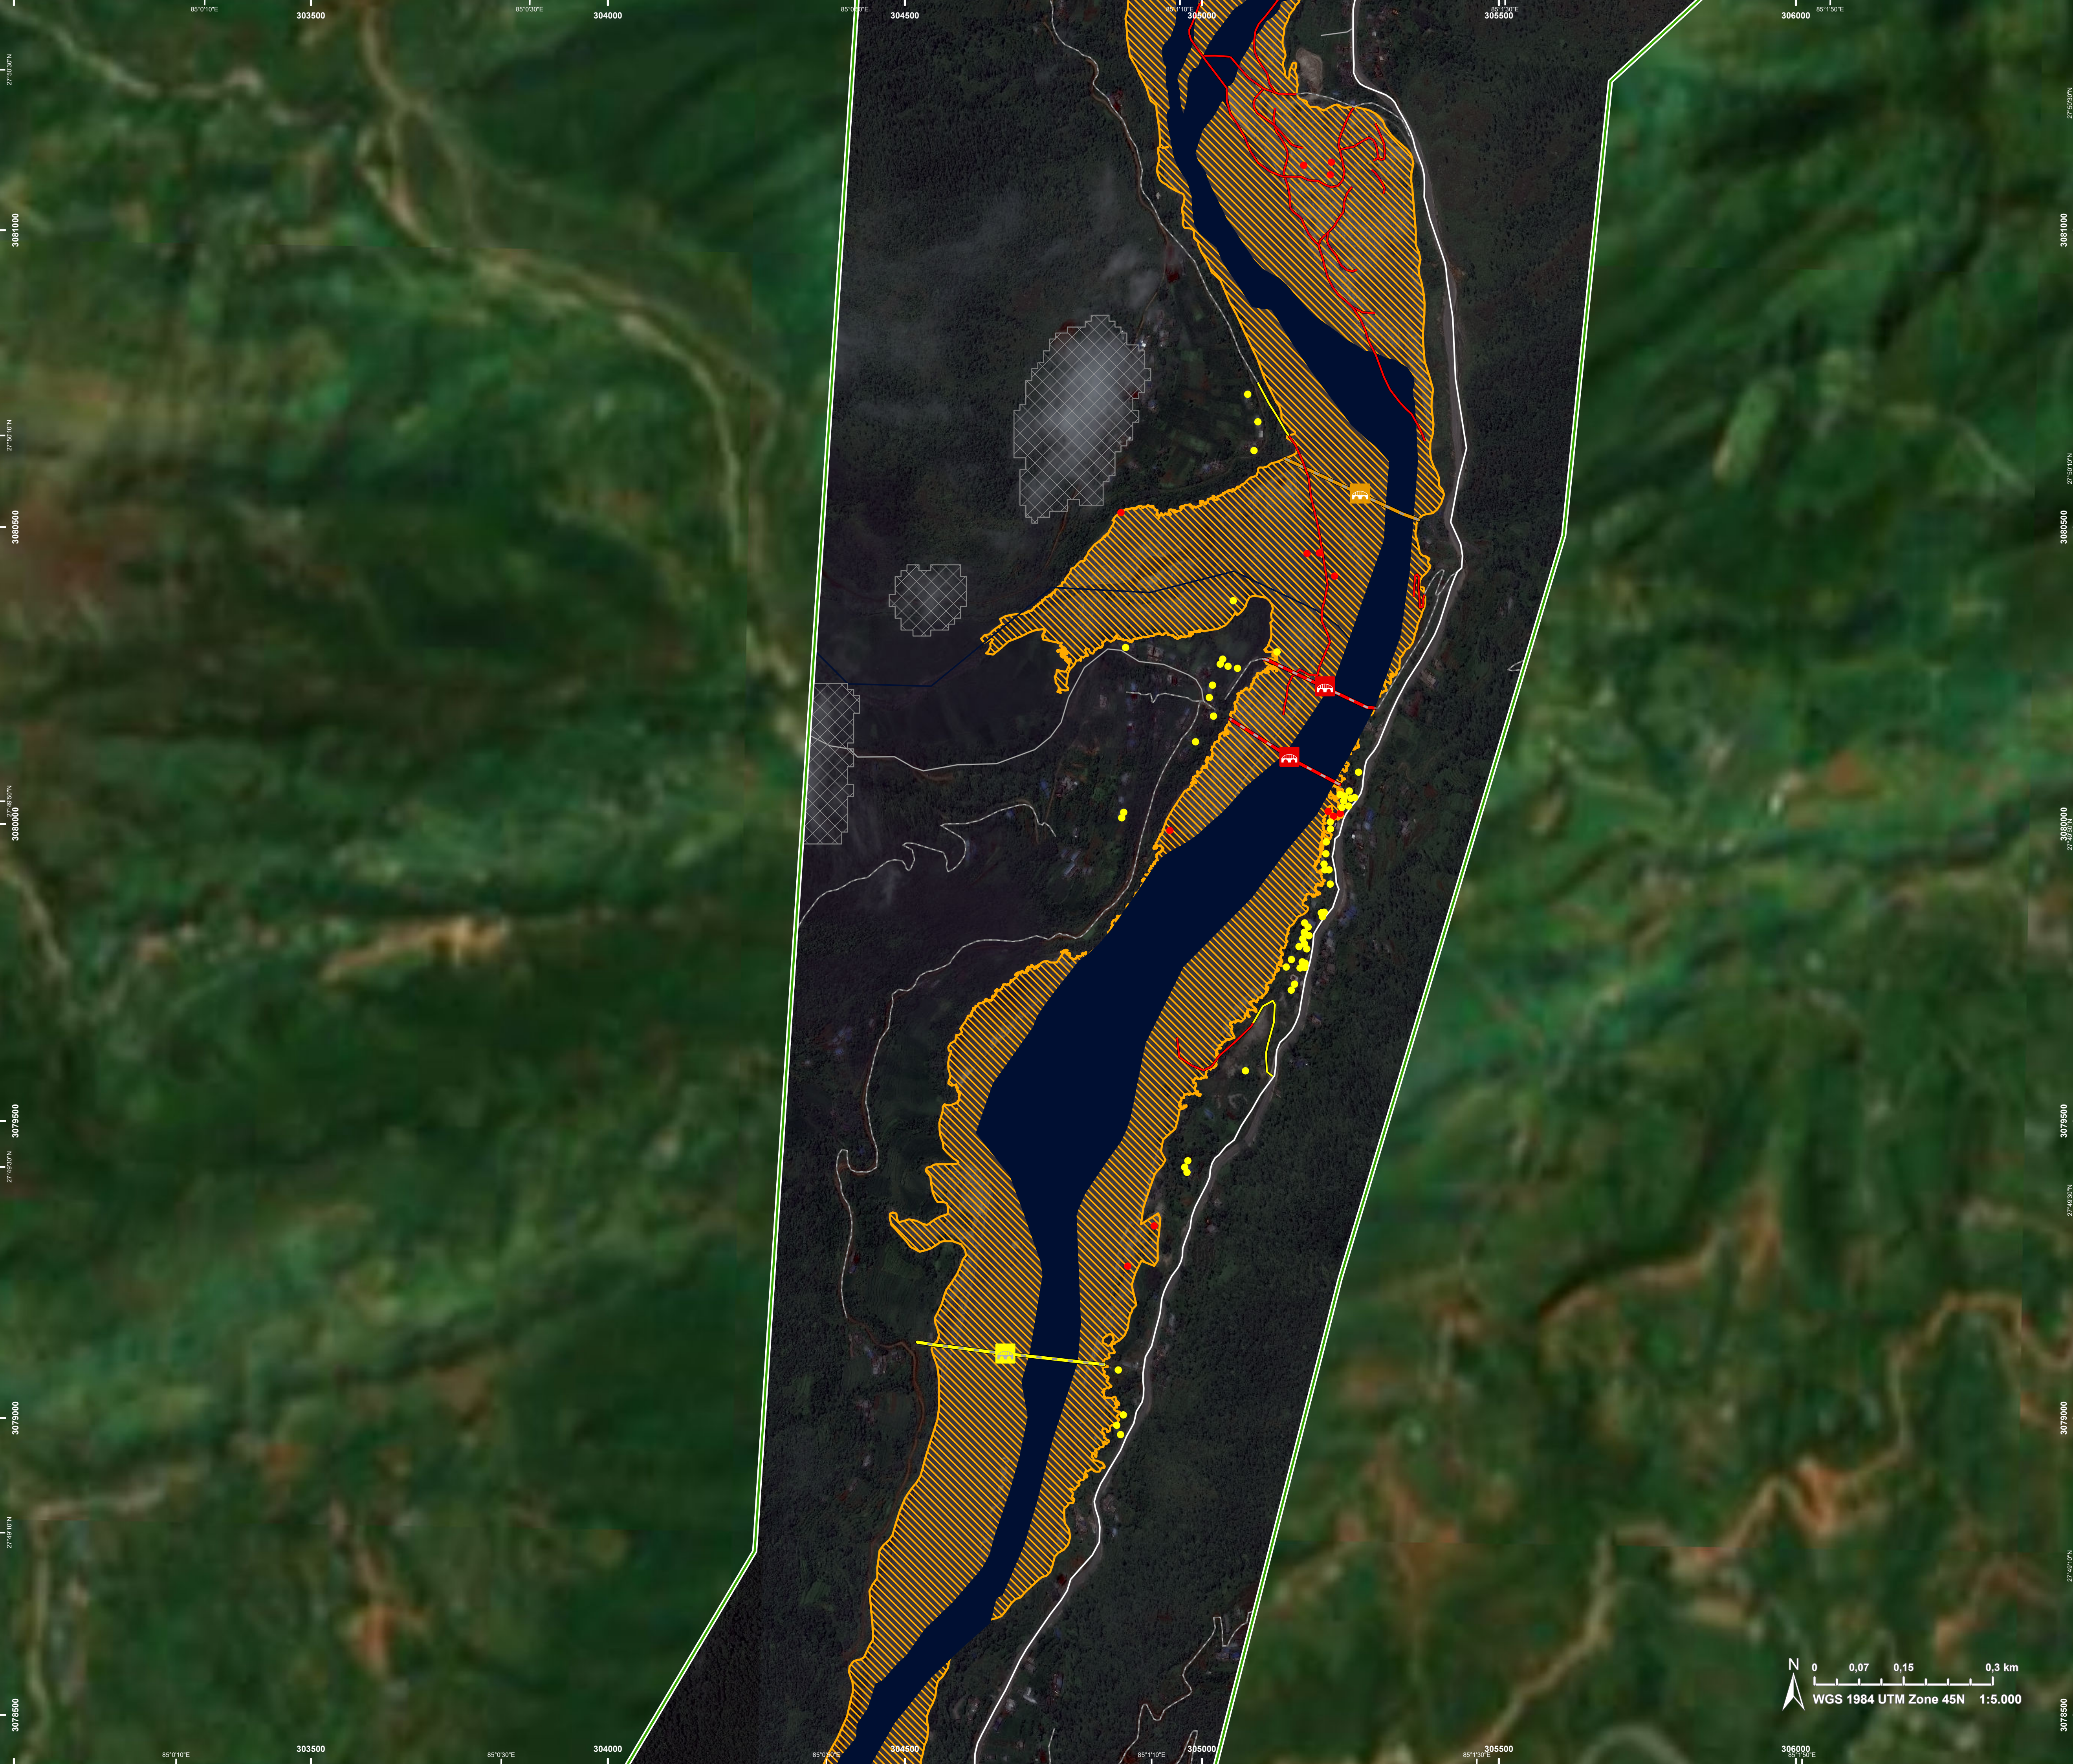
**Situation as of 05/09/2026 06:32 UTC**  
Grading MONIT01 - Detail map 04

**Event:** On the 26 August 2026, a flash flood reportedly triggered by a Glacial Lake Outburst Flood (GLOF) in Nepal has caused significant damage in Rasuwa District. There is a 7 m-deep water level recorded by monitoring stations. Copernicus EMS Rapid Mapping is requested to provide flood extent and damage assessment emergency mapping.

The thematic layer has been derived from post-event satellite image using a semi-automatic approach.

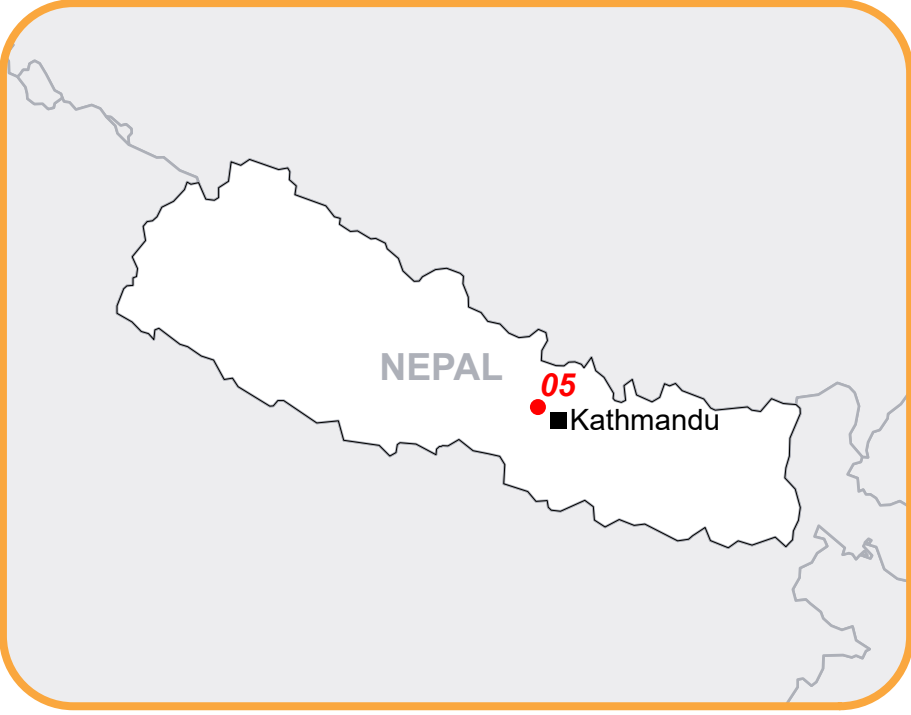
Situation as of 05/09/2026 06:32 UTC  
Grading MONIT01 - Detail map 06

**Event:** On the 26 August 2026, a flash flood reportedly triggered by a Glacial Lake Outburst Flood (GLOF) in Nepal has caused significant damage in Rasuwa District. There is a 7 m-deep water level recorded by monitoring stations. Copernicus EMS Rapid Mapping is requested to provide flood extent and damage assessment emergency mapping.
