**Situation as of 29/10/2023 17:21 UTC**  
Grading MONIT01 - Overview map 01

**Event:** On 25 October around 6.25 UTC, TC OTIS (Cat. 5 Hurricane) made landfall over the area of the coastal City of Acapulco (central Guerrero State, southern Mexico) with maximum sustained winds of 270 km/h. OTIS-23 caused floods and landslides that resulted in evacuations and severe damage. As of 26 October, 34,522 evacuated families in 631 temporary shelters across the affected area according to WHO PAHO and national authorities. Copernicus EMS Rapid Mapping is requested to provide damage assessment emergency mapping.

**Situation as of 29/10/2023 17:21 UTC**  
Grading MONIT01 - Detail map 02

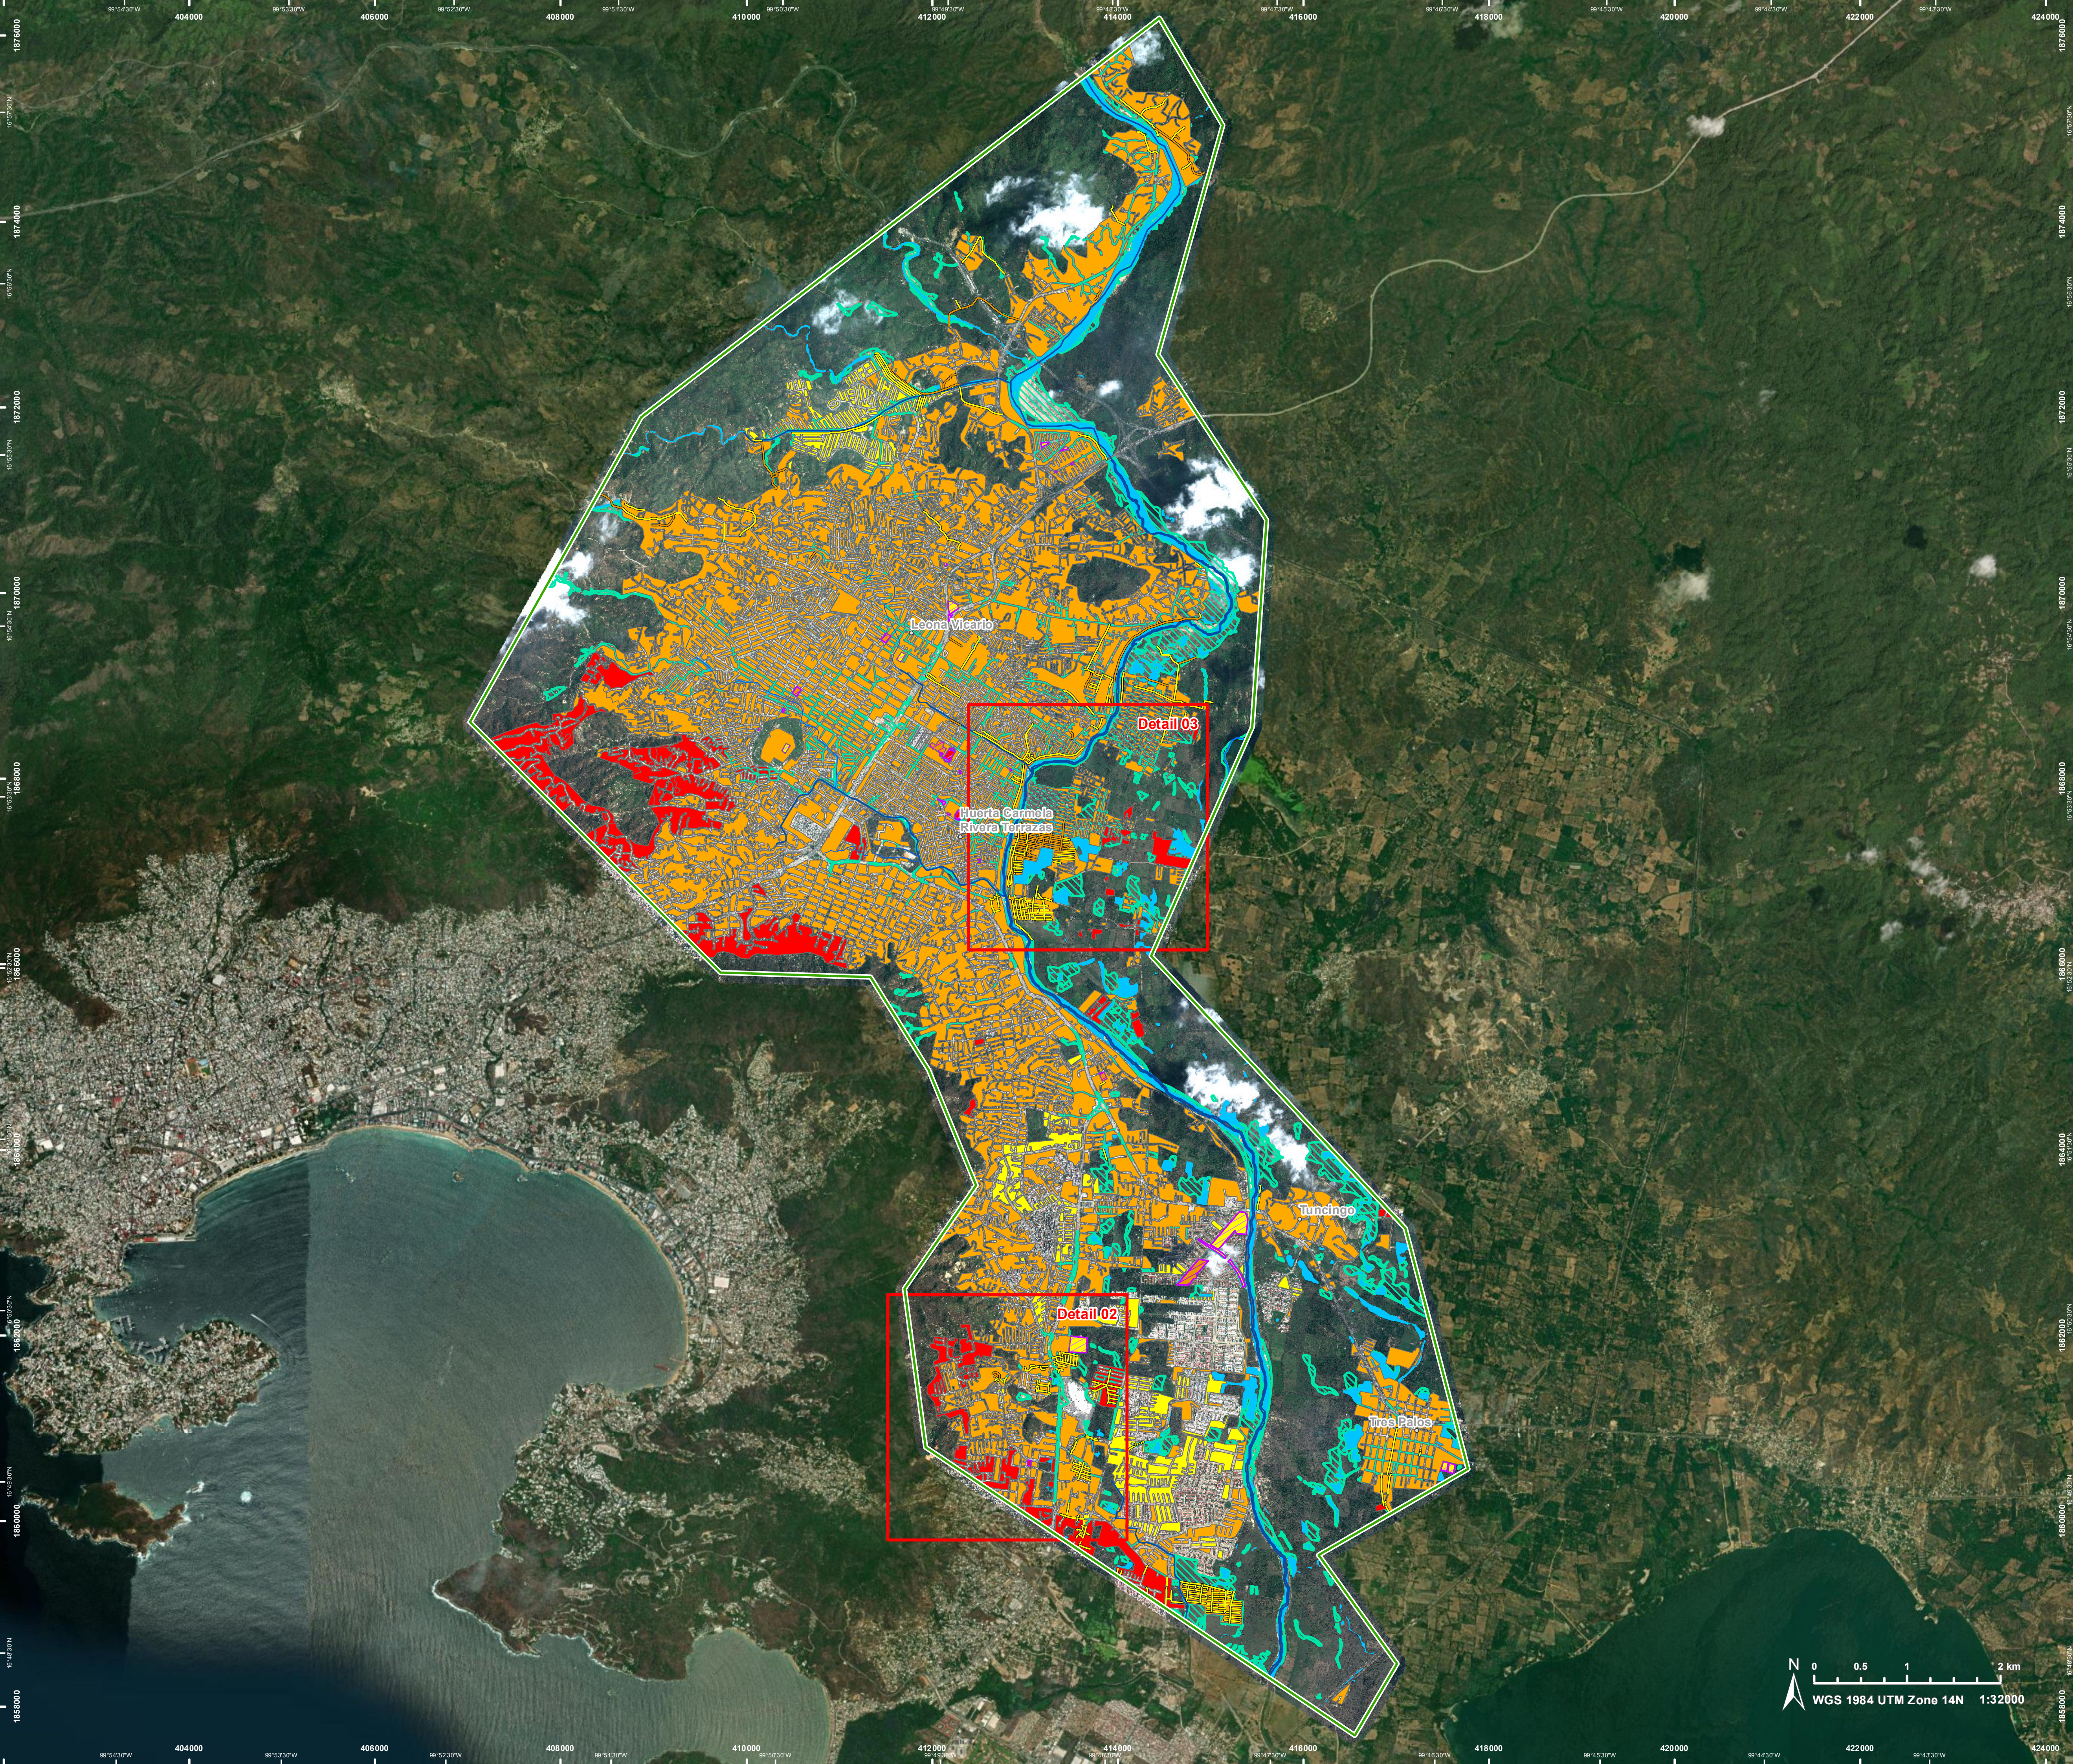
Flooded area 354.4 ha  
Flood trace 869.3 ha

Potentially affected population ~ 180,000

Built-Up 2,636.7 ha

Road 51.5 km

The thematic layer has been derived from post-event satellite image by means of visual interpretation. The current grading analysis cumulates all analysis from previous post-event products.
