EMSR778 - AOI01  
Storm in Honduras  
GRACIAS A DIOS

Situation as of 16/11/2024 11:29 UTC  
First Estimate Product - Overview map 01

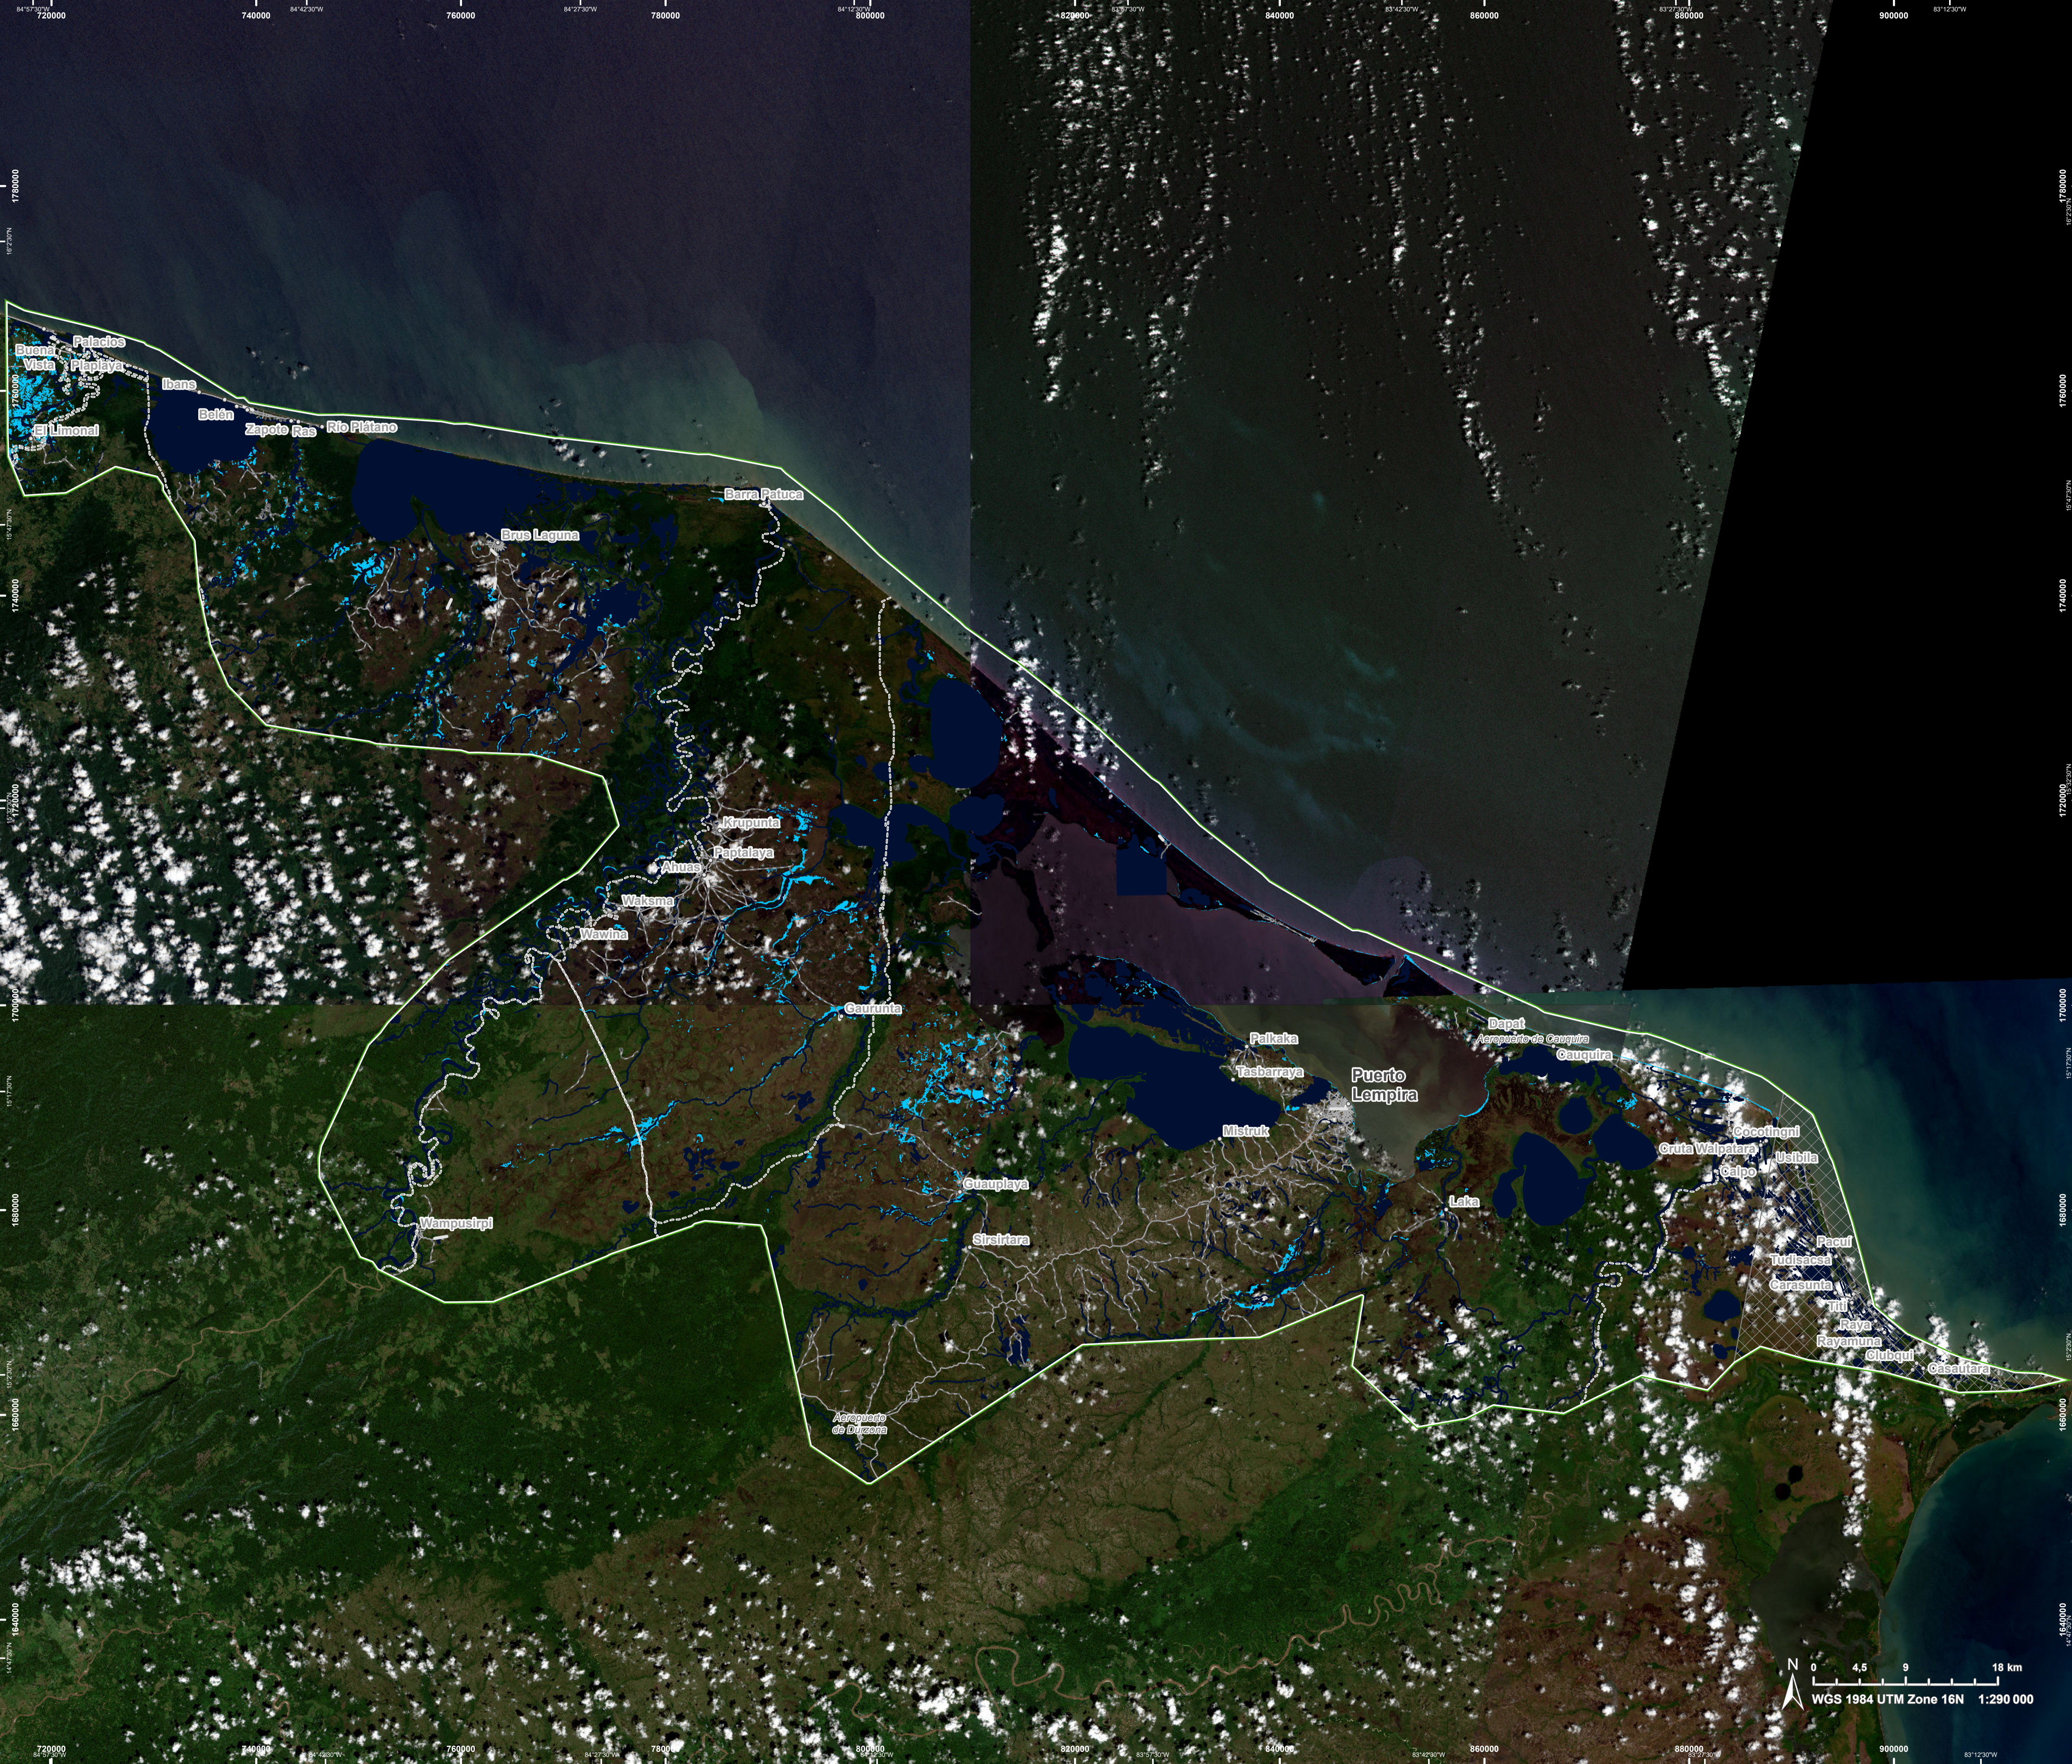
Flooded area 12,556.0 ha

**Event:** On 16 November 2024 at 23:30 Tropical Storm Sara hit Honduras. Specifically, floods and mass movements have been reported to affect the country. Copernicus EMS Rapid Mapping is requested to provide initial rough estimation emergency mapping

Post-event image: Sentinel-1A/B (2024) (acquired on 16/11/2024 at 11:29 UTC, resolution 20.0 m).  
All images are provided under COPERNICUS by the European Union and ESA, all rights reserved.

The thematic layer has been derived from post-event satellite image using a semi-automatic approach. Please be aware that the thematic accuracy might be lower in urban and forested areas due to inherent limitations of the SAR analysis technique.
