EMSR778 - AOI05
Storm in Honduras
SAN PEDRO SULA

Situation as of 16/11/2024 23:58 UTC
First Estimate Product - Overview map 01

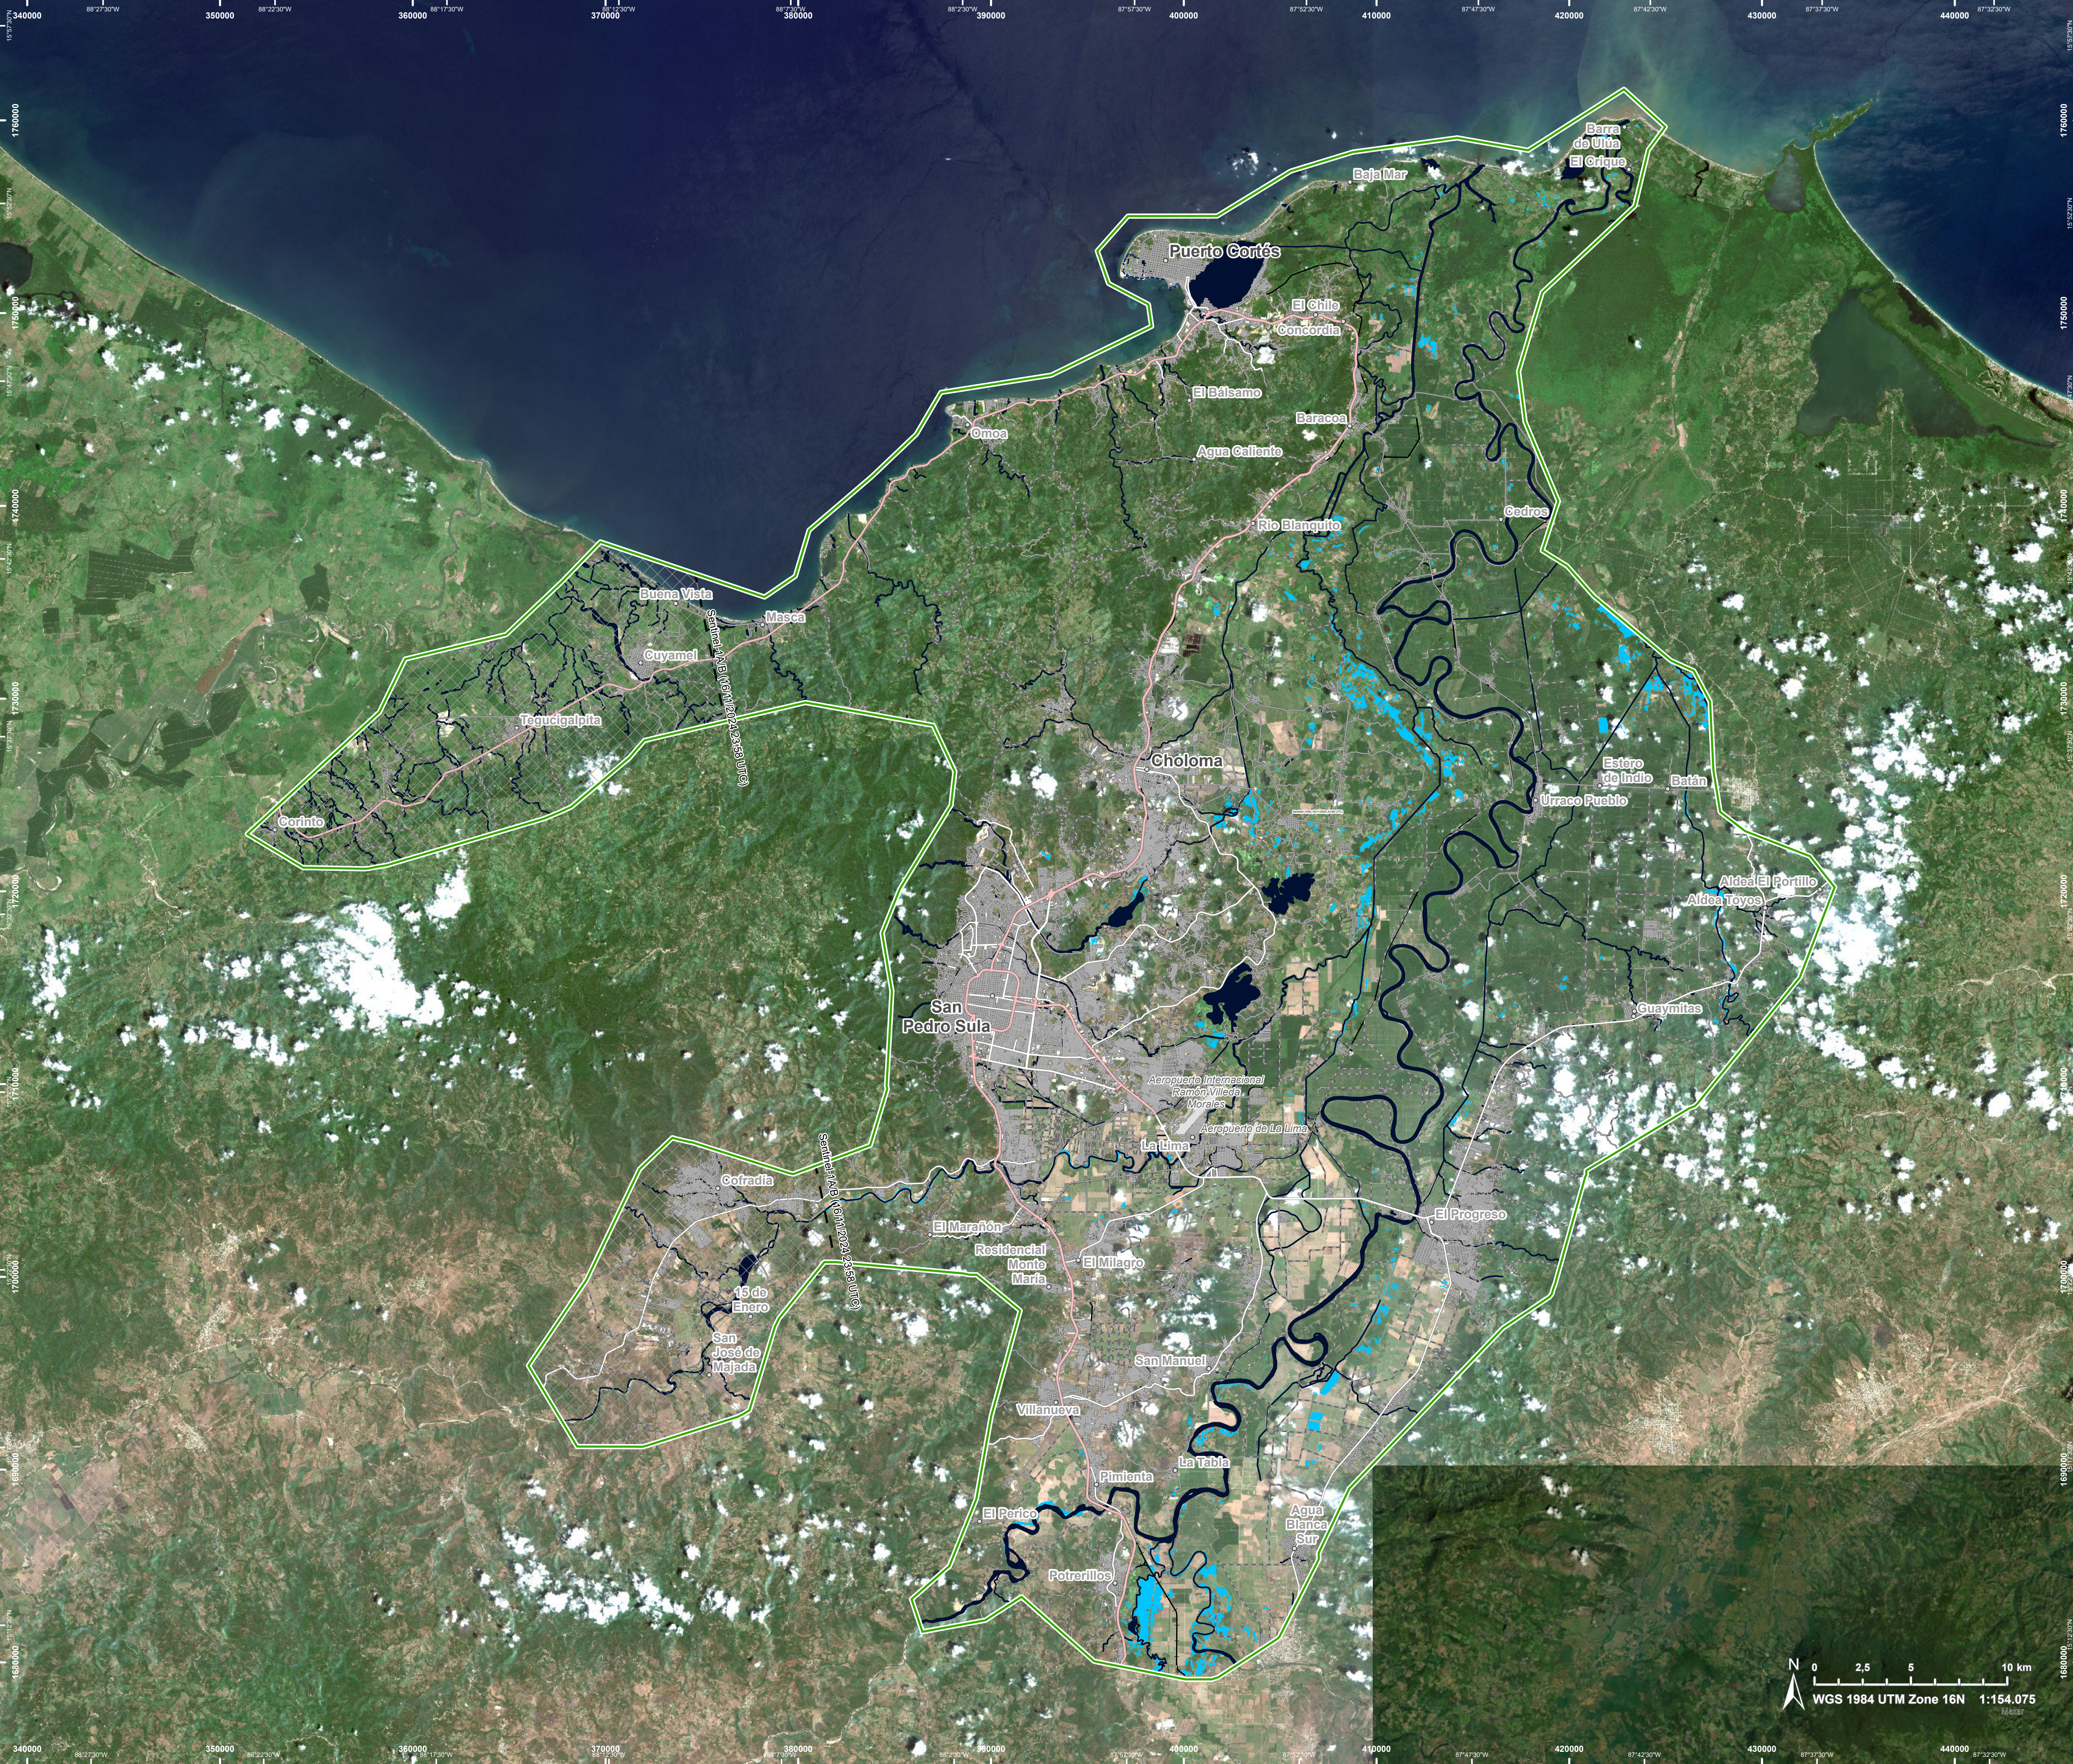
Flooded Area
3,365.8 ha

Data sources and analysis:
Pre-event image: Sentinel-2A/B (2024) (acquired on 21/03/2024 at 16:08 UTC, resolution 10.0 m). This image is used as background image.
Post-event image: Sentinel-1A/B (2024) (acquired on 16/11/2024 at 23:58 UTC, resolution 15.0 m).
All images are provided under COPERNICUS by the European Union and ESA, all rights reserved.

The thematic layer has been derived from post-event satellite image using a semi-automatic approach. Please be aware that the thematic accuracy might be lower in urban and forested areas due to inherent limitations of the SAR analysis technique.

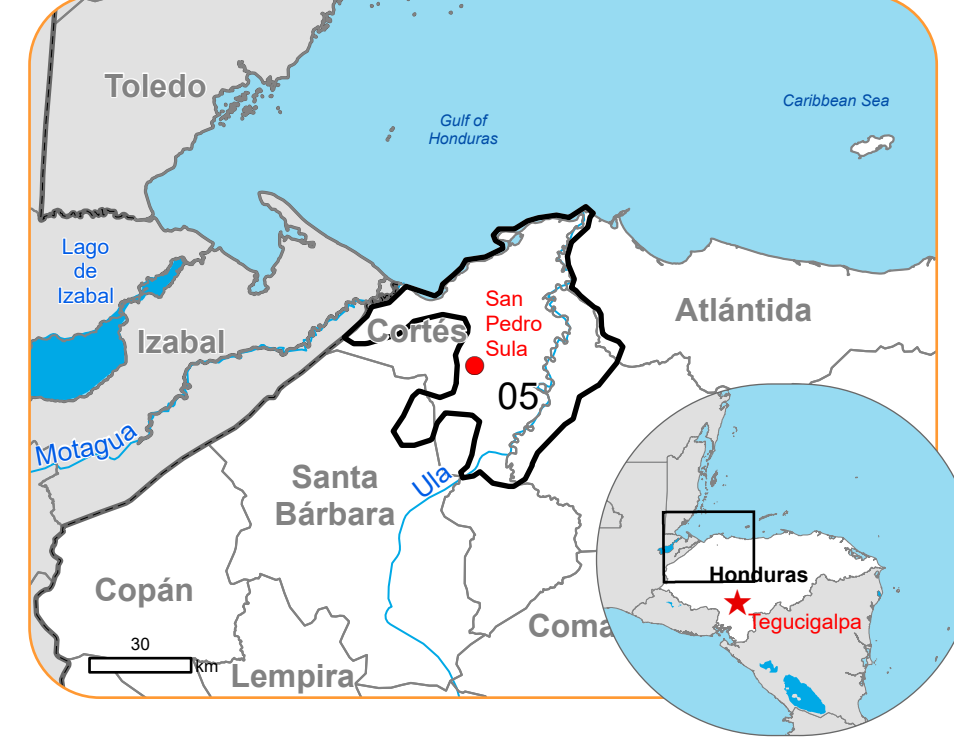
Event: On the 16 November 2024 at 23:30 Tropical Storm Sara hit Honduras. Specifically, floods and mass movements have been reported to affect the country. Copernicus EMS Rapid Mapping is requested to provide initial rough estimation emergency mapping.
