Situation as of 15/12/2024 07:16 UTC
Grading - Overview map 01

Affected Built-up and Transportations

EMSR780 - AOI05
Storm in Mayotte (Fr.)
LA VIGIE

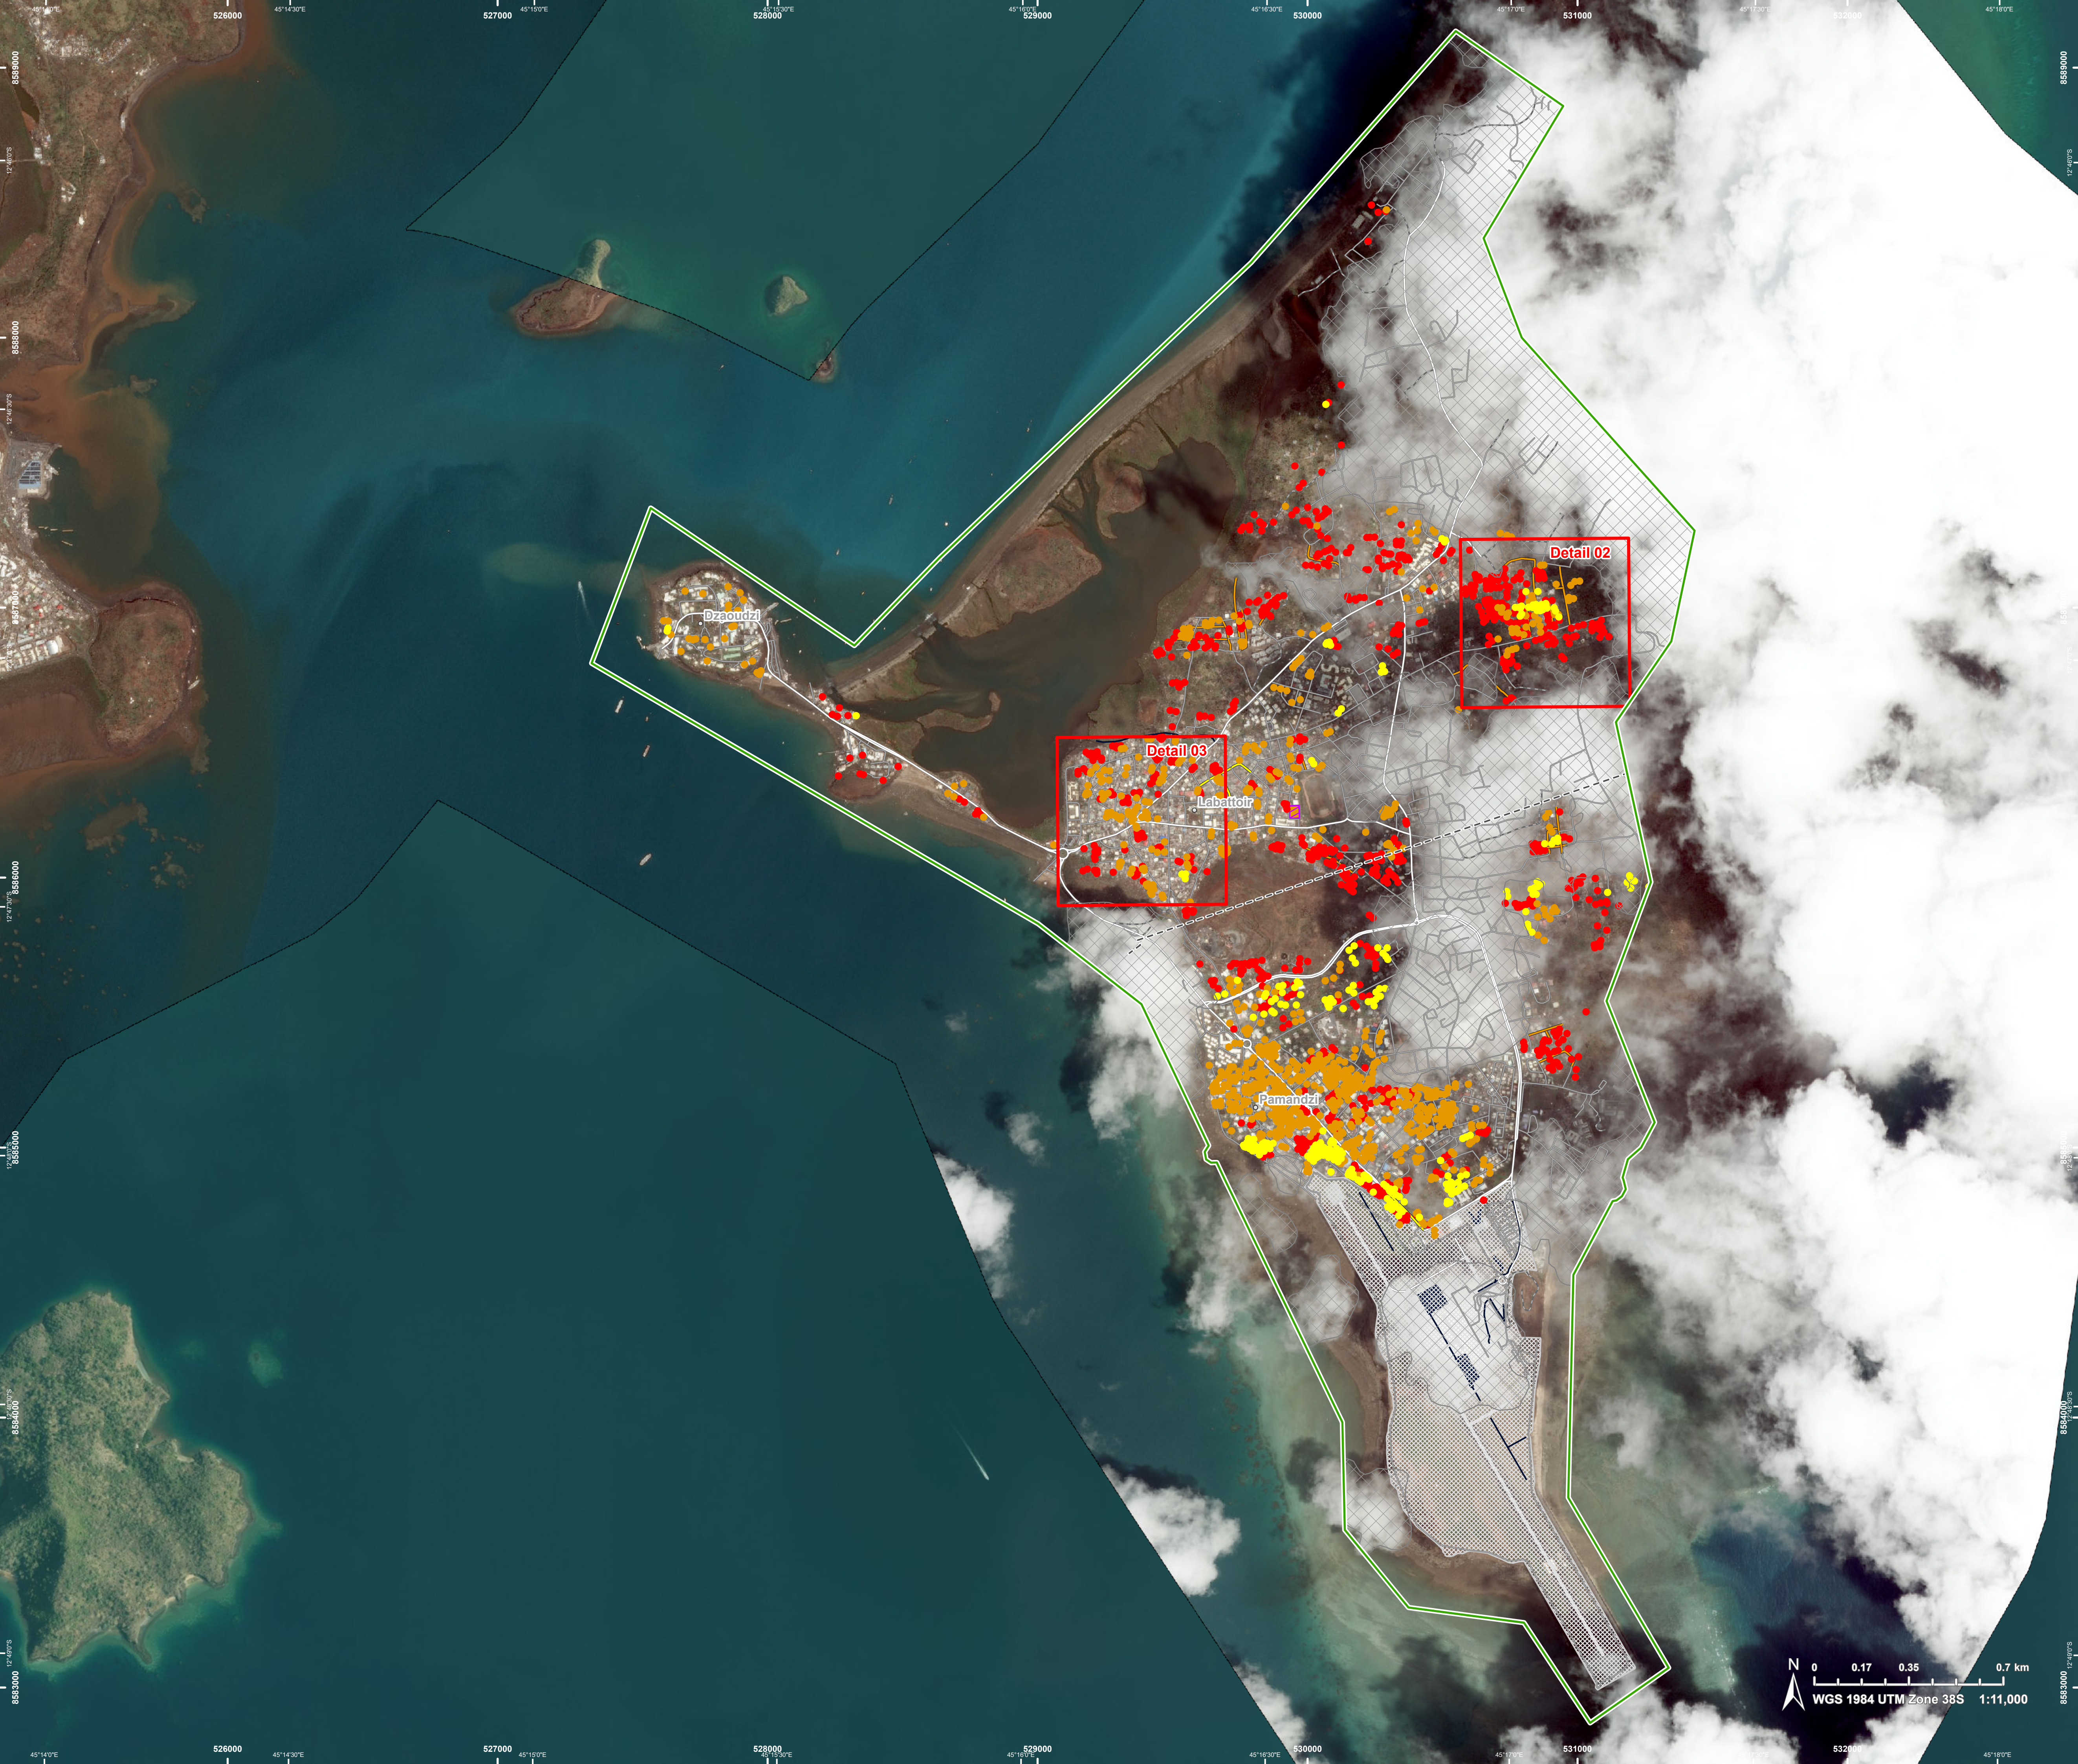
The thematic layer has been derived from post-event satellite image by means of visual interpretation.

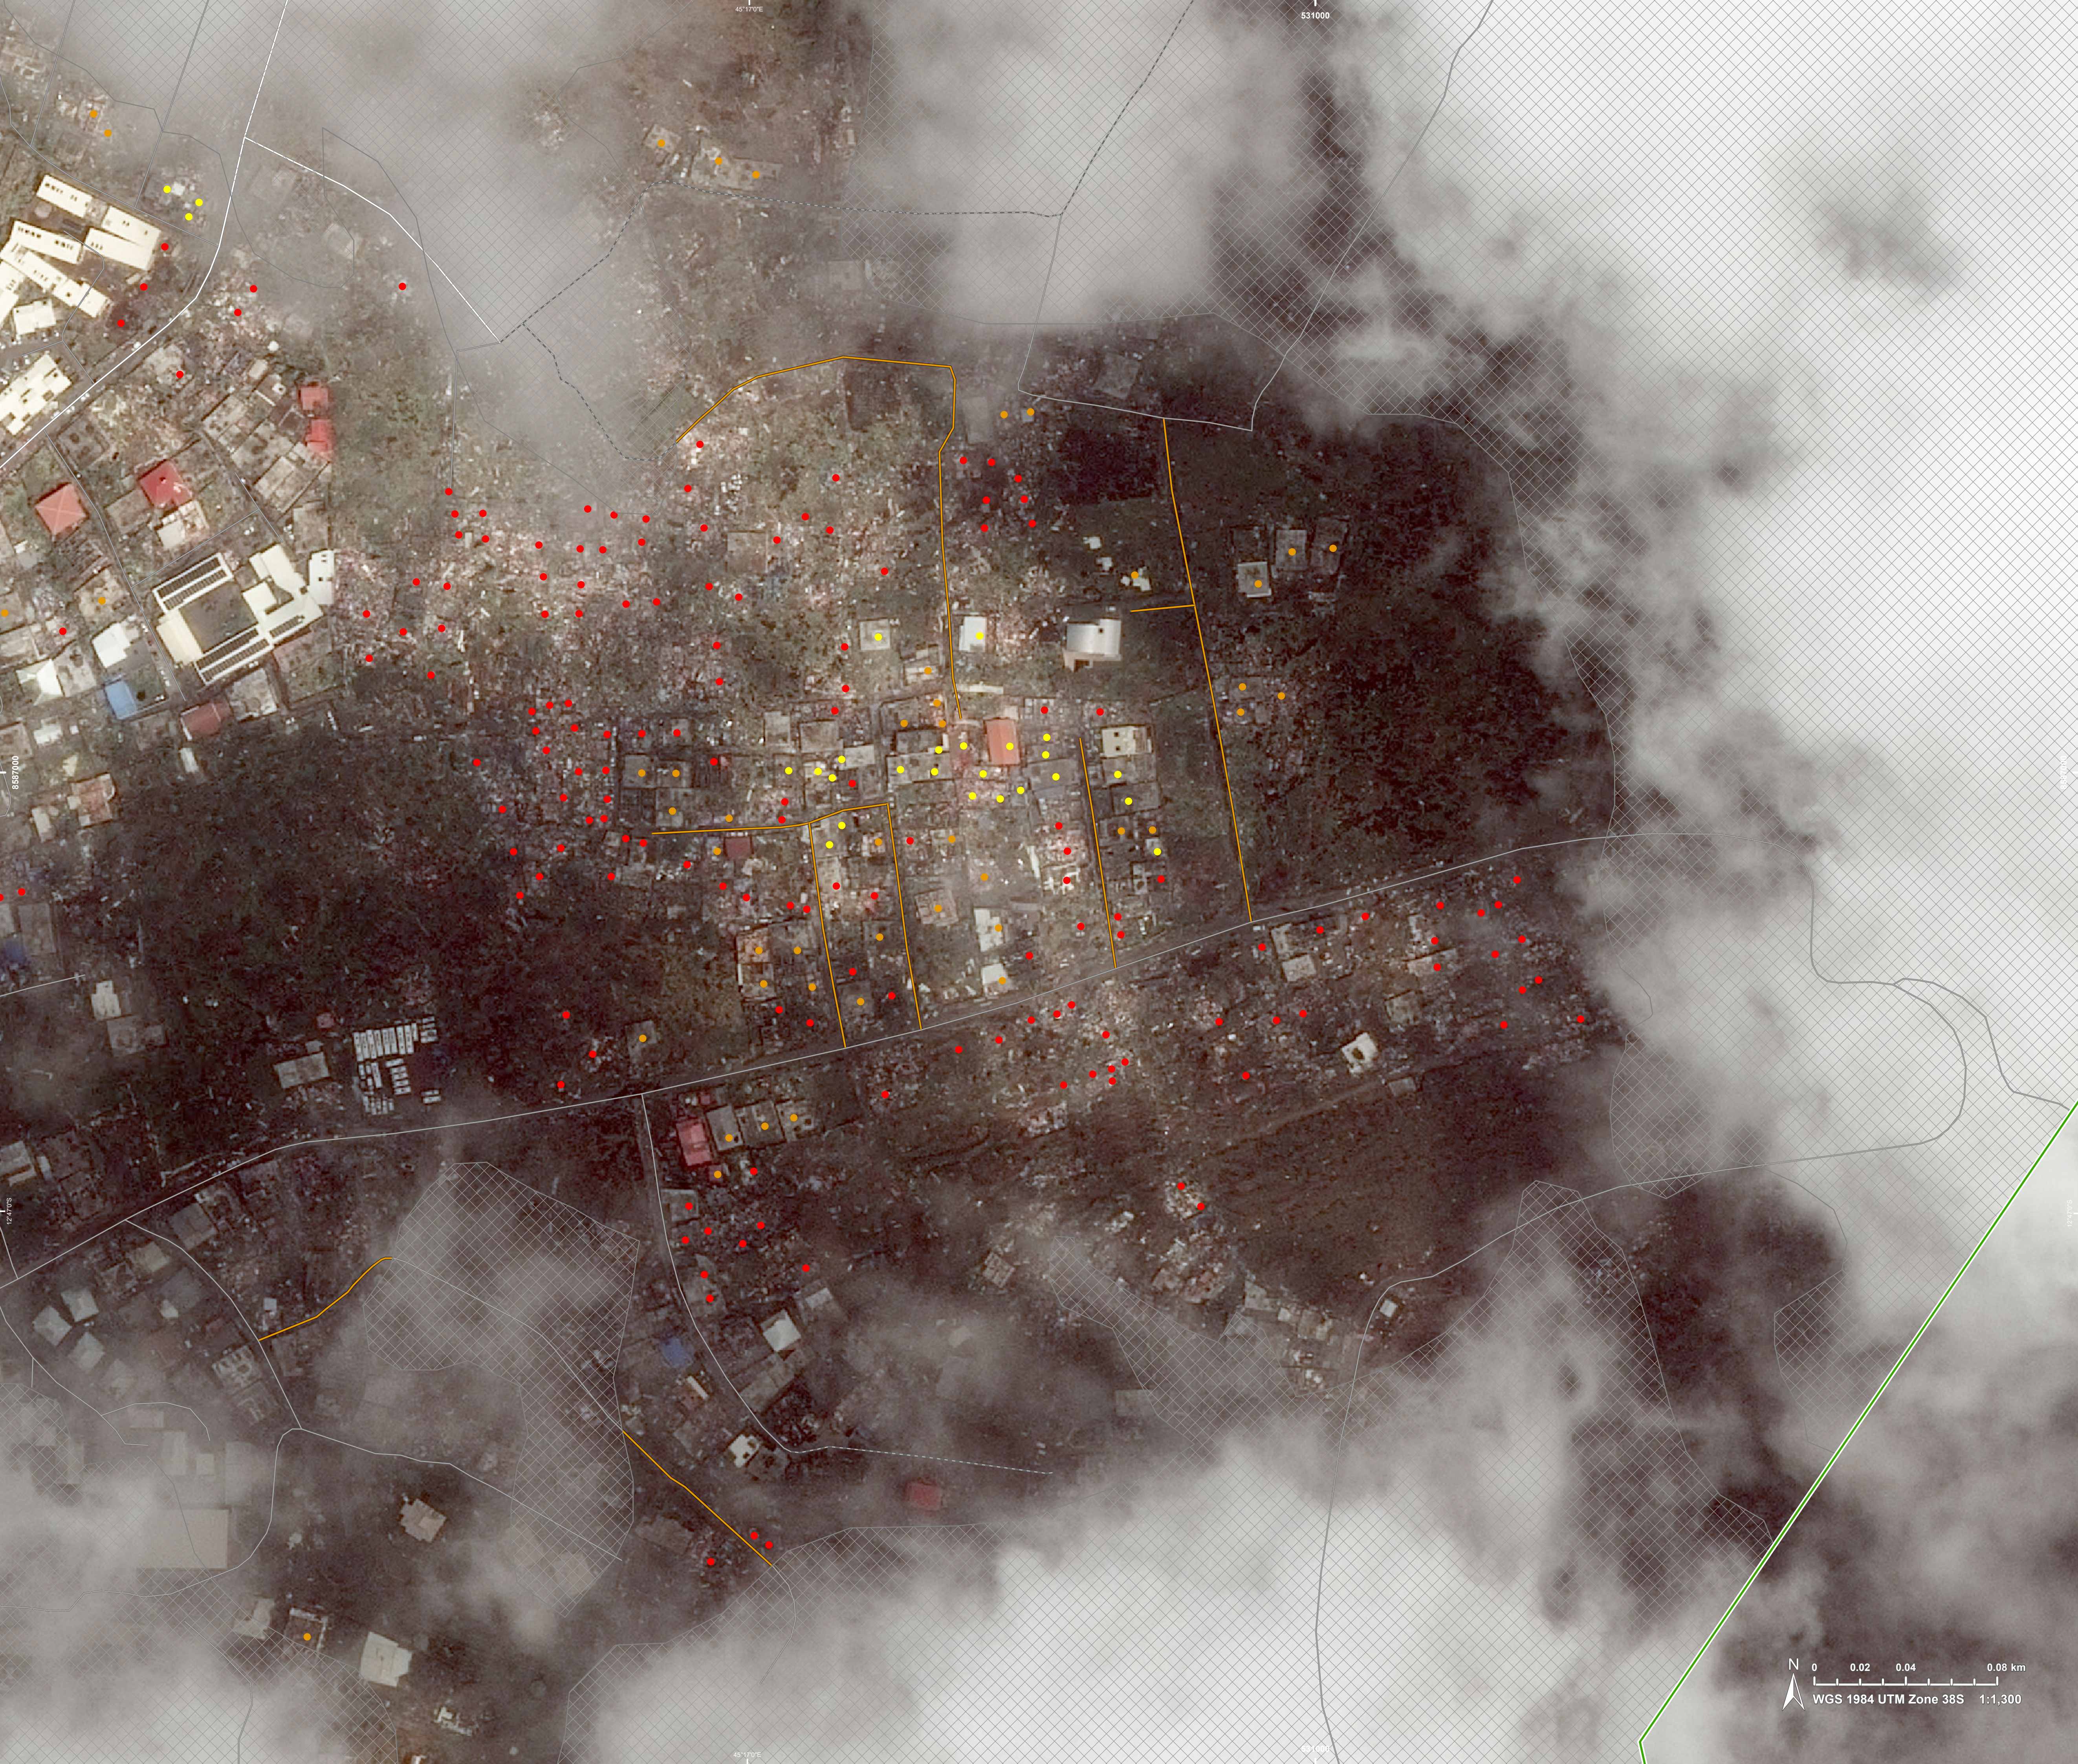
Situation as of 15/12/2024 07:16 UTC
Grading - Detail map 02

The thematic layer has been derived from post-event satellite image by means of visual interpretation.

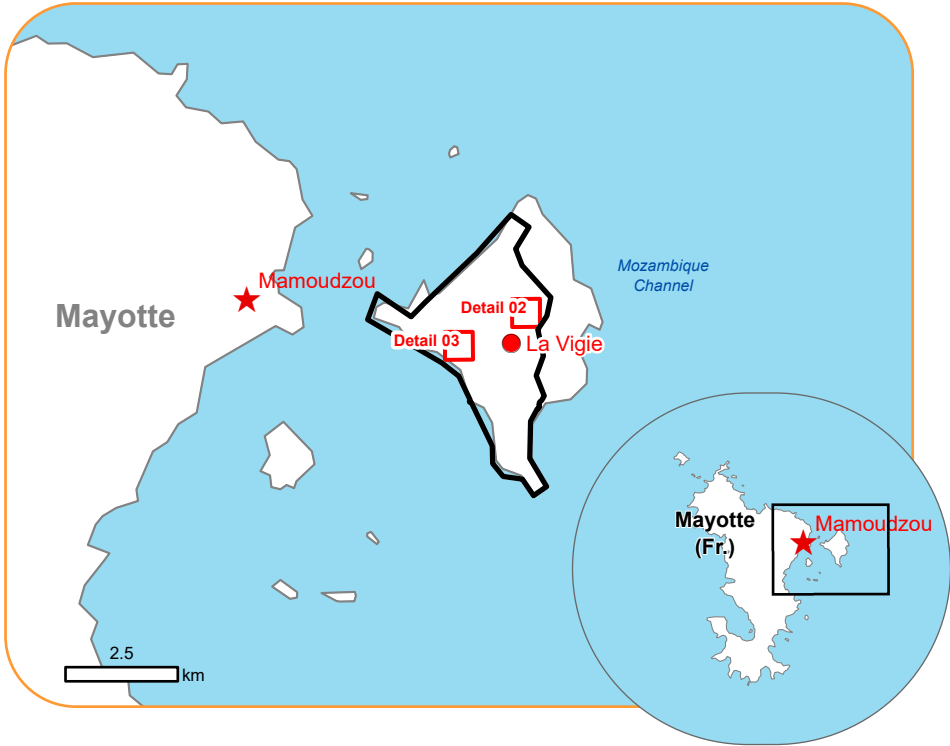
Situation as of 15/12/2024 07:16 UTC
Grading - Detail map 03

The thematic layer has been derived from post-event satellite image by means of visual interpretation.

Consequences within the AOI						
	Unit of measurement		Destroyed	Damaged	Possibly damaged*	Total affected**
Estimated population	Number of inhabitants					NA
Built-up		No.	58	34	15	107
	Residential Buildings	No.	0	0	0	0
	Office buildings	No.	0	0	0	0
	Fire station	No.	0	0	0	0
	Wholesale and retail trade buildings	No.	0	2	0	2
	Industrial buildings	No.	0	0	0	0
	Reservoirs, silos and warehouses	No.	1	0	0	1
	Museums and libraries	No.	0	0	0	0
	School, university and research buildings	No.	0	1	0	1
	Buildings used as places of worship and for religious activities	No.	0	1	1	2
	Hotel buildings	No.	0	0	1	1
	Communication buildings, stations, terminals and associated buildings	No.	0	0	0	0
	Unclassified	No.	791	822	231	1,844
Transportation	Airfield runways	ha	0	0	0	0
	Helipad	ha	0	0	0	0
	Airfield runways	km	0	0	0	0
	Primary Road	km	0	0	0.2	0.2
	Secondary Road	km	0	0	0	0
	Local Road	km	0	2.9	0.3	3.3
	Cart Track	km	0	0.4	0	0.4
