EMSR796 - AOI01  
Flood in Ecuador  
CELICA

Situation as of 14/04/2025 15:49 UTC  
Grading MONIT01 - Overview map 01

Situation as of 14/04/2025 15:49 UTC  
Grading MONIT01 - Detail map 02

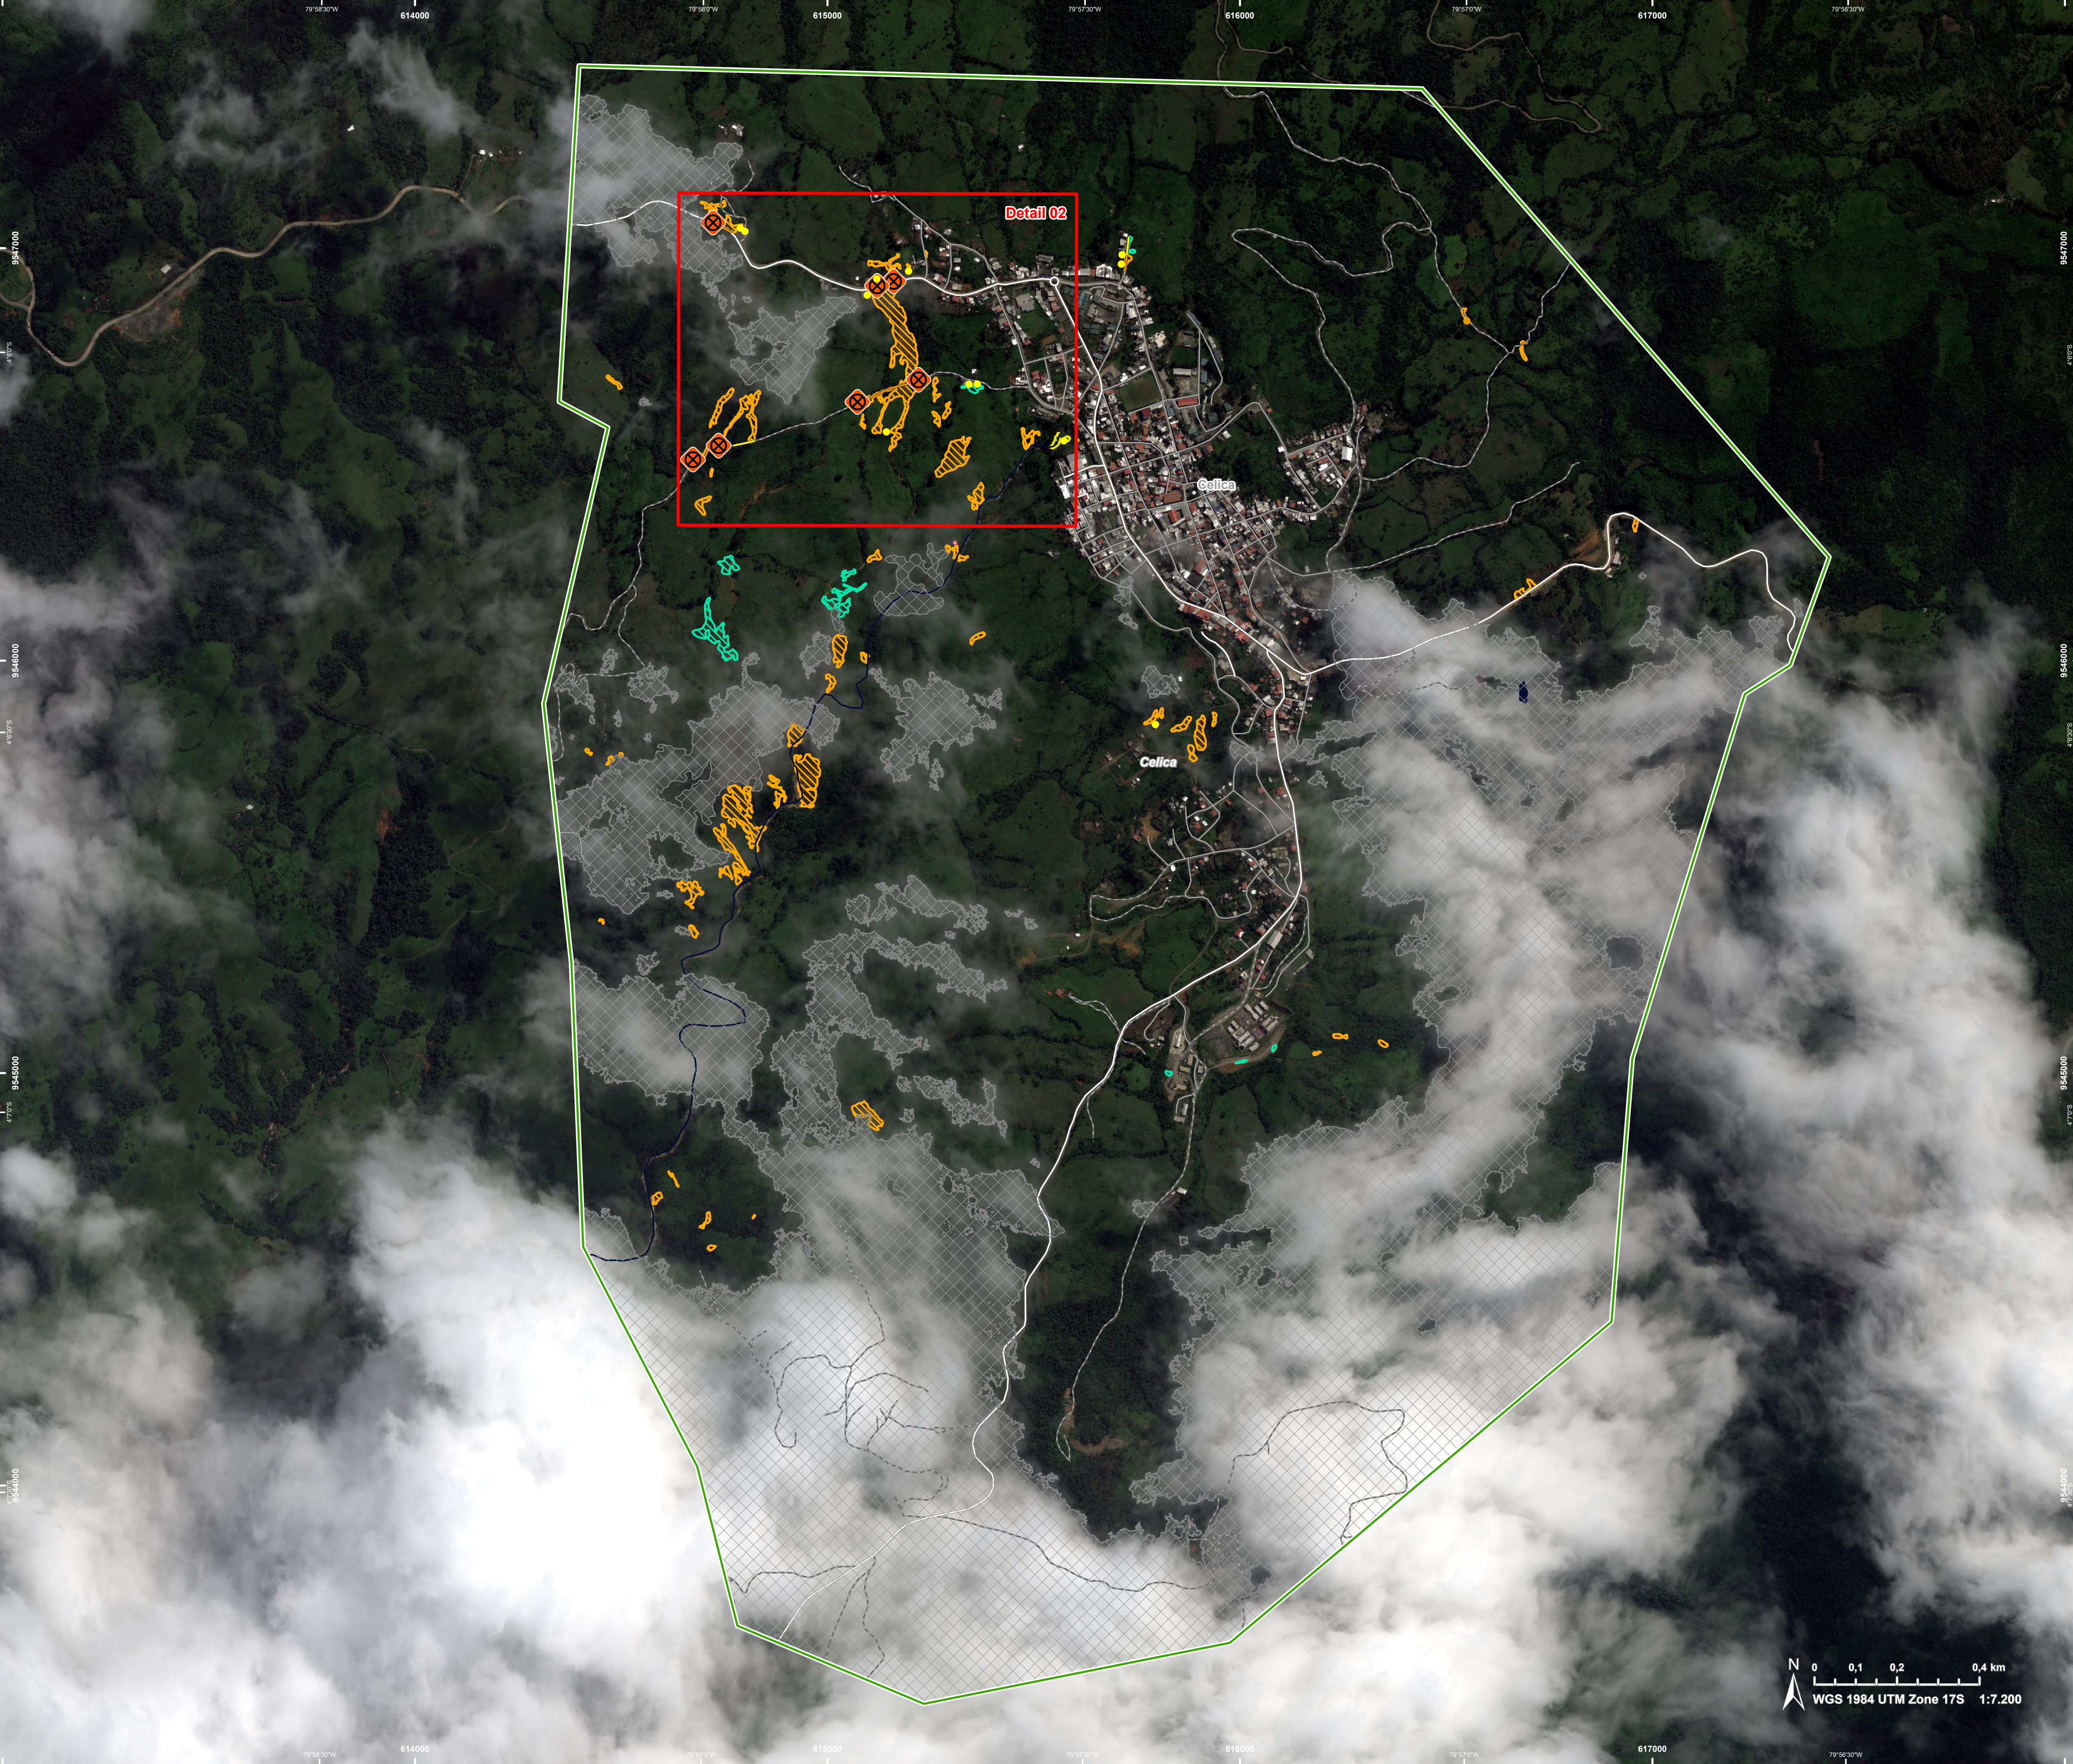
Debris, Rockfall 0.05 ha  
Landslide 5.9 ha  
Flood trace 0.8 ha  
Blocked road / interruption 7 No.

Potentially affected population ~ 10

Built-Up 13 No.  
Road 0.5 km

**Event:** On the 26 February 2025 at 16:00 UTC, heavy rainfall affected western and coastal Ecuador causing floods and triggering landslides. The event is on-going, causing significant damage. Copernicus EMS Rapid Mapping is requested to provide damage assessment emergency mapping.

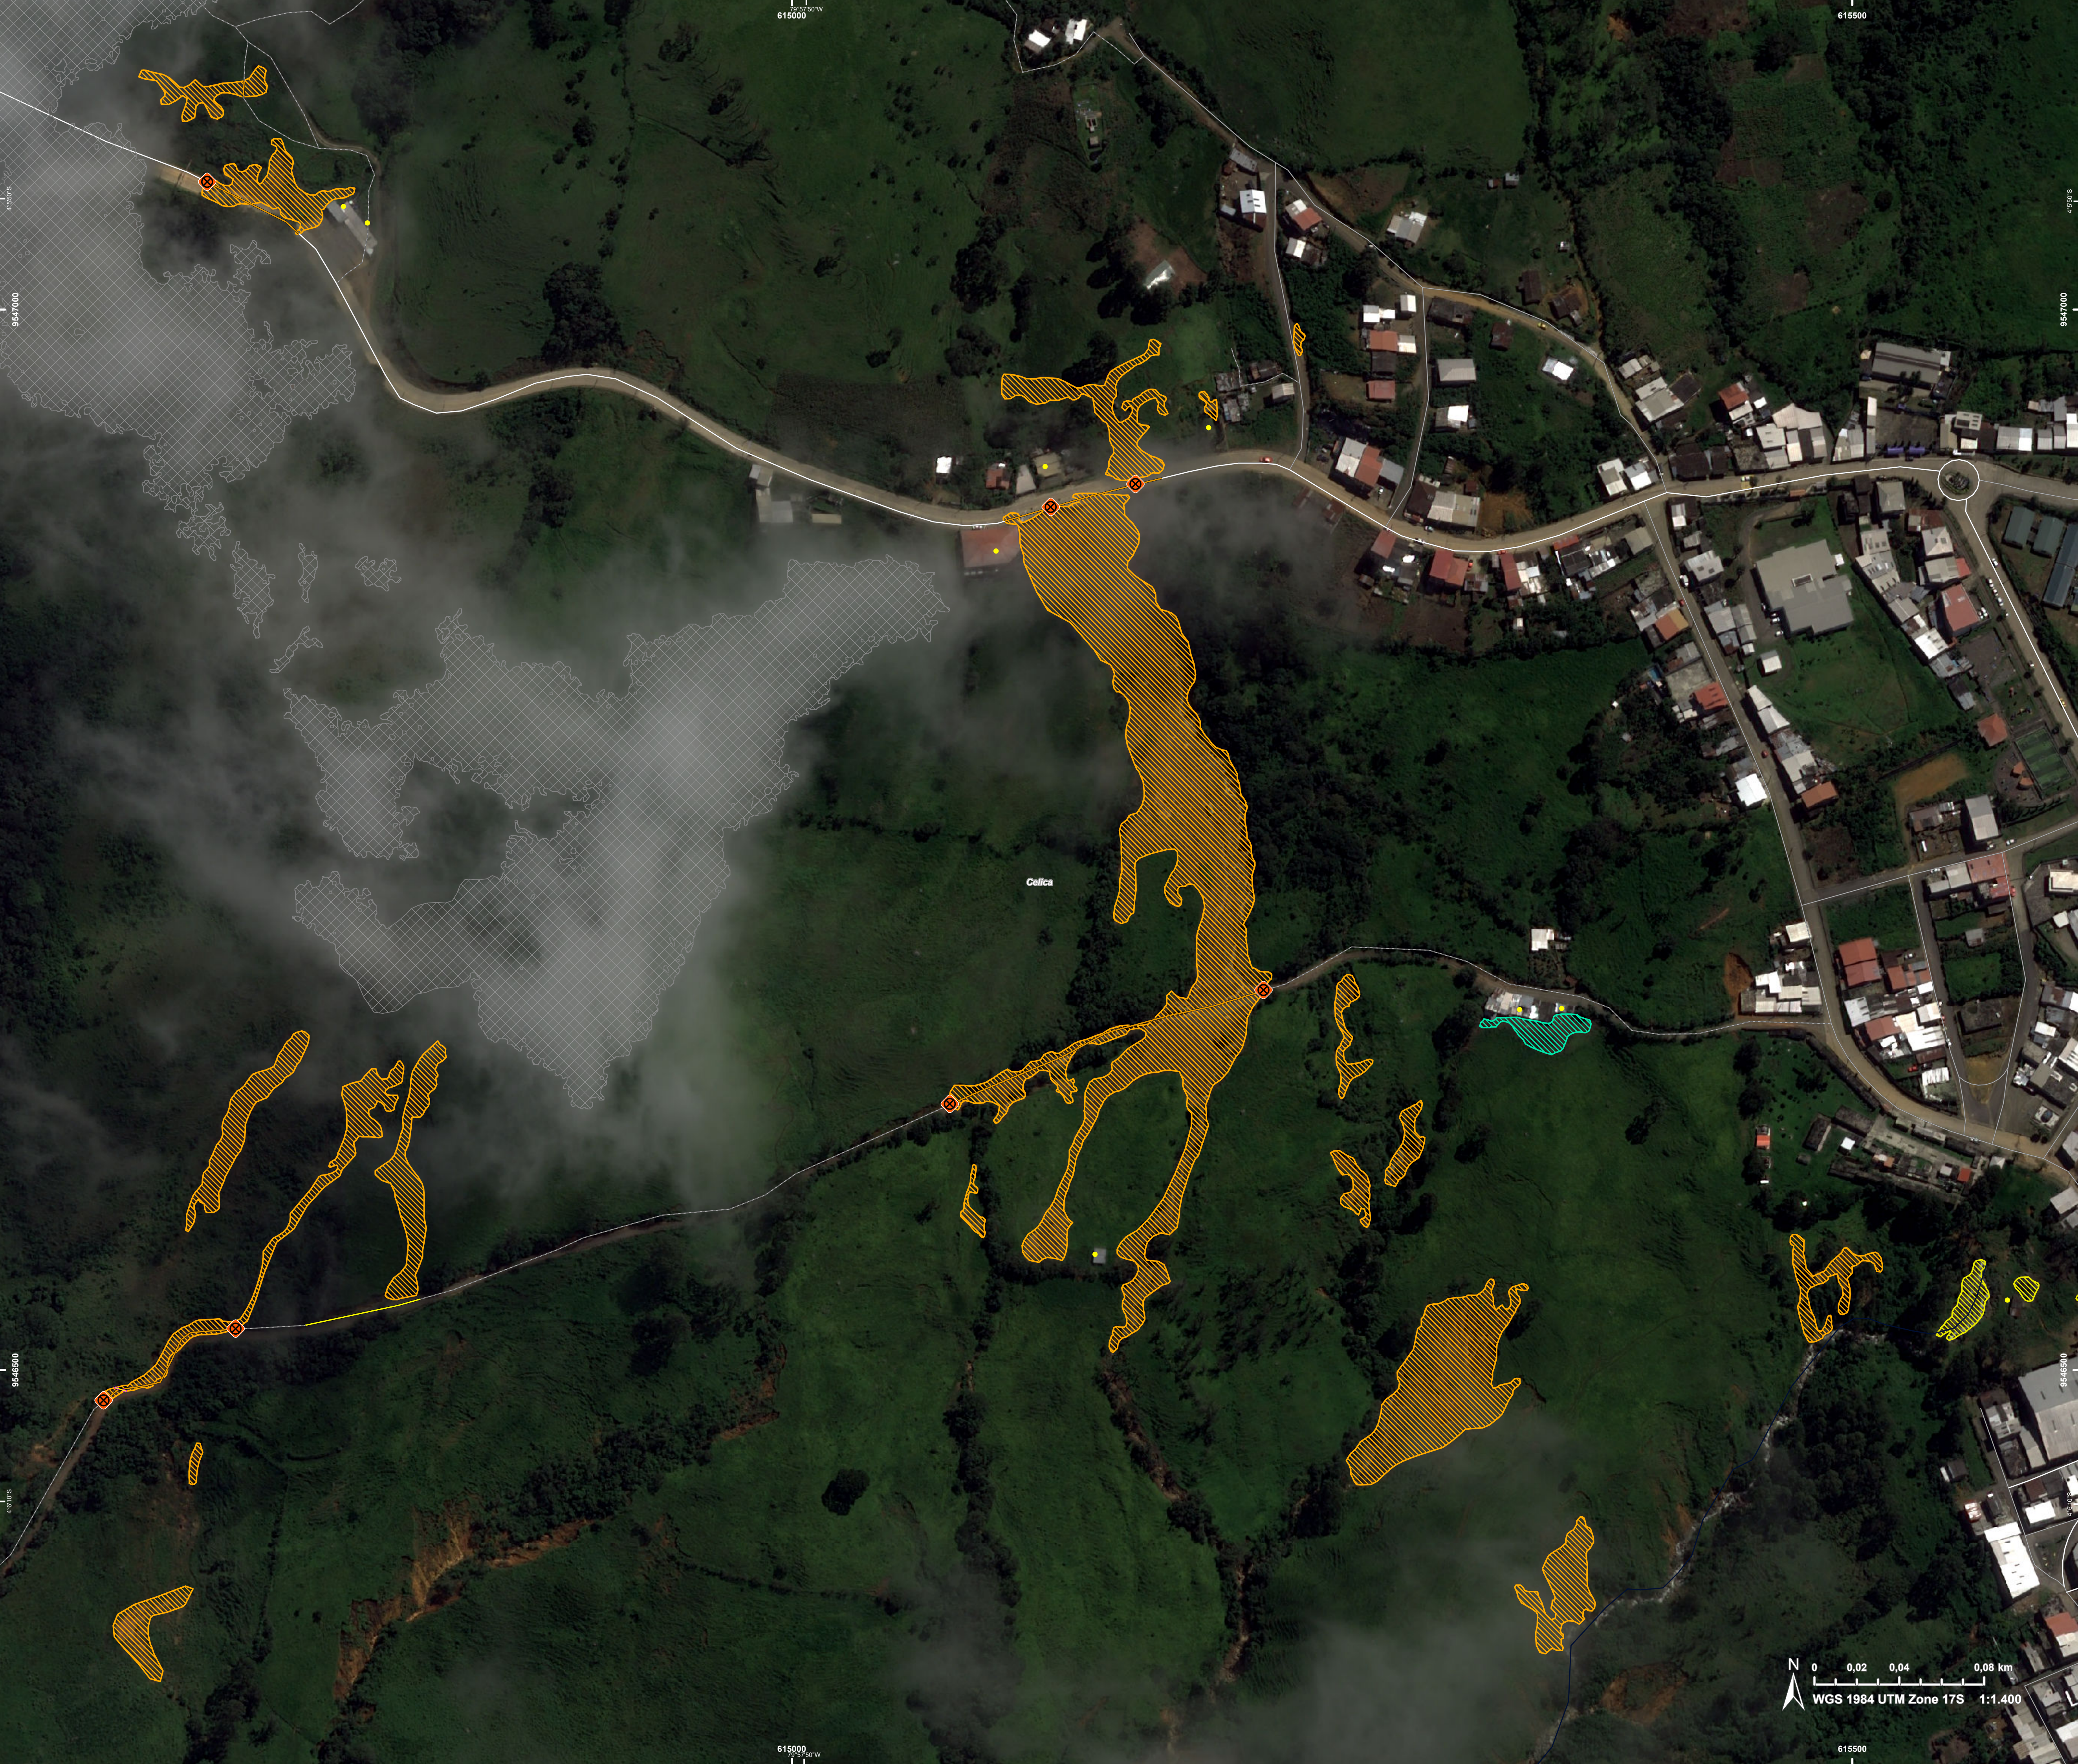
**Event:** On the 26 February 2025 at 16:00 UTC, heavy rainfall affected western and coastal Ecuador causing floods and triggering landslides. The event is on-going, causing significant damage. Copernicus EMS Rapid Mapping is requested to provide damage assessment emergency mapping.

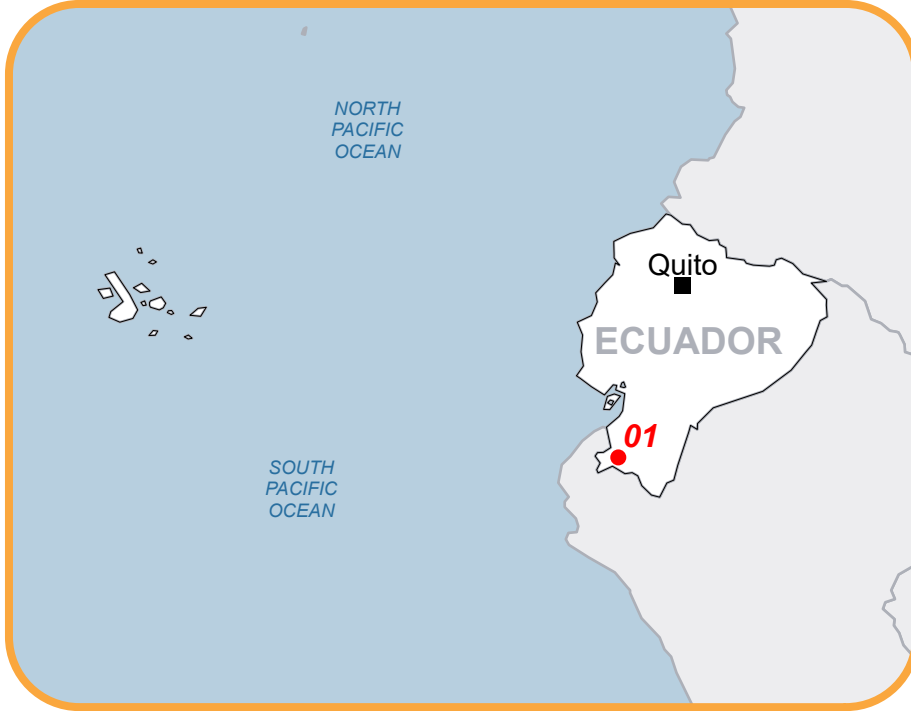
Consequences within the AOI						
	Unit of measurement	Destroyed	Damaged	Possibly damaged*	Total affected**	Total in AOI
Debris, Rockfall	ha					0,05
Landslide	ha					5,9
Flood trace	ha					0,8
Ancillary Crisis Information	Blocked road / interruption	No.				7
Estimated population	Number of inhabitants				~ 10	~ 5.400
Built-up	Residential Buildings	No.	0	1	10	11
	Institutional	No.	0	0	0	0
	Other non-residential buildings	No.	0	0	2	2
	Buildings used as places of worship and for religious activities	No.	0	0	0	0
	Other buildings not elsewhere classified	No.	0	0	0	0
	Communication buildings, stations, terminals and associated buildings	No.	0	0	0	0
Transportation	Primary Road	km	0	0,1	0	0,1
	Secondary Road	km	0	0	0	0
	Local Road	km	0	0,04	0,1	0,1
	Cart Track	km	0	0,3	0,1	0,3
Facilities	Sport and recreation constructions	ha	0	0	0	0
	Long-distance pipelines, communication and electricity lines	km	0	0	0,01	0,01
Land use	Shrub and/or herbaceous vegetation association	ha				3,6
