EMSR796 - AOI01

Flood in Ecuador

CELICA

Situation as of 01/05/2025 15:38 UTC  
Grading MONIT02 - Overview map 01

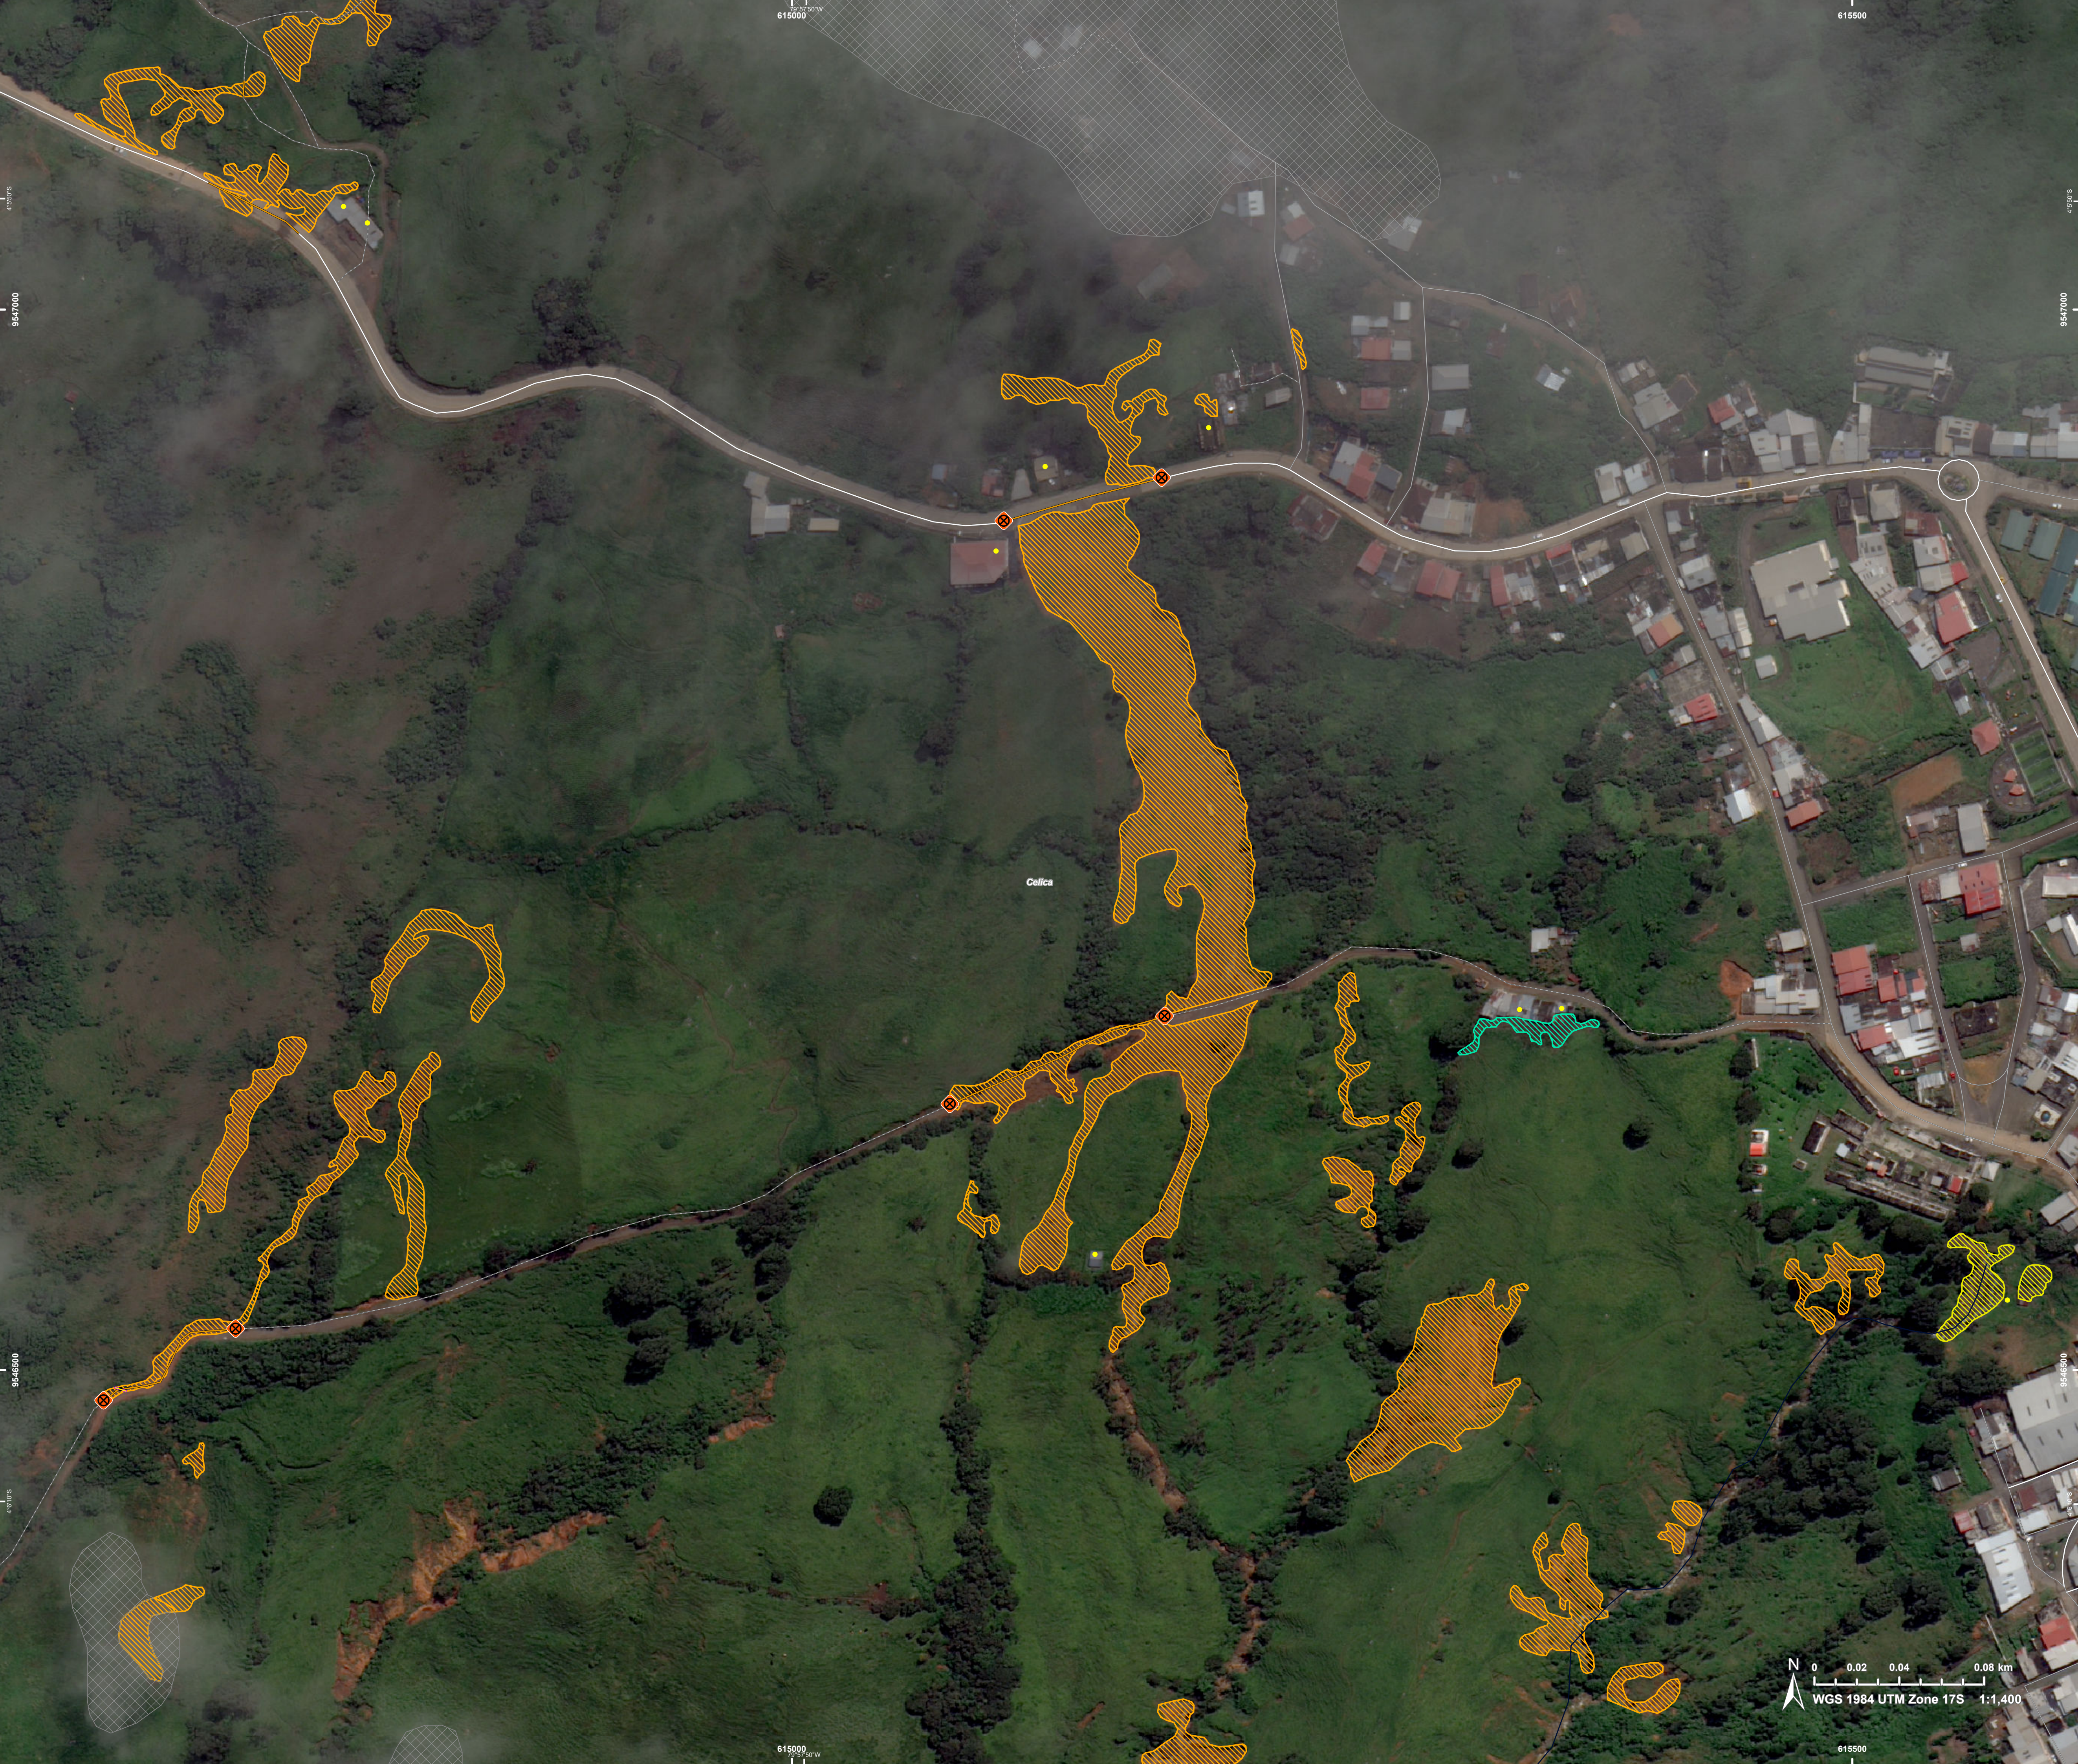
Debris, Rockfall 0.1 ha  
Landslide 8.9 ha  
Flood trace 0.9 ha  
Blocked road / interruption 6 No.

Potentially affected population  
~ 10

Built-Up  
13 No.

Road  
0.5 km

**Event:** On the 26 February 2025 at 16:00 UTC, heavy rainfall affected western and coastal Ecuador causing floods and triggering landslides. The event is on-going, causing significant damage. Copernicus EMS Rapid Mapping is requested to provide damage assesment emergency mapping.

The thematic layer has been derived from post-event satellite image using by means of visual interpretation.

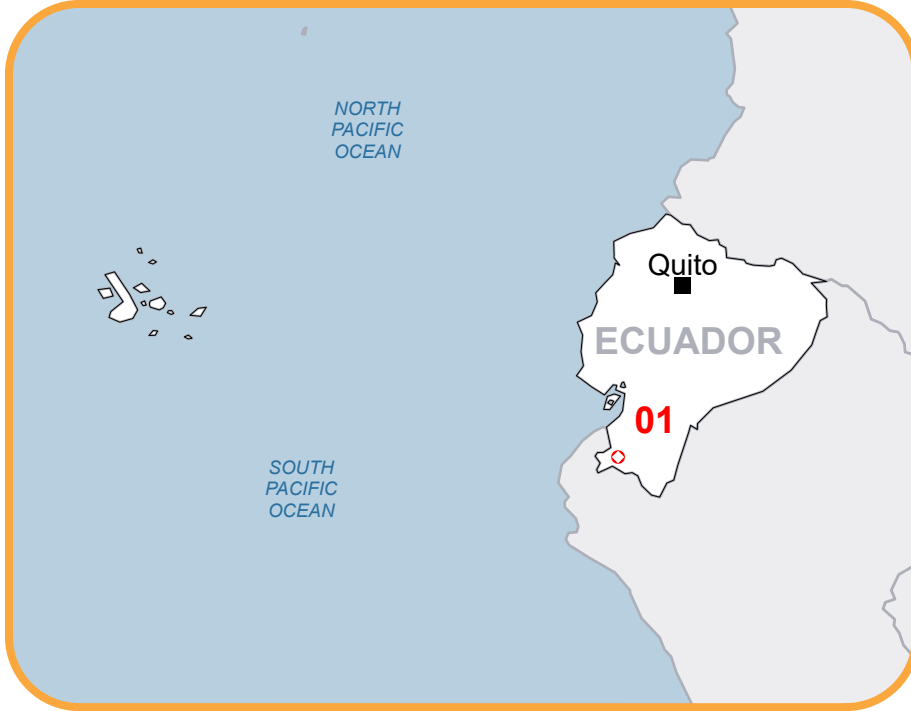
Situation as of 01/05/2025 15:38 UTC  
Grading MONIT02 - Detail map 02

**Event:** On the 26 February 2025 at 16:00 UTC, heavy rainfall affected western and coastal Ecuador causing floods and triggering landslides. The event is on-going, causing significant damage. Copernicus EMS Rapid Mapping is requested to provide damage assesment emergency mapping.

The thematic layer has been derived from post-event satellite image using by means of visual interpretation.
