EMSR796 - AOI03
Flood in Ecuador
SAN ROQUE

Situation as of 30/04/2025 15:56:28 UTC
Grading MONIT02 - Overview map 01

Situation as of 30/04/2025 15:56:28 UTC
Grading MONIT02 - Detail map 02

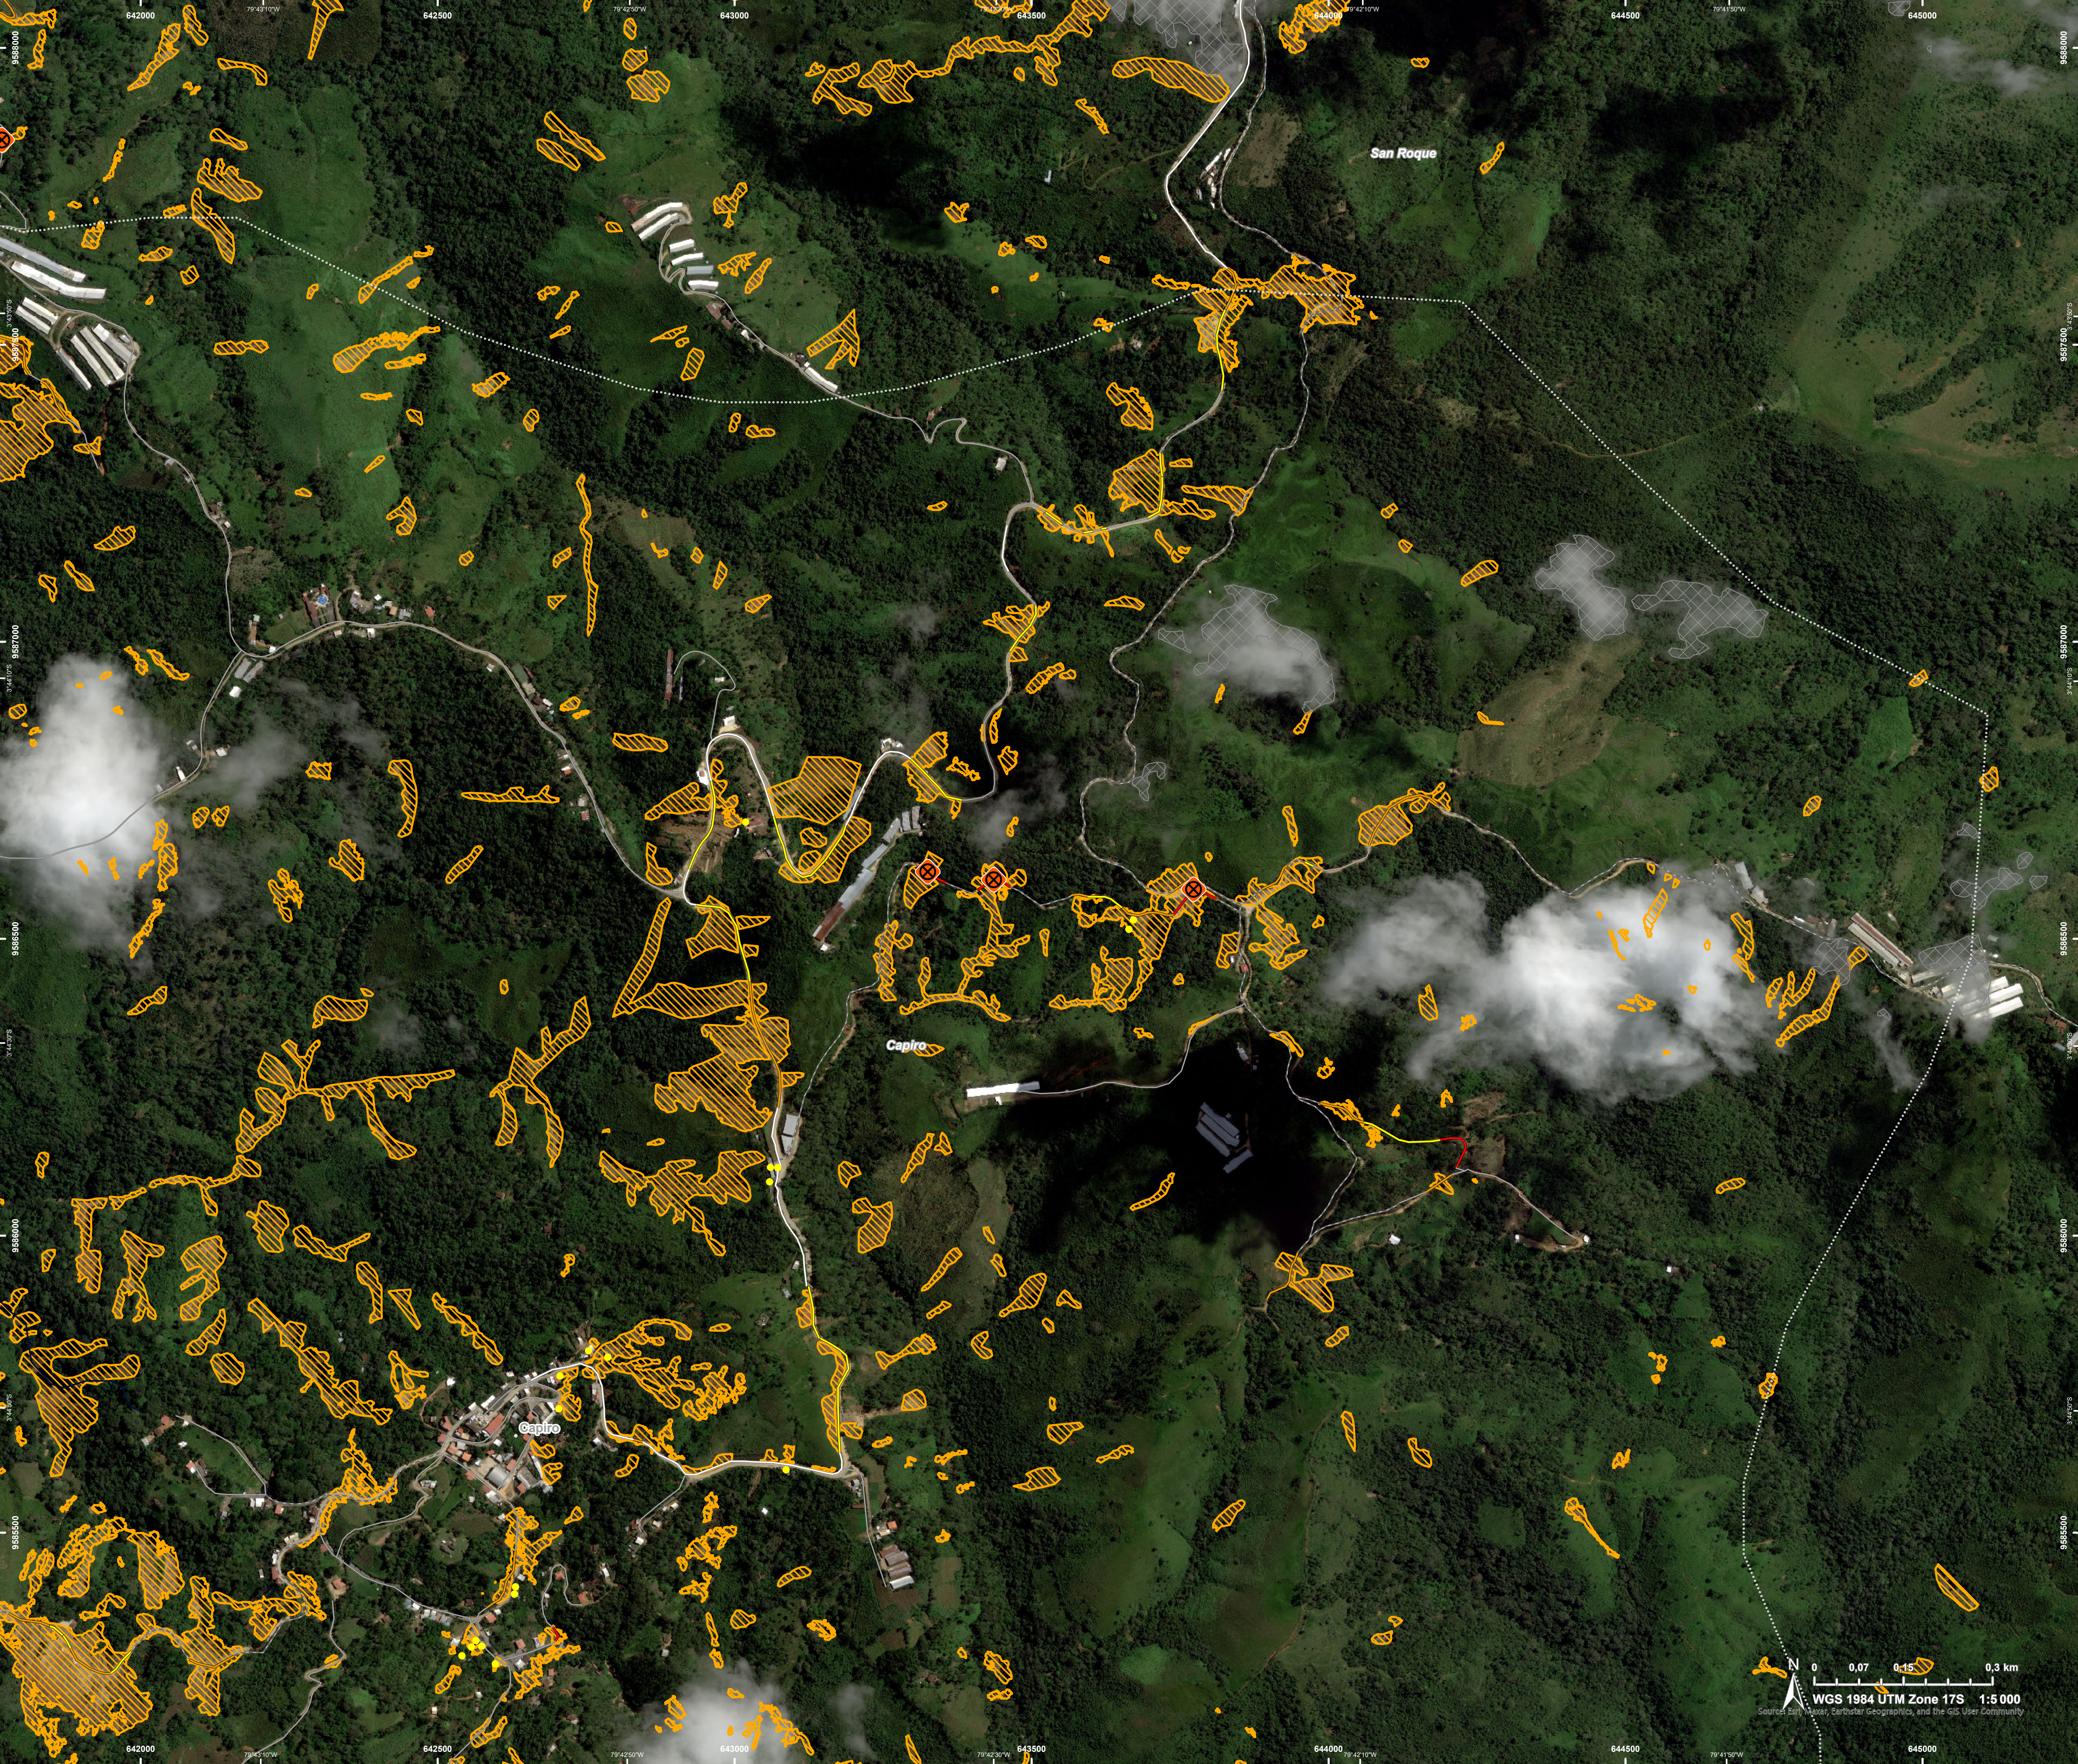
Landslide 133.0 ha

Potentially affected population
~ 40

Built-Up
22 No.

Road
9.3 km

Event: On the 26 February 2025 at 16 :00 UTC, heavy rainfall affected western and coastal Ecuador causing floods and triggering landslides. The event is on-going, causing significant damage. Copernicus EMS Rapid Mapping is requested to provide damage assesment emergency mapping.

The thematic layer has been derived from post-event satellite image by means of visual interpretation.

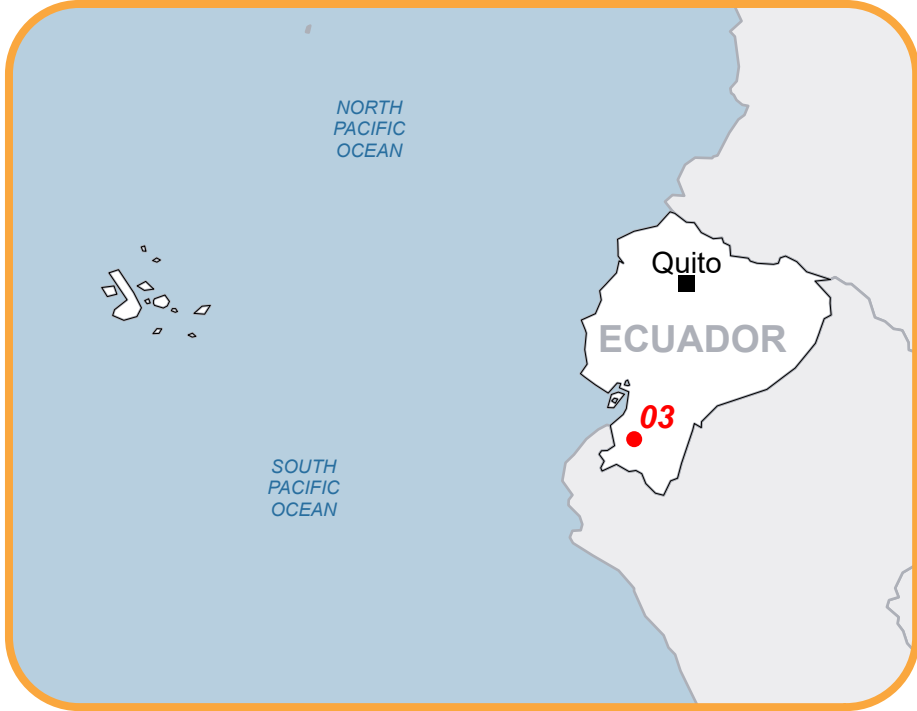
Consequences within the AOI							
	Unit of measurement		Destroyed	Damaged	Possibly damaged*	Total affected**	Total in AOI
Landslide		ha					133.0
Ancillary Crisis Information	Blocked road / interruption	No.					6
Estimated population	Number of inhabitants					~ 40	~ 1 300
Built-up	Residential Buildings	No.	0	0	18	18	NA
	Other non-residential buildings	No.	0	0	4	4	NA
Transportation	Highways	km	0	0	0	0	0.6
	Secondary Road	km	0	0.4	0.9	1.3	4.8
	Local Road	km	0.8	2.2	3.0	6.0	42.1
	Cart Track	km	0.2	0.6	1.2	2.0	25.5
Land use	Forests	ha				118.7	3 889.6
	Shrub and/or herbaceous vegetation association	ha				14.3	655.0
* Presence of damage proxies and proximity with destroyed/damaged asset							
** Sum of all damage classes
