EMSR796 - AOI03

Flood in Ecuador

SAN ROQUE

Grading - Overview map 01

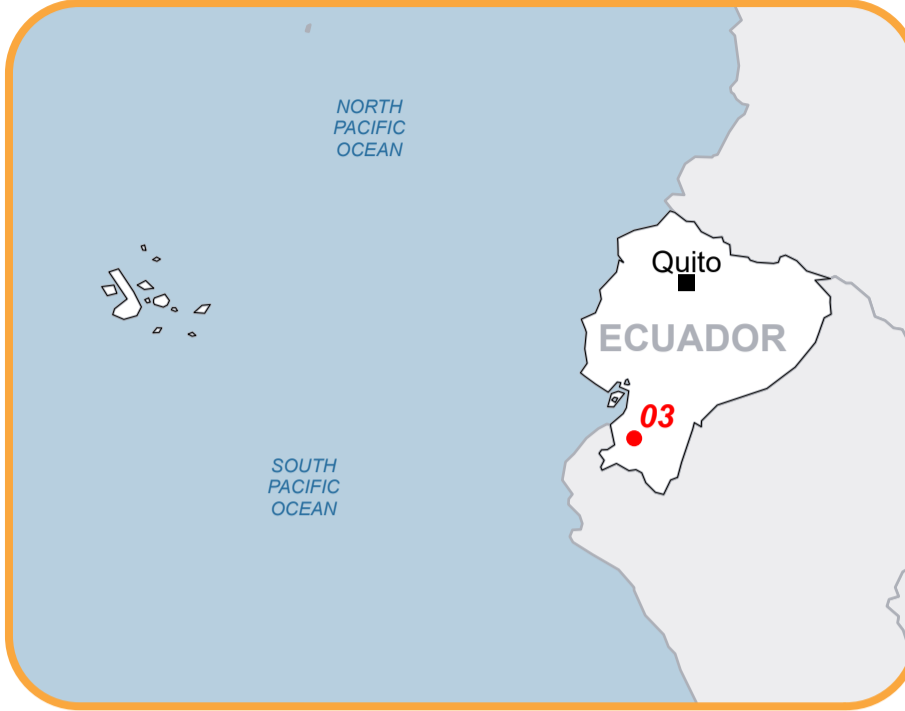
Landslide 53.9 ha

Flood trace 0.1 ha

Potentially affected population ~ 10

6 No.

1.2 km

**Event:** On the 26 February 2025 at 16 :00 UTC, heavy rainfall affected western and coastal Ecuador causing floods and triggering landslides. The event is on-going, causing significant damage. Copernicus EMS Rapid Mapping is requested to provide damage assesment emergency mapping.

The thematic layer has been derived from post-event satellite image by means of visual interpretation.
