Situation as of 16/04/2025 15:38 UTC  
Grading - Overview map 01

EMSR796 - AOI07

Flood in Ecuador

OLMEDO

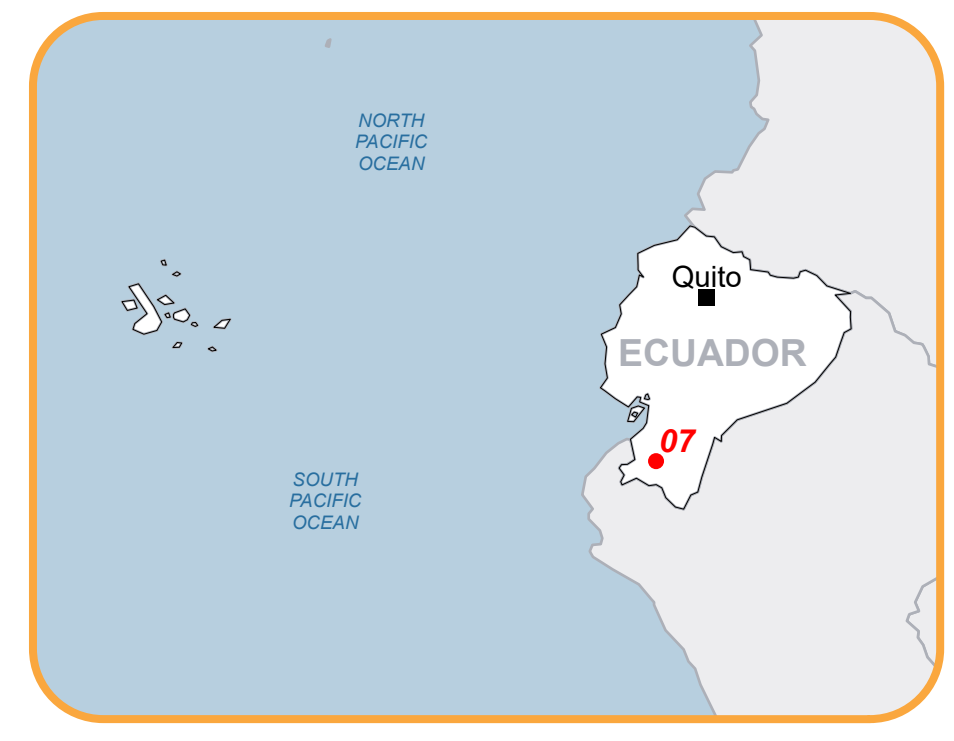
Situation as of 16/04/2025 15:38 UTC  
Grading - Detail map 03

**Event:** On the 26 February 2025 at 16:00 UTC, heavy rainfall affected western and coastal Ecuador causing floods and triggering landslides. The event is on-going, causing significant damage. Copernicus EMS Rapid Mapping is requested to provide damage assessment emergency mapping.

The thematic layer has been derived from post-event satellite image by means of visual interpretation.  
"Not analysed" indicates an area that could not be analysed in any of the post-event images.

Consequences within the AOI							
	Unit of measurement		Destroyed	Damaged	Possibly damaged*	Total affected**	Total in AOI
Flood trace		ha					0.9
Landslide		ha					9.2
Estimated population	Number of inhabitants					~ 20	~ 2,300
Built-up	Residential Buildings	No.	2	4	10	16	979
	Other buildings not elsewhere classified	No.	1	0	0	1	38
Transportation	Highways	km	0	0	0.1	0.1	11.5
	Secondary Road	km	0	0	1.0	1.0	11.7
	Local Road	km	0	0	0.1	0.1	7.9
	Cart Track	km	0	0	0.04	0.04	2.7
Facilities	Constructions for mining or extraction	ha	0	0	3.0	3.0	3.0
	Sport and recreation constructions	ha	0	0	0	0	0.1
Land use	Forests	ha				6.7	1,135.5
	Shrub and/or herbaceous vegetation association	ha				3.4	289.5
* Presence of damage proxies and proximity with destroyed/damaged asset							
** Sum of all damage classes
