**Situation as of 14/11/2025 15:52 UTC**  
Grading - Overview map 01

**Event:** On 25 October 2025 at 20:00, Tropical Storm Melissa is forecast to affect Jamaica and the southern peninsula of Haiti. The event is expected to cause damage to housing, infrastructure, and transport networks due to heavy rainfall, strong winds, flooding, and landslides. Hurricane conditions are forecast for Jamaica during the weekend and subsequently for the southern peninsula of Haiti and Cuba. Copernicus EMS Rapid Mapping is requested to provide flood extent and damage assessment emergency mapping.

EMSR847 - AOI34  
Storm in Jamaica  
PORT ANTONIO

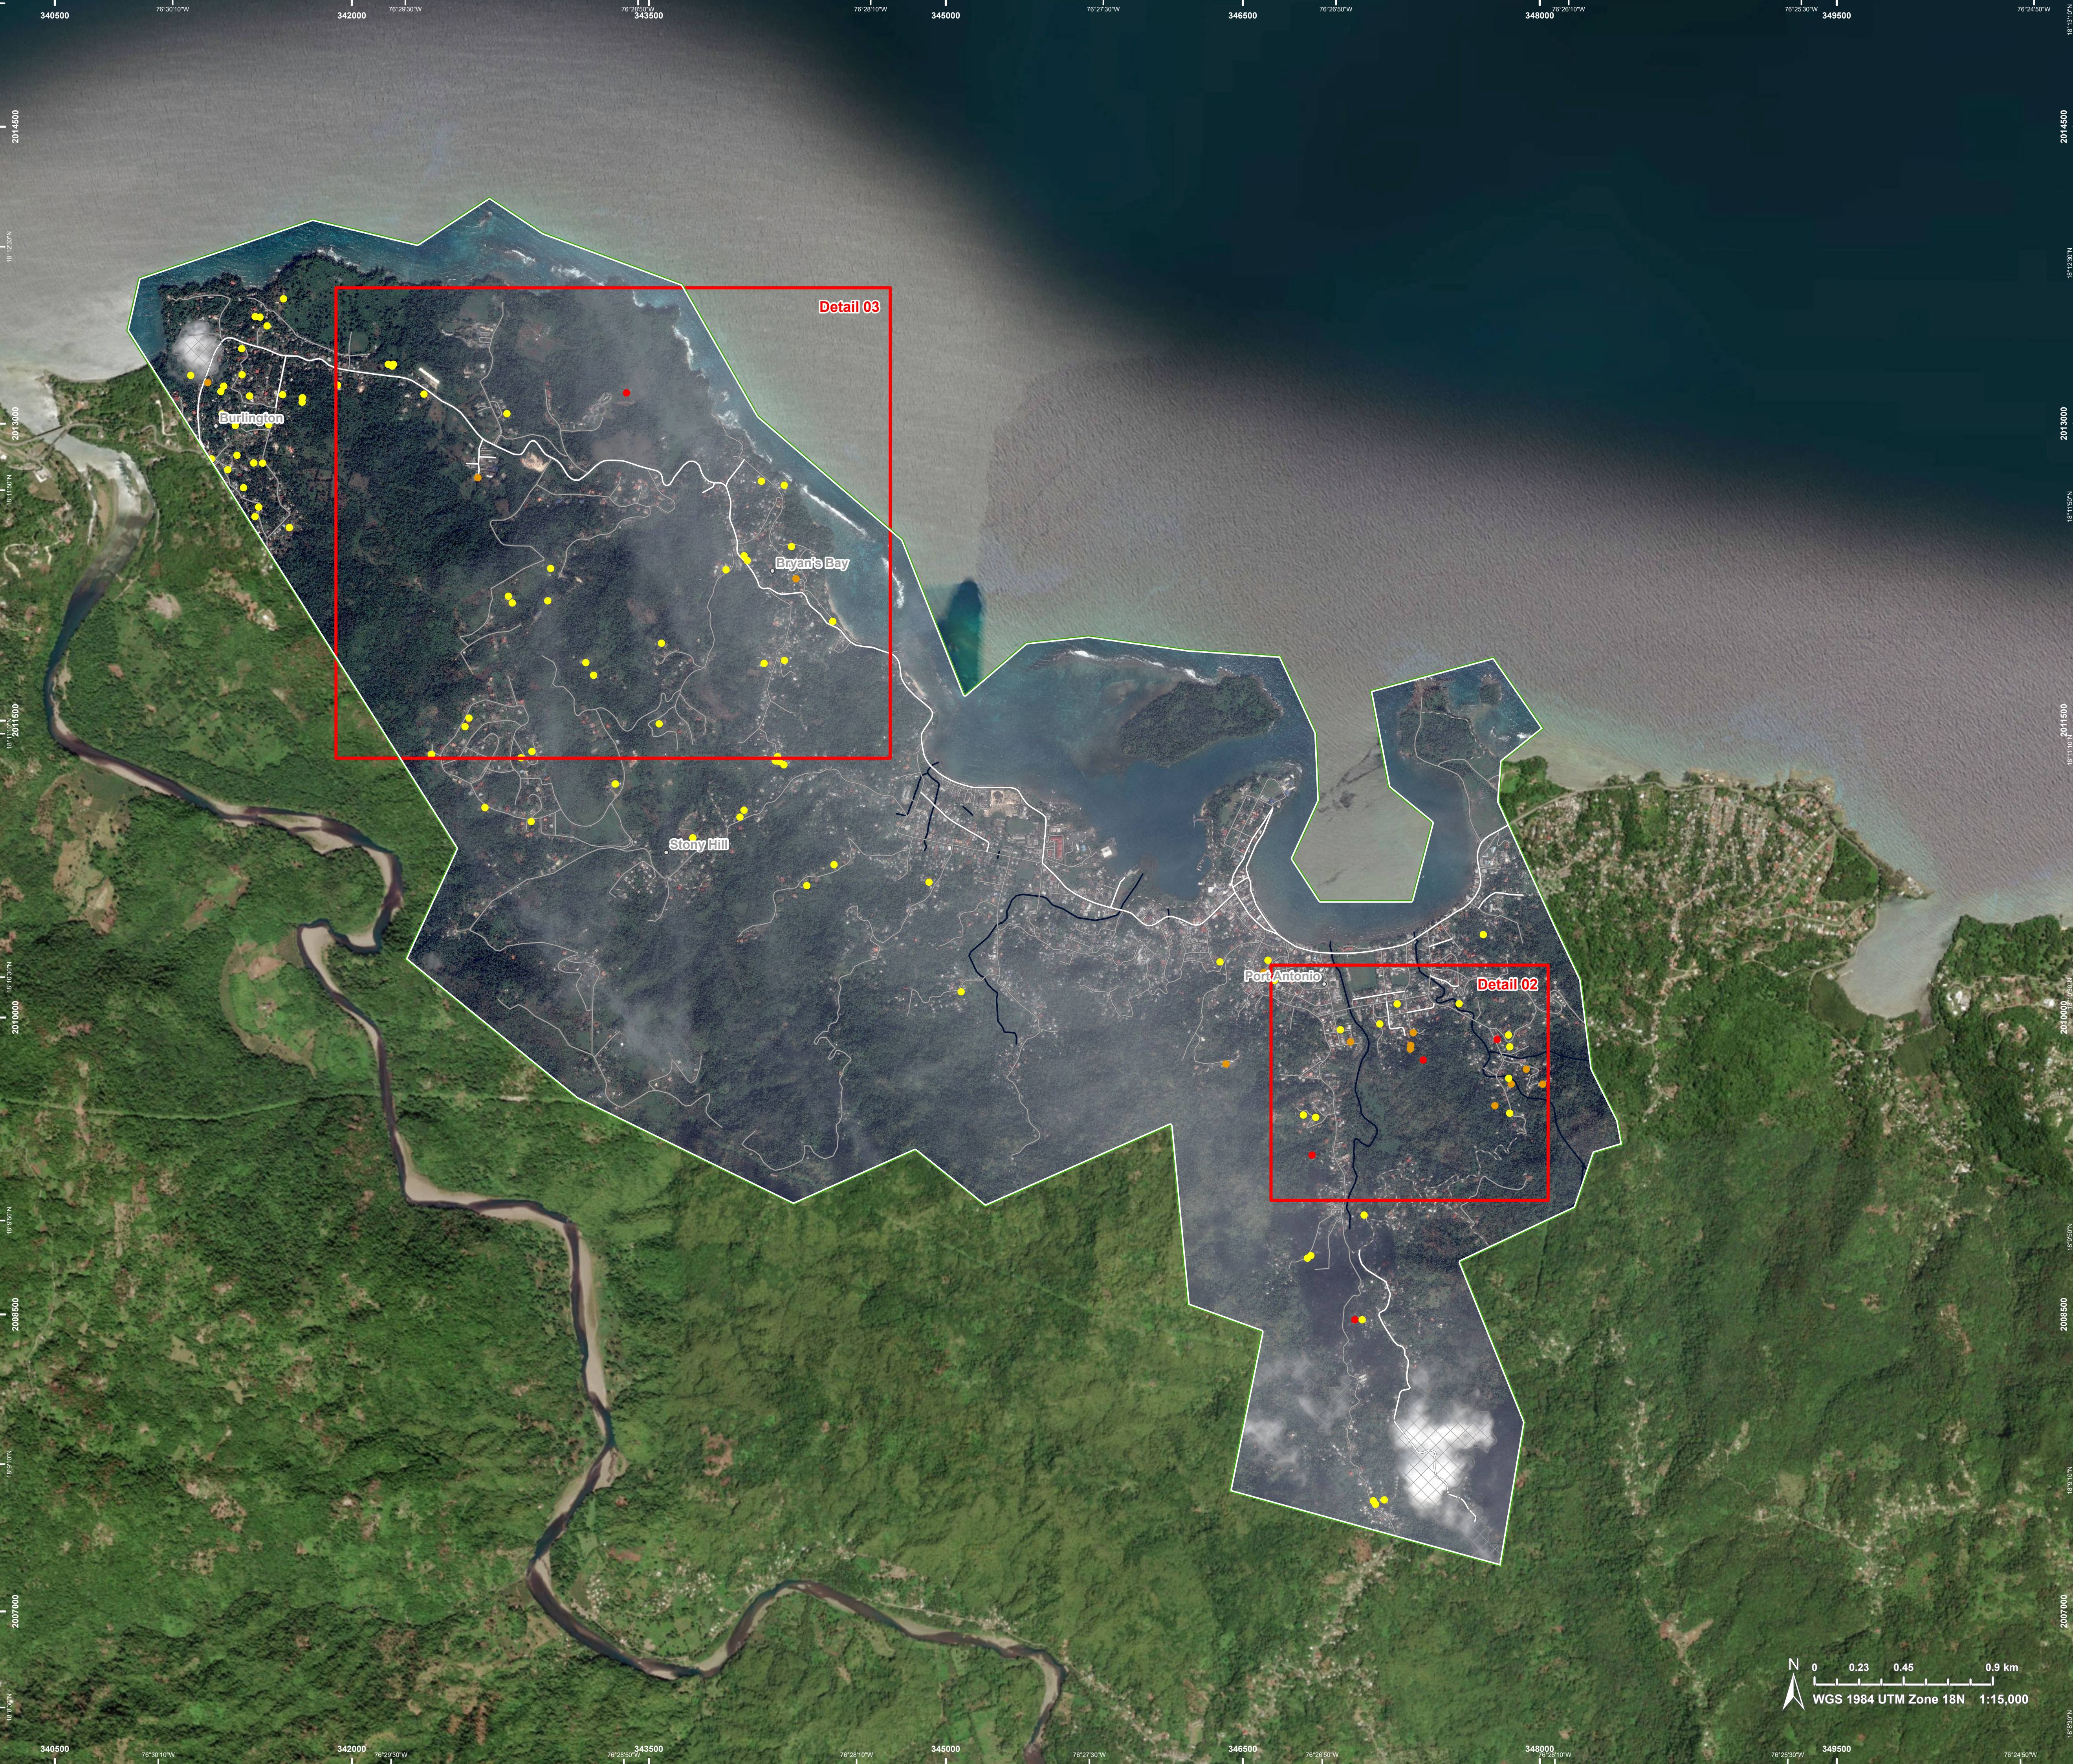
Built-Up  
108 No.

The thematic layer has been derived from post-event satellite image by means of visual interpretation

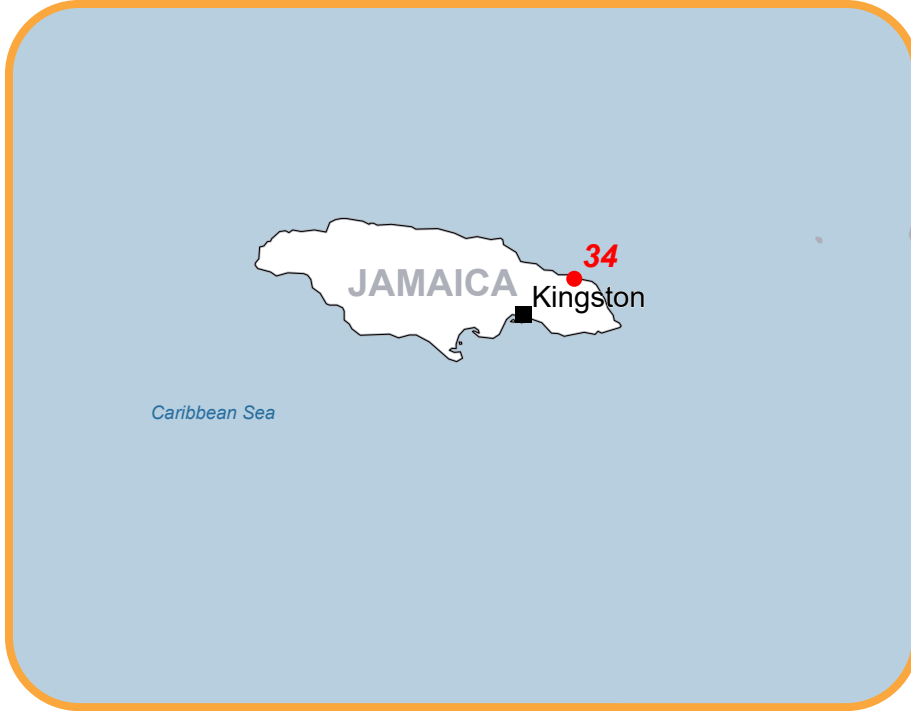
Affected Built-up

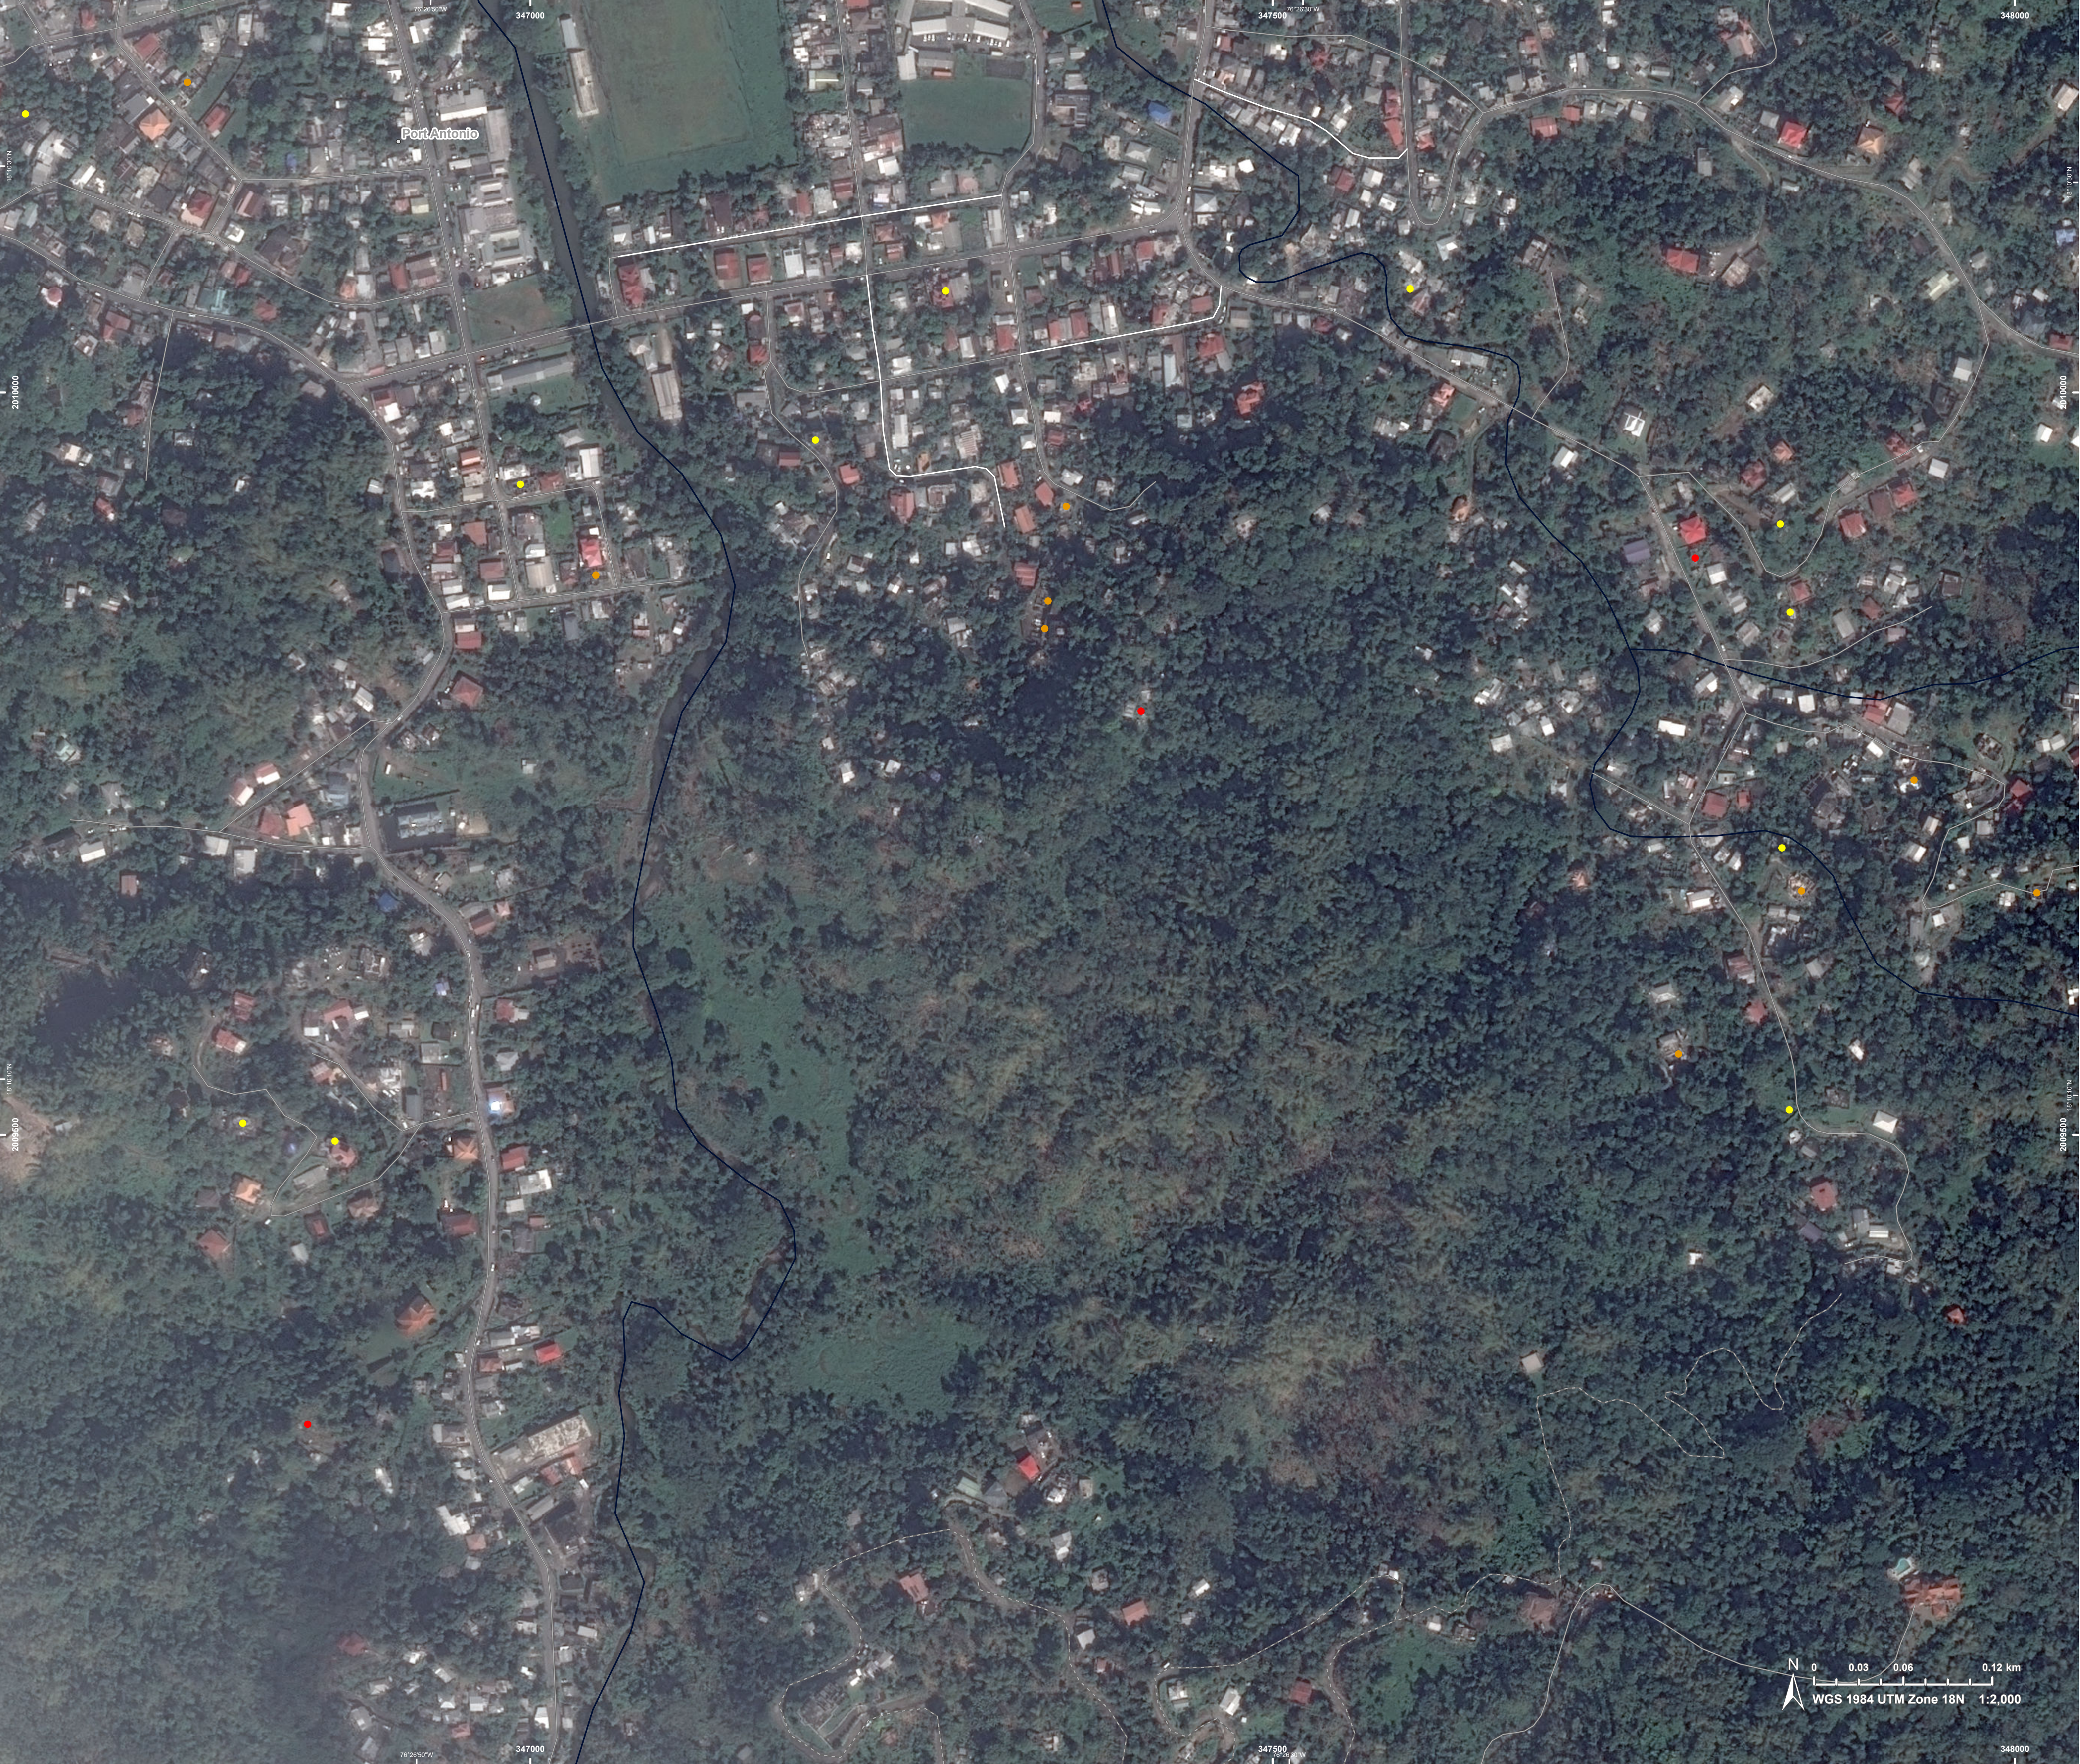
Situation as of 14/11/2025 15:52 UTC  
Grading - Detail map 02

The thematic layer has been derived from post-event satellite image by means of visual interpretation

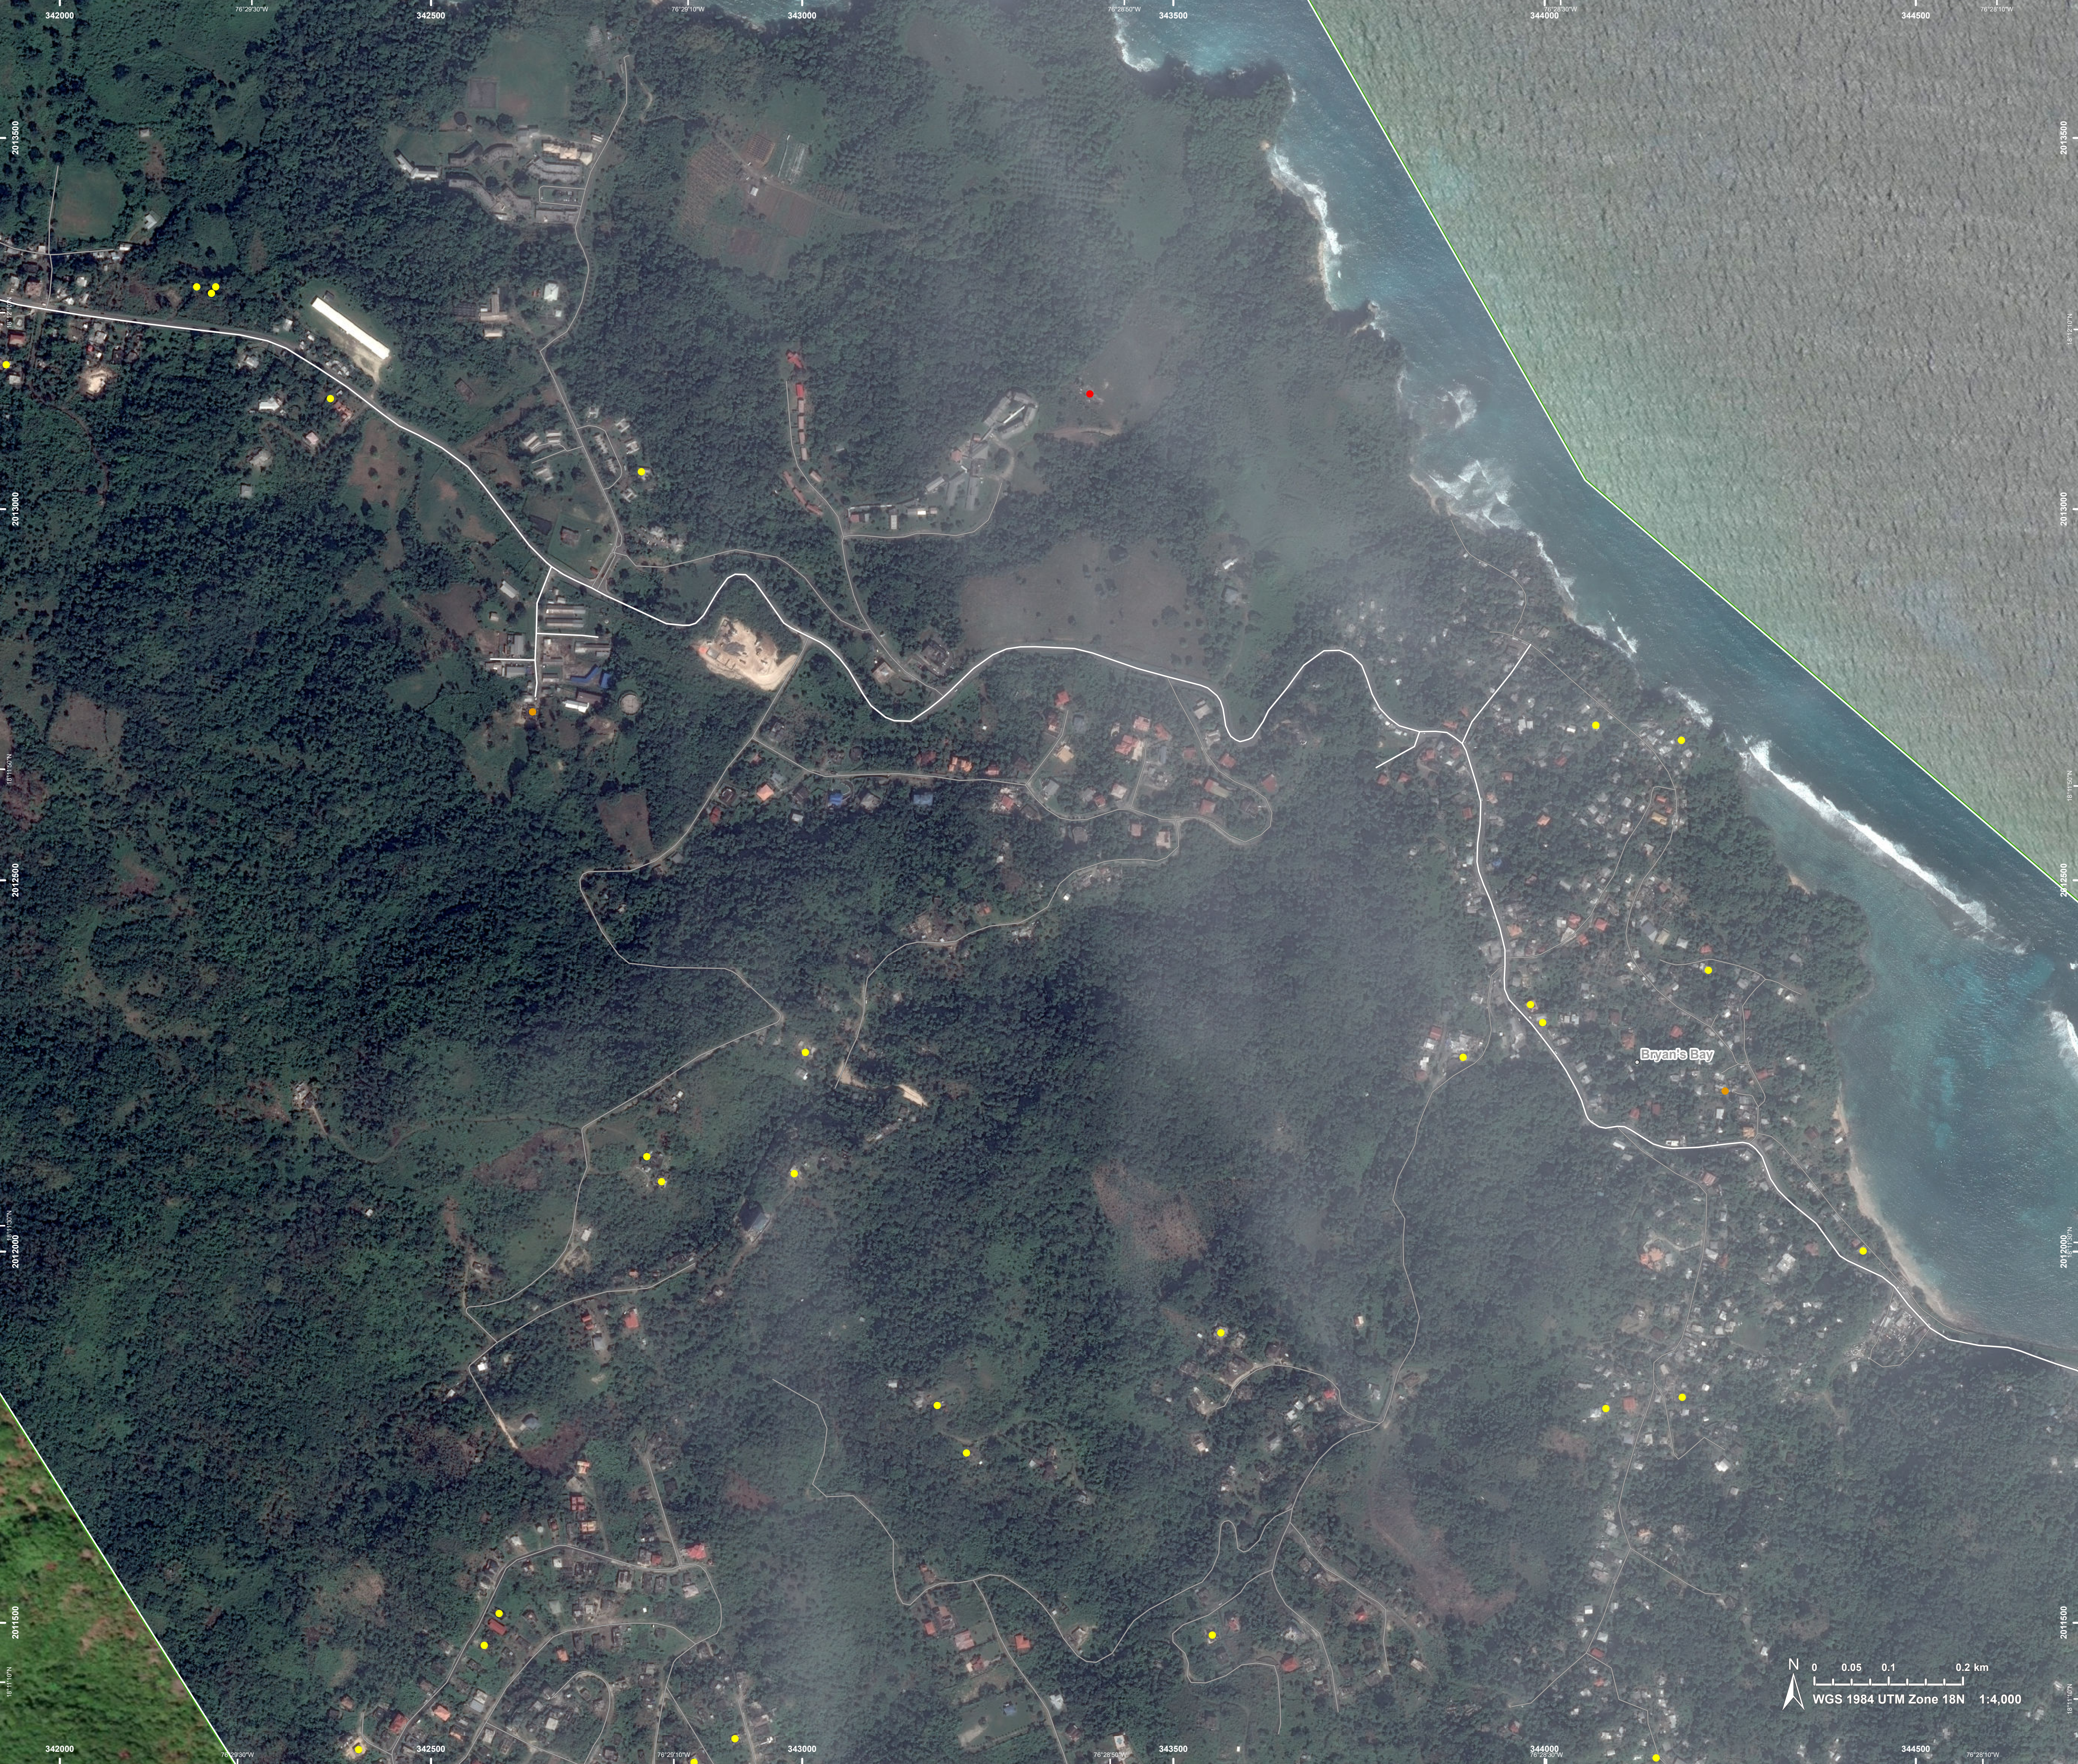
Situation as of 14/11/2025 15:52 UTC  
Grading - Detail map 03

The thematic layer has been derived from post-event satellite image by means of visual interpretation
