EMSR851 - AOI08
Flood in Sri Lanka
PUGODA

Situation as of 05/12/2025 05:02 UTC
Grading - Overview map 01

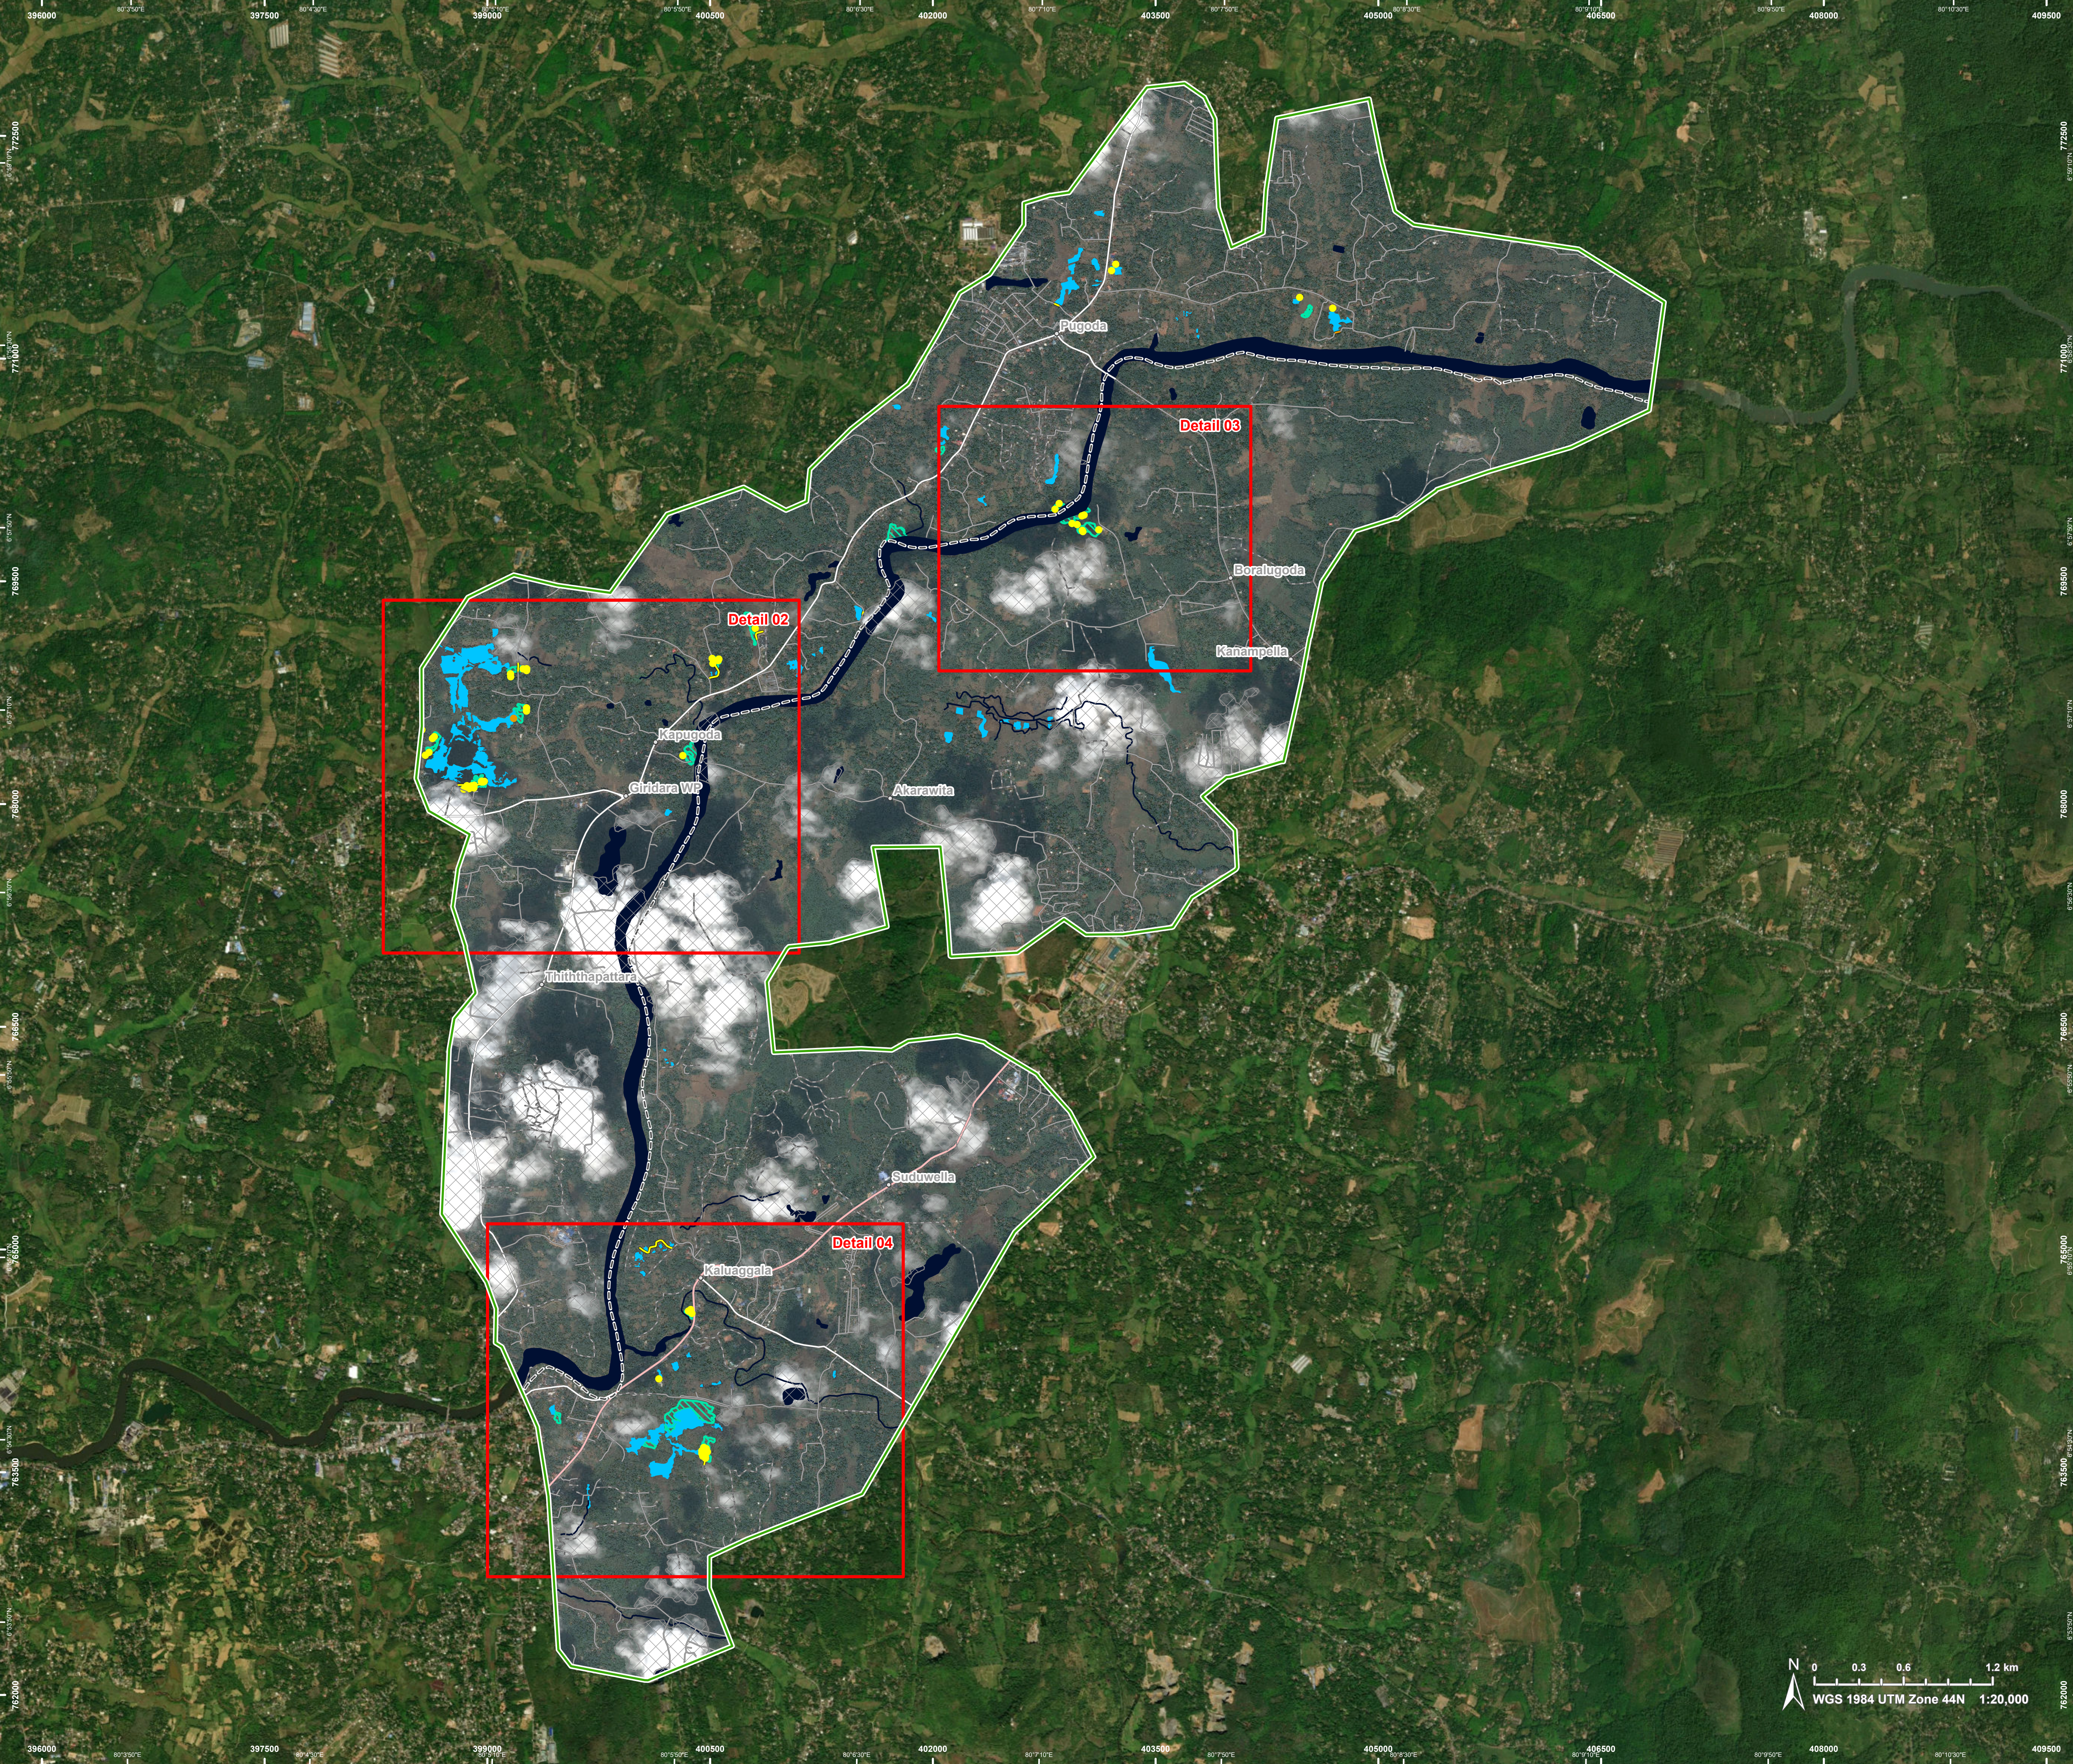
Flood trace
11.1 ha

Flooded area
35.5 ha

Potentially affected
population
~ 200

Built-Up
59 No.

Road
1.0 km

Event: On the 27 November 2025, Tropical Cyclone DITWAH-25 formed over Sri Lanka. The event has caused heavy damage across the country, with floods, landslides and mudslides reported. Copernicus EMS Rapid Mapping is requested to provide flood extent and damage assessment emergency mapping.

The thematic layer has been derived from post-event satellite image using a semi-automatic approach.

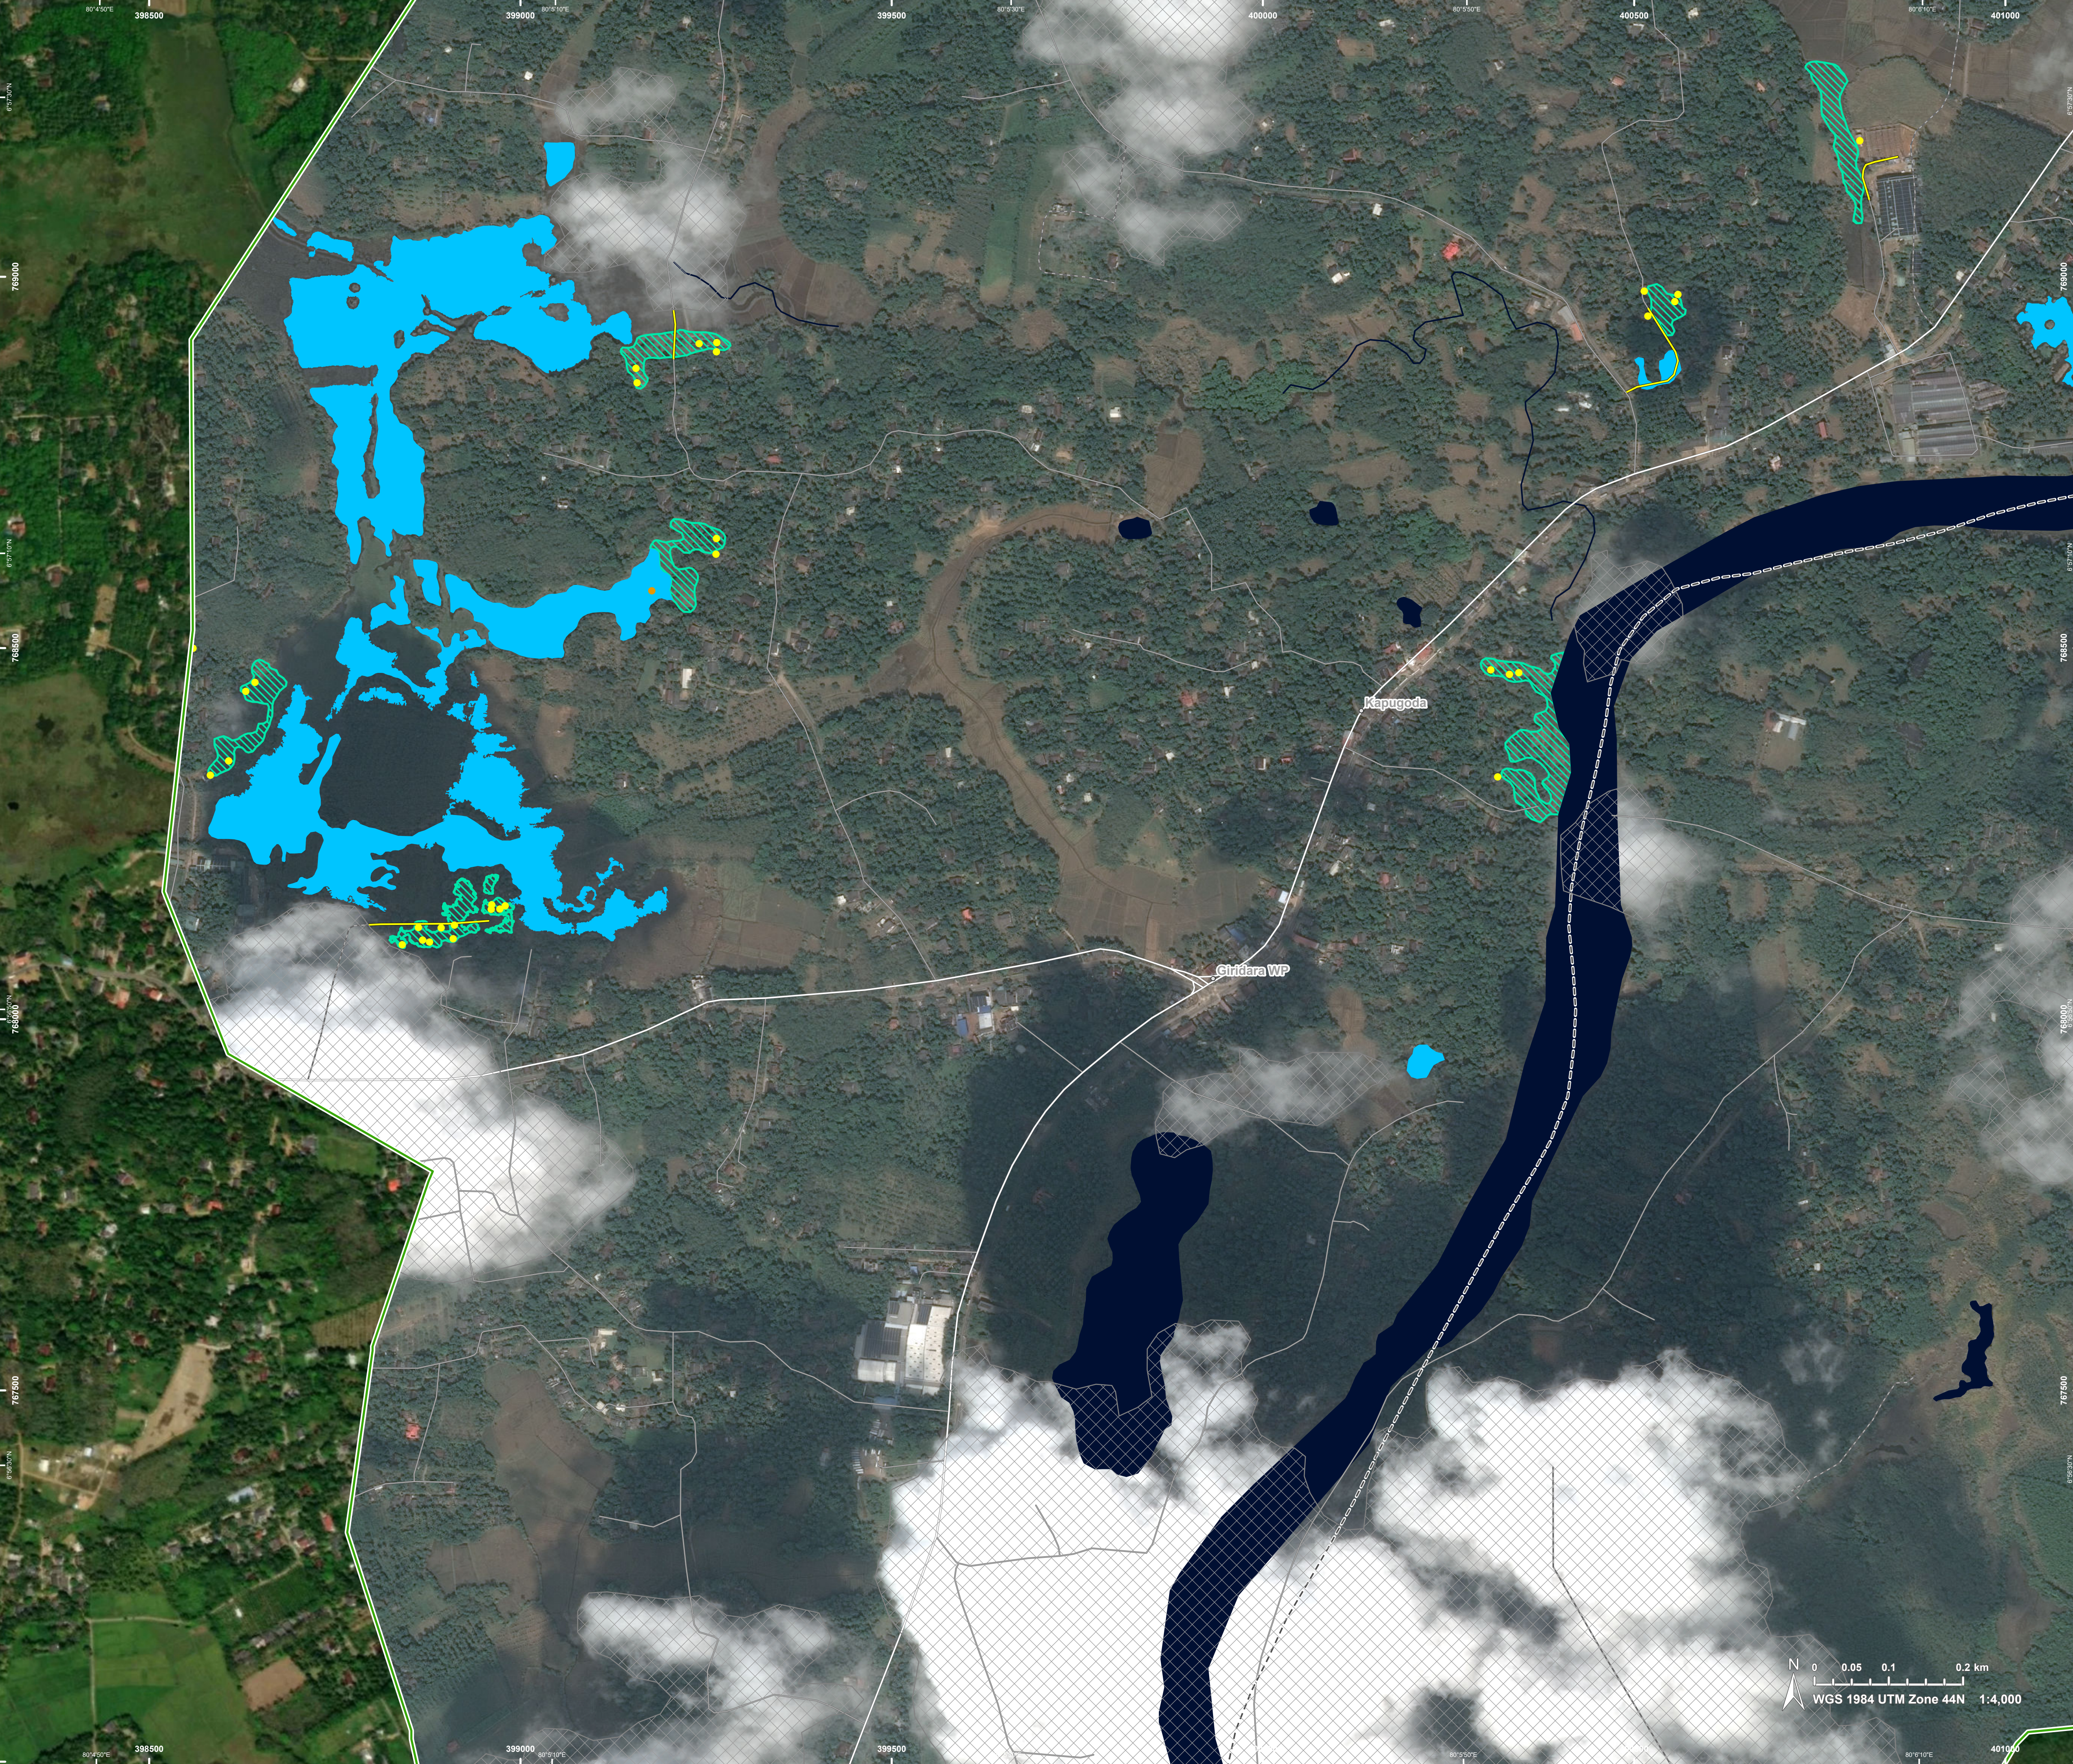
Situation as of 05/12/2025 05:02 UTC
Grading - Detail map 02

Event: On the 27 November 2025, Tropical Cyclone DITWAH-25 formed over Sri Lanka. The event has caused heavy damage across the country, with floods, landslides and mudslides reported. Copernicus EMS Rapid Mapping is requested to provide flood extent and damage assessment emergency mapping.

The thematic layer has been derived from post-event satellite image using a semi-automatic approach.

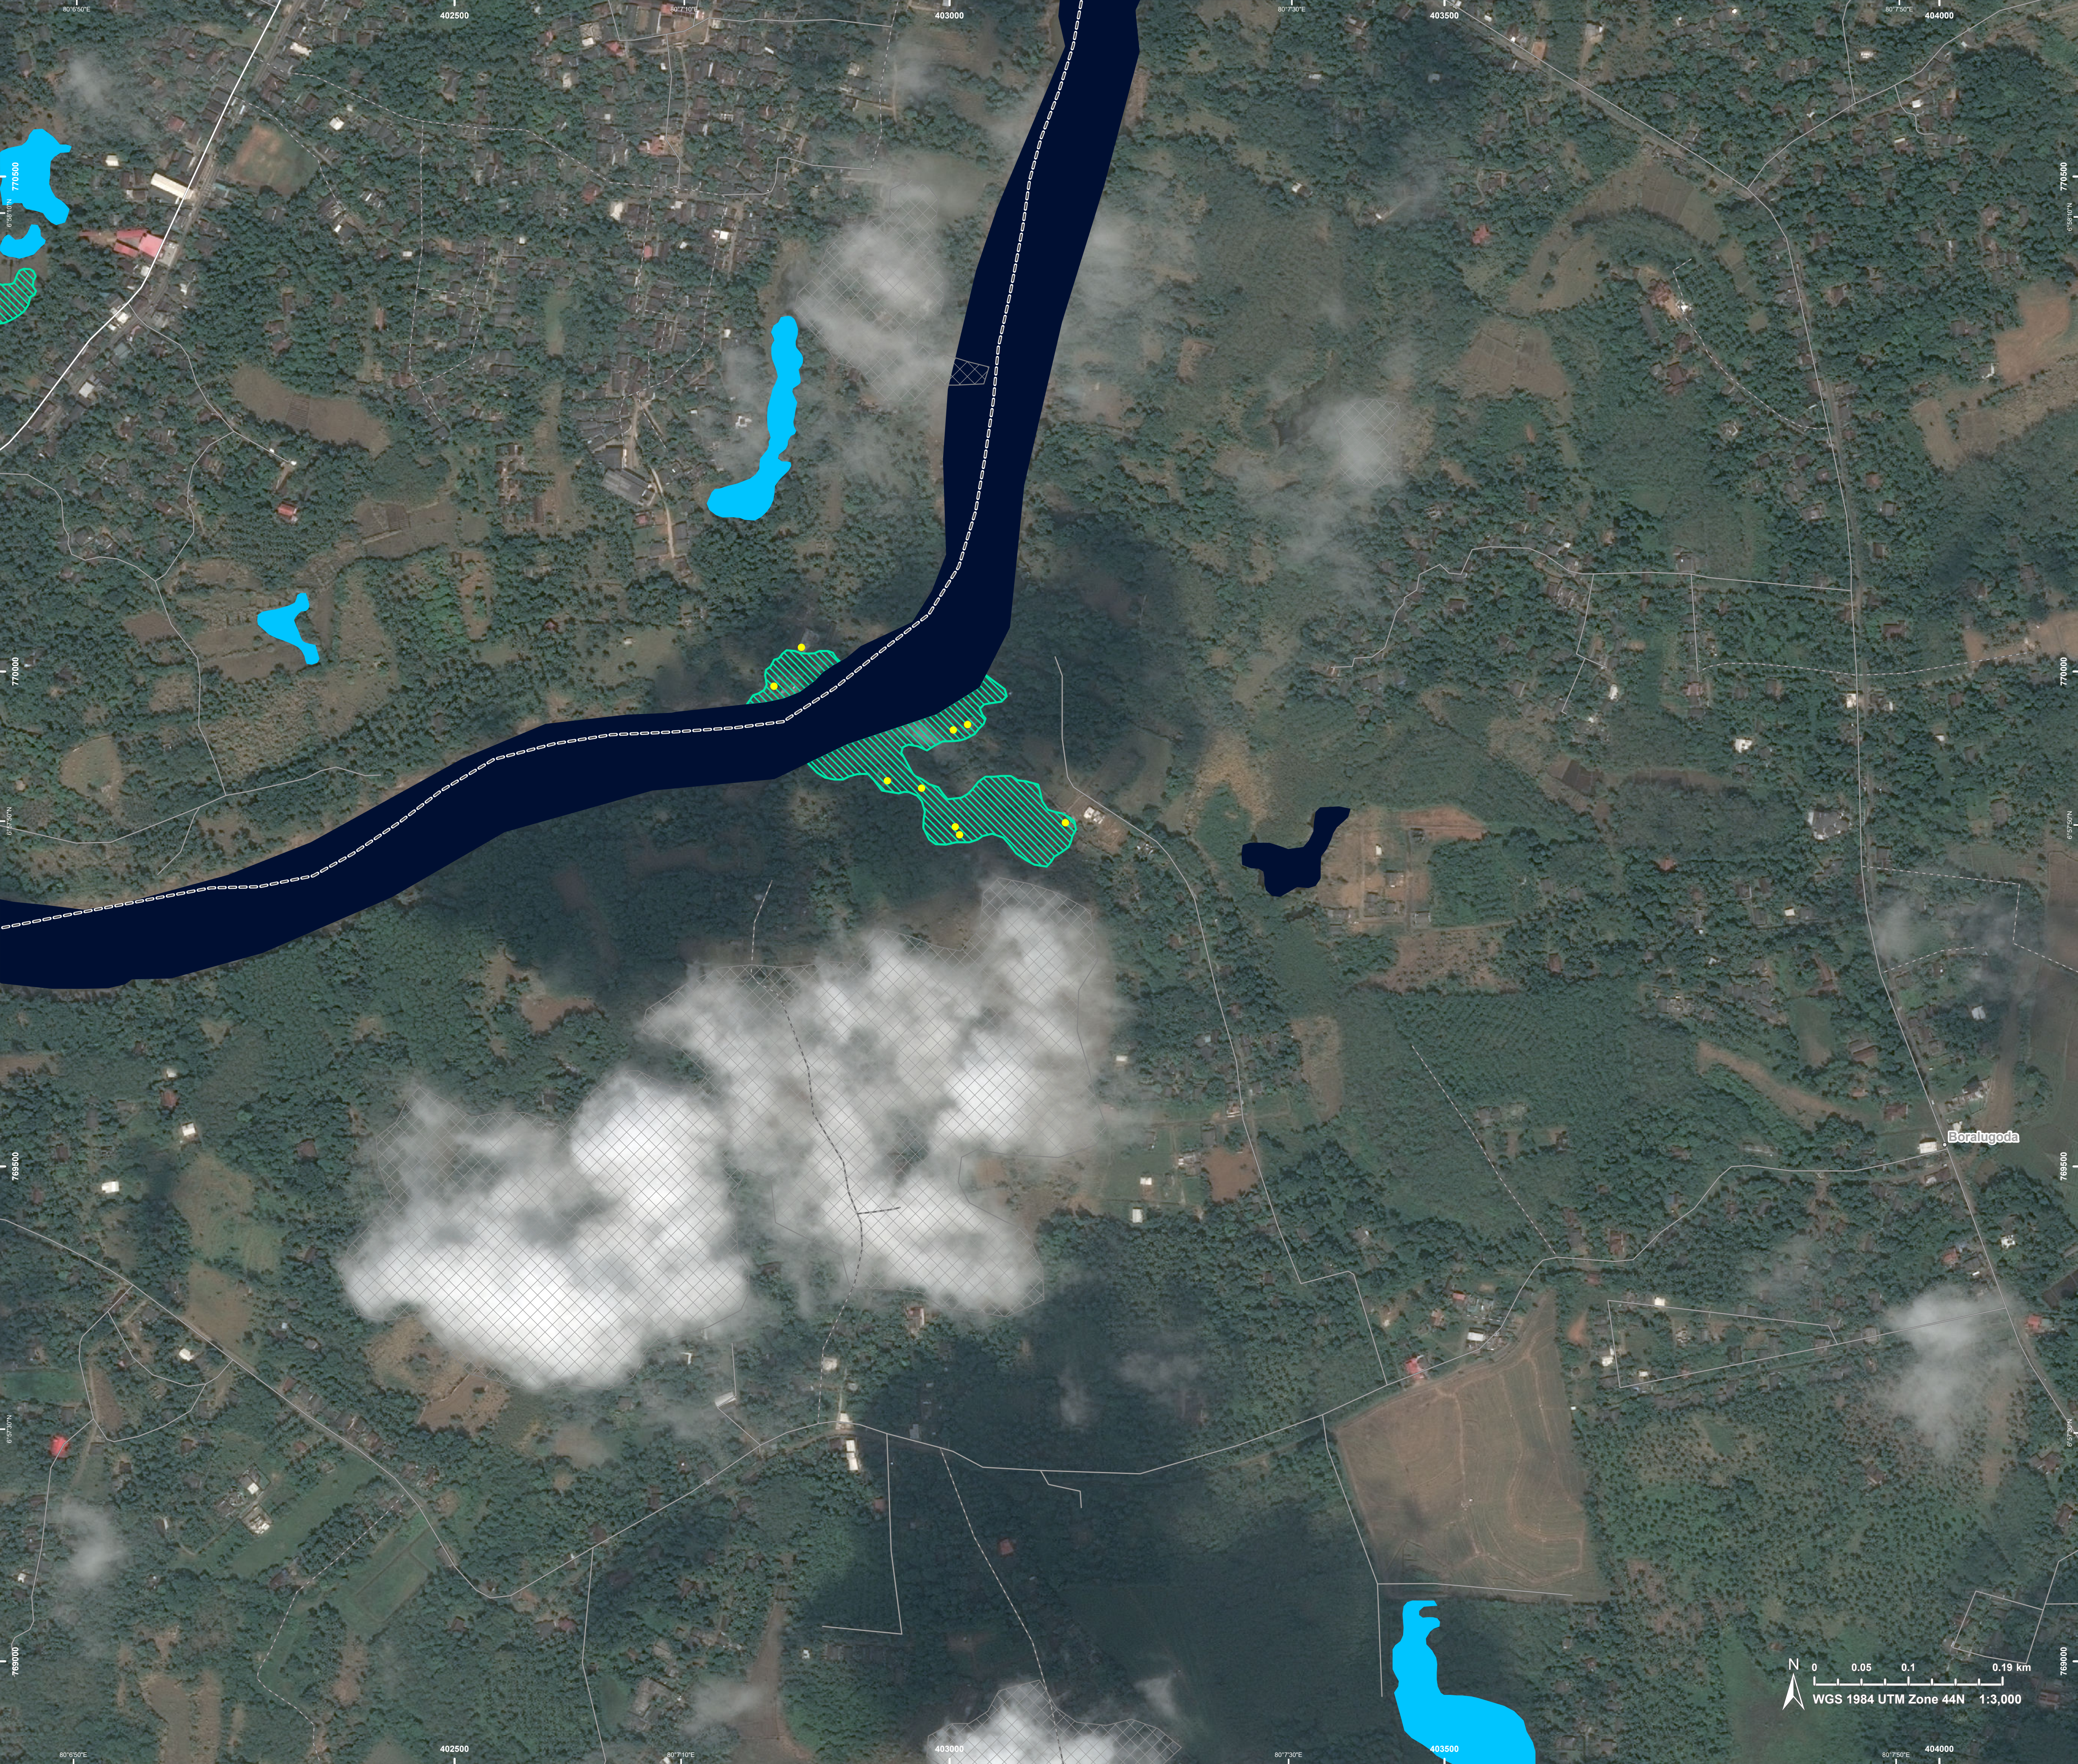
Situation as of 05/12/2025 05:02 UTC
Grading - Detail map 03

Event: On the 27 November 2025, Tropical Cyclone DITWAH-25 formed over Sri Lanka. The event has caused heavy damage across the country, with floods, landslides and mudslides reported. Copernicus EMS Rapid Mapping is requested to provide flood extent and damage assessment emergency mapping.

The thematic layer has been derived from post-event satellite image using a semi-automatic approach.

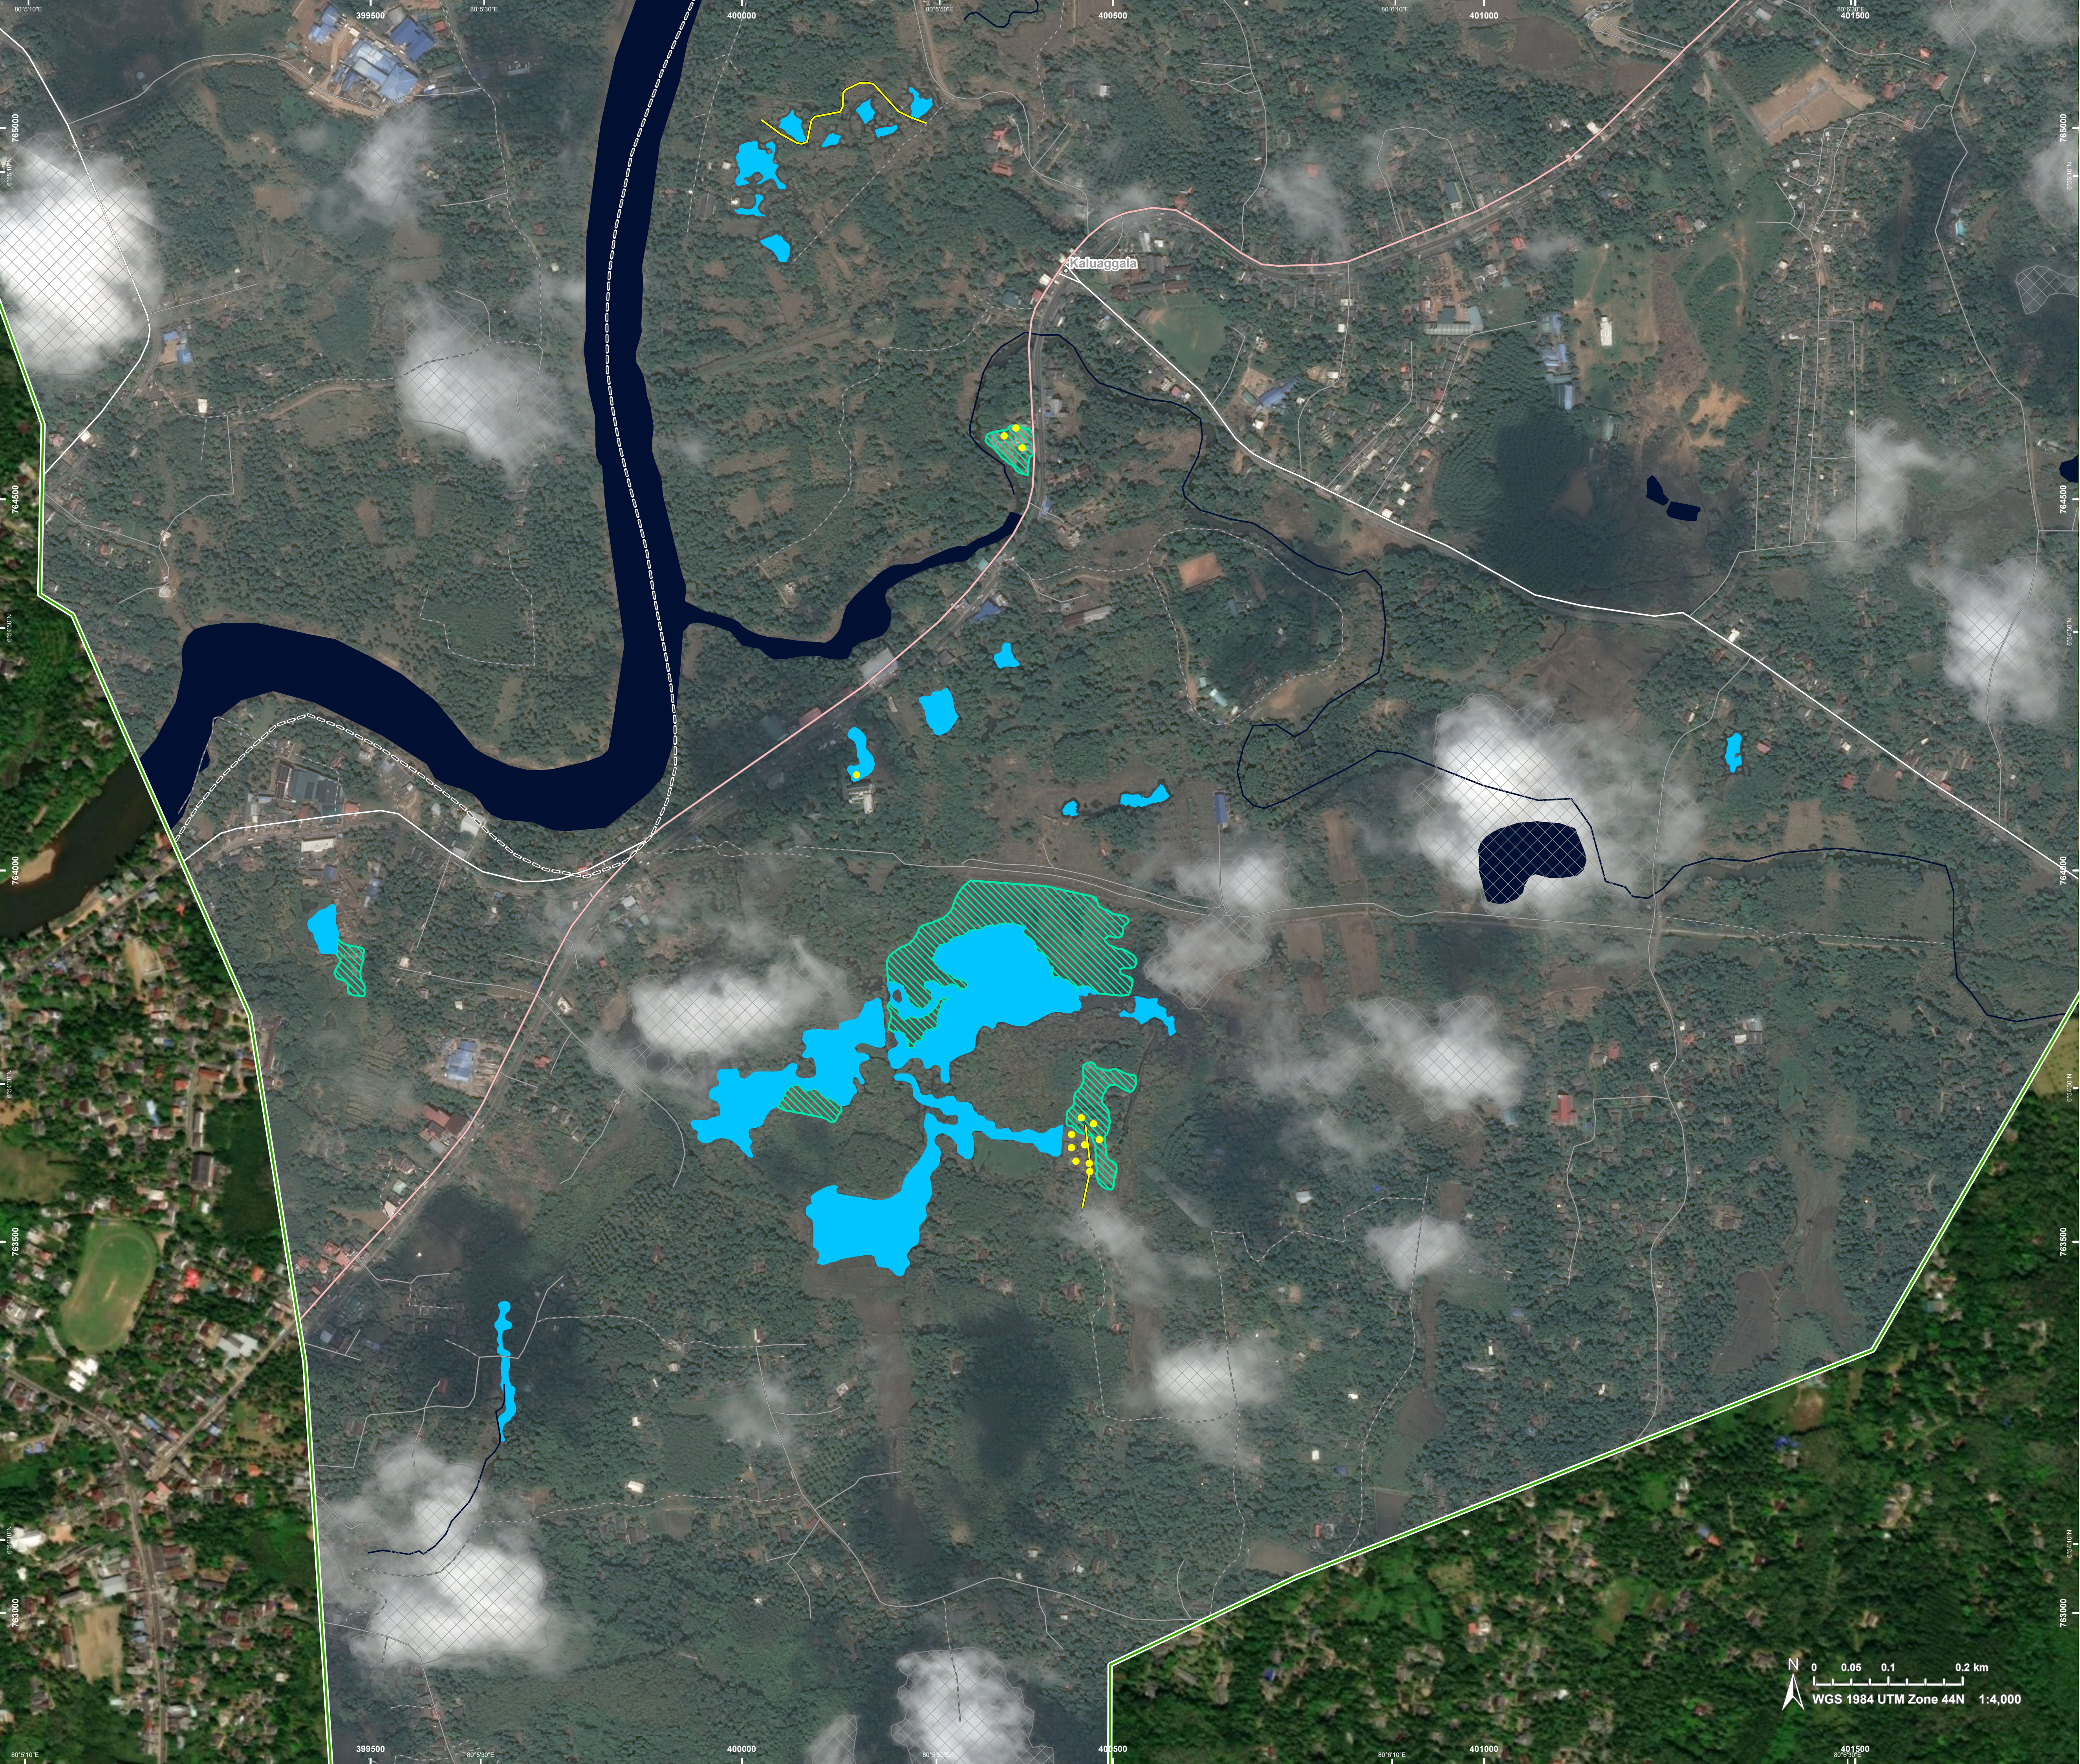
Situation as of 05/12/2025 05:02 UTC
Grading - Detail map 04

Event: On the 27 November 2025, Tropical Cyclone DITWAH-25 formed over Sri Lanka. The event has caused heavy damage across the country, with floods, landslides and mudslides reported. Copernicus EMS Rapid Mapping is requested to provide flood extent and damage assessment emergency mapping.

The thematic layer has been derived from post-event satellite image using a semi-automatic approach.
