Situation as of 21/12/2025 04:51 UTC  
Grading - Overview map 01

**Event:** On the 27 November 2025, Tropical Cyclone DITWAH-25 formed over Sri Lanka. The event caused heavy damage across the country, with floods, landslides and mudslides reported. Copernicus EMS Rapid Mapping was requested to provide flood extent and damage assessment emergency mapping.

EMSR851 - AOI19  
Flood in Sri Lanka  
CHEMMALAI

Situation as of 21/12/2025 04:51 UTC  
Grading - Detail map 02

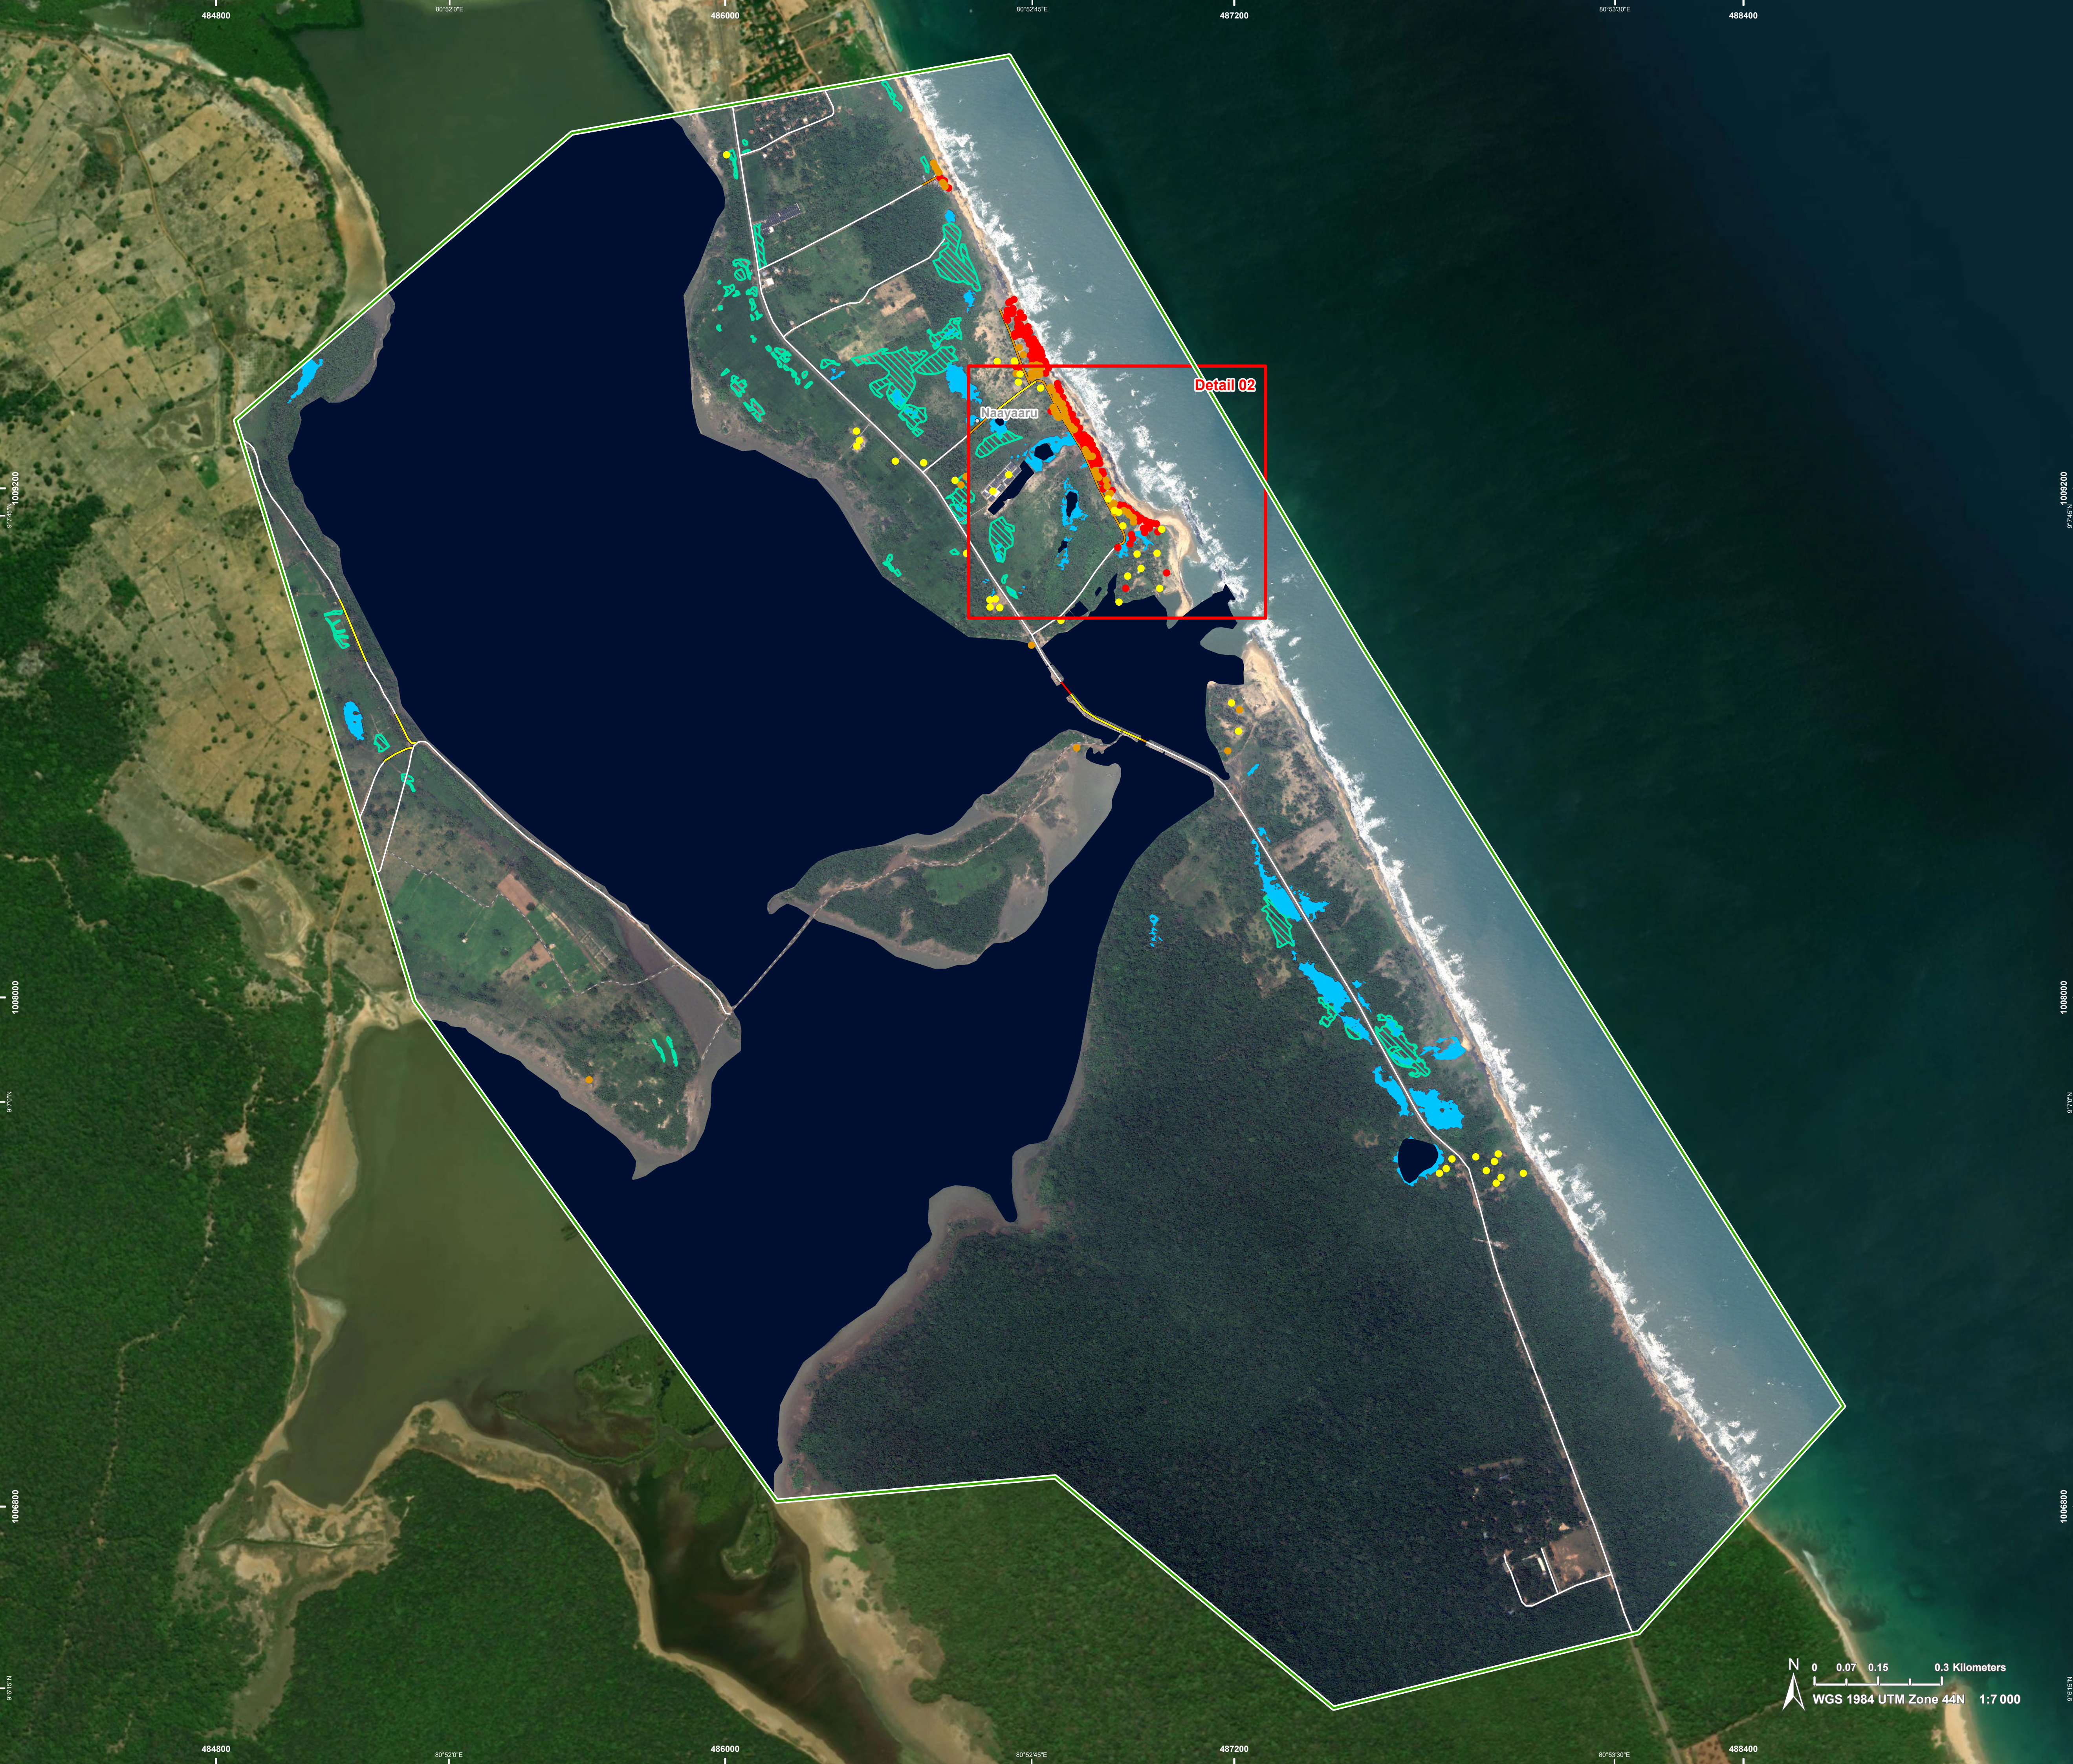
Flood trace  
5.8 ha  
Flooded area  
5.7 ha  
Potentially affected population  
~ Not available

Road  
1.5 km  
Built-Up  
242 No.

The thematic layer has been derived from post-event satellite image using a semi-automatic approach.

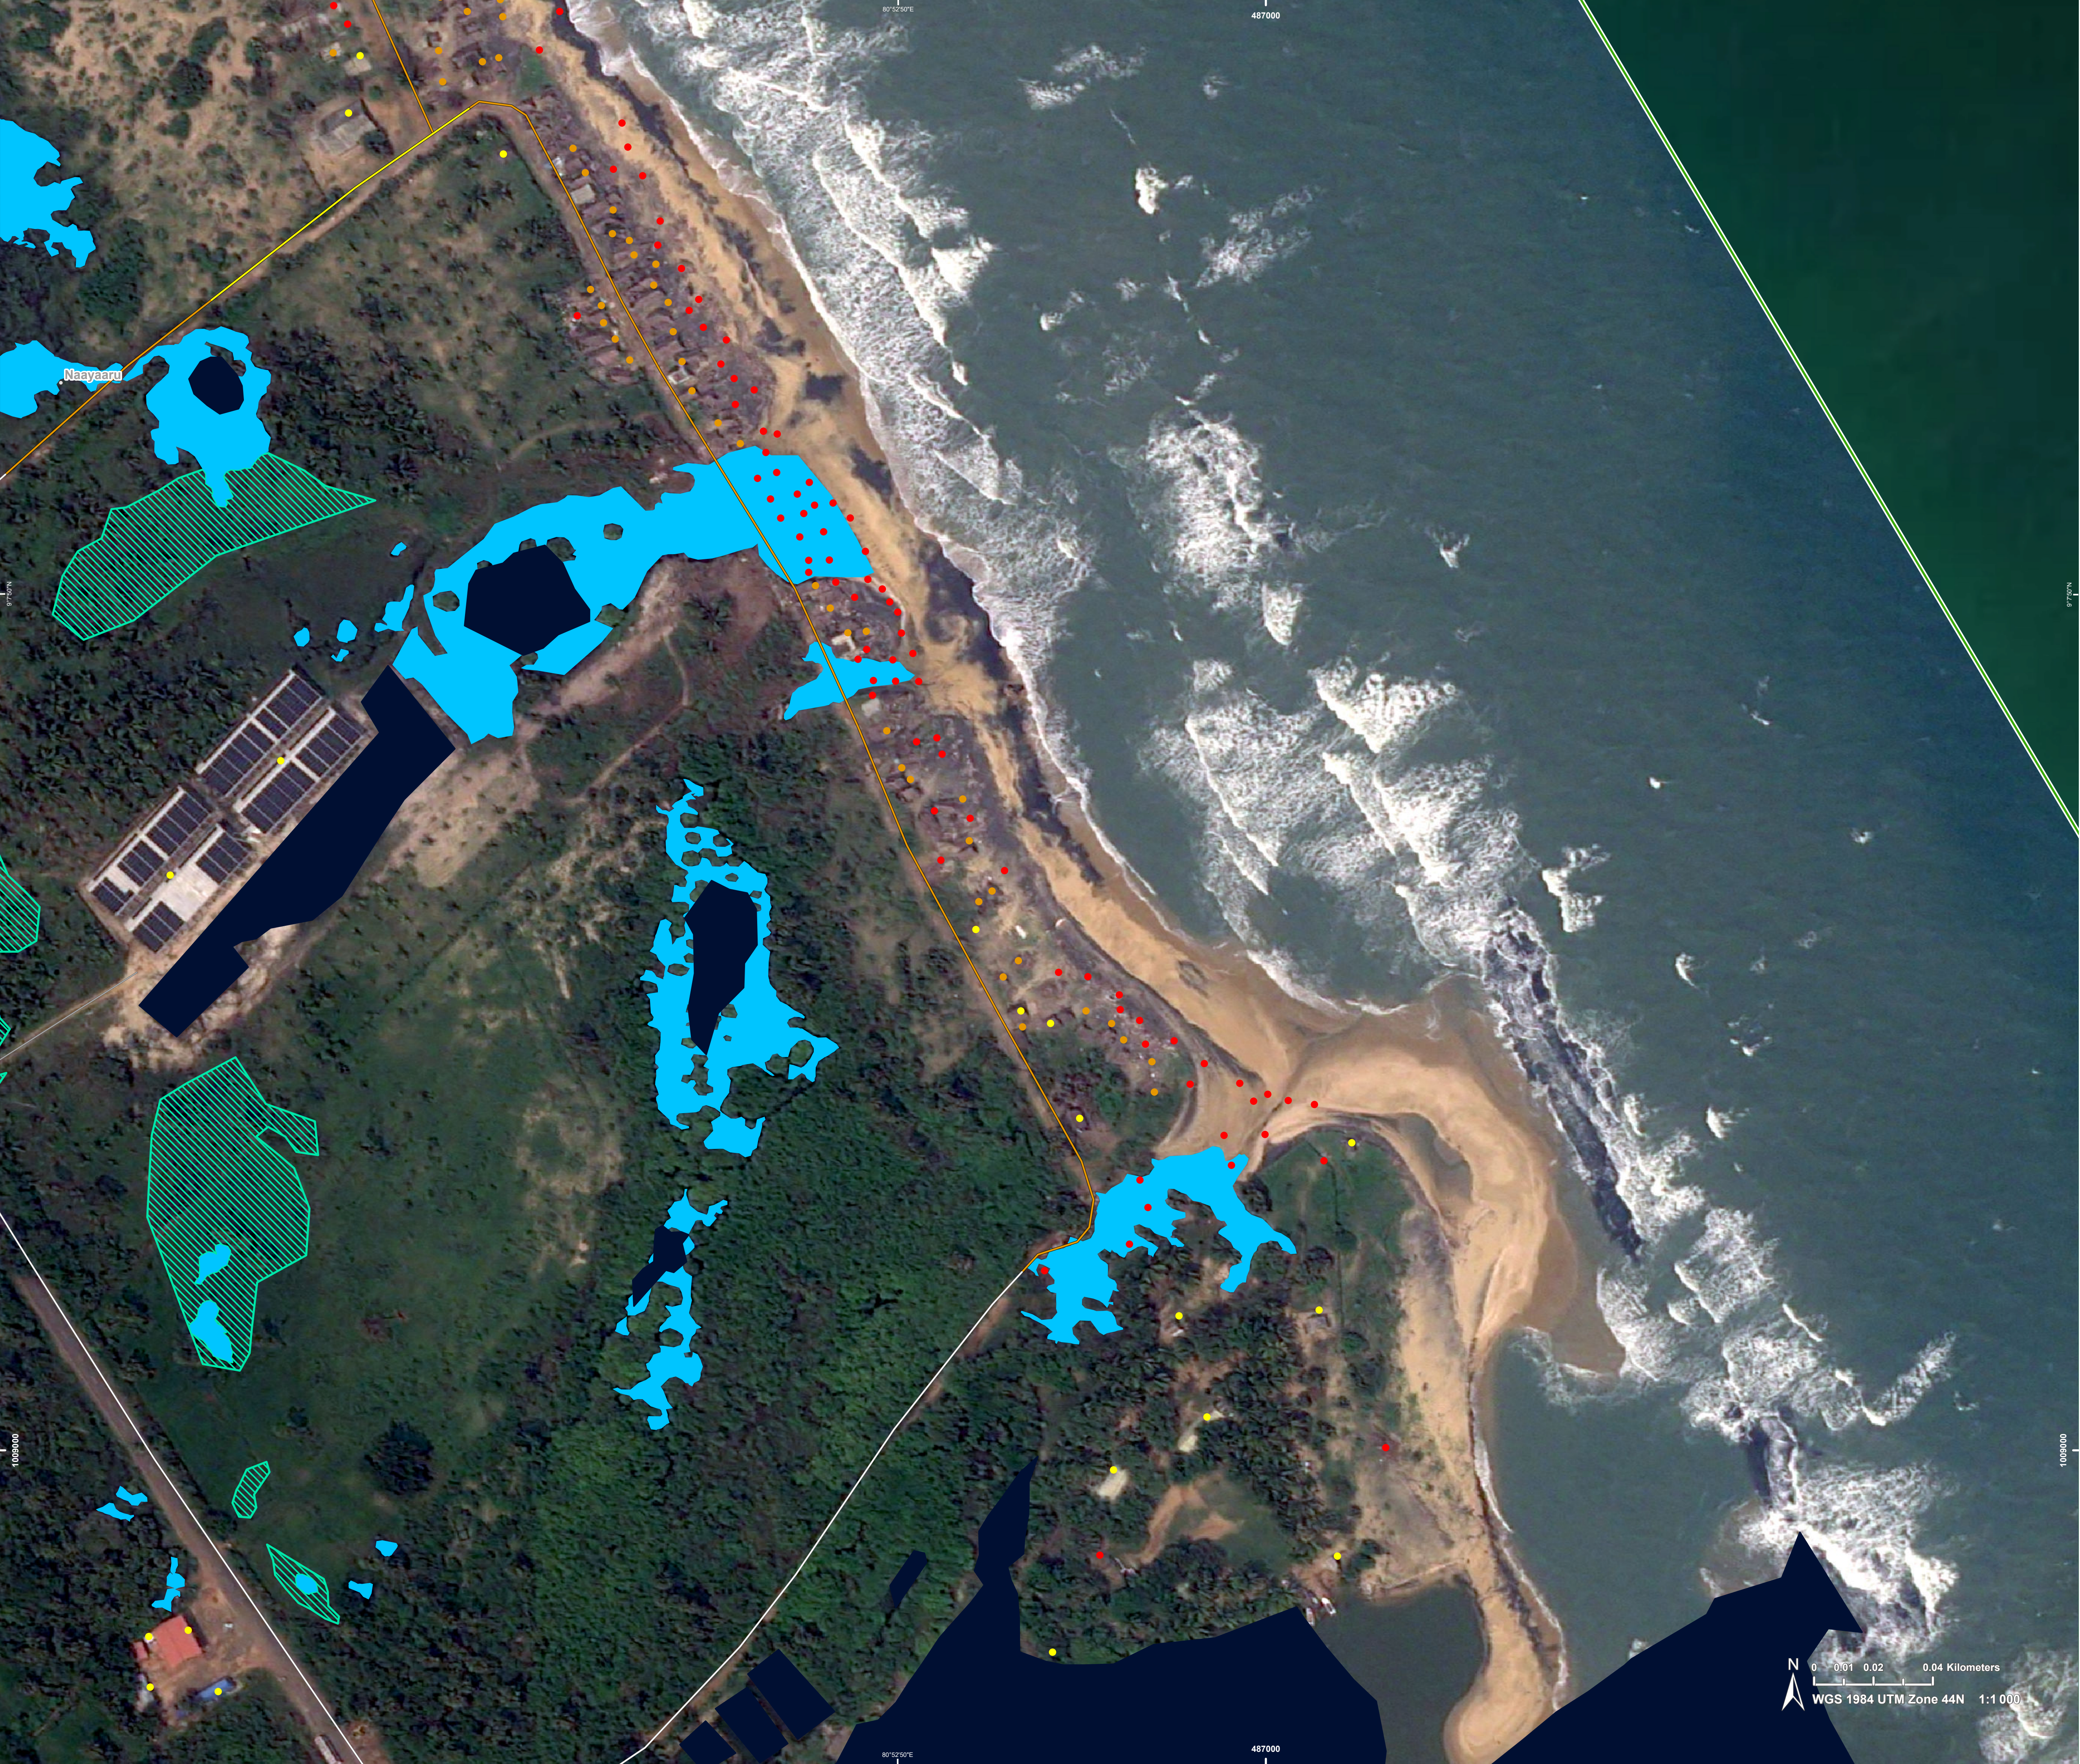
Unit of measurement	LATEST IMPACT	
				EO-based observation*	
Crisis information	Flood trace		ha		5.8
	Flooded area		ha		5.7
	Maximum of all extents**		ha		11.5

Estimated population		Inhabitants	No.	Destroyed	Damaged	Possibly damaged***	Total affected****	Total in AOI
Assets		Built-up	No.				NA	~ 30
	Transportation	Residential Buildings	No.	134	64	44	242	338
		Highways	km	0	0.8	0.4	1.2	4.2
		Secondary Road	km	0.04	0.01	0.2	0.3	4.3
		Local Road	km	0	0	0.1	0.1	2.5
		Cart Track	km	0	0	0	0	1.2
	Land use	Heterogeneous agricultural areas	ha				6.1	107.7
		Forests	ha				2.8	171.1
		Other	ha				2.6	550.5
		Shrub and/or herbaceous vegetation association	ha				0.04	6.0
		Inland wetlands	ha				0	2.4
